Aircraft Type and Registration:	Airbus A320-231, G-JOEM	
No & Type of Engines:	2 IAE V2500-A1 turbofan engines	
Year of Manufacture:	1993	
Date & Time (UTC):	17 March 2004 at 1540 hrs	
Location:	Birmingham Airport, West Midlands	
Type of Flight:	Public Transport (Passenger)	
Persons on Board:	Crew - 6	Passengers - 168
Injuries:	Crew - None	Passengers - None
Nature of Damage:	Damage to forward left cabin door	
Commander's Licence:	Airline Transport Pilot's Licence	
Commander's Age:	36 years	
Commander's Flying Experience:	7,000 hours (of which 4,400 were on type) Last 90 days - 155 hours Last 28 days - 50 hours	
Information Source:	Aircraft Accident Report Form submitted by the pilot and further enquiries by the AAIB

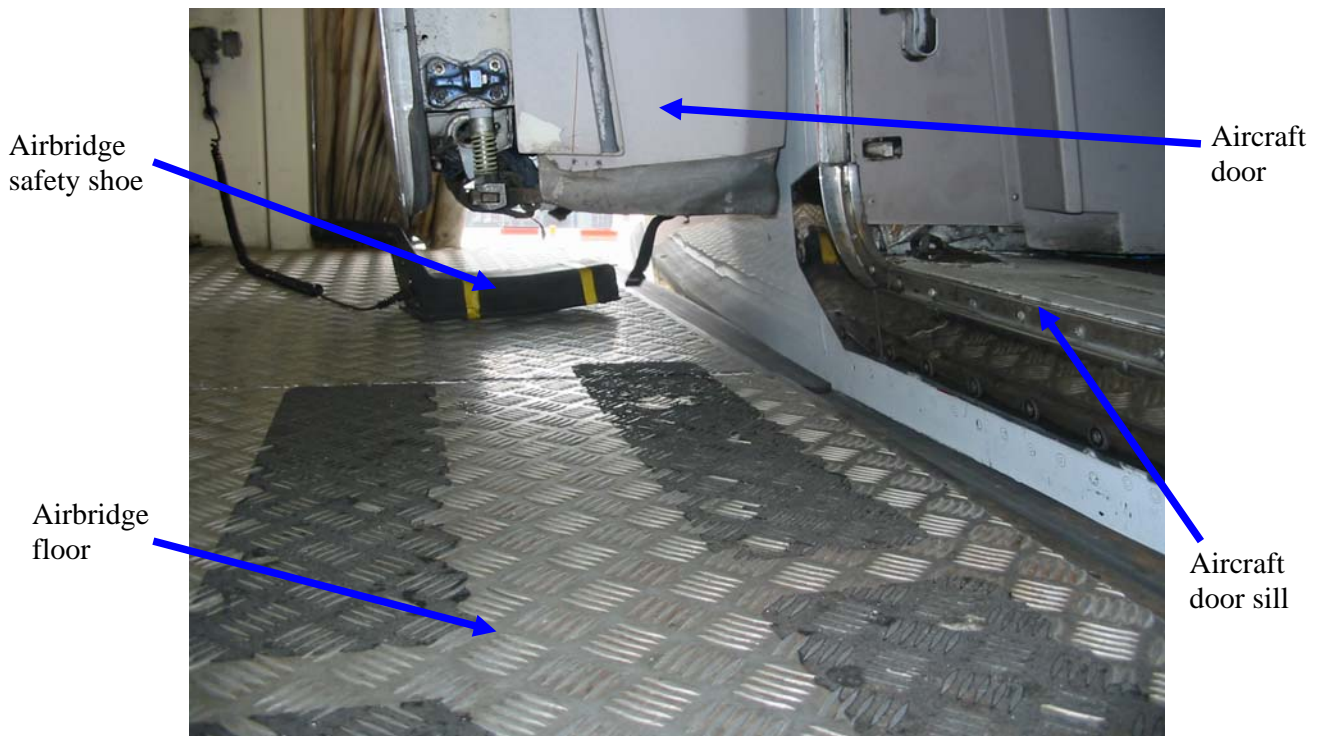
Figure 2

The ground agent pressed the autolevel reset button, which was flashing on the airbridge control panel, and passenger boarding was stopped. She stated that the airbridge then moved up slightly and she immediately hit the emergency stop button, thus cutting power to the airbridge and freezing its position. The passengers who had already boarded were disembarked, to reduce the pressure on the bottom of the aircraft door; the airbridge controls were reset and the airbridge was moved away from the aircraft. The forward left door of the aircraft had sustained damage to its hinges and its bottom edge.
