INCIDENT

Aircraft Type and Registration:	Airbus A320-214, G-BXKD
No & Type of Engines:	2 CFM56-5B4/P turbofan engines
Category:	1.1
Year of Manufacture:	1997
Date & Time (UTC):	15 January 2005 at 1635 hrs
Location:	London Gatwick Airport, West Sussex
Type of Flight:	Public Transport (Passenger)
Persons on Board:	Crew - 7 Passengers - 177
Injuries:	Crew - None Passengers - None
Nature of Damage:	Left nose wheel detached from aircraft
Commander's Licence:	Airline Transport Pilot's Licence
Commander's Age:	40 years
Commander's Flying Experience:	6,200 hours (of which 4,400 were on type) Last 90 days - 113 hours Last 28 days - 55 hours
First Officer's Flying Experience	4,392 hours (of which 2,566 were on type) Last 90 days - 82 hours Last 28 days - 36 hours
Information Source:	AAIB Field Investigation

Synopsis

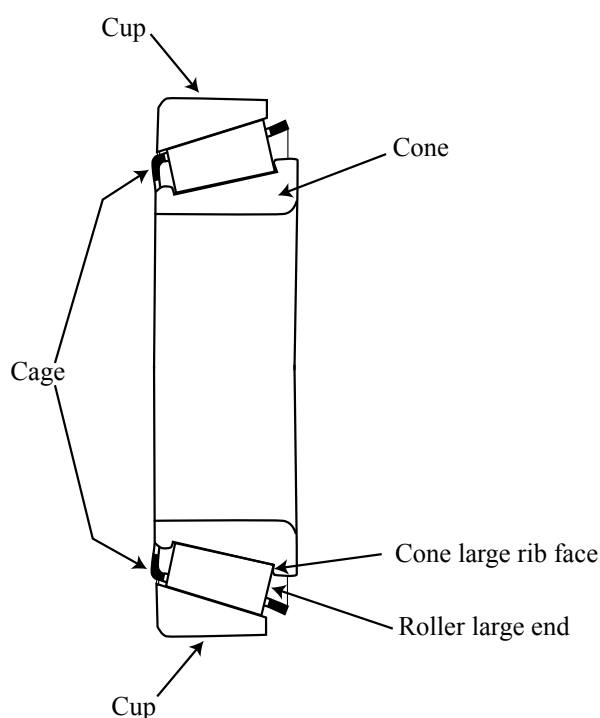
Figure 4

The nose wheel bearing consists of a cone, taper roller, cup and cage (Figure 4). The cup is fixed to the hub and is not normally replaced at wheel overhaul unless there is any evidence of physical damage. The tapered rollers are spaced and retained on the cone by the cage. The radial and side forces on tapered roller bearings are reacted primarily by the tapered races and roller bodies, and also by the roller large end and cone large rib faces.

Roller end scoring results from metal to metal contact between the roller large end and cone rib face. In normal operation the roller body rolls along the face of the cone, whilst the roller large end moves with a sliding and rolling motion across the cone large rib face. However, if the load between the roller large end and rib face is too high, or there is insufficient lubrication,

then metal to metal contact between the roller large end and rib face could occur. This contact may result in the micro-welding and tearing of metal causing excessive heat to be generated. The increase in friction at the roller large end would cause the rollers to start to skew and slide along the cone face, causing the softer cage pockets to be distorted. A further increase in temperature might be sufficient to cause the rollers to weld to the cone and 'bearing lock up' to occur.
