ACCIDENT

Aircraft Type and Registration:	SZD-48-1 Jantar Sandard 2, G-CFHV	
No & Type of Engines:	None	
Year of Manufacture:	1980	
Date & Time (UTC):	31 May 2009 at 1400 hrs	
Location:	Long Mynd Airfield, Shropshire	
Type of Flight:	Private	
Persons on Board:	Crew - 1	Passengers - None
Injuries:	Crew - 1 (Fatal)	Passengers - N/A
Nature of Damage:	Glider destroyed	
Commander's Licence:	BGA Bronze certificate	
Commander's Age:	49 years	
Commander's Flying Experience:	53 hours (of which 2 were on type) Last 90 days - 38 hours Last 28 days - 11 hours	
Information Source:	AAIB Field Investigation

Synopsis

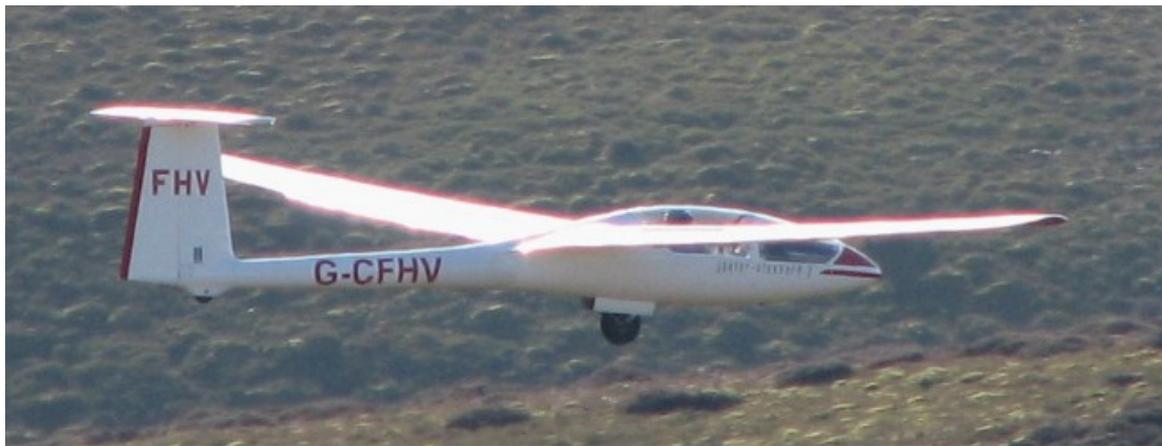
Figure 1

The Jantar Standard 2 is a high performance sailplane of Standard Class, see Figure 1. The cantilever shoulder wings have single glass fibre main spars, no ribs and are covered with foam core moulded skins. The wings have simple ailerons and airbrakes in the upper and lower surfaces of each wing. There is provision for water ballast, but this facility was not used on the accident aircraft. The glass fibre fuselage has a steel tube central frame, and the rear portion is stiffened by half-frames and ribs. The seat back is adjustable to accommodate pilots of varying sizes. The cantilever T-tail is of similar construction to the wings and has a spring trim in the elevator. There is a retractable monowheel with disc brake and a semi-recessed tail wheel.

Jantar Standard 2 G-CFHV
