# AAIB Bulletin S1/2011

## SPECIAL

### SERIOUS INCIDENT

<b>Aircraft Type and Registration:</b>	ATR 72-202, EI-SLG	
<b>No &amp; Type of Engines:</b>	2 x Pratt and Whitney PW124B turboprop engines	
<b>Year of Manufacture:</b>	1990	
<b>Date &amp; Time (UTC):</b>	15 March 2011 at 2130 hrs	
<b>Location:</b>	Near Edinburgh Airport	
<b>Type of Flight:</b>	Commercial Air Transport (Non-Revenue)	
<b>Persons on Board:</b>	Crew - 2	Passengers - None
<b>Injuries:</b>	Crew - None	Passengers - N/A
<b>Nature of Damage:</b>	None	
<b>Commander's Licence:</b>	Air Transport Pilot's Licence	
<b>Commander's Age:</b>	45 years	
<b>Commander's Flying Experience:</b>	TBA	
<b>Information Source:</b>	AAIB Field Investigation

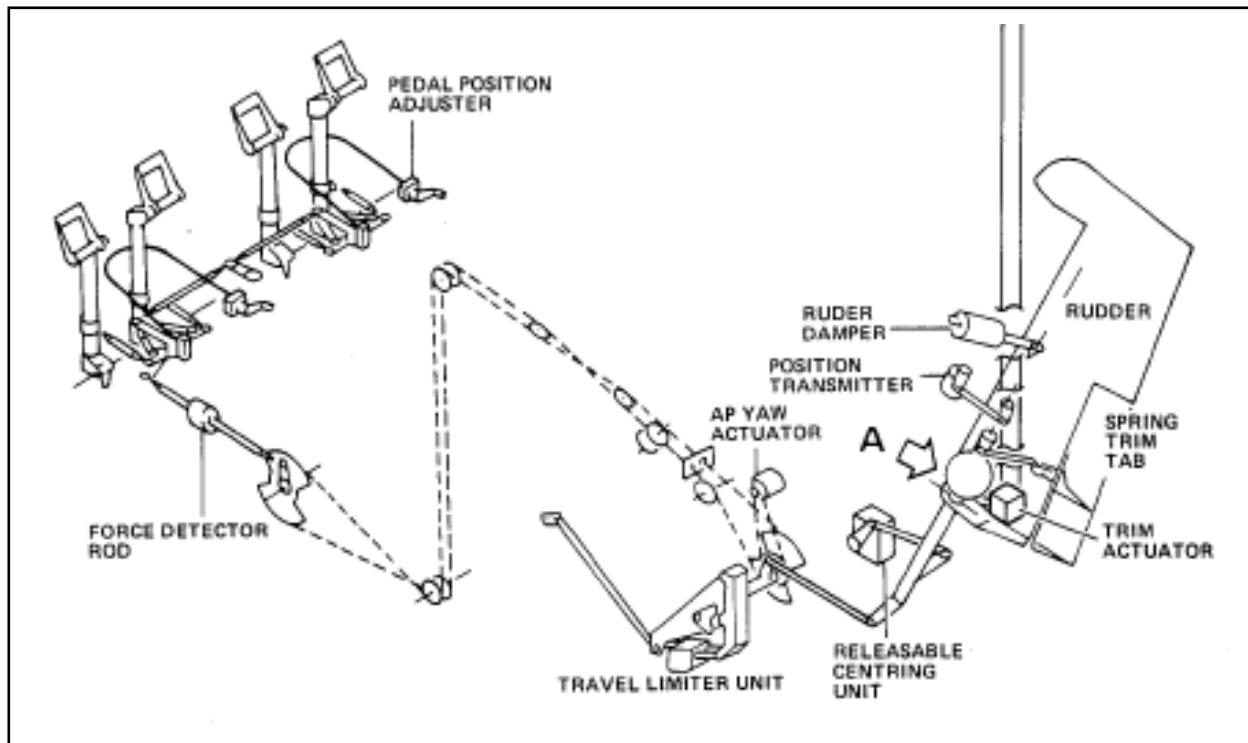
**Figure 1**  
ATR 72 Rudder control system

The rudder linkage on the ATR 72 is a mechanical system composed of quadrants, pulleys, rods and a cable (Figure 1). The rudder pedals are linked to a force detector rod which produces movement of the forward quadrant. A cable loop links the forward and aft quadrants. The rudder is operated by means of mechanical linkages connected to the rudder rear quadrant shaft.

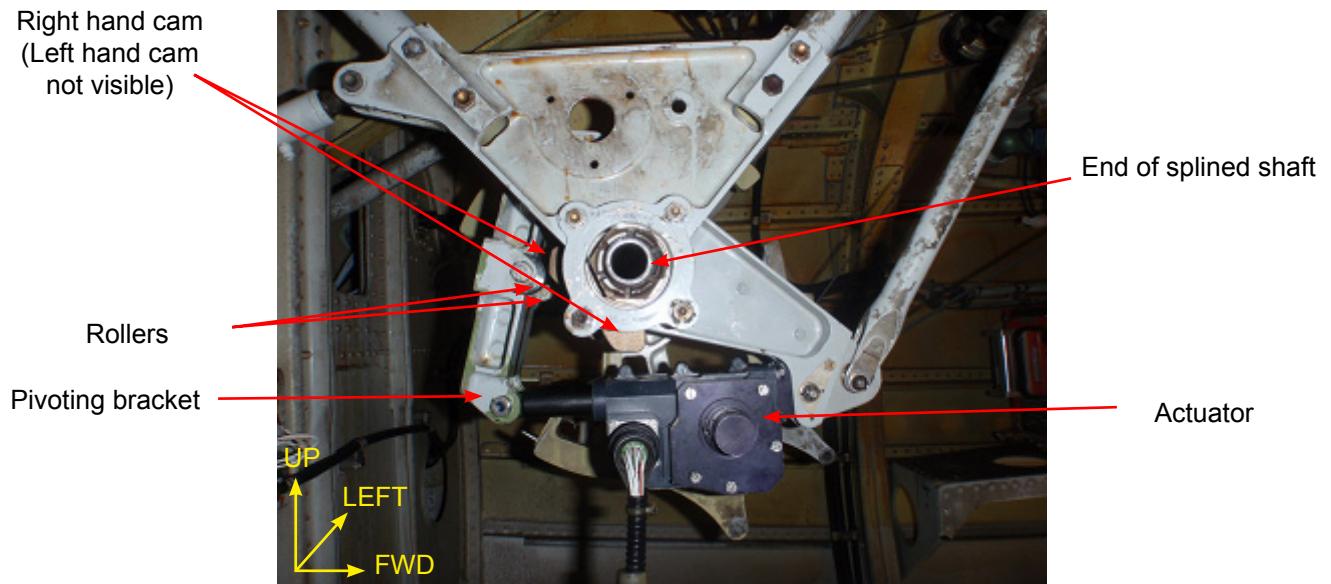
**Figure 2**  
Rudder Travel Limitation Unit

The TLU comprises an electrical actuator with two output shafts, two vee-shaped cams mounted on the rudder rear quadrant shaft and a pivoting bracket on which are mounted two rollers. The position of the pivoting bracket and hence the rollers is a function of the actuator extension. When the actuator is retracted, each roller is positioned into the vee groove of its corresponding cam (Figure 2).

In the reduced authority position the actuator retracts, rotating the bracket about its pivot, thereby engaging the rollers in the vee cams and thus mechanically limiting

the rudder deflection. In the full authority position the actuator extends, disengaging the rollers from the vee cams such that rudder deflection is no longer limited. A green LO SPD indicator light illuminates in the cockpit when the TLU is in the full authority position.
