AIRCRAFT ACCIDENT REPORT 7/2008

Air Accidents Investigation Branch

**Report on the accident to
Aerospatiale SA365N, registration G-BLUN
near the North Morecambe gas platform
Morecambe Bay
on 27 December 2006**

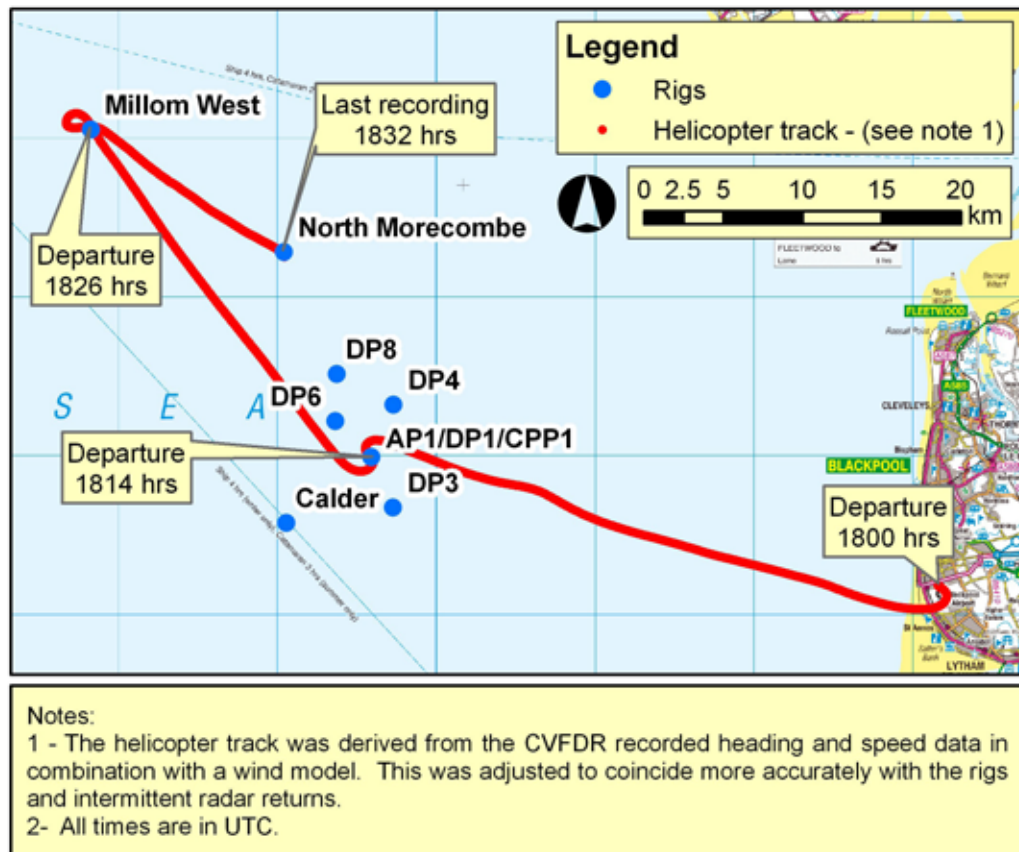
Figure 1

Overview of the helicopter movements

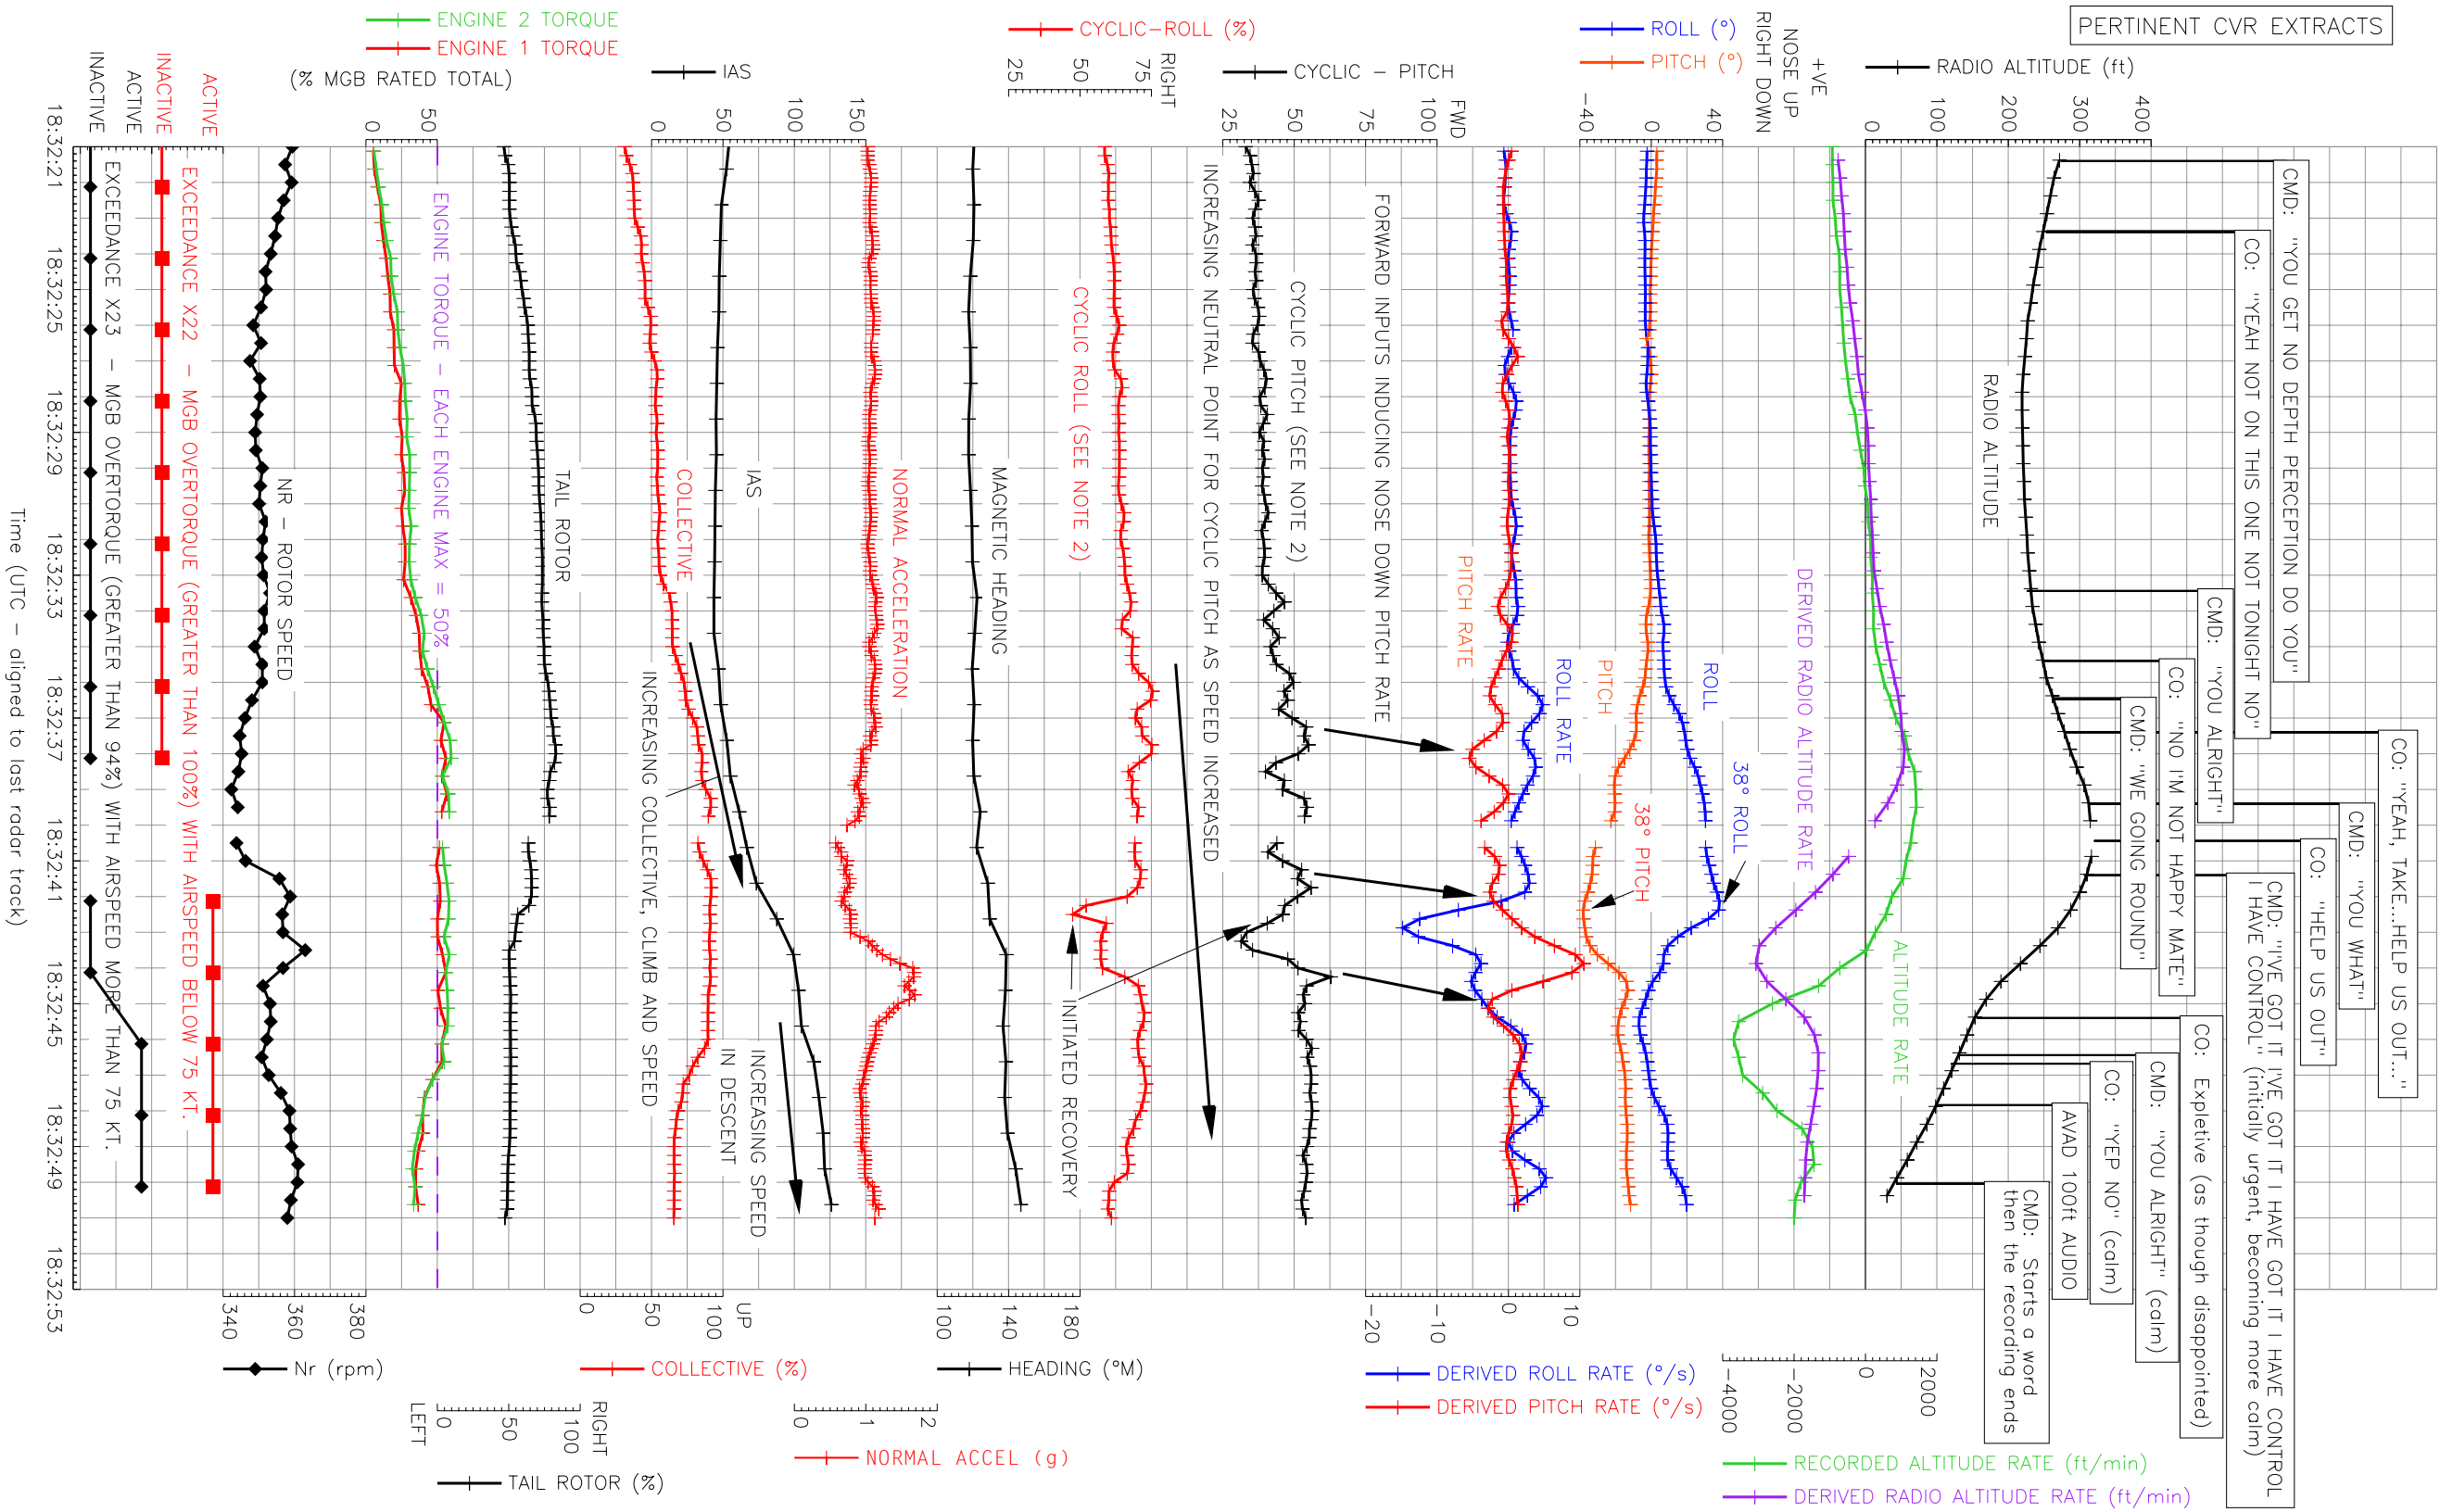
Figure 2

Pertinent data and audio extracts from the final portion of the flight, commencing at 18:32:21 hrs, are presented at Figure 2. The crew had already established visual contact with the platform and the commander had called 55 kt. At 18:32:21 hrs, the commander said “YOU GET NO DEPTH PERCEPTION DO YOU”, and the co-pilot replied “YEAH NOT ON THIS ONE NOT TONIGHT NO”. The first part of the approach was then marked by steady increases in the collective, tail rotor input, cyclic pitch and cyclic roll input; the radio height initially decreased then increased.

call. Cockpit communications were calm and there were no indications of additional problems. The last recorded radio altitude was 30 ft; at this time the helicopter attitude was a 12° nose down, with 20° bank to the right and the IAS was 126 kt. The recording ended at 18:32:50 hrs.

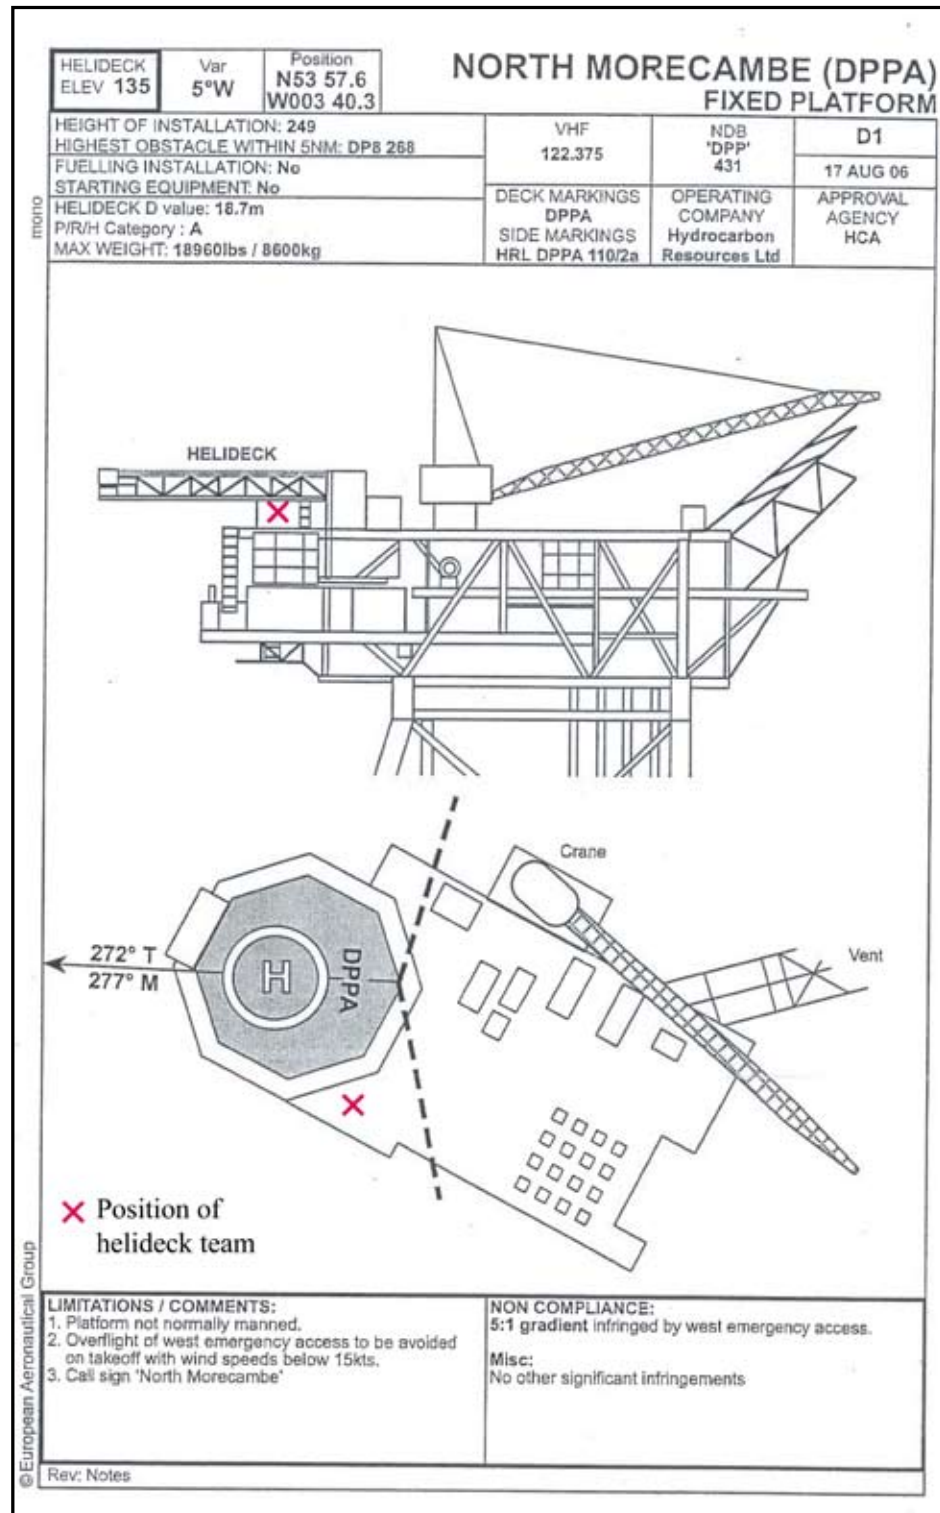
Figure 3
Location of helideck team

The three-man helideck team on the North Morecambe platform were positioned on the south-eastern edge of the helideck on steps, just below the level of the helideck (see Figure 3 for a diagram of the North Morecambe platform and the location of the helideck team). They were waiting for the helicopter to pick up a passenger and some freight. When they first saw the helicopter they estimated the visibility to be about 1,500 m. Everything appeared normal, and they assumed that the helicopter would complete a standard approach and landing on the platform. After what seemed to be a controlled turn to its right the helicopter appeared to initiate a go-around, although it seemed to be faster and closer to the platform than normal. The helicopter was then seen to bank slightly right as it continued past them, maintaining a steady rate of descent.

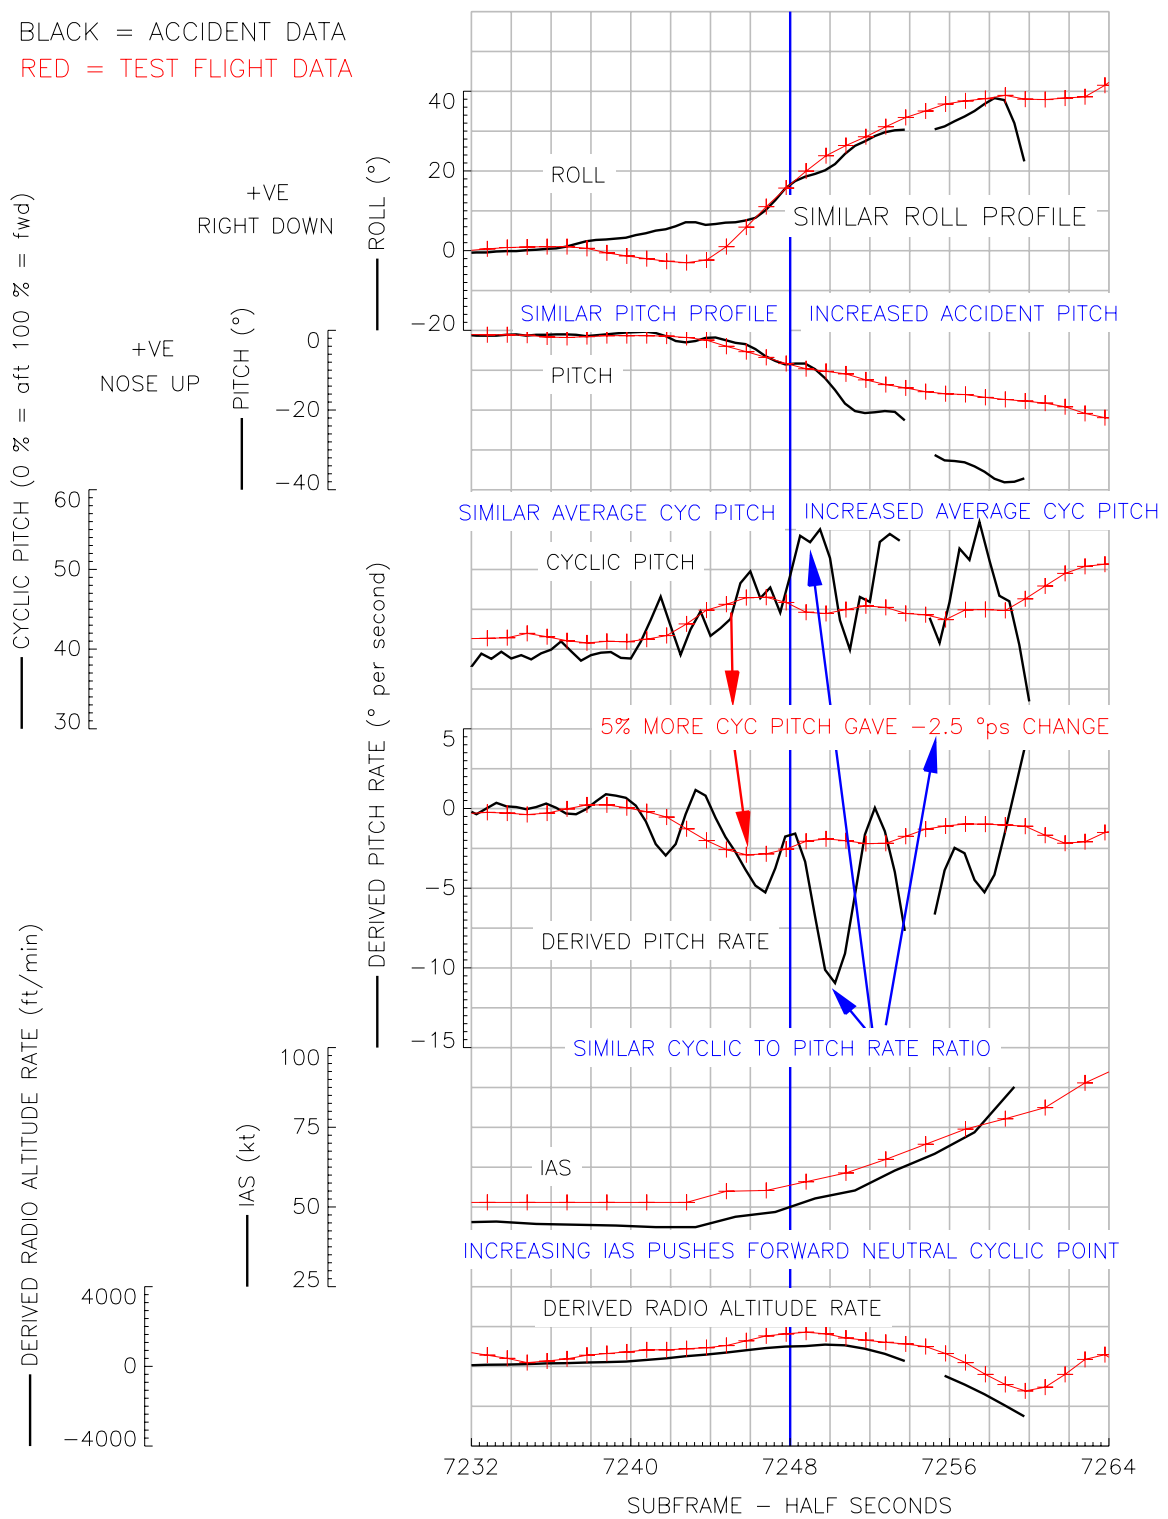
Figure 5

Whilst the flight test did not replicate the extreme pitch attitude achieved prior to the accident, it did replicate many of the characteristics for the entry into the pitch manoeuvre. A comparison of one of the flight test manoeuvres with the accident data is shown in Figure 5. The roll parameters demonstrate a close match as does the initial pitch deviation. The differences are that the test flight was approximately 8 kt faster and was entered whilst in a climb of approximately 500 fpm instead of roughly level. This resulted in the use of approximately 3% more cyclic pitch input to maintain neutral pitch with no change in helicopter motion. The test flight data indicates that with an additional 5% cyclic pitch input a 2.5° per sec nose down pitch rate was produced. The initiation of the pitching motion during the accident flight is less smooth but the peaks indicate a similar relationship in the order of 5% increased cyclic to 2.5° per sec nose down pitch rate. The pitch parameters deviate from each other when the accident data shows additional cyclic pitch inputs. Additional cyclic pitch input on the accident flight resulted in a pitch rate response similar in ratio to that recorded on the test helicopter. Given the variables that actually affect the helicopter's longitudinal characteristics it is acknowledged that this is only a crude comparison, but one that yields similar behaviour.

Comparison of pitch and roll parameters of the accident flight with the flight test data

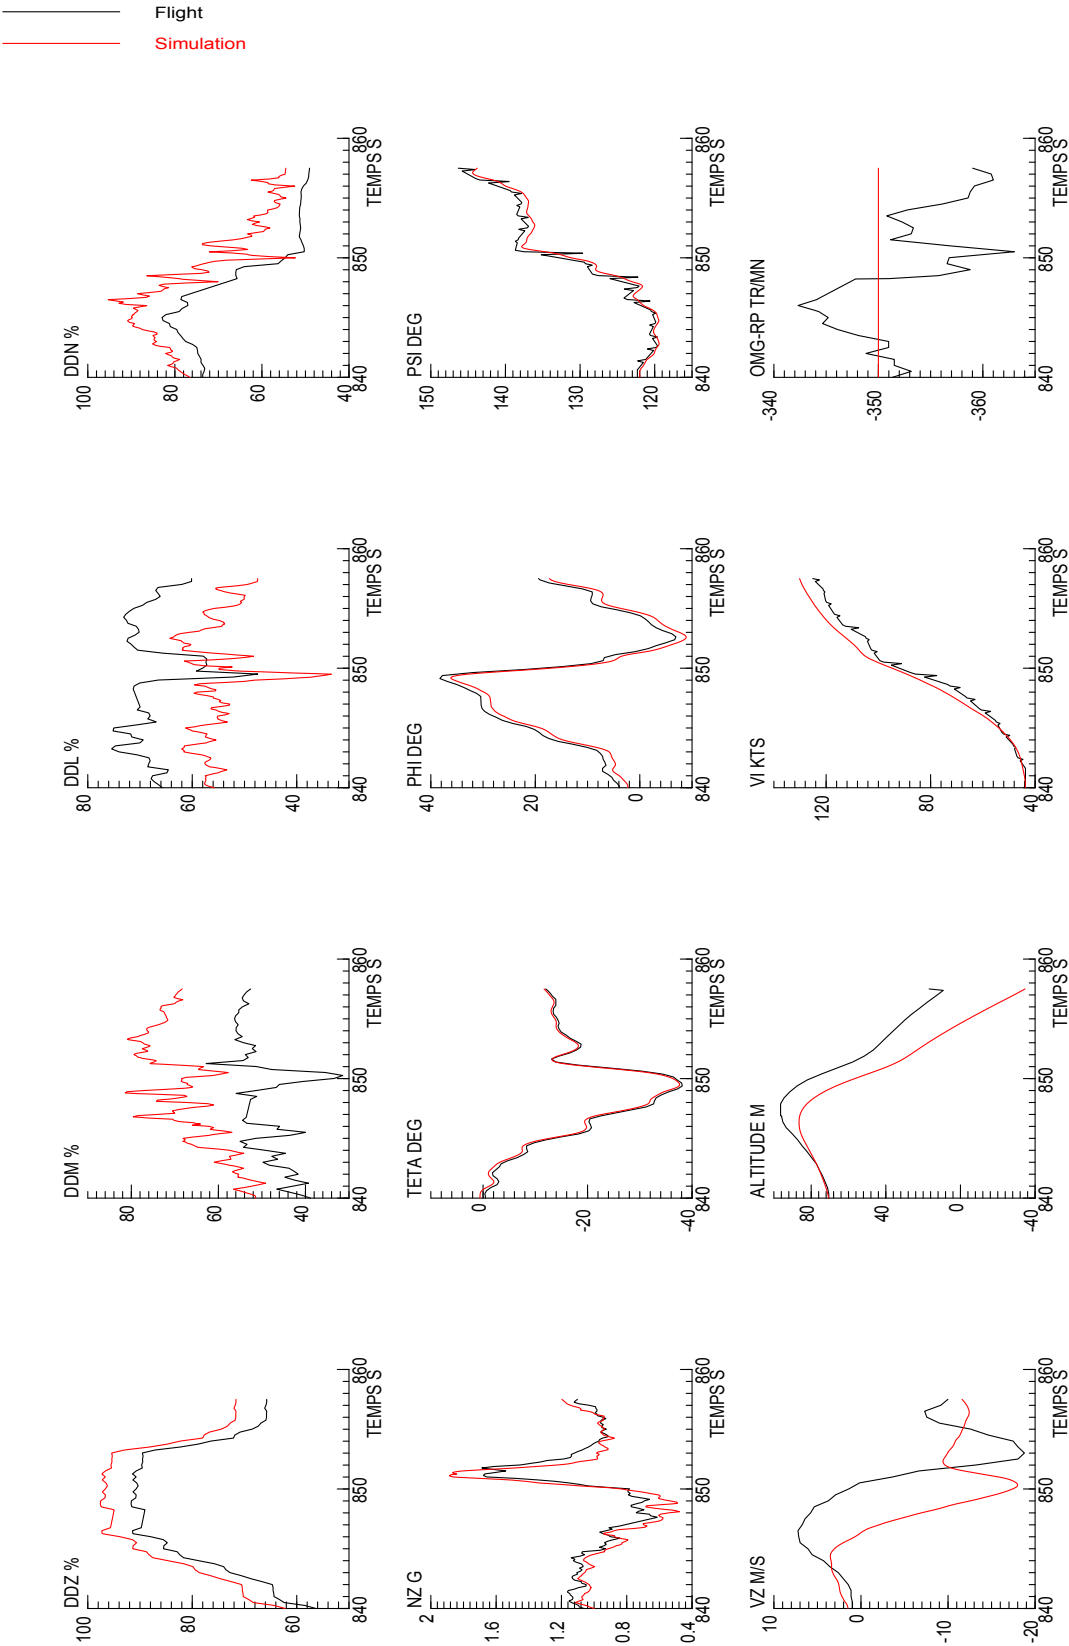
- It demonstrates a capability to pilot the trajectory in normal condition. The presence of wind gusts during the flight are highly probable and may explain differences observed on cyclic stick between simulation and flight.

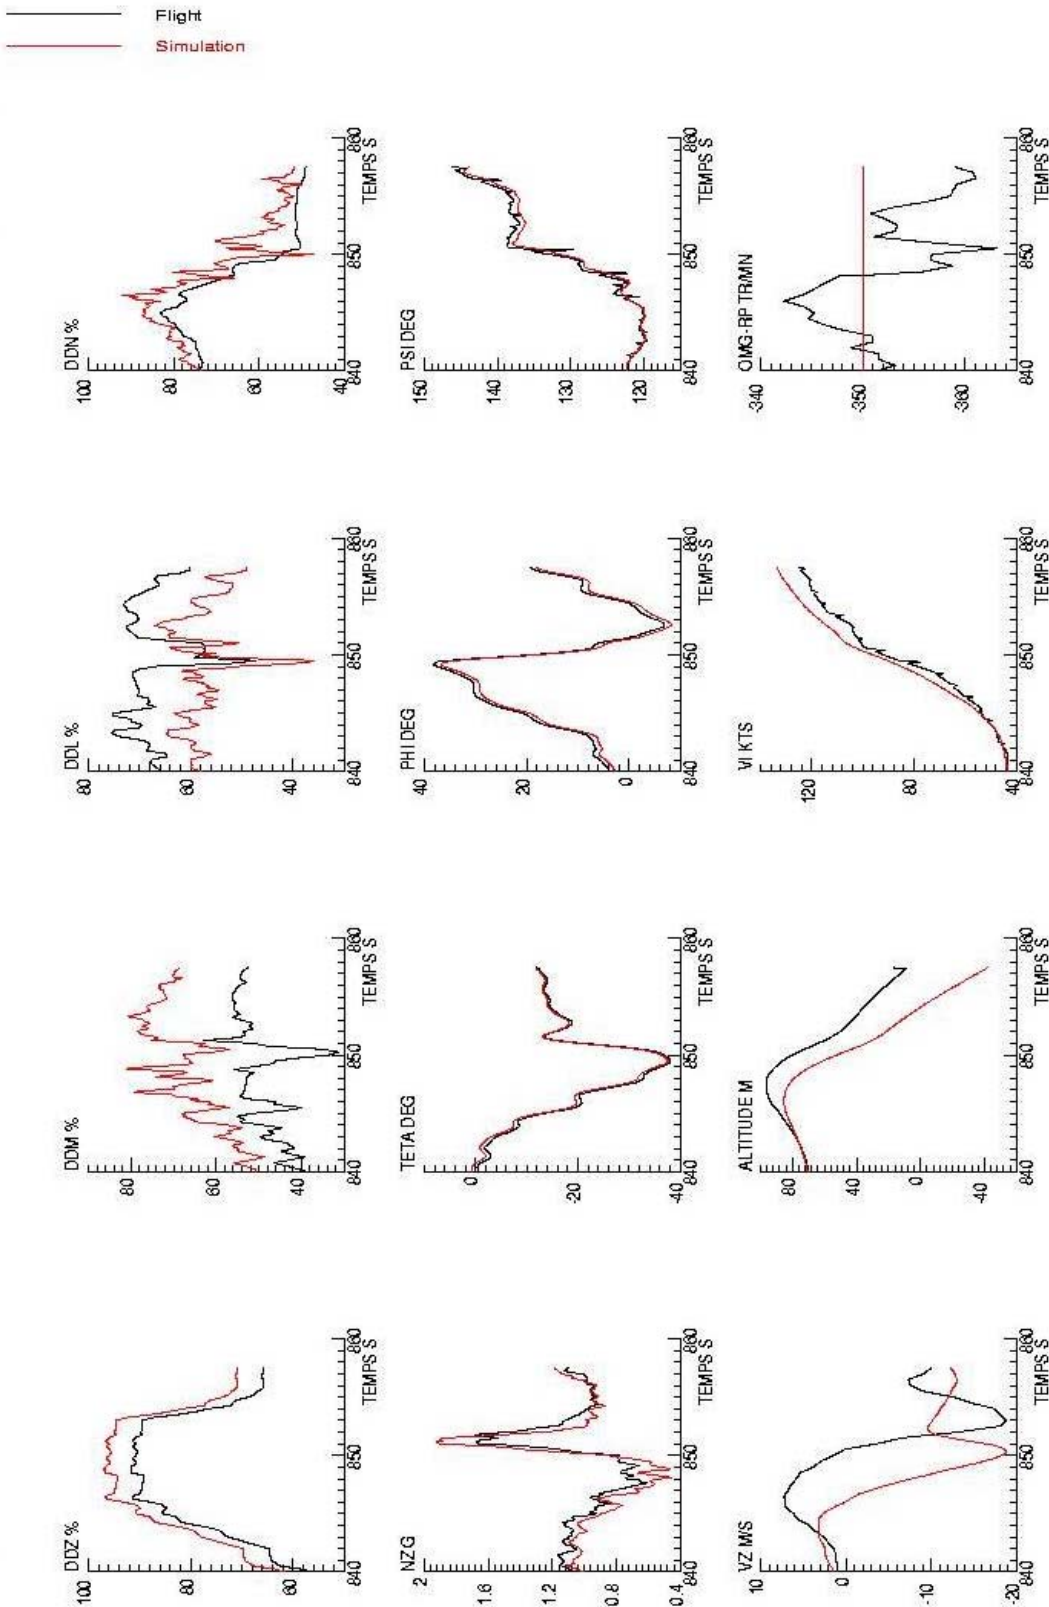
- It demonstrates a capability to pilot the trajectory in normal condition. Compared to the previous simulation (Crash G-BLUN - ETAGA conclusions - Corrected time base.doc) the additional sideslip increases the DDN of 3% and the DDL of 2%.
