**Report on the accident between
Cessna 402C, G-EYES and
Rand KR-2, G-BOLZ
near Coventry Airport
on 17 August 2008**

Aircraft Accident Report No: 8/2010 (EW/C2008/08/05)

Aircraft Types: 1) Cessna 402C
2) Rand KR-2

Registrations: 1) G-EYES
2) G-BOLZ

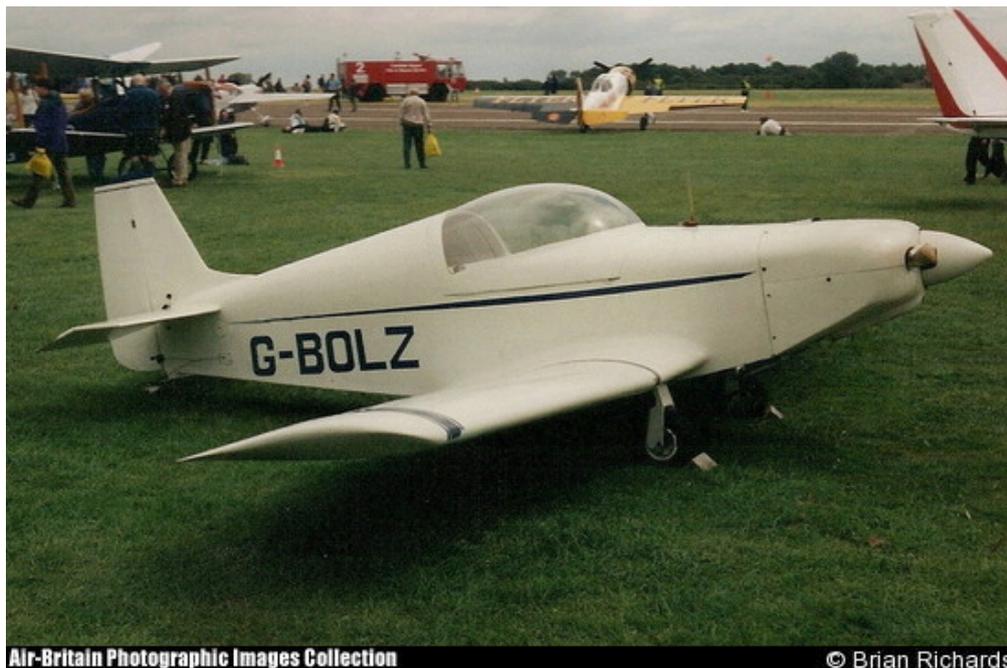
Figure 5

This aircraft was constructed by the owner/pilot and first flew in 1991. It was operated on a Permit to Fly, which was valid at the time of the accident. There was no record of any current defects in either the aircraft or engine log books. Prior to the accident flight, its third flight in the past 12 months, it had flown 653 hours and 40 minutes.

G-BOLZ

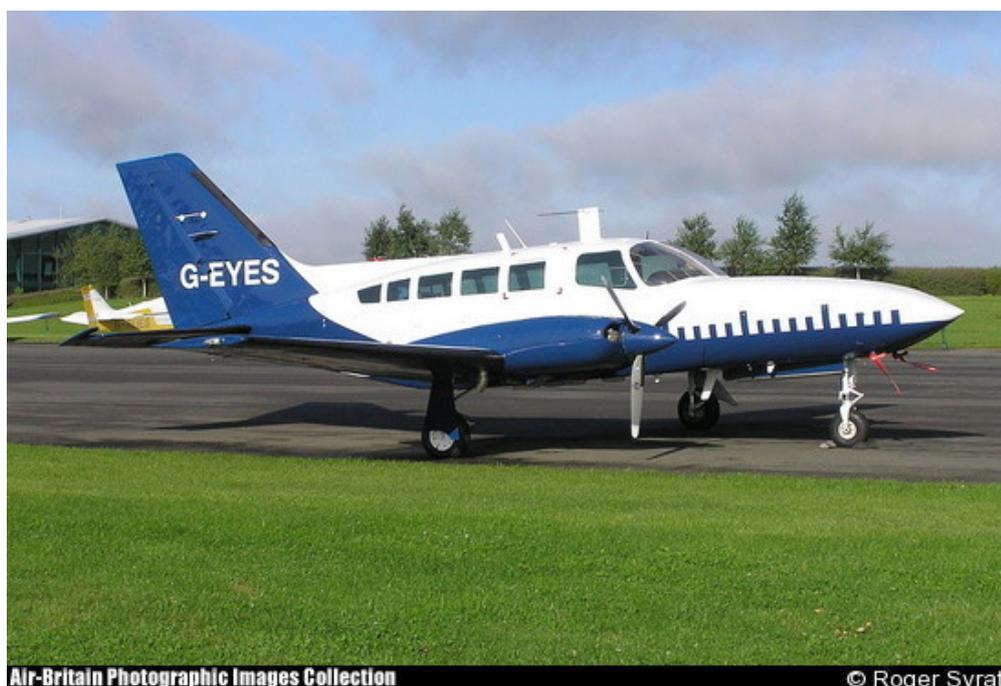
Figure 6

The aircraft held a valid Certificate of Airworthiness and Airworthiness Review Certificate. There were no significant defects recorded.

G-EYES

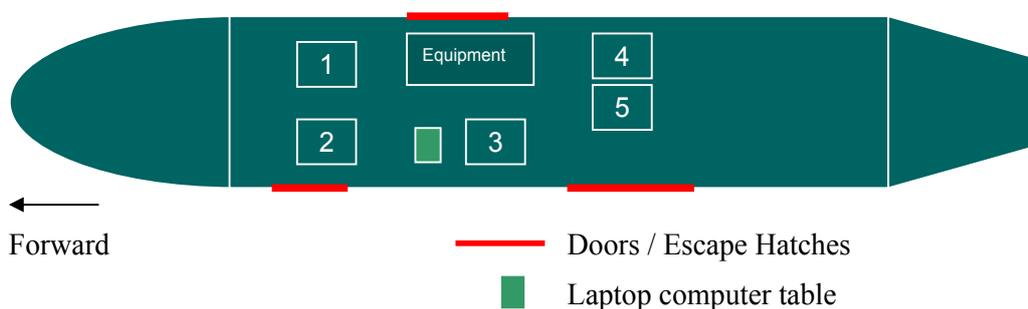
Figure 7

The interior was configured for the ILS calibration role and seats were provided for two pilots, a calibration engineer and two additional persons. The pilots' seats were fitted with car-type lap belts with a single shoulder strap; the calibration engineer's seat was equipped with a lap belt, crotch strap and two shoulder straps and the two remaining seats were equipped with lap belts only. The general cabin layout is shown in Figure 7. Calibration equipment was mounted on the floor tracks on the right side of the cabin and an additional monitor was mounted on the left side of the instrument panel (Figure 8). A table was positioned in front of the calibration engineer's seat for the use of a laptop computer.

G-EYES cabin layout

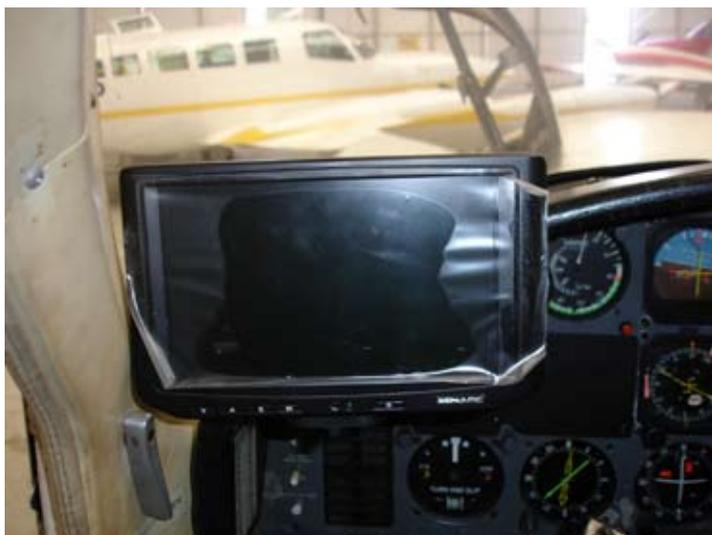
Figure 8

'Pilot vision has been considered and complied with by installing the monitor at a position where the view of the pilot was not impeded. It is also established that the clear view in rain and icing conditions is not affected and that the view through the opening window is also unaffected by this installation.'

This was carried out by the design engineer sitting in the pilot's seat and assessing the view. Pilots from the operator were also consulted to ensure that they were satisfied that the monitor did not significantly impair the view out of the cockpit.

Calibration equipment, pilot's monitor

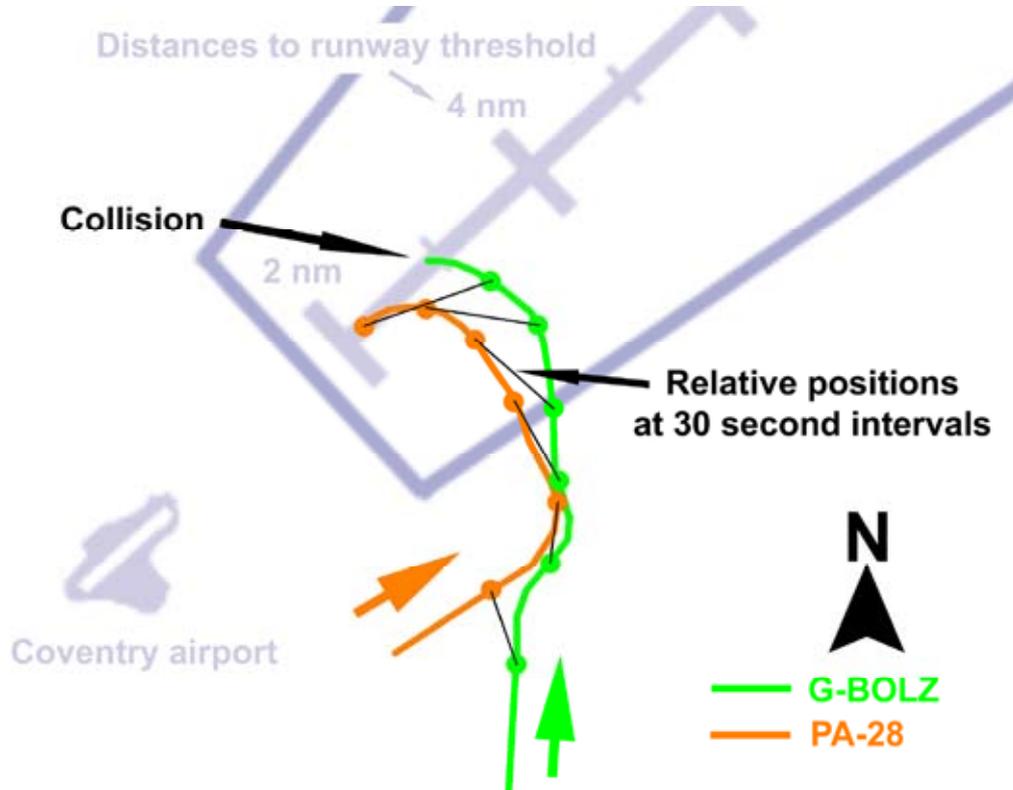
Figure 9

Figures 9 and 10 were generated from the amalgamation of the recorded data discussed above and show the tracks of G-BOLZ, G-EYES and the PA-28. Figure 10 shows that the bearing of G-BOLZ relative to the nose of G-EYES remained almost constant for approximately three minutes before the collision.

Separation between G-BOLZ and the PA-28
