**Air Accidents Investigation Branch**

**Report on the incident to  
Airbus A340-642, registration G-VATL  
en-route from Hong Kong to London Heathrow  
on 8 February 2005**

Published 4 September 2007

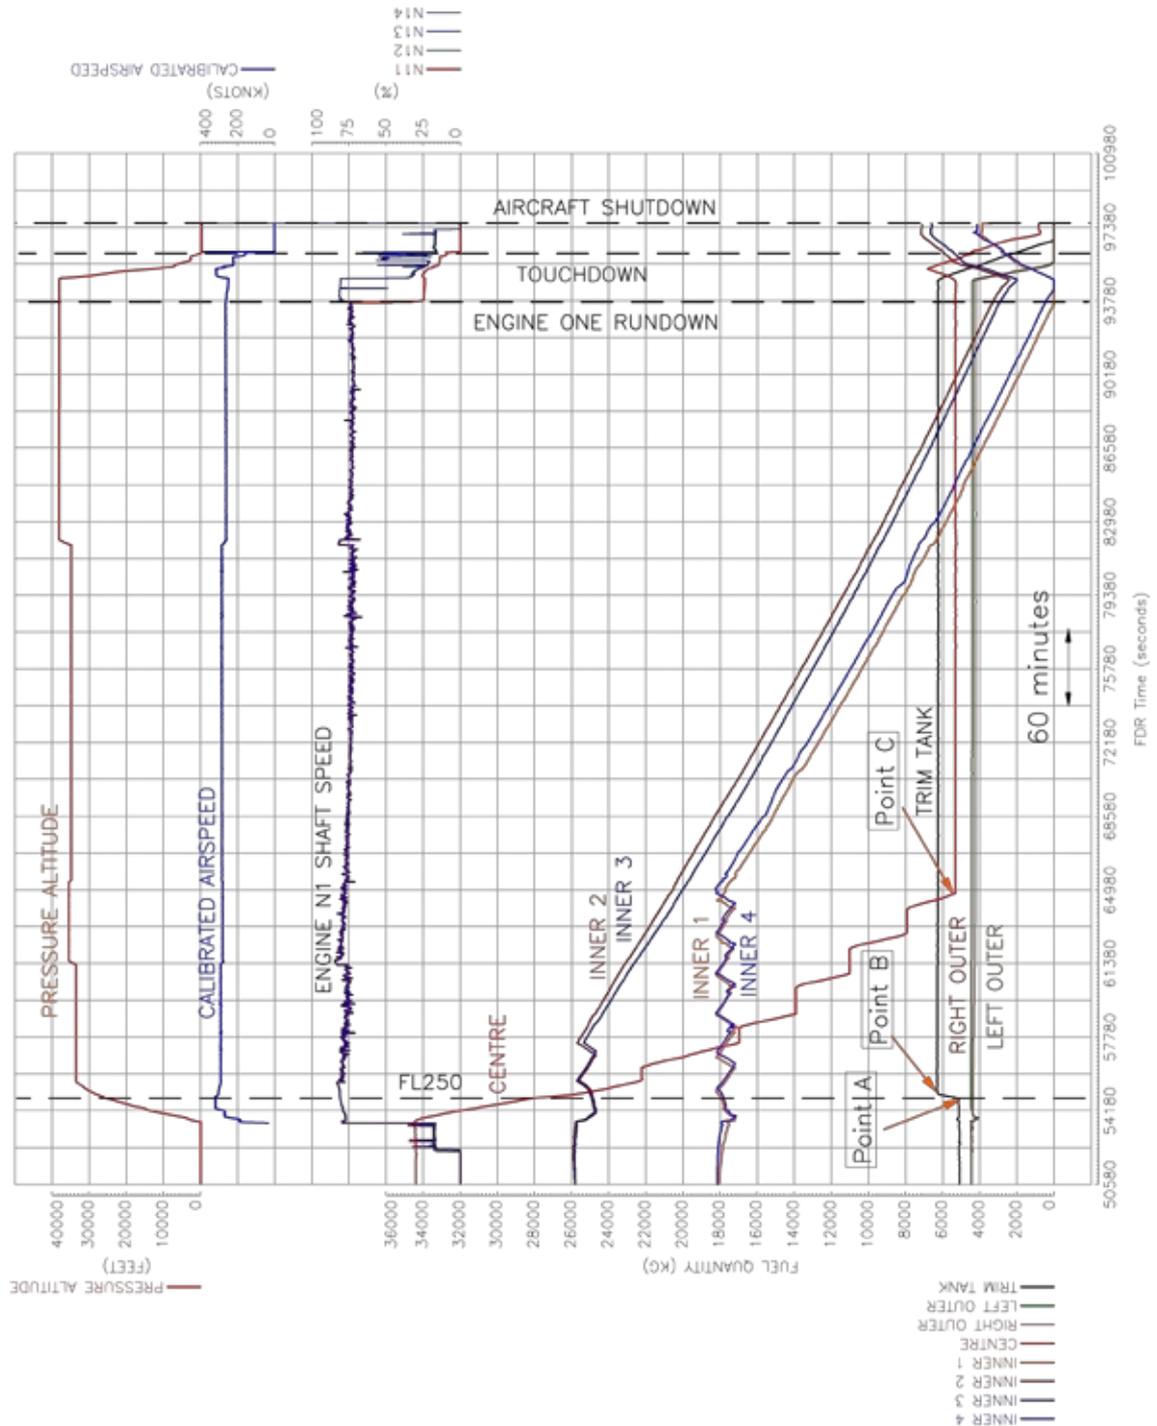
Figure 1

Takeoff occurred at about 1621 hrs with a total recorded fuel quantity of 135,400 kg<sup>8</sup>. Shortly after takeoff an autopilot was engaged. The aircraft climbed and when it was at about FL250 the trim tank quantity started to increase (see Appendix I, Figure 1, Point A). The aircraft continued to climb until it reached about FL335 at about 1655 hrs. By then the trim tank quantity had stabilised at about 6,280 kg (Figure 1, Point B).

At about 1928 hrs at FL354, the centre fuel tank quantity stabilised at about 5,312 kg (Figure 1, Point C).

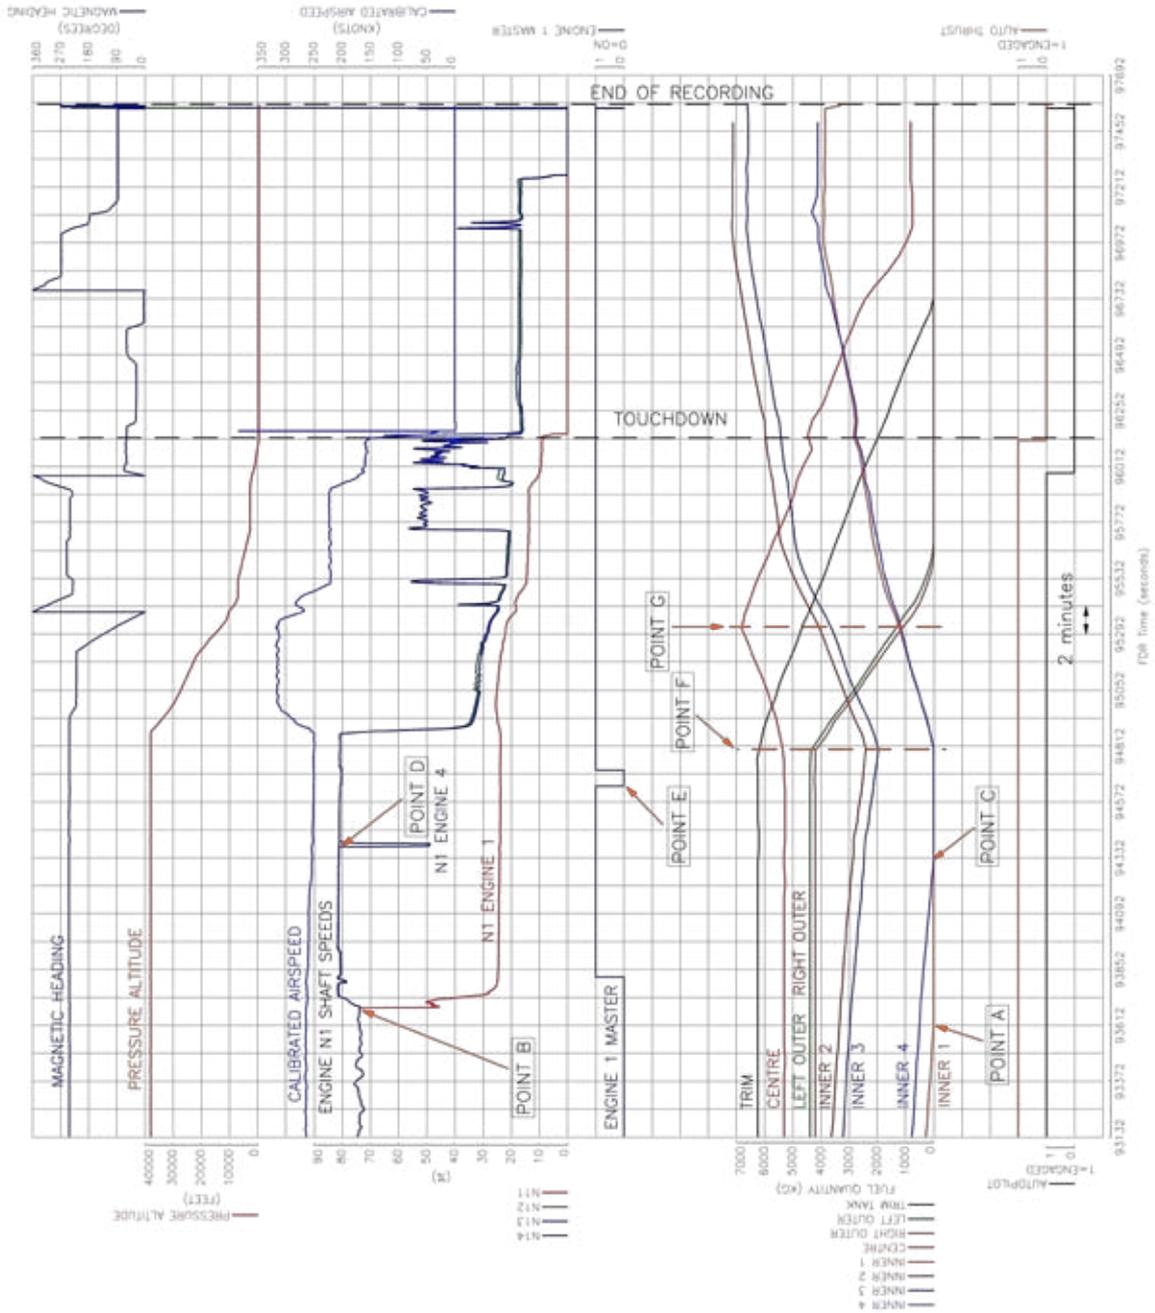
Figure 2

At 0328 hrs, at FL380 and at an airspeed of about 264 kt, the INNER 1 fuel tank quantity reduced to zero (Appendix 2, Figure 2, Point A). About 40 seconds later the No 1 engine  $N_1$  parameter decreased and the aircraft yawed (Figure 2, Point B) which alerted the crew to an engine problem. The No 1 engine thrust lever was retarded to the idle position and the numbers 2, 3 and 4 thrust levers were set to the maximum continuous thrust (MCT) detent position. Nevertheless, the airspeed slowly started to reduce.

At about 0340 hrs the Inner 4 fuel tank quantity reduced to zero (Figure 2, Point C). About 25 seconds later the No 4 engine  $N_1$  shaft speed started to reduce (Figure 2, Point D). Within 4 seconds the  $N_1$  shaft speed had reduced from about 80% to about 50%. This time the co-pilot said “*ITS NUMBER FOUR*” and, almost immediately, the commander said “*OPENING THE CROSS FEEDS*”. Shortly afterwards the No 4 engine  $N_1$  shaft speed started to increase. It continued to increase until it had stabilised at 80% some 11 seconds later. During this time the No 4 thrust lever position remained in the MCT detent position.

The commander advised ATC that the aircraft had a fuel management problem, that they needed to land as soon as possible, and that Amsterdam would be suitable airport. ATC subsequently provided a clearance to descend from FL380 to FL200 and shortly afterwards the flight crew initiated a descent (Figure 2, Point E). When the aircraft started to descend the airspeed was about 250 kt.

commander said he was concerned that fuel was not transferring out of the centre fuel tank to the inner fuel tanks. Subsequently the flight crew referred to a centre inner transfer tank fault procedure, during which they were recorded saying that the centre to inner fuel transfer switch was being set to the MANUAL position. The flight crew then discussed whether the fuel in the centre tank might be unusable if the centre tank quantity was less than 35 tonnes. One pilot then said *“WE DON'T KNOW WHETHER IT'S COMING OUT”*. The flight crew then agreed that they had about 10 tonnes of usable fuel. At the time the total fuel quantity in the four inner fuel tanks was about 9,985 kg and there was a total of about 14,000 kg of fuel in the centre, trim and outer fuel tanks. A short time later the centre tank fuel quantity started to reduce (Figure 2 Point G).

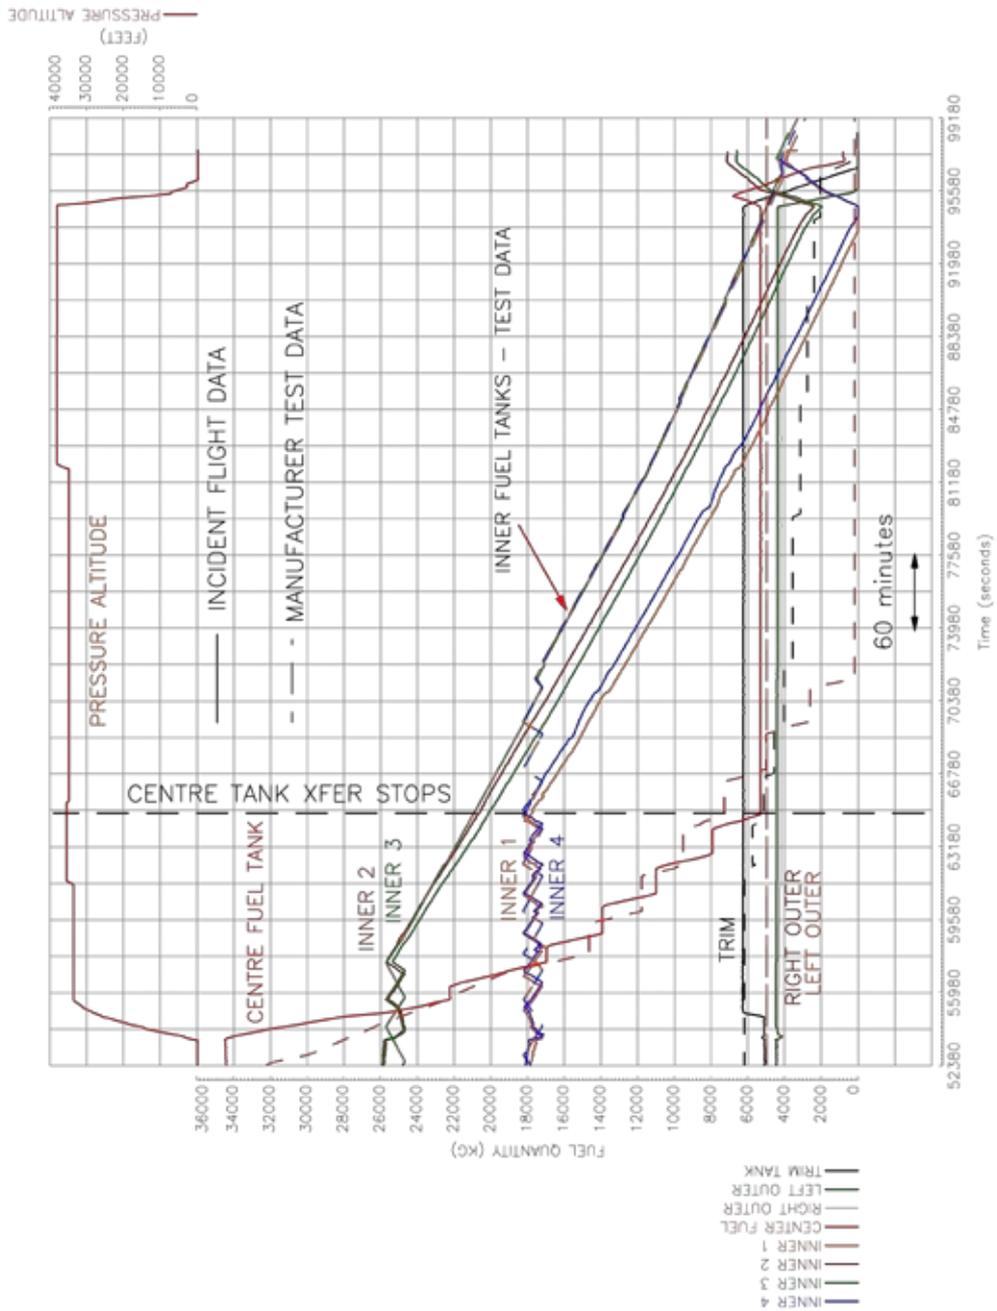
The aircraft manufacturer provided data that reflected normal fuel transfer. The graph at Appendix I Figure 3 illustrates fuel quantities during the incident flight plotted against normal fuel transfer data. It should be noted that due to variances in fuel burn between the manufacturer's data and the incident flight, 8,900 kg/hour against the average fuel burn of about 9,500 kg/hour respectively, the individual tank quantities do not track one another exactly, but they do typify the normal transfer of fuel from both the trim and the centre fuel tanks. The data was aligned so that the total fuel quantities were within 50 kg when G-VATL entered the cruise phase.
