ACCIDENT

Aircraft Type and Registration:	i) Airbus A340-313, 6Y-JMP ii) Boeing 777-222, N781UA
No & Type of Engines:	i) 4 CFM56-5C turbofan engines ii) 2 Pratt & Whitney PW4000 turbofan engines
Category:	1.1
Year of Manufacture:	i) 1992 ii) 1996
Date & Time (UTC):	14 July 2004 at 1254 hrs
Location:	Runway 27L Holding Area, London Heathrow Airport
Type of Flight:	i) Commercial Air Transport (Passenger) ii) Commercial Air Transport (Passenger)
Persons on Board:	i) Crew - 4 Passengers - 273 ii) Crew - N/K Passengers - N/K
Injuries:	i) Crew - N/K Passengers - N/K ii) Crew - None Passengers - None
Nature of Damage:	i) Damage to left winglet ii) Damage to right wing tip
Commander's Licence:	i) N/K ii) Air Transport Pilot's Licence
Commander's Age:	i) N/K ii) 47 years
Commander's Flying Experience:	i) N/K ii) 20,000 hours (of which 806 were on type) Last 90 days - 230 hours Last 28 days - 60 hours
Information Source:	AAIB Field Investigation

Synopsis

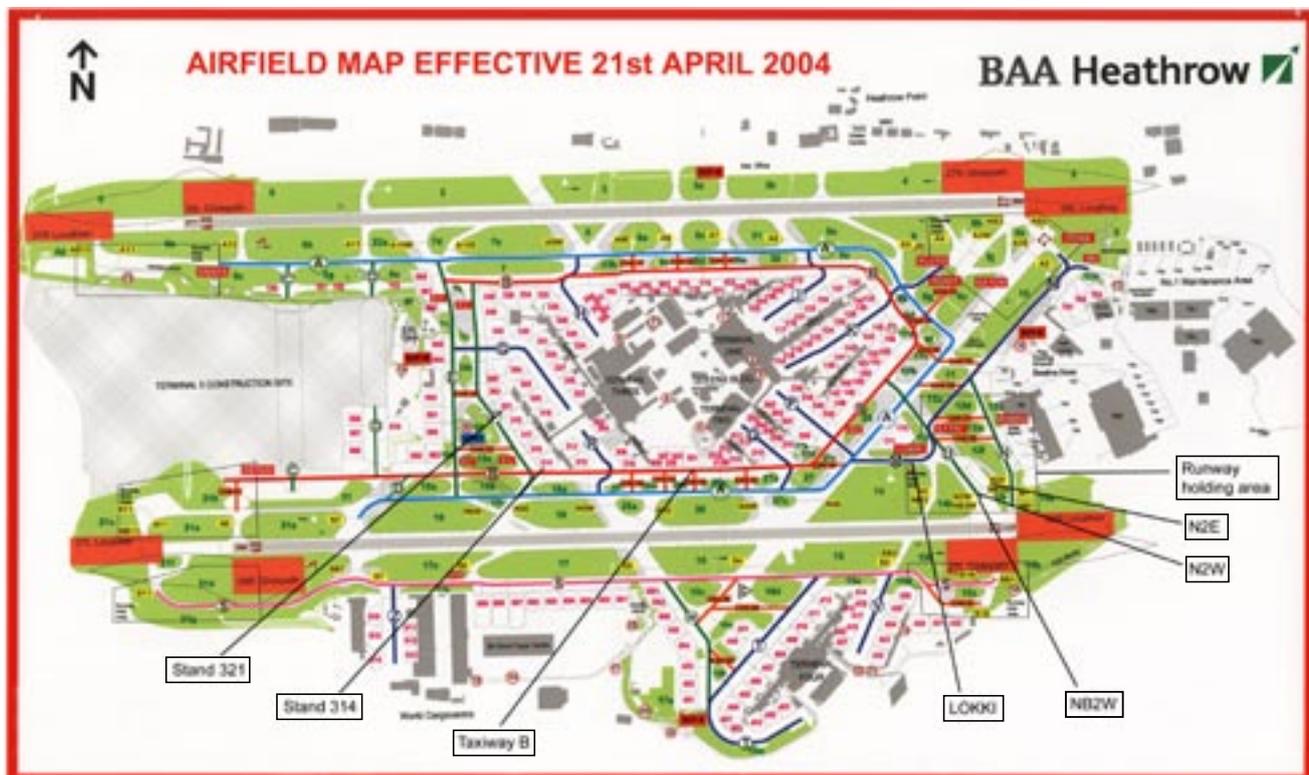
Figure 1
Taxi Chart

Stand 321, which is also at Terminal Three, had been cleared by the Ground Movement Controller (GMC) to follow the A340, again for a departure from Runway 27L. See Figure 1.

¹ For the locations of the various taxiways and holding area and traffic bars at London Heathrow Airport (LHR) referred to in the following narrative, see Figures 1 and 2.
