ACCIDENT

Aircraft Type and Registration:	Rans S6-ESD (Modified), Coyote II, G-MYSP	
No & Type of Engines:	1 Rotax 582-48 piston engine	
Year of Manufacture:	1992 (Serial no: PFA 204-12265)	
Date & Time (UTC):	28 August 2013 at 1118 hrs	
Location:	Redhill Aerodrome, Surrey	
Type of Flight:	Private	
Persons on Board:	Crew - 1	Passengers - None
Injuries:	Crew - 1 (Fatal)	Passengers - N/A
Nature of Damage:	Aircraft destroyed	
Commander's Licence:	National Private Pilot's Licence (Aeroplanes)	
Commander's Age:	57 years	
Commander's Flying Experience:	63 hours (of which 4 were on type) Last 90 days - 9 hours Last 28 days - 3 hours	
Information Source:	AAIB Field Investigation

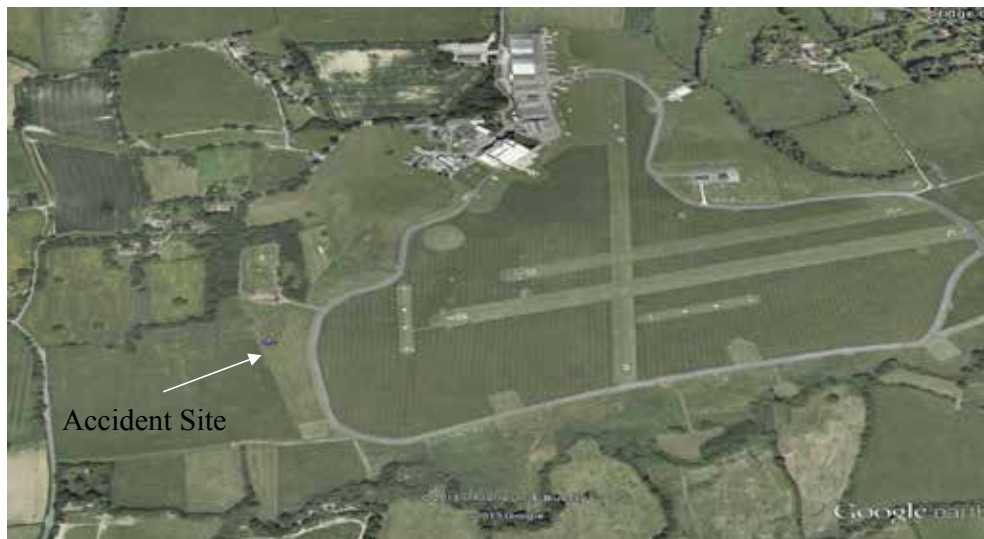
Figure 1
Redhill Aerodrome

Redhill Aerodrome is located 4 nm north-north-east of Gatwick Airport. It has six grass runways, the longest (08R/26L) being 897 m in length (Figure 1).
