Air Accidents Investigation Branch

**Report on the accident to
Airbus A320-211, registration JY-JAR
at Leeds Bradford Airport
on 18 May 2005**

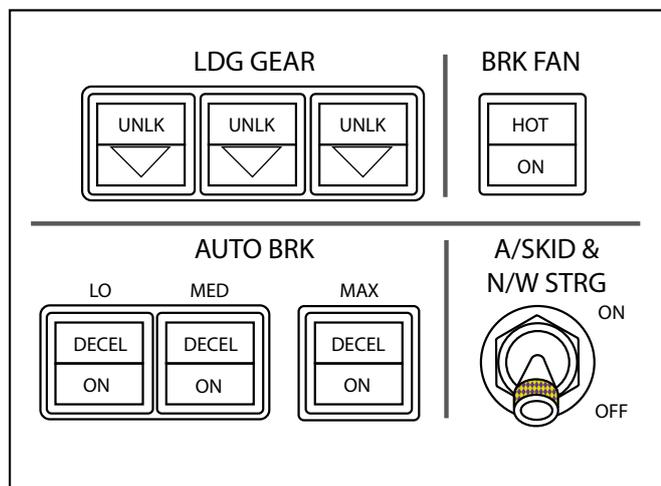
Figure 2

Flight deck controls consist of left and right brake pedals for each pilot, an autobrake control panel and an A/SKID & N/W STRG (Anti-skid and Nosewheel Steering) On/Off switch (Figure 2) on the forward panel and a parking brake switch on the centre console. The flight deck brake pedals drive resolvers (with a left and a right channel) that convert pedal displacement into four parallel electrical signals. In Normal braking mode these pass to the BSCU as the pilots' manual braking commands.

AutoBrake Selection and A/SKID & N/W STRG Switches

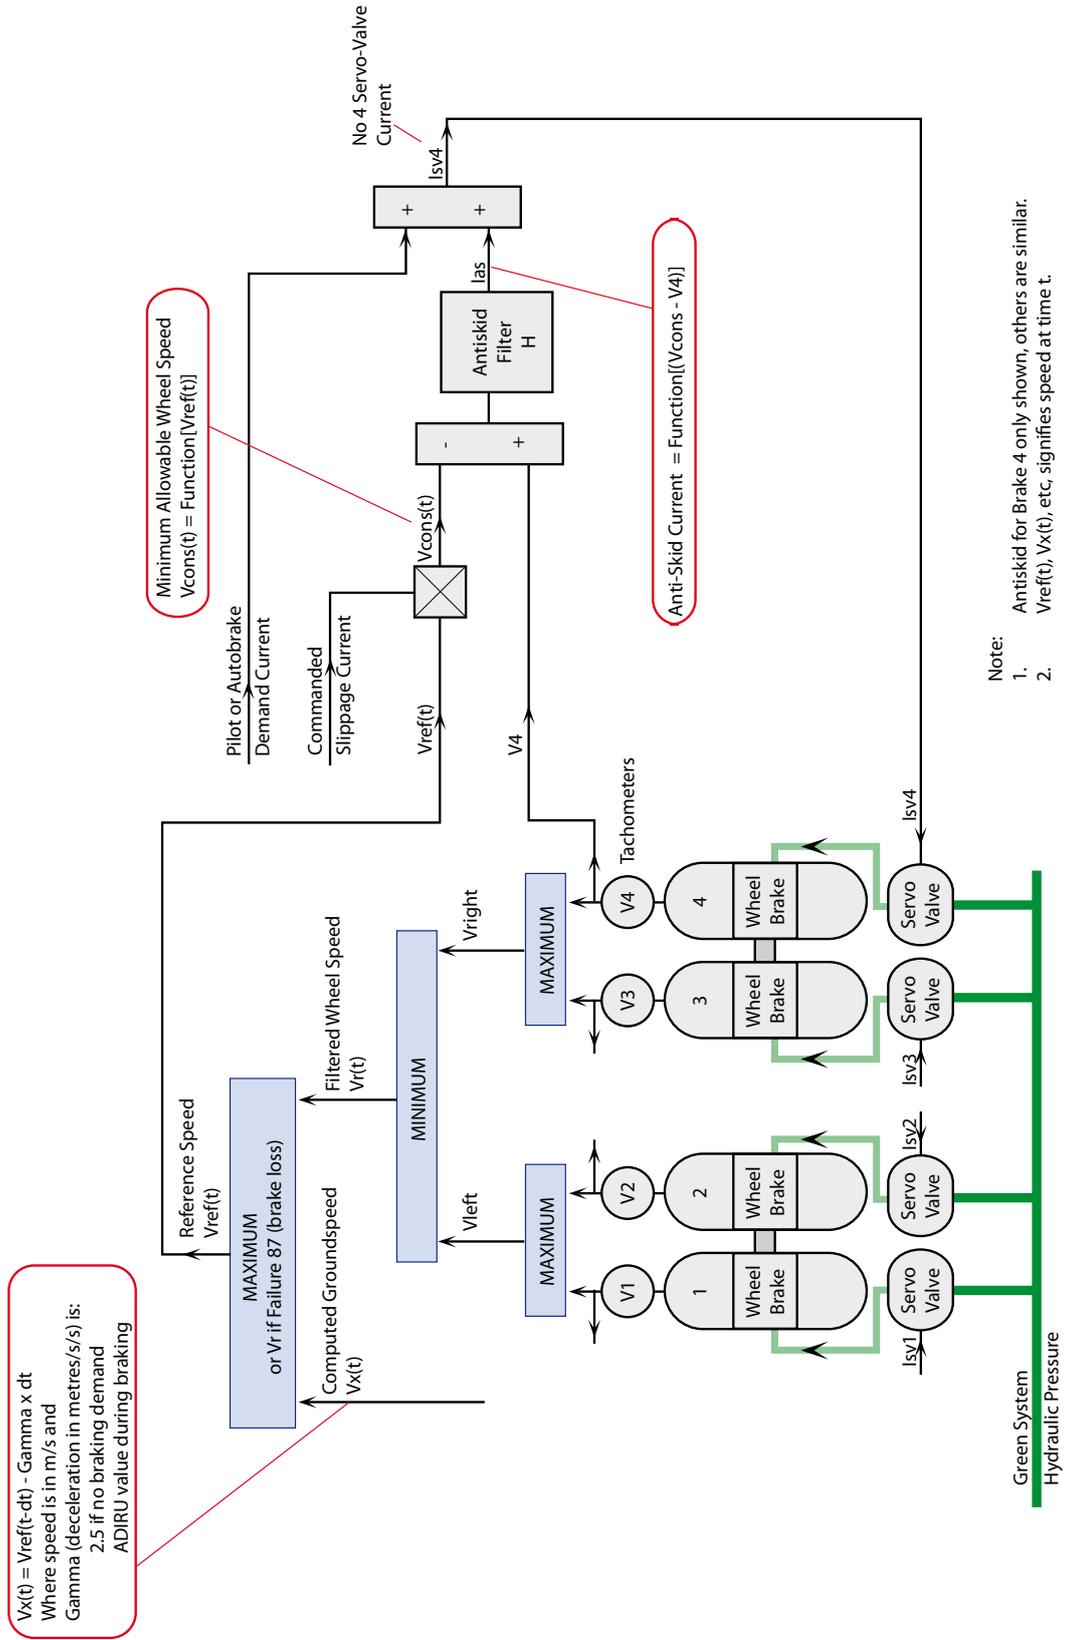
Figure 3
 A320 Wheel Braking System Schematic

Tachometer signals, indicating wheel rotation rate, are converted to a groundspeed via multiplication by a nominal tyre rolling radius. The maximum groundspeed signal from the pair of wheels on each MLG is determined (Figure 3), to give a V_{left} and a V_{right} value, and the minimum of these two values is taken as the filtered wheel speed, V_r . This logic would prevent V_r from being affected by a single erroneous tachometer signal.

It was reported that the electrical noise that could be generated in the tachometer signal by driveshaft resonance (see paragraph 1.18.2) tended to have a significantly asymmetric nature. This asymmetry could prevent it from being adequately suppressed by BSCU electrical filters intended to limit noise transmission. It appeared that the resultant excessive electrical noise passing into the BSCU could be interpreted as a higher individual wheel speed (V_1 , V_2 , V_3 or V_4 , see Figure 3) than was in fact the case.

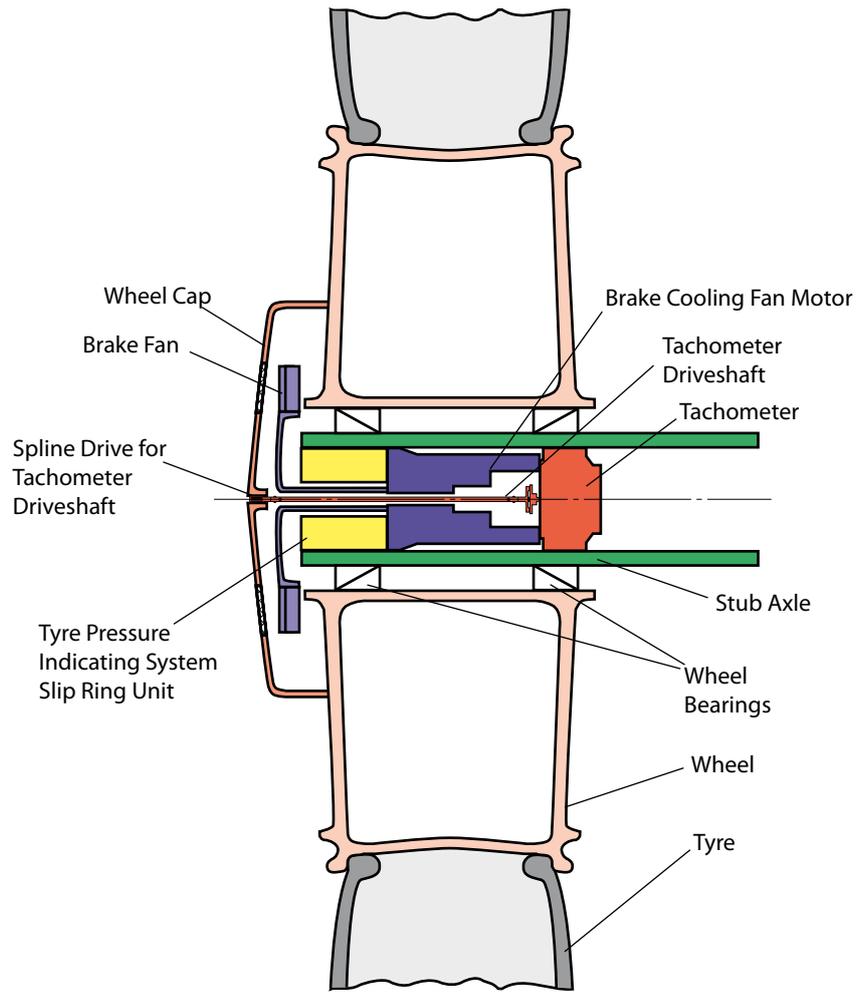
Figure 4
Mainwheel Assembly

The tachometer for each mainwheel is located in the respective wheel stub axle (see Figure 4) and connected to the wheel by a driveshaft and the wheel cap (sometimes called the ‘debris guard’).

JY-JAR was fitted with carbon brake packs, each with an optional brake cooling fan system and an optional Tyre Pressure Indicating System (TPIS). The brake fan is driven by an electric motor fitted in the wheel axle and a TPIS slip-ring unit is mounted on the outer end of the motor. The tachometer is mounted on the inner end of the motor. With this configuration the tachometer driveshaft passes through the fan and the TPIS units and is required to be longer than for an installation where a brake fan is not fitted.
