ACCIDENT

Aircraft Type and Registration:	Airbus A300B4-622R(F), D-AEAP
No & Type of Engines:	2 Pratt & Whitney PW4158 turbofan engines
Year of Manufacture:	1994 (Serial no: 724)
Date & Time (UTC):	14 April 2012 at 1753 hrs
Location:	East Midlands Airport, Derby
Type of Flight:	Commercial Air Transport (Cargo)
Persons on Board:	Crew - 3 Passengers - None
Injuries:	Crew - None Passengers - N/A
Nature of Damage:	Damage to nose landing gear and minor damage to a tug
Commander's Licence:	Airline Transport Pilot's Licence
Commander's Age:	53 years
Commander's Flying Experience:	5,878 hours (of which 111 were on type) Last 90 days - 79 hours Last 28 days - 20 hours
Information Source:	AAIB Field Investigation

Synopsis

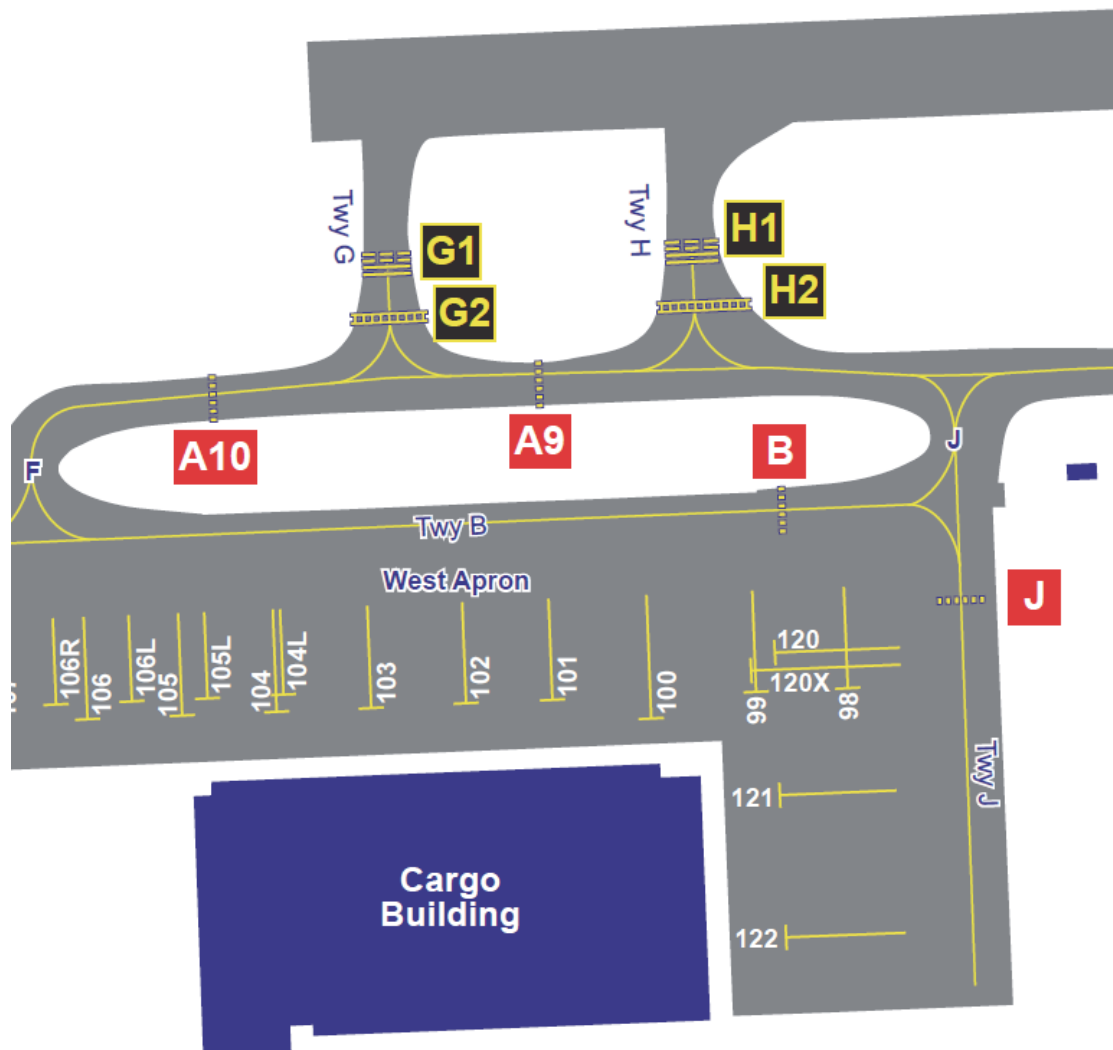
Figure 1

The aircraft was parked on Stand 102 on the West Apron at East Midlands Airport, a dedicated cargo area (see Figure 1). At 1744 hrs, when the aircraft was ready to depart the commander made a radio call to ATC to request start and pushback clearance. The PF completed the Before Start scan and called for the Before Start checklist. When start clearance had been obtained, he contacted the ground crew headset operator on the flight interphone and advised him that the aircraft was ready to push.

Cargo ramp area at East Midlands Airport

Meanwhile, the PF completed the After Start scan, with some intervention from the PNF, and called for the After Start checklist. The checklist was completed and the PF then asked the PNF to request taxi clearance from ATC. At 1753 hrs, the aircraft was cleared to taxi to the Golf 1 holding point for Runway 09, which was near the aircraft and in sight of the flight crew (see Figure 1). The PF switched on the taxi light and increased power to start taxiing.
