AAIB Bulletin No: 6/94

Ref: EW/G93/10/09

Aircraft Type and Registration: Piper PA-28-161 Cherokee Warrior II, G-BRDF

G-BRDF CRANKSHAFT FAILURE

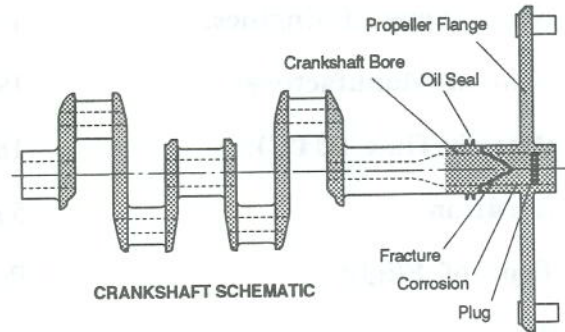
The propeller was recovered and examination showed that the engine crankshaft had fractured just behind the integral propeller mounting flange, near the position of the forward oil seal (Figs 1 and 2).

The engine was bulk stripped and the components examined, with no abnormalities found except for those concerning the crankshaft, described below. Detailed specialist examination of the crankshaft fracture showed that the fracture surfaces had been damaged by rubbing and corrosion but concluded that the separation had resulted from a high cycle reverse torsional fatigue mechanism that had initiated from a number of corrosion pits in the crankshaft bore. After the cracks had progressed through a substantial proportion of the crankshaft section the rate of advance had increased until the remaining unseparated portion had failed as a result of overload. It was clear that much of the cracking had occurred in high cycle fatigue and that it had progressed over an extended period of service.

The bore through the forward section of the crankshaft was found to be coated in a thick layer of solid oil sludge-like deposit, in the order of $\frac{1}{4}$ inch thick, consistent with the centrifuging effect that would be present in this area with the crankshaft turning. In an area immediately behind the plug, heavy corrosion was present on the surface of the crankshaft bore (Fig 3). It was noted that the reduced diameter portion of the bore effectively constituted a weir, making the larger diameter forward part of the bore a sump into which debris or water entering the bore would be centrifugally separated from the oil while the engine was operating and where it would remain trapped when the engine stopped. It also appeared possible that the forward portion of the crankshaft could be a relatively cool area with the engine running and thereby particularly conducive to condensation. The bore also exhibited heavy machining scores and extensive brittle cracking across these scores. Microsection examination and hardness measurements showed that the bore had a hardened layer, typical of that produced by carbo-nitriding, with deep corrosion pitting and cracking present, and parts of the outer surface of the forward portion of the crankshaft had a less complete hardened layer.
