Air Accidents Investigation Branch

**Report on the accident to
Cessna Citation 500
registration VP-BGE
2nm NNE of Biggin Hill Airport
30 March 2008**

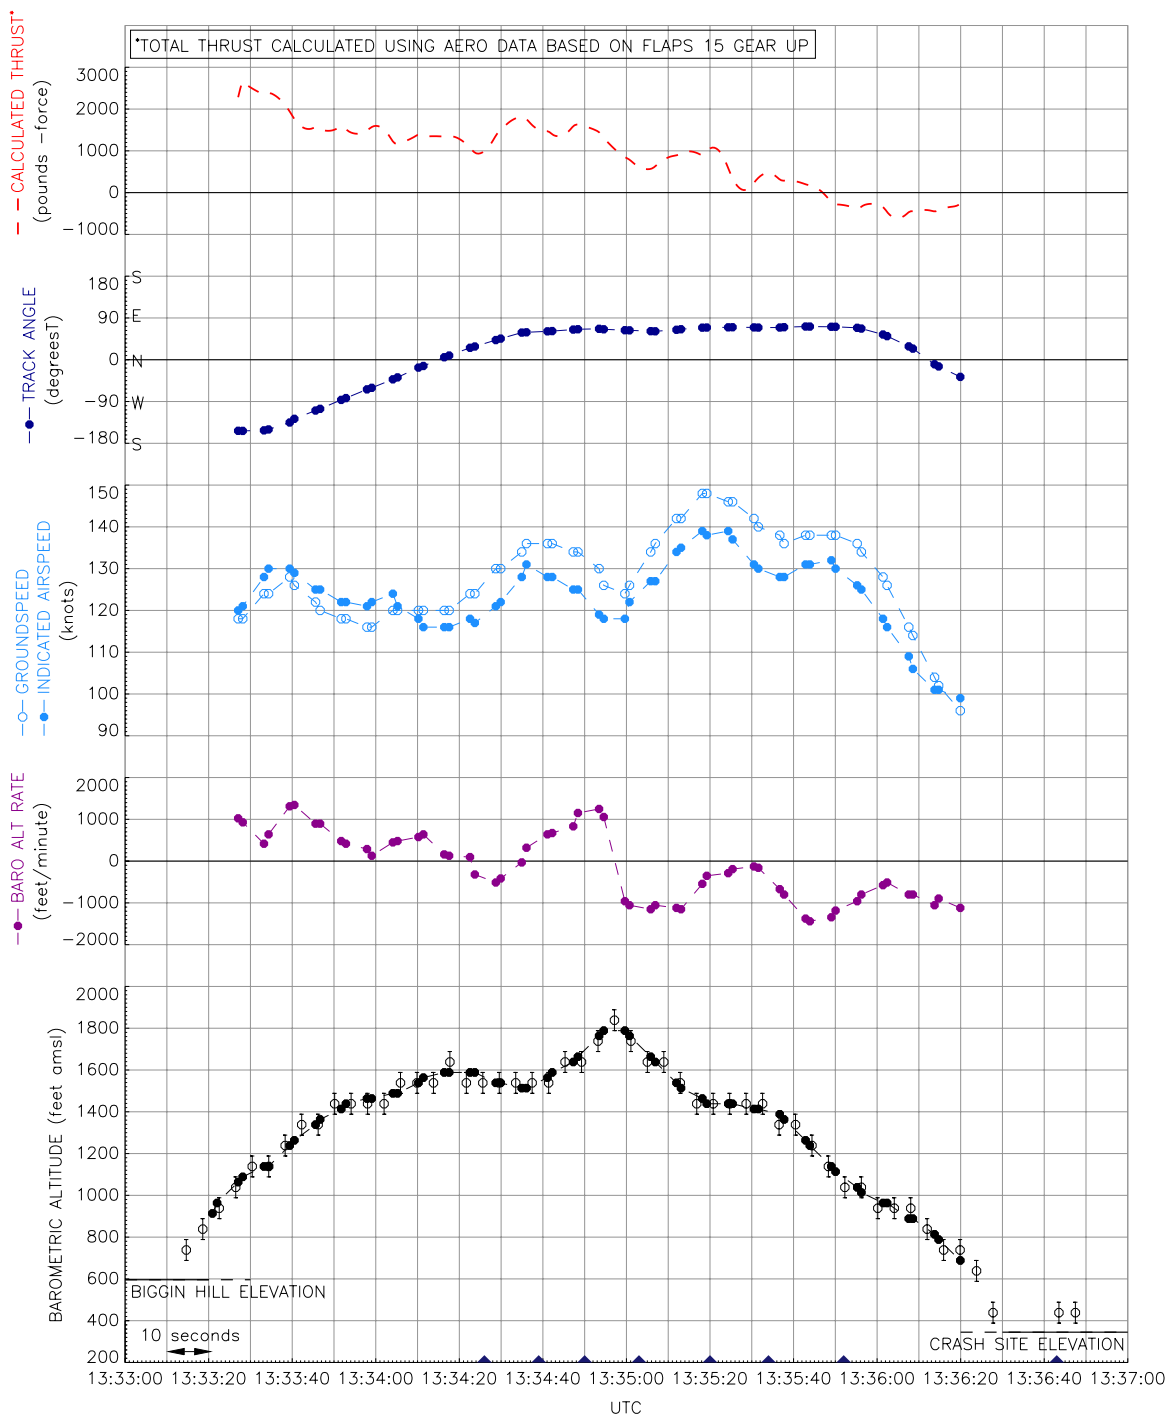
The thrust predictions made using this direct method are plotted in Figure 13 (flaps 15, gear up). The low sample rate (ie two points every six seconds) and the position uncertainty of the Mode S data introduce unrealistic noise and discontinuities in performance calculations based on this data. To reduce these effects, a smooth track was computed by first calculating true airspeed from the recorded Mode S indicated airspeed and weather information, and selecting winds such that the integration of the true airspeed vector plus the wind vector resulted in a track that closely matched the track recorded by the radar.

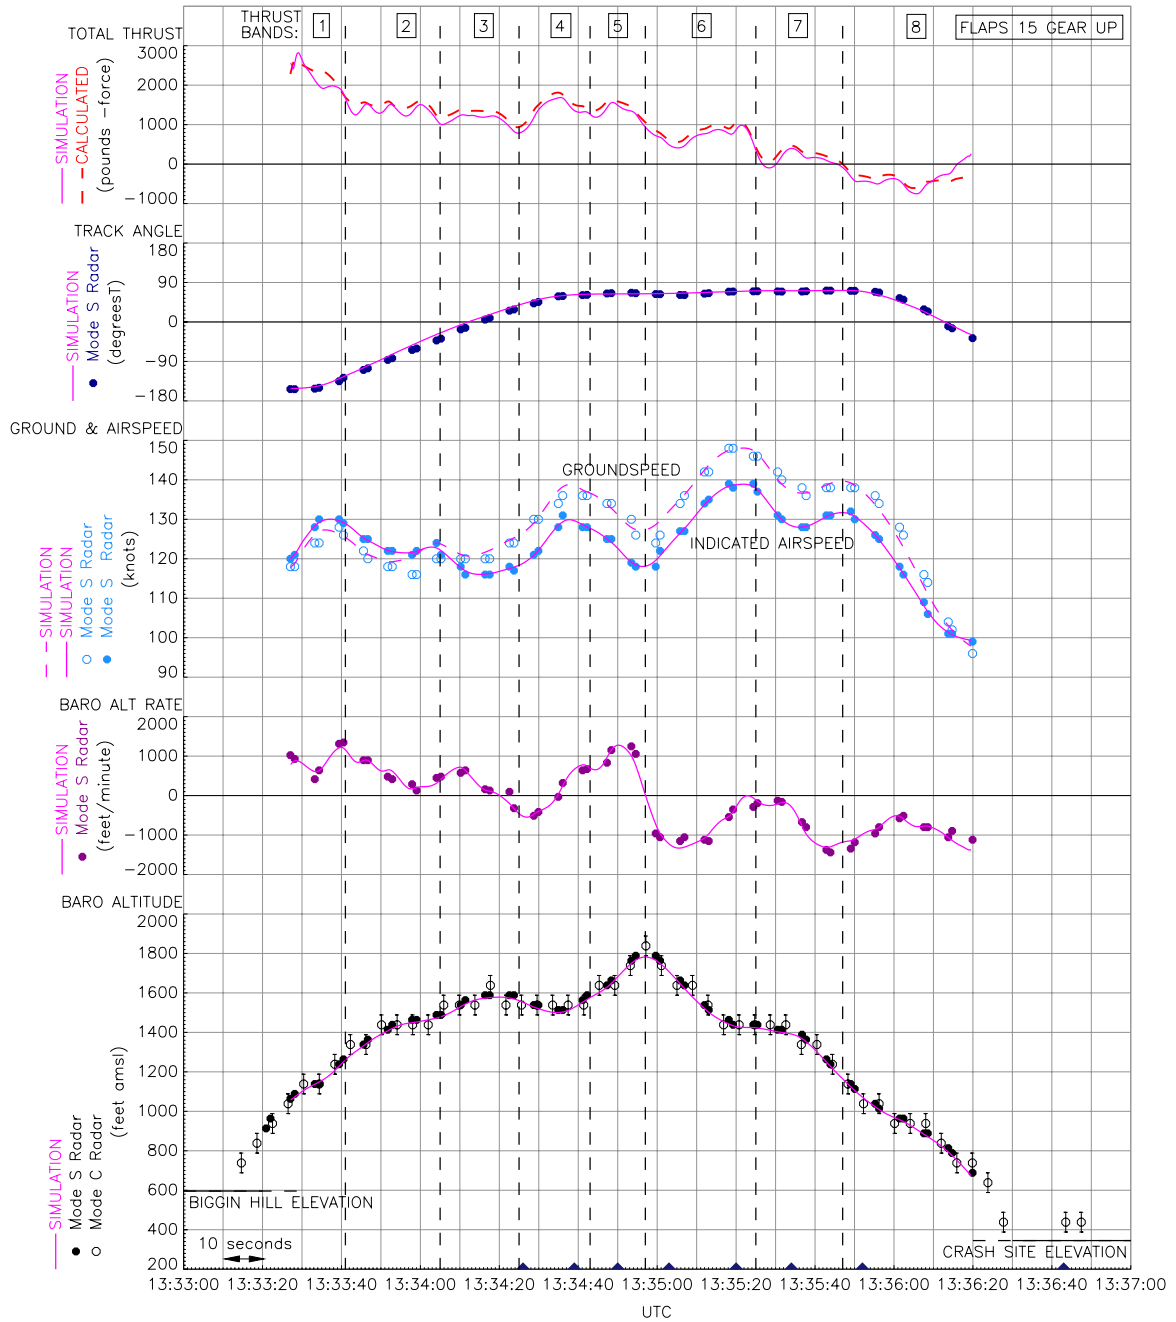
Also indicated in Figure 14 are the points in the fight where there are general changes or breaks in the level of the predicted thrust. These points split the accident fight into bands (labelled 1 to 8) where the thrust predictions are roughly the same level, and where local variations in the thrust are similar in magnitude to those seen in the circuit fight data where the N_1 values (and hence thrust) were constant. Note that the available takeoff thrust (ie 95.6% N_1) for the accident fight was calculated to be in the order of 1,600 pounds-force per engine and fight idle, as seen in the circuit data, equates to about zero thrust for the simulation. The additional drag of a windmilling engine compared to an engine at fight idle would, therefore, lead to a negative thrust component.

Figure 14 shows the results for the aircraft configuration of faps15 and gear up. Although other scenarios were considered, the results for faps 15 gear up gave the closest results in terms of how well the computer simulation was able to track the accident fight accurately. This was also the 'as found' configuration of the aircraft at the accident site.

Figure 14 shows that Band 1 is the only section of the fight where the predicted thrust is sufficiently higher than 1,600 pounds-force and so is consistent with two engines operating. For Bands 2 to 6, the total predicted thrust levels are very close to but always less than 1,600 pounds-force, so could be as a result of either both engines operating at a low thrust setting or one engine operating near to 1,600 pounds-force with the other engine at idle.

While the information presented in Figure 14 shows that approximately 70 seconds prior to impact both engines were not producing thrust, the witness marks identified on the fuel metering valves of both engine fuel controls and the engine instrument readings confirmed that both engines were operating at impact. The results of the flight test, engine test cell and simulator tests were analysed to determine if it may have been possible to restart one or both engines in the time available from when the no-thrust condition was identified until impact.

Performance analysis indicates that the section of the flight from Bands 2 to 7 (Figure 14), would have been possible on only one engine. However, as the individual engine thrust levels are not known, it is equally conceivable that one or both engines were operating at low thrust throughout this period.

After Band 7 (Figure 14), the total thrust is calculated to be less than zero which would mean that neither engine was running. This negative thrust level occurs at about the time when the aircraft might have been expected to commence its final descent and where the thrust would normally be reduced by the pilot.

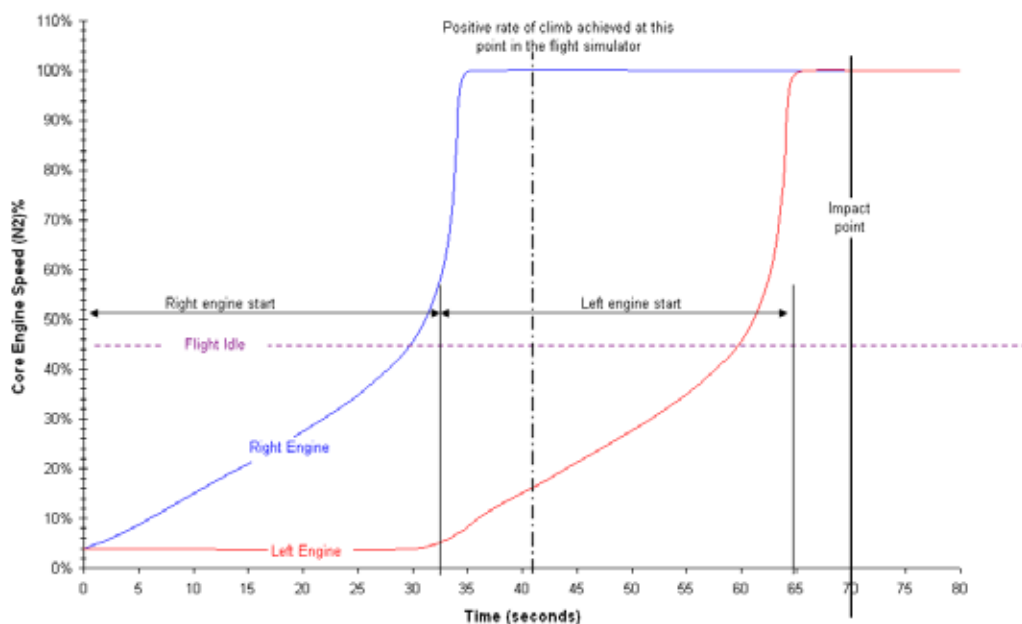
Figure 17

If the throttles were then moved forward as rapidly as possible, acceleration of the engine from idle to maximum thrust could be achieved in 4.5 seconds. It follows that maximum thrust could have been available from one engine within 34.5 to 39.5 seconds from initiation of an engine start. Assuming that a second engine start was initiated immediately the first engine had reached its idle speed, maximum thrust could have been available on both engines between 64.5 and 74.5 seconds after initiating the first engine start, as shown in Figure 17.

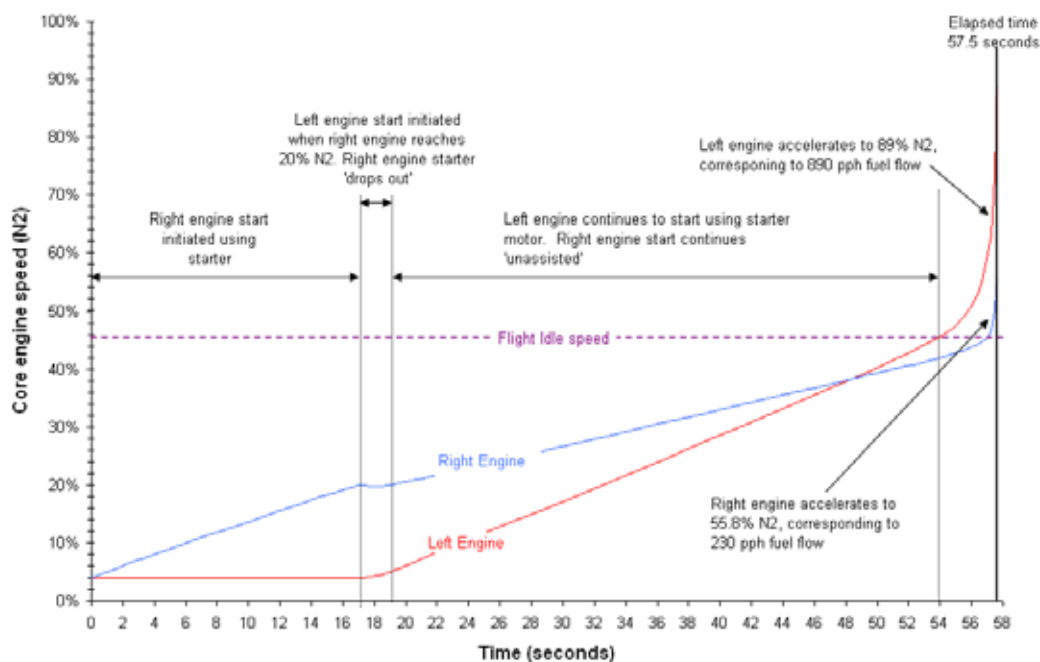
The witness marks found on the left and right engine fuel metering valves show that the left engine was closer to the maximum thrust position than the right engine when the aircraft struck the house. Analysis of the data from the engine test cell runs shows that, due to the reduced rate of acceleration of the first engine after the disengagement of the engine starter, the second engine to be started would achieve maximum thrust several seconds before the first. Figure 18 illustrates that in this situation it may have been possible to start both engines and achieve a fuel flow of 890 pph and 230 pph on the left and right engine respectively (as found at initial impact) if the relights had been initiated at least 57.5 seconds prior to impact.
