**Air Accidents Investigation Branch**

**Report on the accident to  
Cessna Citation 500  
registration VP-BGE  
2nm NNE of Biggin Hill Airport  
30 March 2008**

Published 21 May 2010

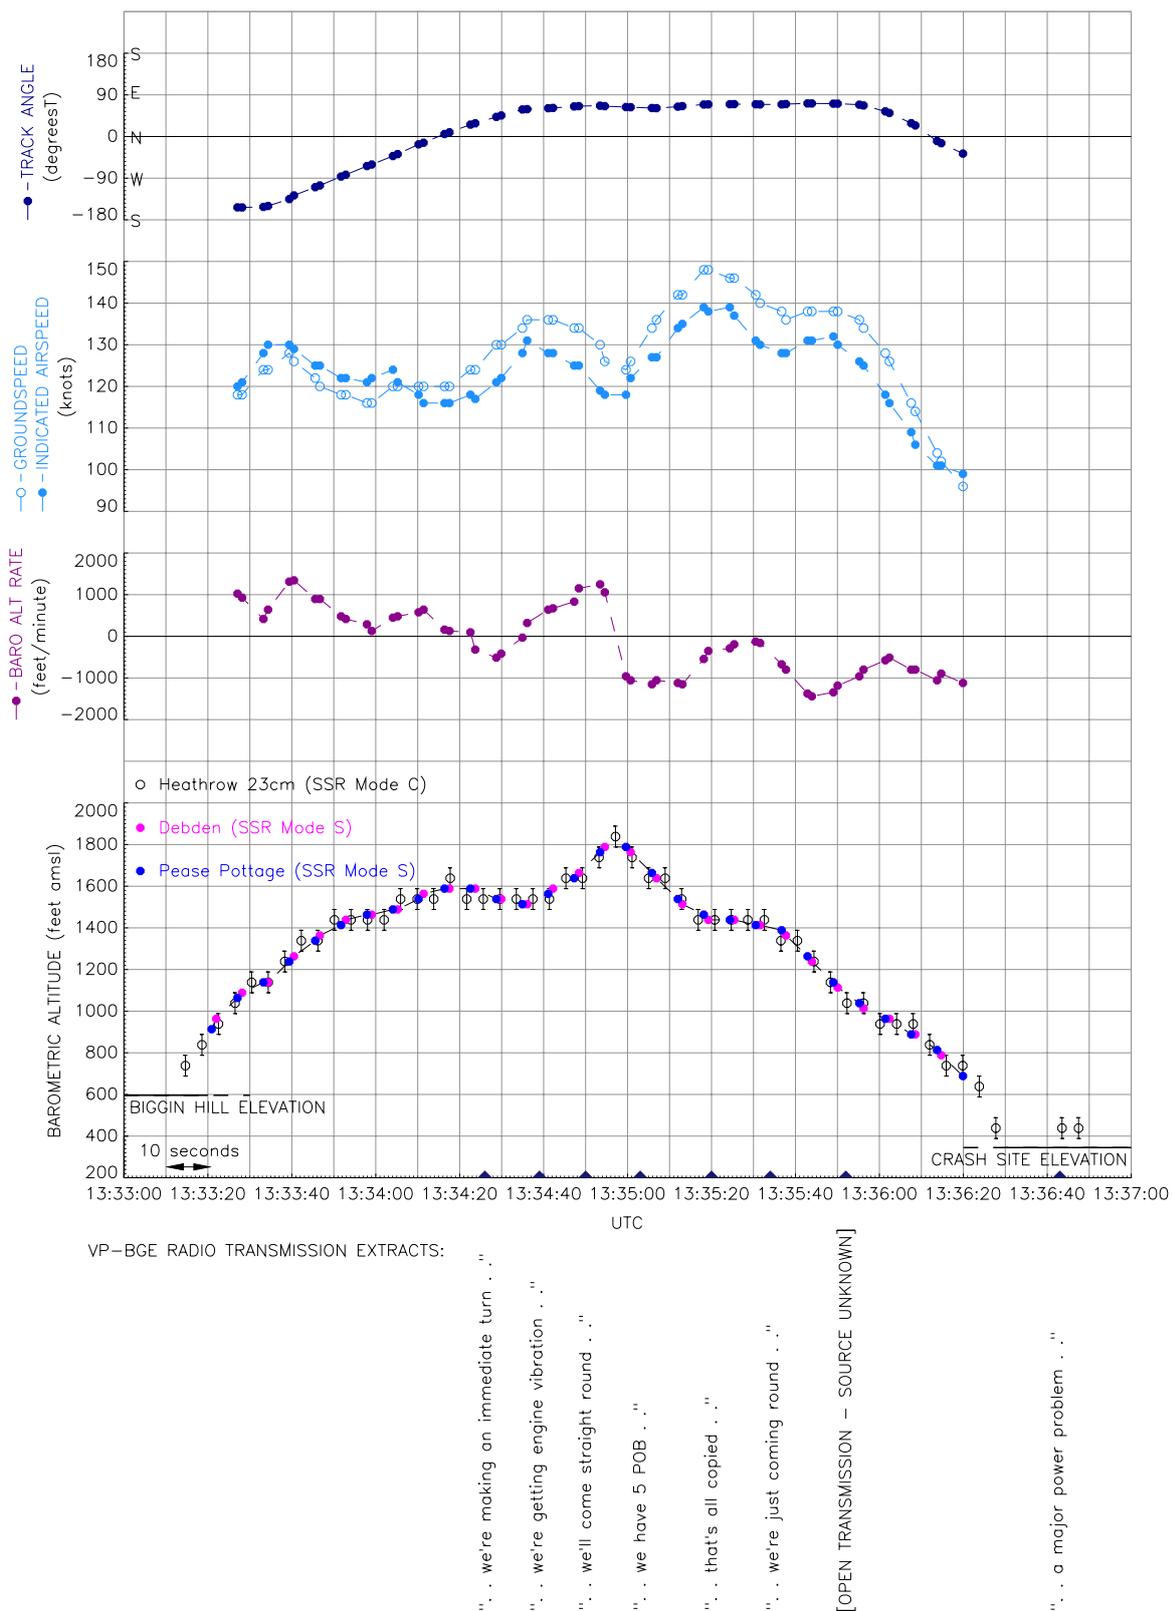
**Figure 6**  
Radar airborne data

The airborne data from VP-BGE for the accident flight is presented at Figure 6. The barometric altitude shown has been corrected for the area QNH of 1000 mb. The airfield and accident site elevations are shown for clarity together with markers indicating when there was a radio transmission from the aircraft.

The Mode S radar first detected the aircraft at 900 ft amsl (300 ft aal), climbing away from the airfield. The aircraft continued to climb, levelling 56 seconds later at just under 1,600 ft amsl, as it was turning downwind. The climb rate varied considerably throughout this period. The airspeed also varied, reaching a maximum of just over 130 KIAS and reducing to 116 KIAS as the aircraft levelled off.

The four final points (altitude only) are SSR Mode C returns showing the aircraft still descending. There is a gap of 16 seconds between the second and third points, indicating three missing returns. The last point shows the aircraft at 440 ft amsl (95 ft above the crash site elevation) and, based on the radar position, between 130 m and 550 m from the crash site.

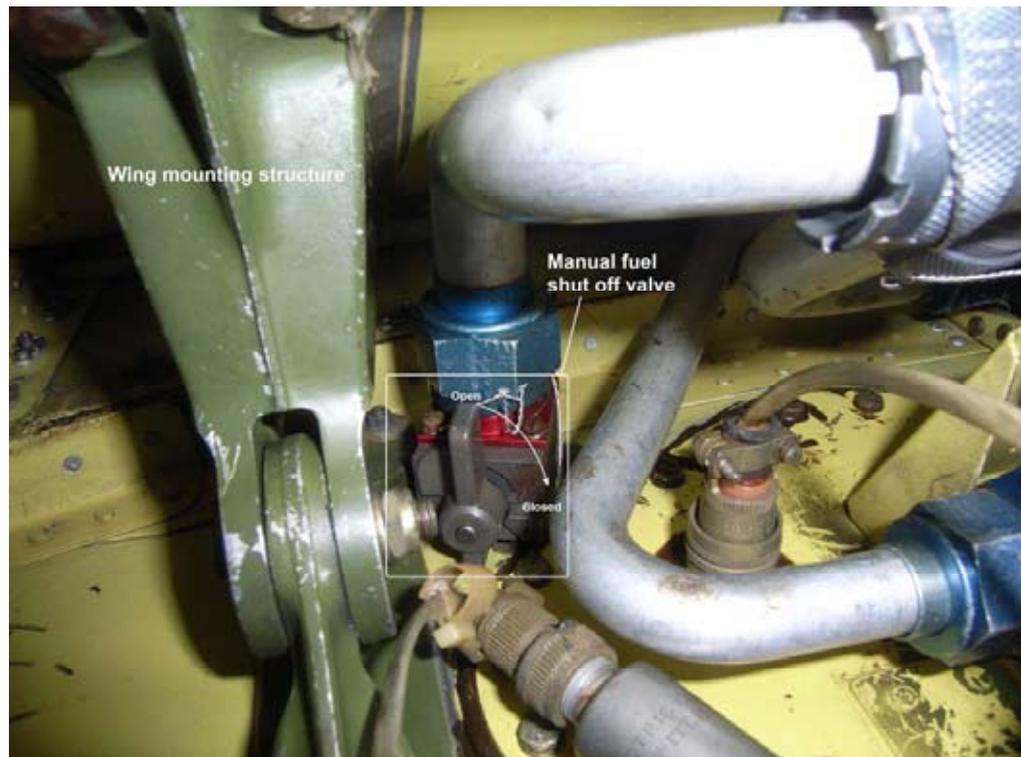
**Figure 9**

Manual fuel shut-off valve

The position of all the valves within the aircraft fuel system, with the exception of the left manual fuel shut-off valve, indicated that the fuel system was in its normal configuration. The manual shut-off valves are only operable by maintenance personnel and no maintenance had been carried out in the area of the valves for some time. Operational tests carried out on an aircraft confirmed that had the valve been in a partially open position prior to takeoff, the left engine would have been unable to achieve the required takeoff thrust. This should have been immediately apparent to both pilots. To achieve the 90% closed position the manual shut-off valve was found in, the valve lever would need to have been turned towards the rear of the aircraft and held in position against the action of the return spring. In view of the distortion of the forward left wing mounting structure, which is positioned immediately forward of the shut-off valve (Figure 9, page 31), it is thought probable that the wing mount moved aft during the impact. This would have forced the valve lever out of the open detent and moved the valve towards the closed position.

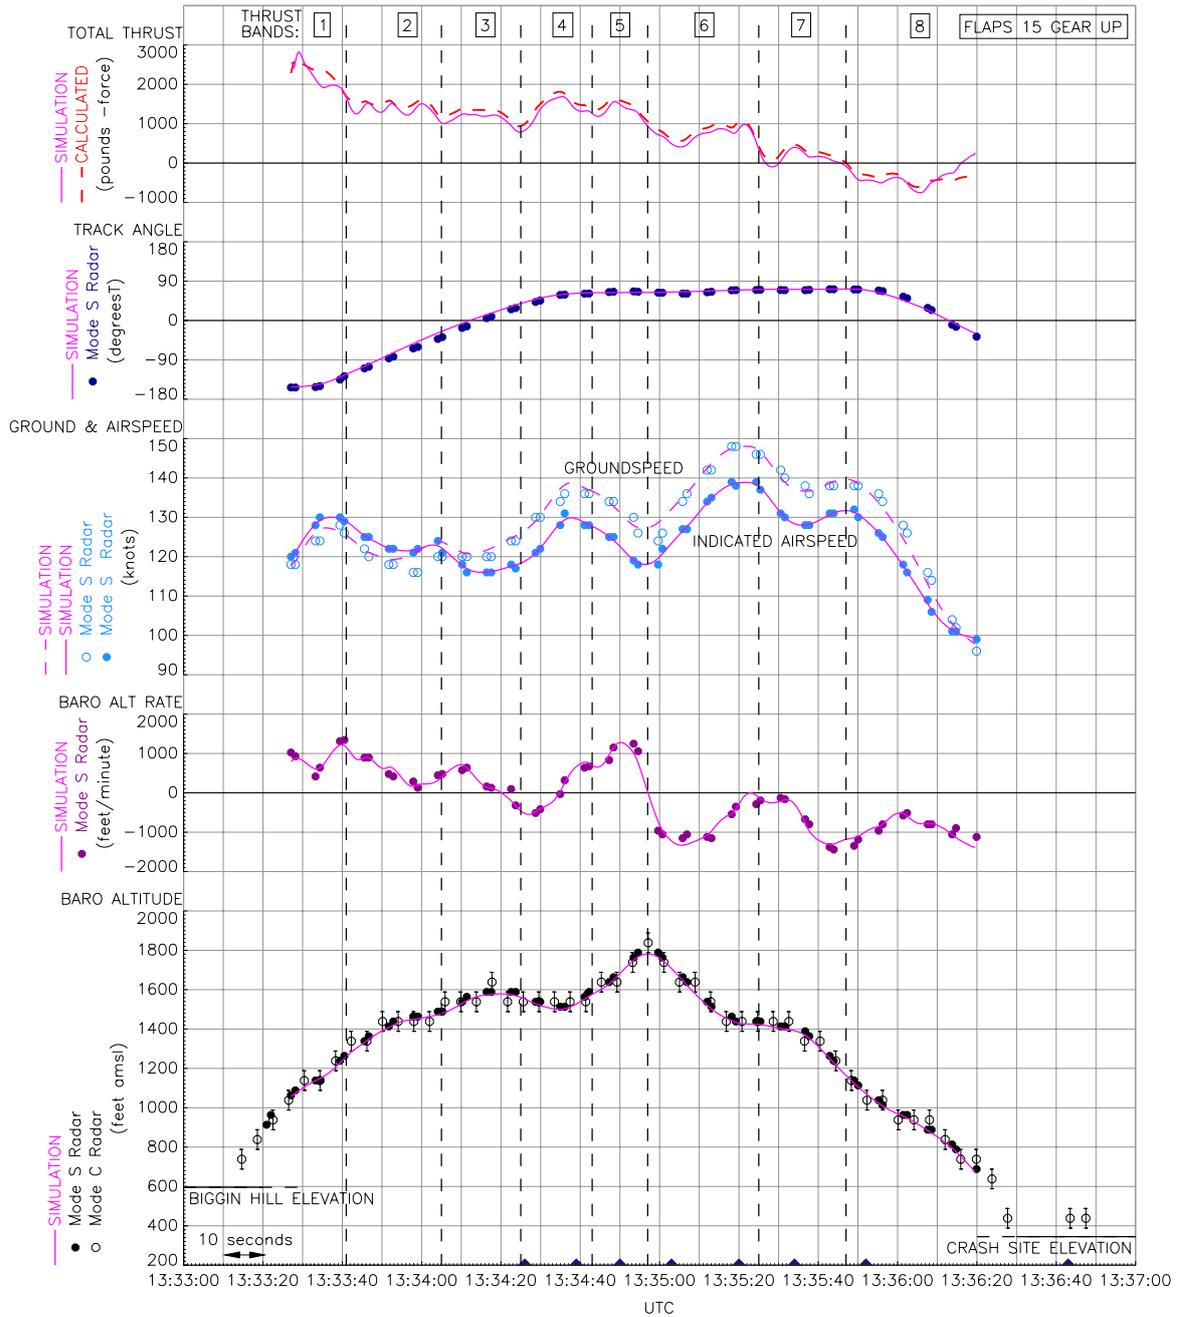
Also indicated in Figure 14 are the points in the flight where there are general changes or breaks in the level of the predicted thrust. These points split the accident flight into bands (labelled 1 to 8) where the thrust predictions are roughly the same level, and where local variations in the thrust are similar in magnitude to those seen in the circuit flight data where the  $N_1$  values (and hence thrust) were constant. Note that the available takeoff thrust (ie 95.6%  $N_1$ ) for the accident flight was calculated to be in the order of 1,600 pounds-force per engine and flight idle, as seen in the circuit data, equates to about zero thrust for the simulation. The additional drag of a windmilling engine compared to an engine at flight idle would, therefore, lead to a negative thrust component.

The performance analysis of the Mode S radar data (Figure 14, page 43) showed that the accident flight could be divided into a number of thrust bands where the predicted thrust was approximately level, with the breaks between these thrust bands corresponding to the points in the flight where stepped thrust changes may have been made.

Figure 14 shows the results for the aircraft configuration of flaps15 and gear up. Although other scenarios were considered, the results for flaps 15 gear up gave the closest results in terms of how well the computer simulation was able to track the accident flight accurately. This was also the 'as found' configuration of the aircraft at the accident site.

Figure 14 shows that Band 1 is the only section of the flight where the predicted thrust is sufficiently higher than 1,600 pounds-force and so is consistent with two engines operating. For Bands 2 to 6, the total predicted thrust levels are very close to but always less than 1,600 pounds-force, so could be as a result of either both engines operating at a low thrust setting or one engine operating near to 1,600 pounds-force with the other engine at idle.

While the information presented in Figure 14 shows that approximately 70 seconds prior to impact both engines were not producing thrust, the witness marks identified on the fuel metering valves of both engine fuel controls and the engine instrument readings confirmed that both engines were operating at impact. The results of the flight test, engine test cell and simulator tests were analysed to determine if it may have been possible to restart one or both engines in the time available from when the no-thrust condition was identified until impact.

Performance analysis indicates that the section of the flight from Bands 2 to 7 (Figure 14), would have been possible on only one engine. However, as the individual engine thrust levels are not known, it is equally conceivable that one or both engines were operating at low thrust throughout this period.

After Band 7 (Figure 14), the total thrust is calculated to be less than zero which would mean that neither engine was running. This negative thrust level occurs at about the time when the aircraft might have been expected to commence its final descent and where the thrust would normally be reduced by the pilot.

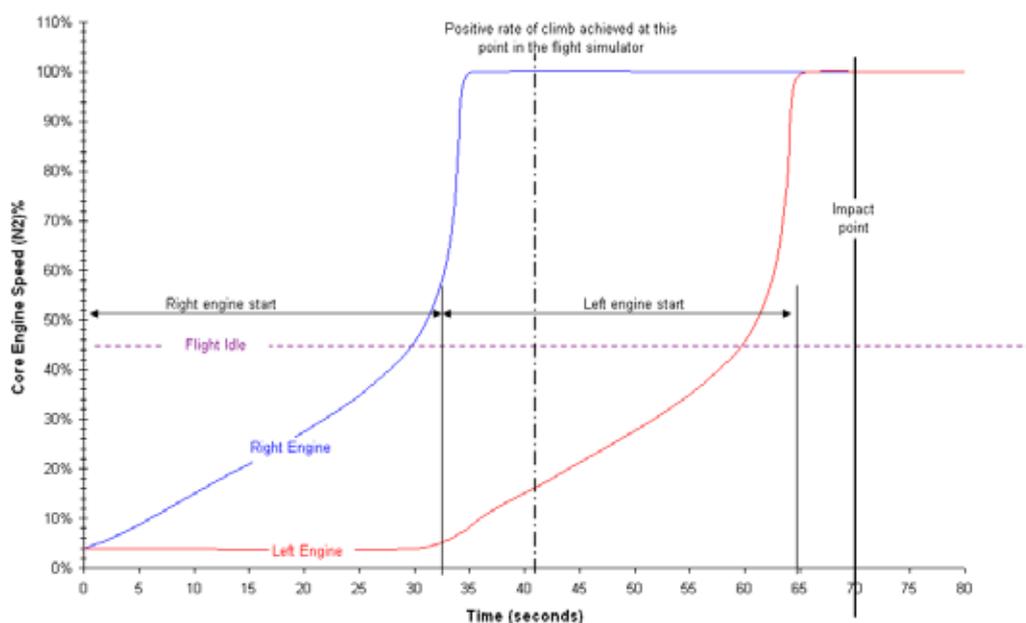
**Figure 17**

If the throttles were then moved forward as rapidly as possible, acceleration of the engine from idle to maximum thrust could be achieved in 4.5 seconds. It follows that maximum thrust could have been available from one engine within 34.5 to 39.5 seconds from initiation of an engine start. Assuming that a second engine start was initiated immediately the first engine had reached its idle speed, maximum thrust could have been available on both engines between 64.5 and 74.5 seconds after initiating the first engine start, as shown in Figure 17.

Engine starter assisted relight performance

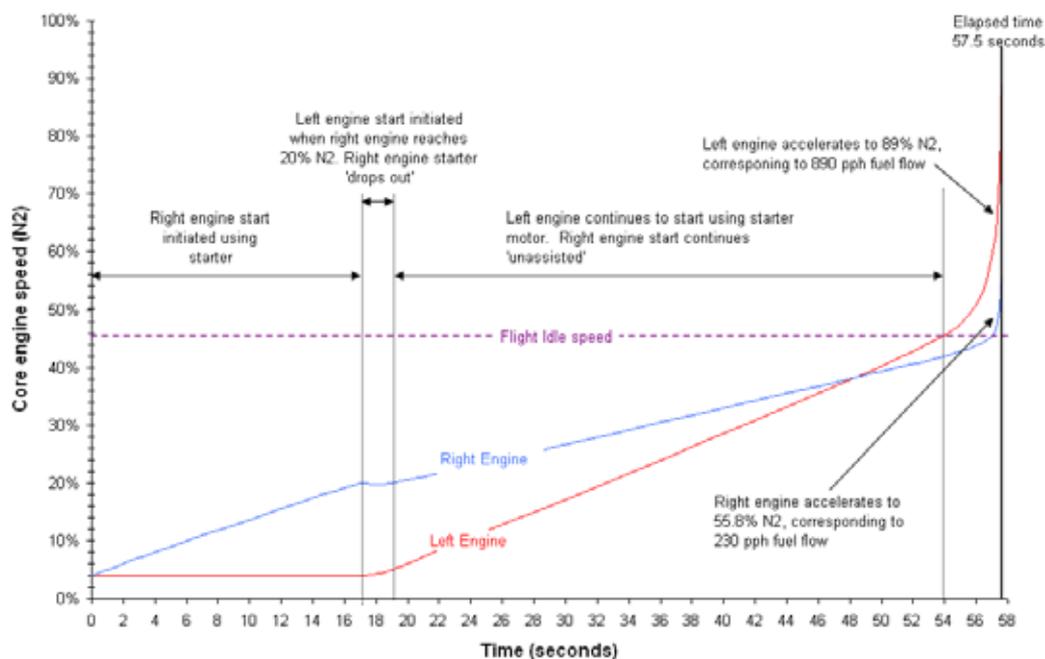
**Figure 18**

The witness marks found on the left and right engine fuel metering valves show that the left engine was closer to the maximum thrust position than the right engine when the aircraft struck the house. Analysis of the data from the engine test cell runs shows that, due to the reduced rate of acceleration of the first engine after the disengagement of the engine starter, the second engine to be started would achieve maximum thrust several seconds before the first. Figure 18 illustrates that in this situation it may have been possible to start both engines and achieve a fuel flow of 890 pph and 230 pph on the left and right engine respectively (as found at initial impact) if the relights had been initiated at least 57.5 seconds prior to impact.
