**AIRCRAFT ACCIDENT REPORT 2/2007**

**Air Accidents Investigation Branch**

**Report on the serious incident to  
Boeing 777-236, G-YMME  
on departure from London Heathrow Airport  
on 10 June 2004**

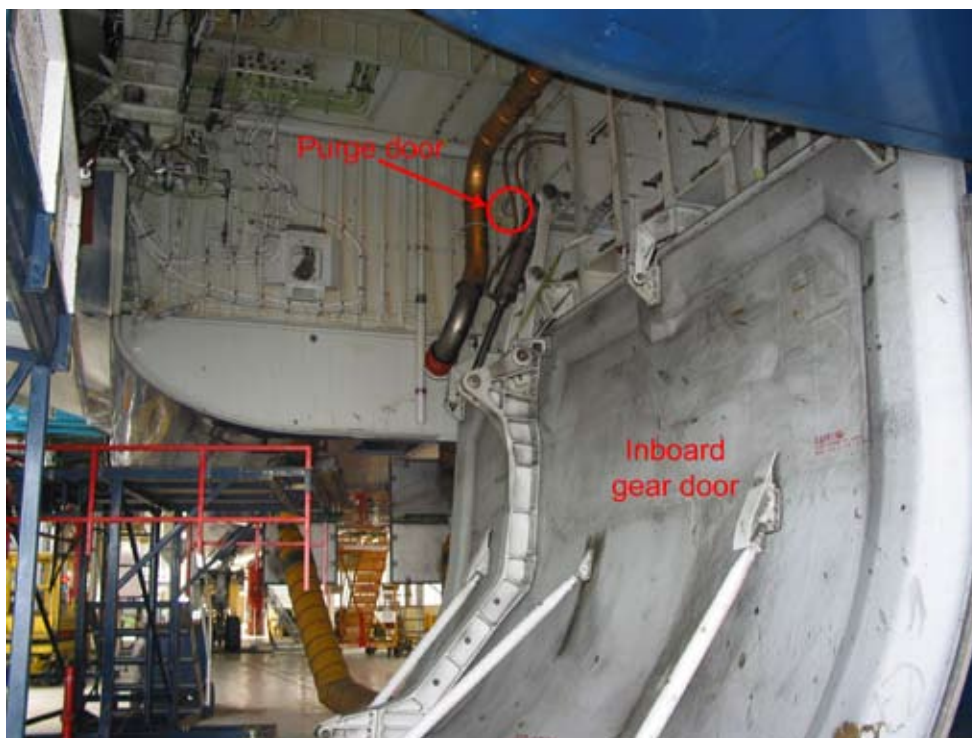
**Figure 8**

The purge door is located on the rear spar of the centre section of the CWT approximately 7 inches left of the aircraft centreline (see Figures 6 and 8). It can be accessed from inside the left wheel well or from inside the CWT. The purge door is a circular panel of approximately 4.5 inches diameter with 6 bolt holes around its circumference. It is a plug type door which is pressed into the purge door opening from within the tank (see Figure 9). The purge door opening has a diameter of 2.5 inches and is visible from the ground when the left inboard main gear door is open. For all normal operations this main gear door remains closed; it opens only briefly to permit the landing gear to extend and retract. The door can be opened on the ground to conduct maintenance inside the wheel well but it would not be normal to do this during a turn-around between flights. When the inboard main gear door is closed the purge door is not visible from ground level.

Purge door visibility with left main inboard gear door open

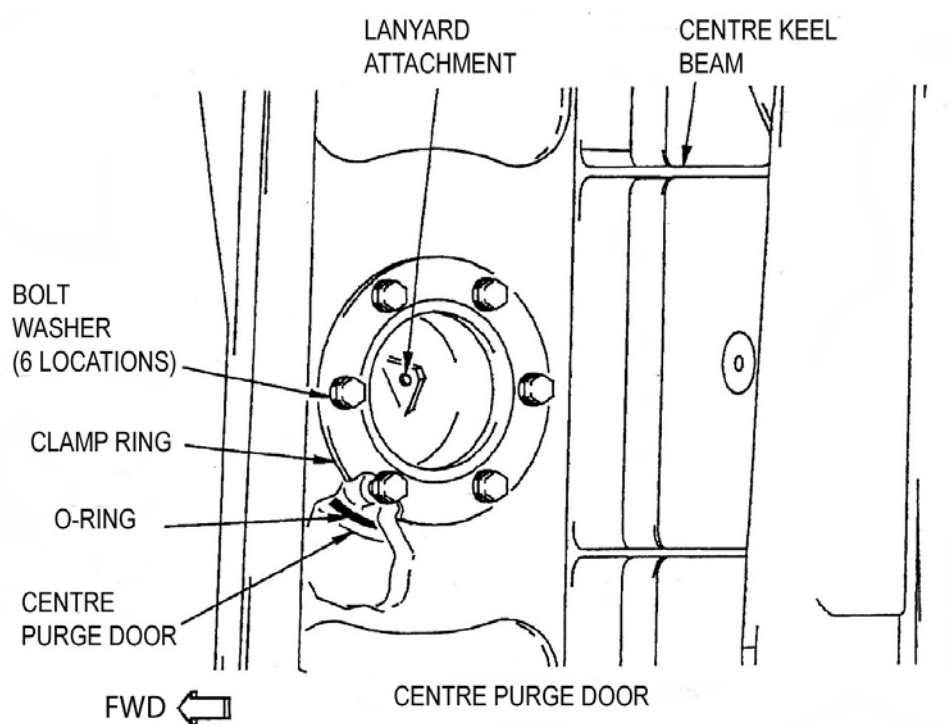
**Figure 9**

Boeing 777 purge door installation diagram  
(Copied with permission of The Boeing Company)

The purge door removal procedure (AMM ref 28-11-04) called for the CWT to be defuelled and then a lanyard attached to the purge door. The procedure noted that the purge door could fall into the tank once the bolts were removed if the lanyard was not attached. After attaching the lanyard, the bolts, washers and clamp ring were to be removed (see Figure 9) and then the purge door lowered by its lanyard into the tank. The next step in the procedure called for the purge door to be physically removed from the aircraft by entering the CWT and removing the purge

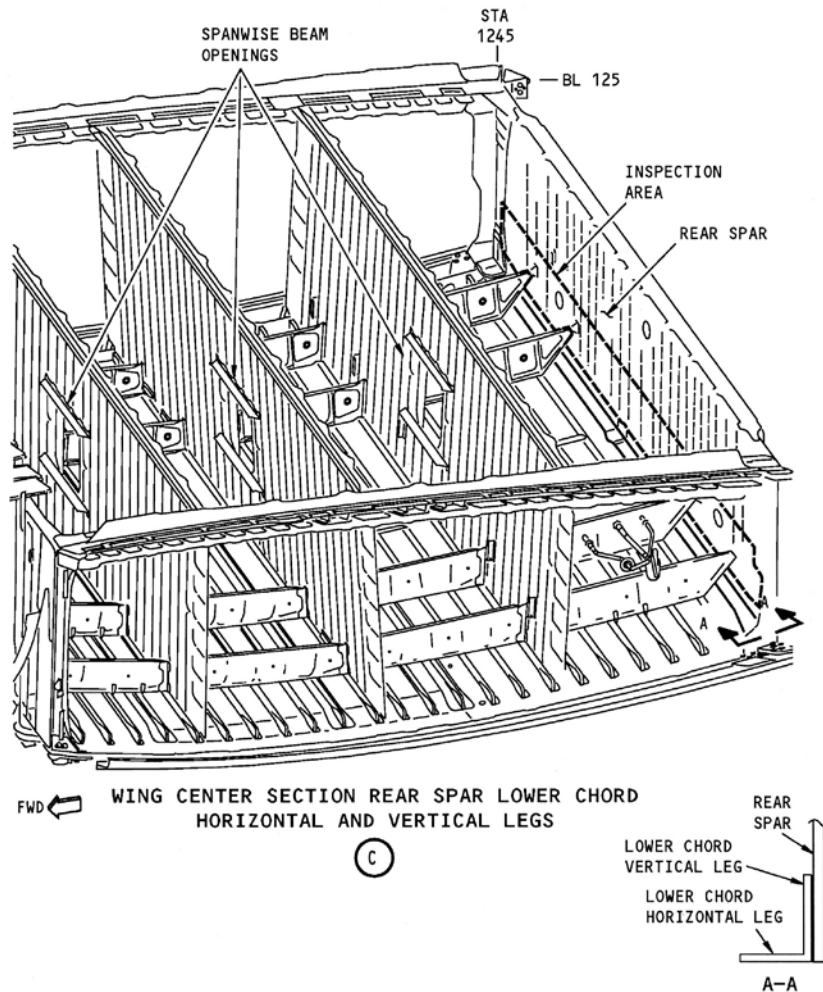
**Figure 11**

The rear spar forms the aft wall of the centre section of the CWT. It can only be inspected by entering an access hole (139AZ) in the front section of the tank, removing the baffle doors and then passing aft through the exposed openings in the spanwise beams (see Figure 11, page 26). A pictorial description of the area to be inspected was provided on a Boeing task card. This task card (revision May 2003) incorrectly showed the front spar or forward spanwise beam (depending upon interpretation – see section 1.6.11.2) as the area to be inspected and did not detail the access requirements. The engineer who carried out the inspection on G-YMME followed the pictorial description and incorrectly inspected the forward spanwise beam instead of the rear spar. Consequently, the engineer did not remove the baffle doors or enter the rear section of the CWT where the purge door was located.

There are a number of errors in Figure 10 and these can best be visualised by comparing it to a corrected diagram in Figure 11. Both figures depict the forward section of the centre section of the CWT, but Figure 10 has the front spar incorrectly labelled as the rear spar, the STA (station) numbers are reversed and the FWD arrow in the lower diagram of Figure 10 points the wrong way. In Figure 10 the area shown to be inspected (A-A) is the lower section of the front spar but it could be interpreted to be the lower section of the forward spanwise beam due to the FWD arrow pointing the wrong way. A new diagram, Figure 12, clearly shows the aft section of the CWT and the area to be inspected on the rear spar.

Revised diagram for rear spar inspection, part 1 (Rev 5 September 2004)  
(Copied with permission of The Boeing Company)

The revised and corrected diagrams shown in Figure 11 and Figure 12 were published in a revised Boeing task card on 5 January 2005. Figure 11 was published in a revised AMM on 5 September 2004 and Figure 12 was published in a revised AMM on 5 January 2005 (interim diagrams were published prior to these - see section 5.2.1 on safety action for details).

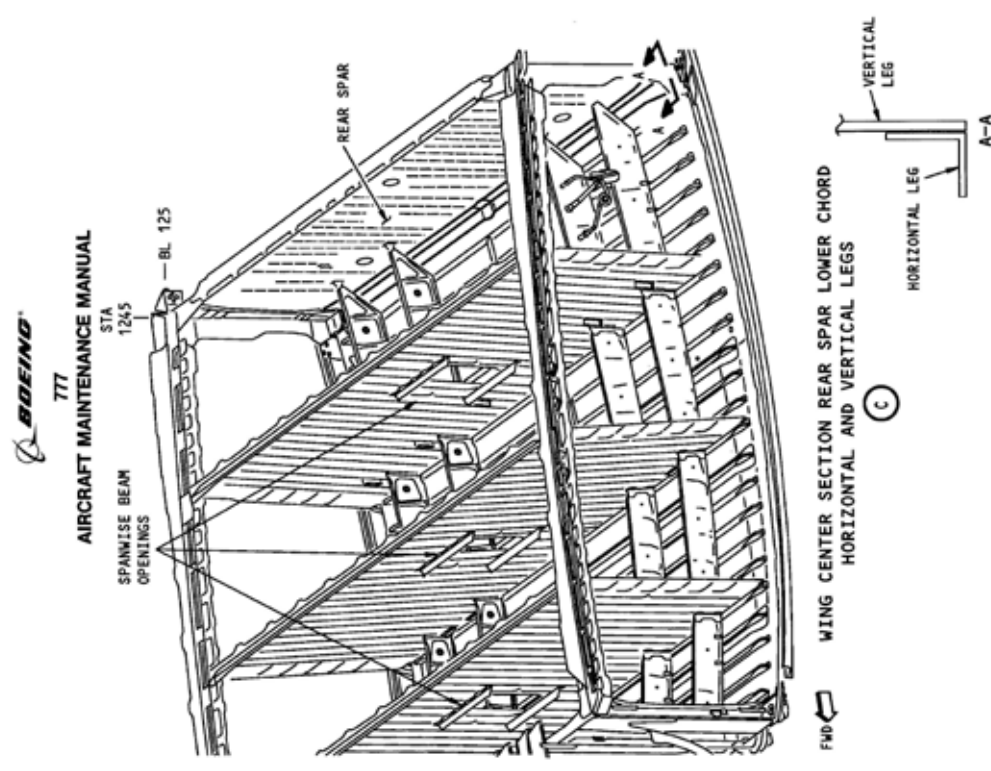
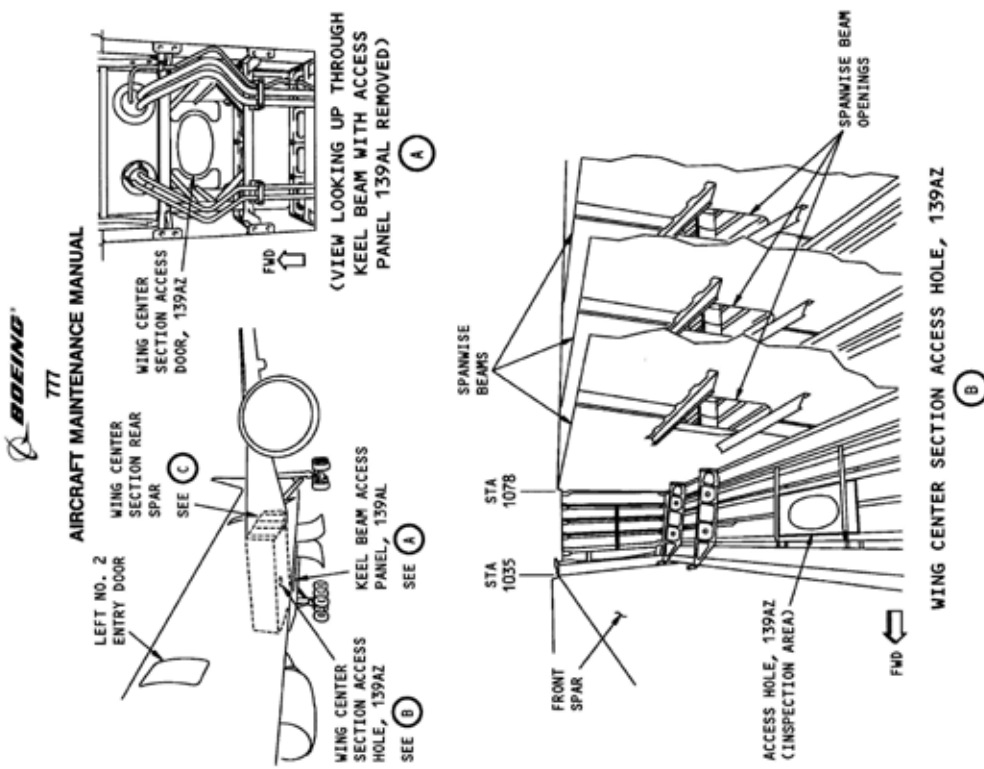
A corrected version of the rear spar inspection diagram was published in the 5 May 2004 revision (Revision 41) of the AMM and of the Boeing task cards (see Appendix 3, it is an earlier version of Figures 11 and 12). This AMM revision was shipped to the operator on a CD (Compact Disc) on 22 April 2004 but, for unknown reasons, it was not received by the operator until 8 June 2004 (a month after the G-YMME maintenance). However, even without this delay the revised diagram would not have been sent to the maintenance organisation in time for G-YMME's maintenance because the operator and the maintenance organisation were under an AMM freeze period and were still using AMM revision 39, dated 5 September 2003 (see section 1.17.11 for the reason behind the freeze). This AMM freeze continued at the maintenance organisation until 24 January 2005. However, following the G-YMME incident, a copy of the revised diagram was sent to the maintenance organisation on a CD on 19 July 2004.

Rear spar inspection from 777 Aircraft Maintenance Manual Revision 41 (5 May 2004)  
(earlier versions of the diagrams depicted in Figures 11 and 12 of the report)  
(Copied with permission of The Boeing Company)
