**INCIDENT**

<b>Aircraft Type and Registration:</b>	Jetstream 4100, G-MAJA
<b>No &amp; Type of Engines:</b>	2 Garrett Airesearch (Honeywell) TPE331-14HR-802H Turboprop engines
<b>Year of Manufacture:</b>	1994
<b>Date &amp; Time (UTC):</b>	29 June 2005 at 1523 hrs
<b>Location:</b>	Manchester Airport, Manchester
<b>Type of Flight:</b>	Public Transport (Passenger)
<b>Persons on Board:</b>	Crew - 3                      Passengers - 10
<b>Injuries:</b>	Crew - None                      Passengers - None
<b>Nature of Damage:</b>	Nil
<b>Commander's Licence:</b>	Airline Transport Pilot's Licence
<b>Commander's Age:</b>	50 years
<b>Commander's Flying Experience:</b>	3,270 hours (of which 1,310 were on type) Last 90 days - 275 hours Last 28 days - 52 hours
<b>Information Source:</b>	AAIB Field Investigation

**Synopsis**

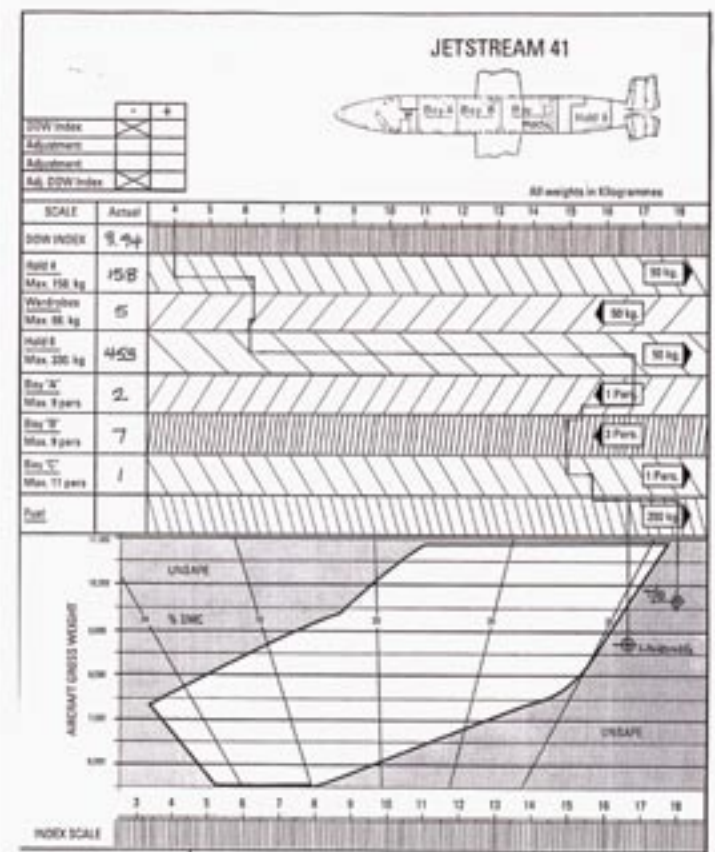
Figure 1 (Left)

had not been weighed and that they were not planning to weigh them. The bags were then loaded into the two baggage compartments; Holds 4 and 6 (see Figure 1). These were both filled to volumetric capacity and the remaining bags (approximately five) were stored in the passenger cabin. The commander appreciated that the centre of gravity would be positioned significantly aft as a result of the full baggage compartments and asked the cabin attendant to seat the passengers in the forward seats. All the loading information was then passed to the first officer who completed the manual loadsheet which the commander then signed. Throughout this period the first officer had remained on the flight deck. The passengers then boarded the aircraft and it was noted by the commander that they possessed a significant amount of hand baggage.
