## ACCIDENT

<b>Aircraft Type and Registration:</b>	Boeing 747-443, G-VLIP	
<b>No &amp; Type of Engines:</b>	4 General Electric CF6-80C2B1F turbofan engines	
<b>Year of Manufacture:</b>	2001	
<b>Date &amp; Time (UTC):</b>	20 March 2007 at 0654 hrs	
<b>Location:</b>	London Gatwick Airport	
<b>Type of Flight:</b>	Commercial Air Transport (Passenger)	
<b>Persons on Board:</b>	Crew - 17	Passengers - 238
<b>Injuries:</b>	Crew - None	Passengers - None
<b>Nature of Damage:</b>	Damage to underside of the two right engine nacelles	
<b>Commander's Licence:</b>	Airline Transport Pilot's Licence	
<b>Commander's Age:</b>	54 years	
<b>Commander's Flying Experience:</b>	15,925 hours (of which 4,885 were on type) Last 90 days - 127 hours Last 28 days - 34 hours	
<b>Information Source:</b>	AAIB Field Investigation

### Synopsis

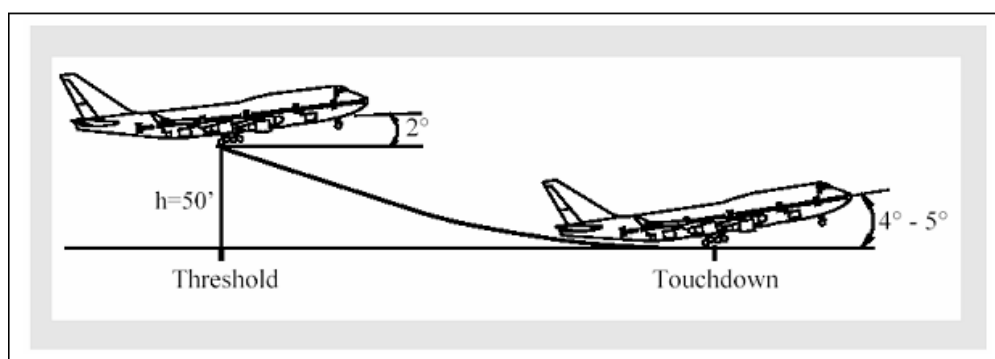
Figure 1

The aircraft attitude required for contact between the engine nacelles and the ground surface during a landing, as advised in the B747-400 FCTM, is shown in Figure 1. The diagram caters for the different makes of engine fitted to the aircraft type ie General Electric (GE), Pratt & Whitney (PW) and Rolls Royce (RR) and is based on a rigid wing, as opposed to one that flexes.

G-VLIP's pitch attitude at touchdown was lower than the 4° - 5° nose up attitude recommended in the B747-400 FCTM. However, information from the FCTM also indicated that the respective pitch and roll attitudes at landing (6.7° right bank and 1° nose down) had not exceeded the ground contact envelope of the nacelles. Instead, at a pitch attitude of 1° nose down,
