**ACCIDENT**

<b>Aircraft Type and Registration:</b>	Eurocopter AS332L2 Super Puma, G-CHCG	
<b>No &amp; Type of Engines:</b>	2 Turbomeca Makila 1A2 turboshaft engines	
<b>Year of Manufacture:</b>	2003	
<b>Date &amp; Time (UTC):</b>	3 March 2006 at 1503 hrs	
<b>Location:</b>	104 nm north-east of Aberdeen VOR/DME	
<b>Type of Flight:</b>	Commercial Air Transport	
<b>Persons on Board:</b>	Crew - 2	Passengers -18
<b>Injuries:</b>	Crew - None	Passengers - None
<b>Nature of Damage:</b>	Lightning strike damage to one main rotor blade, one tail rotor blade and other components including all three main rotor servo-actuators	
<b>Commander's Licence:</b>	Airline Transport Pilot's Licence	
<b>Commander's Age:</b>	58 years	
<b>Commander's Flying Experience:</b>	Approximately 15,000 hours (of which about 2,500 hrs were on type) Last 90 days - 91 hours Last 28 days - 29 hours	
<b>Information Source:</b>	AAIB Field Investigation

**Synopsis**

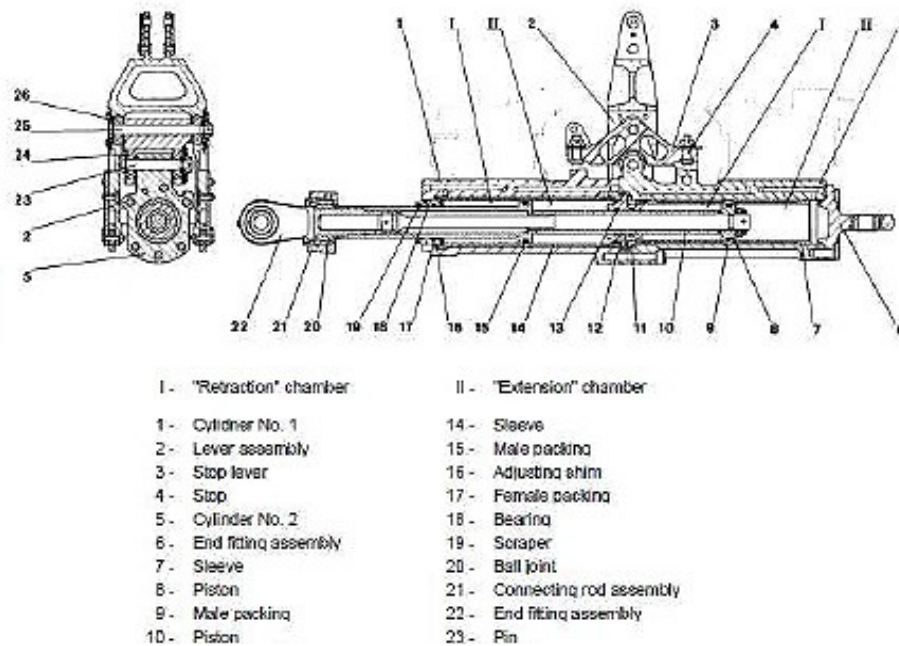
**Figure 2**

The AS322 has dual hydraulic systems and, to achieve the necessary redundancy in the primary flying controls, the main rotor servo actuators have a tandem arrangement (see Figure 2) in which each hydraulic system supplies power to separate pistons, although the pistons are on a common shaft forming part of a single actuator. Either system can control the helicopter on

AS332L main rotor servo actuator

its own but, of course, they normally work together. It can be seen that the Fescolized portion of one piston extends out of the body of the actuator (No 1, or Left system) and is therefore visible externally, but the piston of the other system (No 2, or Right) remains completely hidden internally. A drain hole between the intermediate bearings of No 2 system should provide witness of any internal leakage past the Fescolized rod.
