Aircraft Type and Registration:	Cessna T310R, N6834L	
No & Type of Engines:	2 Teledyne Continental TSI0-520-BB piston engines	
Year of Manufacture:	1981	
Date & Time (UTC):	30 March 2004 at 0840 hrs	
Location:	Near Laneshaw Bridge, Colne, Lancashire	
Type of Flight:	Private	
Persons on Board:	Crew - 1	Passengers - None
Injuries:	Crew - 1 (Fatal)	Passengers - N/A
Nature of Damage:	Aircraft destroyed	
Commander's Licence:	Private Pilot's Licence and FAA Private Pilot's Certificate issued on basis of UK Licence	
Commander's Age:	57 years	
Commander's Flying Experience:	627 hours (of which 403 were on type) Last 90 days - 3 hours Last 28 days - 0 hours	
Information Source:	AAIB Field Investigation

Synopsis

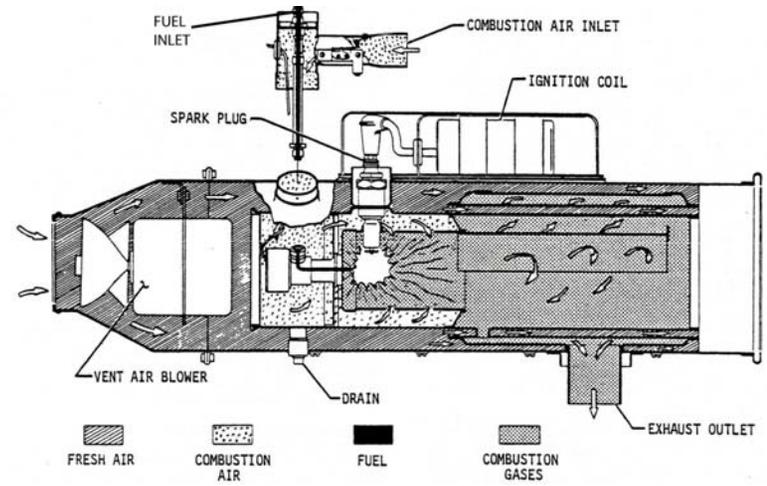
Figure 4 - Heater and ventilation system - T310R

The layout and functioning of the cabin heating and ventilation system can be seen at Figures 4, 5 and 6. Figure 4 shows the position of the combustion heater in the nose of the aircraft and the routing of the heating and ventilation air flows into the cabin. Figure 5 shows the principal components of the system (combustion heater, ventilation fan, centrifugal fan and fuel pump), as configured for a bench test. Figure 6 illustrates the internal functioning of the combustion heater.
