Air Accidents Investigation Branch

**Report on the accident between
Grob G115E (Tutor), G-BYXR and
Standard Cirrus Glider, G-CKHT
at Drayton, Oxfordshire
on 14 June 2009**

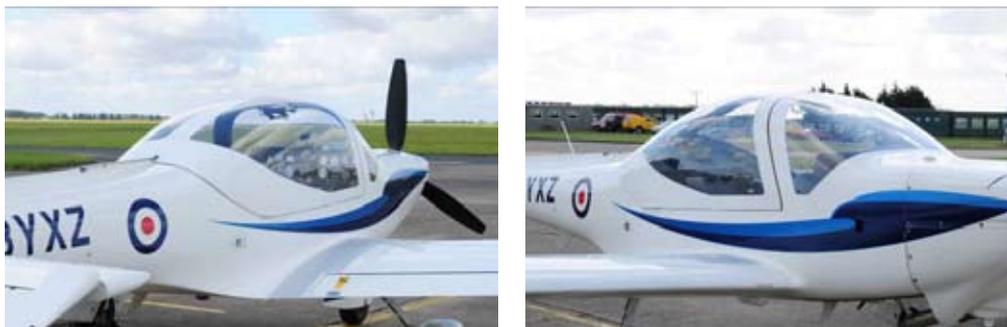
Figure 1

The Tutor is fitted with a single piece windscreen and a sliding canopy containing two large acrylic panels, Figure 1. The frame around the windscreen and the forward frame on the canopy are both approximately 9 cm wide. The two acrylic panels in the canopy are also attached to a frame located along the canopy centre line, which is approximately 16 cm wide. The canopy operating handle, which is coloured silver, is mounted on the forward section of this frame.

Windscreen and canopy

Visibility from the cockpit is generally very good and it is possible to see both tailplanes. Nevertheless, previous work undertaken by QinetiQ, in support of an investigation involving the mid-air collision of two Tutor aircraft, established that the canopy and windscreen frames can obscure part of the pilot's field of view. With a fixed head position for a pilot sitting in the right seat, the canopy and windscreen frame will obscure an area of sky, approximately, between 25° and 55° above the normal horizon and the lateral field-of-view between 25° and 47° . The QinetiQ report noted that it is possible for the pilot to look around this obscuration. The CAA test pilot reported that during his flight evaluation of the Tutor he was able to conduct a comprehensive look-out prior to each manoeuvre, without having to move his head extensively. AAIB inspectors, who have flown in the Tutor, also experienced no difficulty in looking around the windscreen and canopy frame.

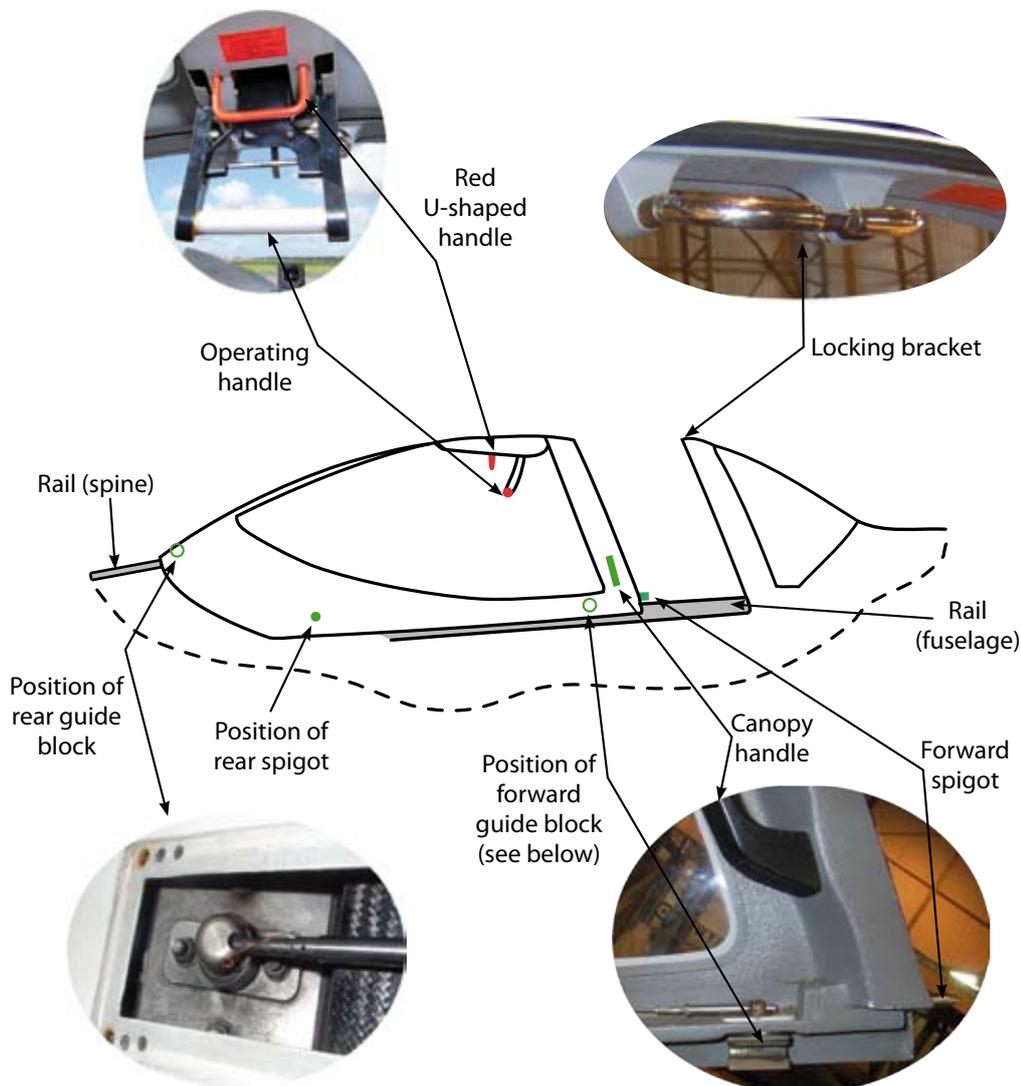
Figure 2

The sliding canopy, which has a mass of 20.4 kg, is located on three guide blocks, which run on rails mounted on the fuselage spine aft of the cockpit and on each side of the fuselage, Figure 2. When the canopy is pushed closed it presses against a seal on the windscreen frame and four spigots on the bottom of the canopy engage in bushes mounted in the windscreen frame and on the canopy rail. To lock the canopy in the closed position, the operating handle is moved fully forward, causing a hook to latch onto a locking bracket mounted on the windscreen frame. The canopy can be moved along its rails by the use of handles mounted on the inside of the canopy.

Canopy operating and jettison system

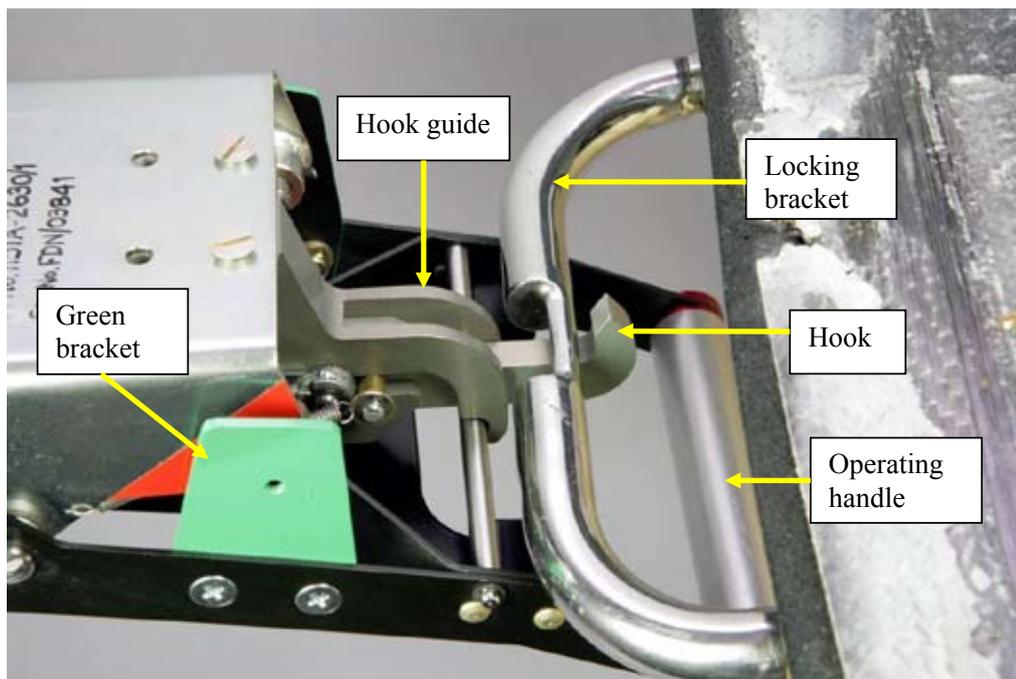
Figure 3

The canopy is opened in two stages. Firstly, the operating handle is moved rearwards until it reaches a stop just beyond the vertical position; this releases the hook from the locking bracket, Figure 3.

Salient features of the canopy operating mechanism, with the canopy in the closed and locked position

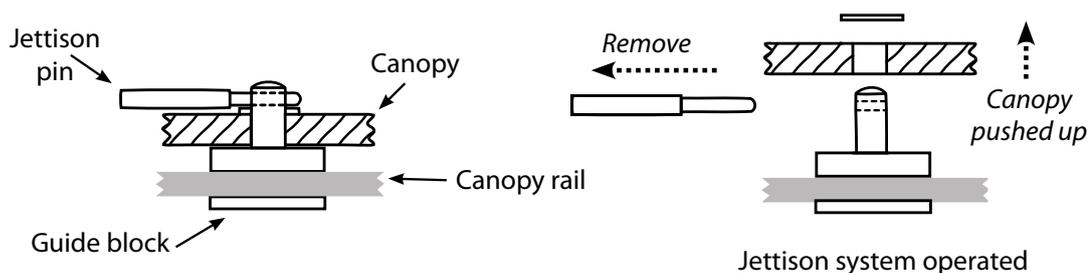
Figure 4

1. A 'U' shaped red handle (also called a 'jettison' handle and locking lever) must be pulled from the canopy operating mechanism. This allows the canopy operating handle to be moved rearwards by approximately 170°, which causes the hook to disengage from the locking bracket and withdraw from its guide.
2. As the canopy operating handle is moved rearwards beyond the vertical position, three Bowden cables operate and pull a 'jettison' pin out of each of the three canopy guide blocks, Figure 4. At this stage, the canopy is still attached to the aircraft by the four spigots.

Operation of canopy jettison pins

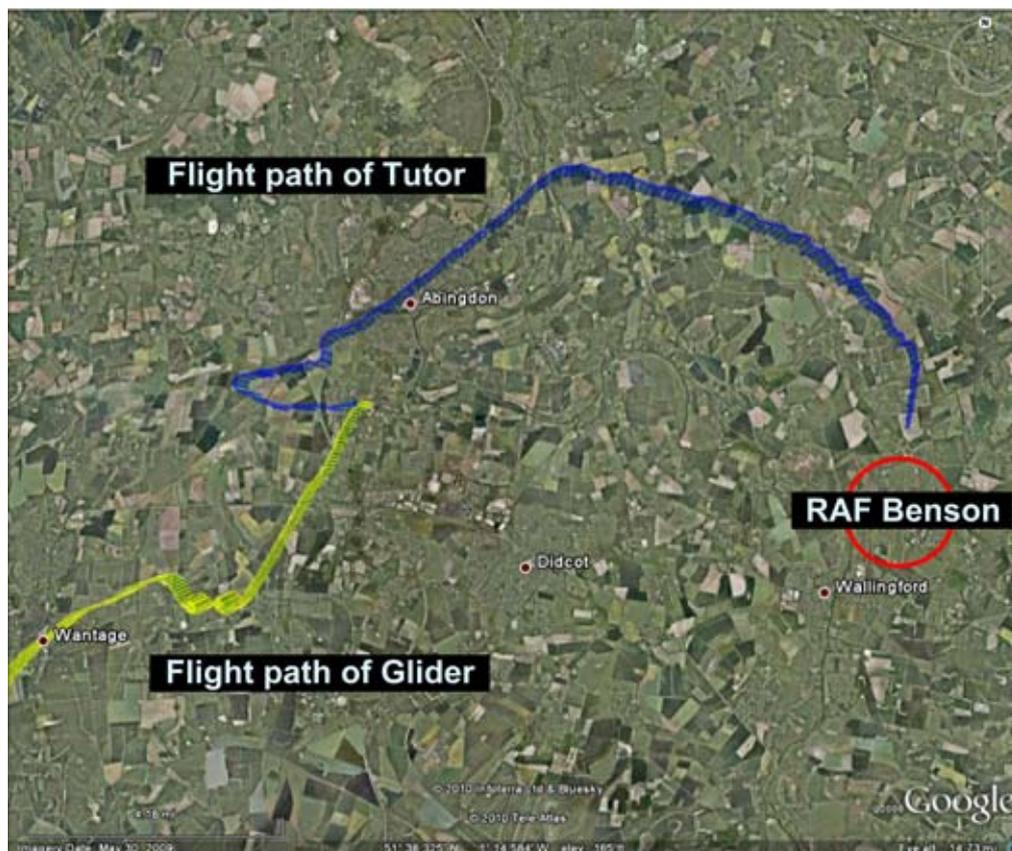
Figure 5

The glider approached the area from the south-west and, when approximately 3 nm from Drayton, completed a number of thermalling turns climbing to 4,500 ft. The glider then continued on a track of 030° towards Abingdon.

Flight tracks of Tutor (G-BYXR) and glider (G-CKHT)

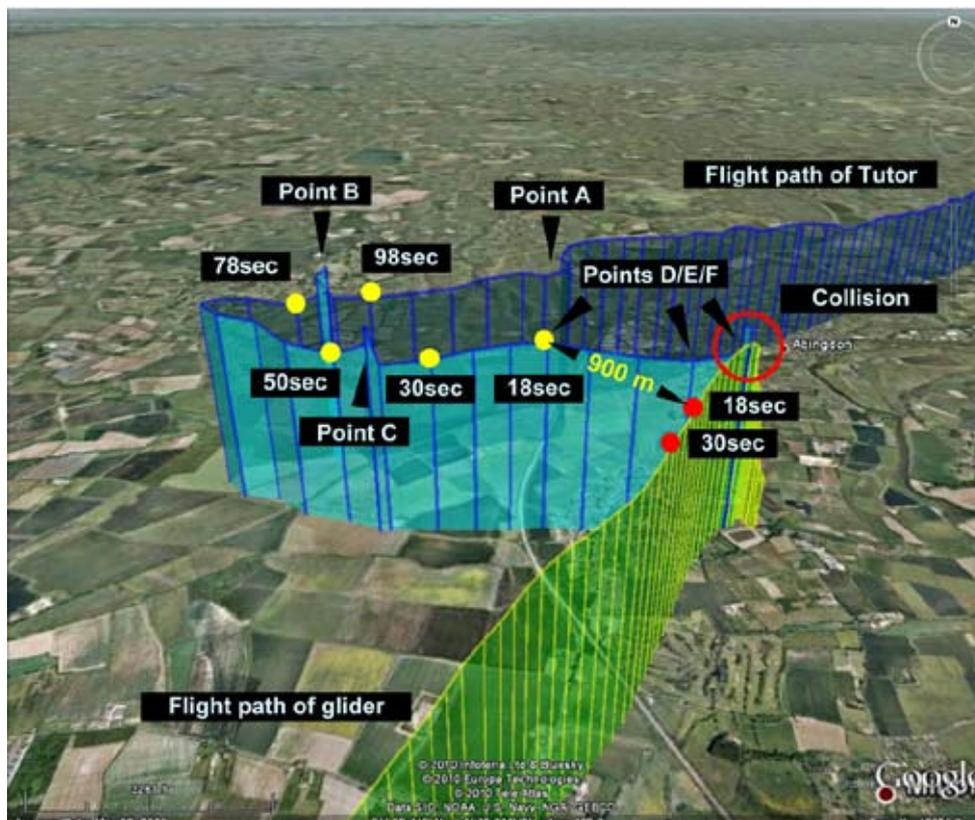
After departing RAF Benson, the Tutor passed Abingdon at 4,300 ft. It then made a series of turns with small changes in altitude (Point A), Figure 6 and 7, which brought it on to a westerly track, before accelerating to a ground speed

The Tutor descended and accelerated to 3,900 ft, climbed rapidly to 4,700 ft and then descended to 3,800 ft (Point C). It exited this manoeuvre on a track of approximately 085°, at a similar position from which this manoeuvre had commenced. The aircraft were now 30 seconds from the collision and separated by 1 nm. From this position, the Tutor climbed to 4,200 ft and then started a gradual descent.

Relative flight paths of Tutor (G-BYXR) and glider (G-CKHT) as viewed from the south

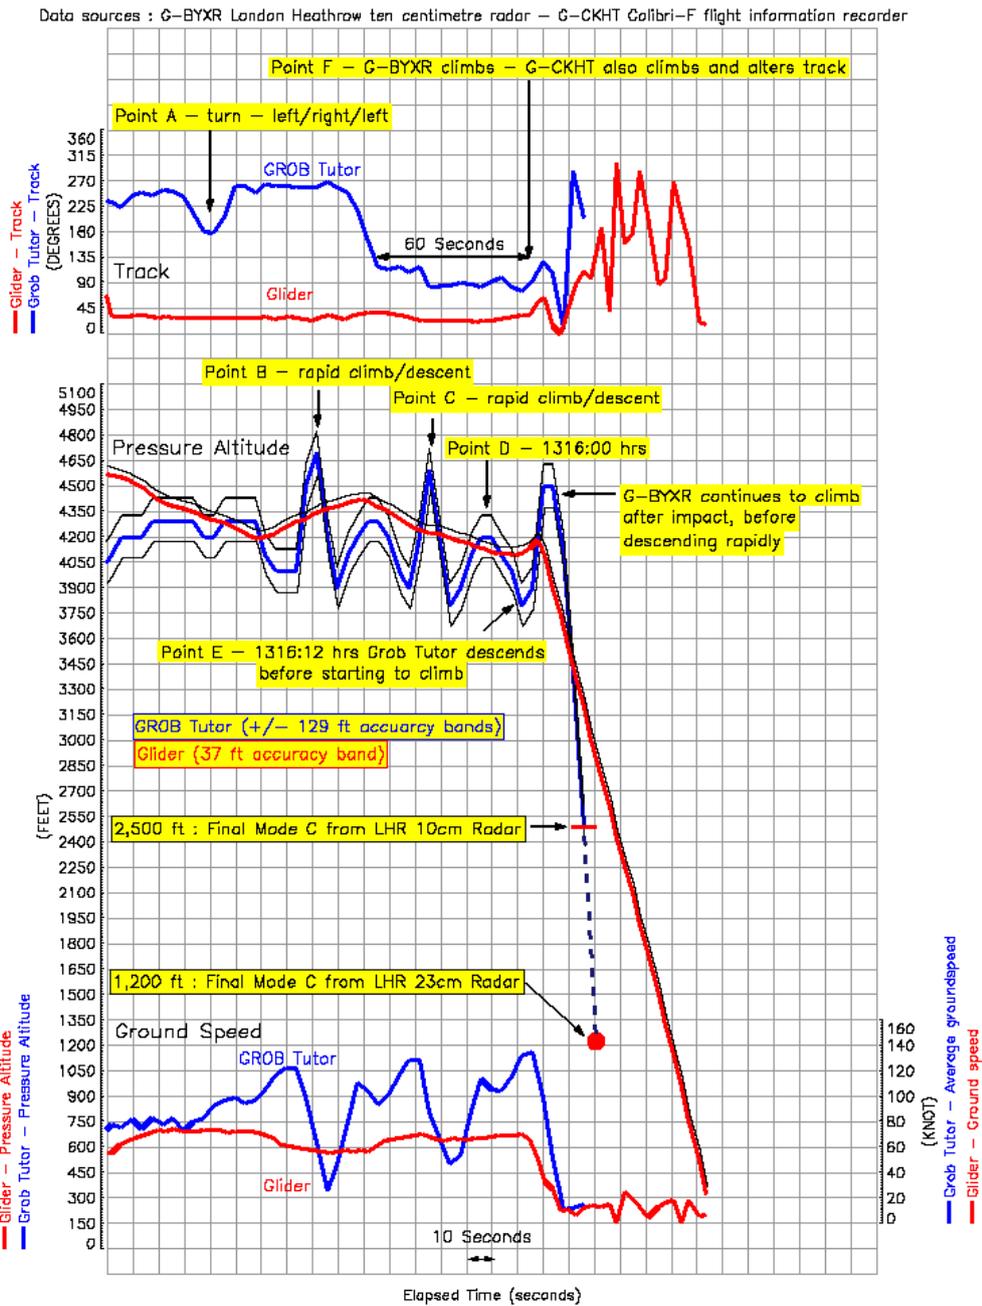
If the maximum altitude accuracies² of the Tutor's transponder, and the glider's flight information recorder, are applied and the Tutor was flying straight and level, then the relative position of the glider would have been between 16° and 32° above the Tutor. However, as the separation reduced, the glider would have moved higher in the Tutor pilot's field-of-view.

Figure 7
Relative attitudes of Tutor (G-BYXR) and glider (G-CKHT)

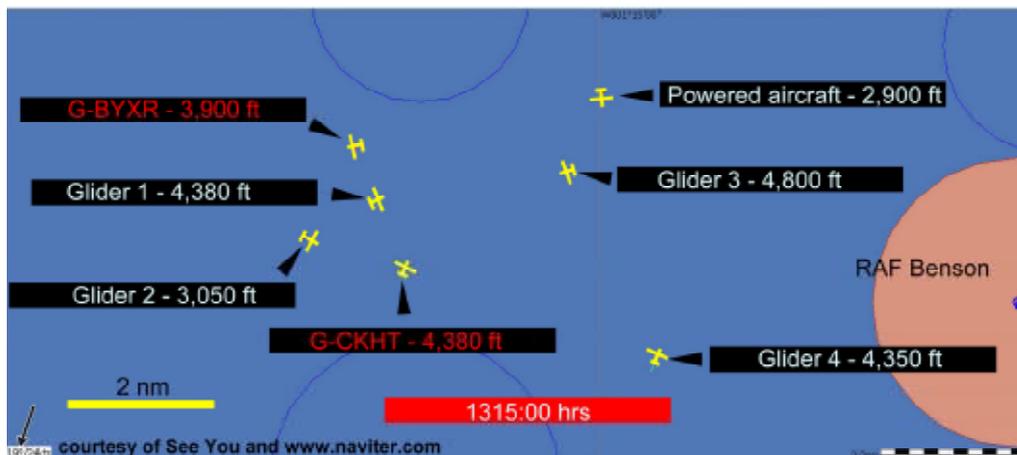
Figure 8

There were four other gliders (Glider 1 to 4) and one powered aircraft operating within 3.5 nm of the accident site about 80 seconds before the collision. The nearest aircraft was a glider, which is referred to as Glider 1, positioned about 0.7 nm from the Tutor and 1 nm mile from the glider (G-CKHT).

Proximity of other aircraft 78 seconds before the collision

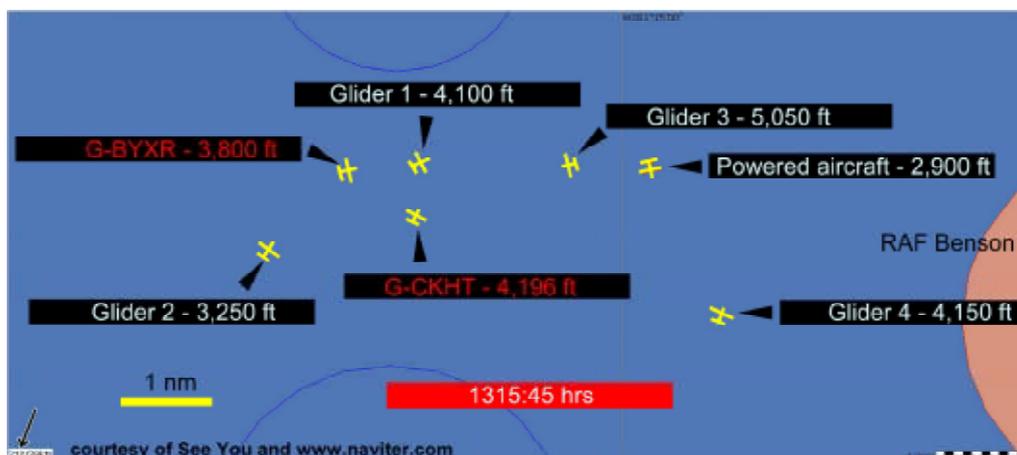
Figure 9

Proximity of other aircraft 33 seconds before the collision

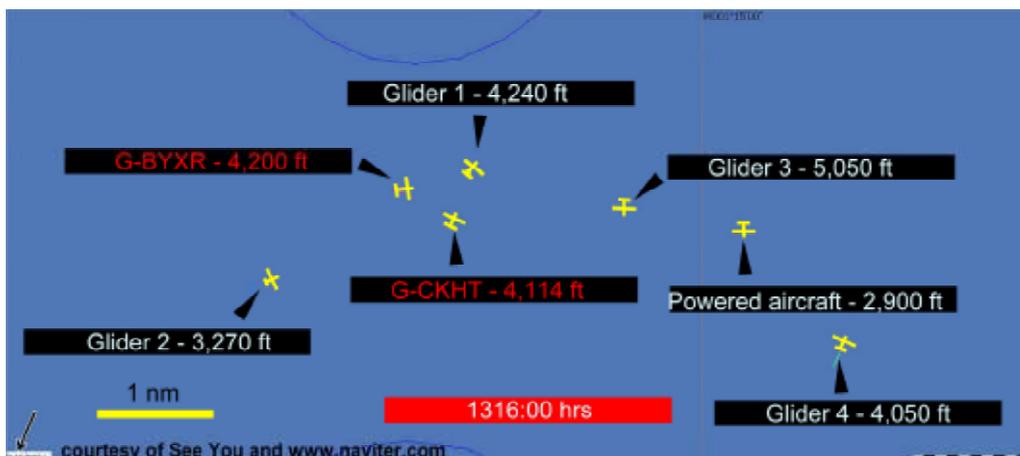
Figure 10

Proximity of other aircraft 18 seconds before the collision

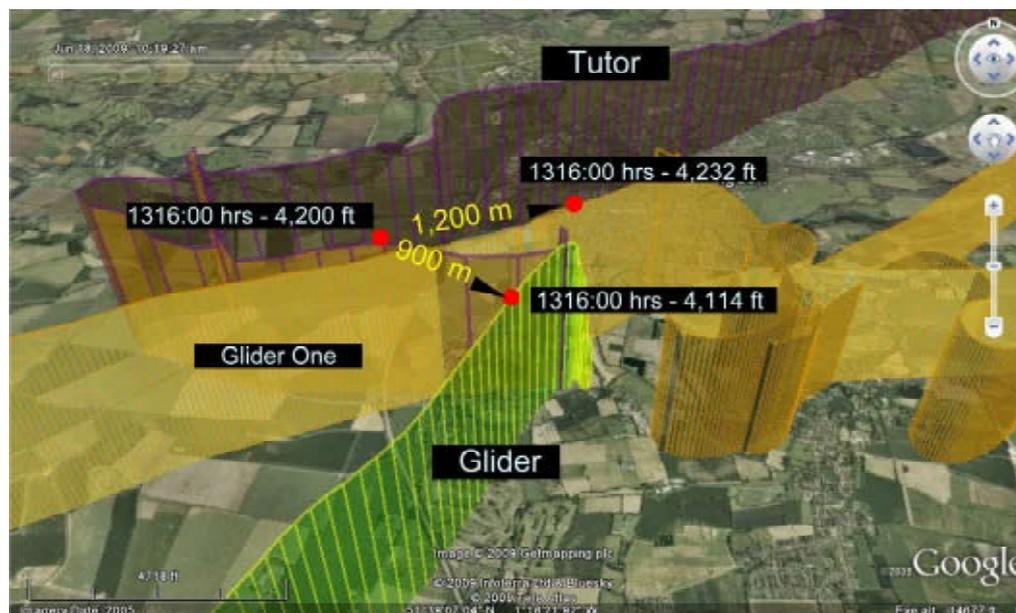
Figure 11

The relative flight of Glider 1 and the accident aircraft prior to the collision is shown at Figure 11.

Relative flight path of Glider 1 in relation to accident aircraft

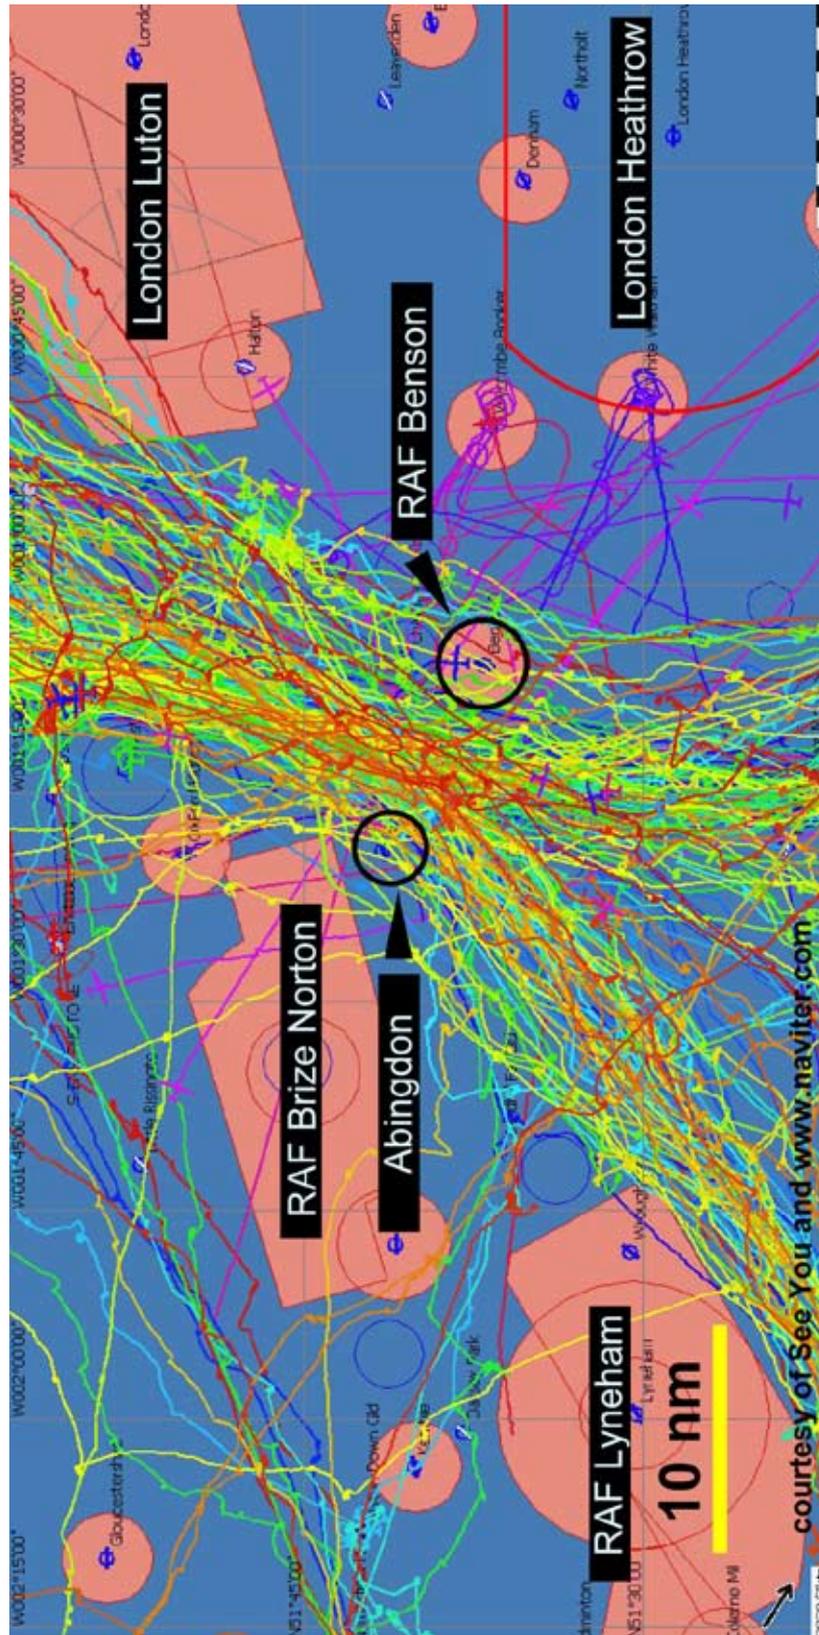
From the combination of nearly 600 flight records, it was established that between 1200 hrs and 1330 hrs, 118 aircraft had operated within 10 nm of RAF Benson, with the majority of these aircraft routing through the gap between the RAF Brize Norton CTR and RAF Benson ATZ, Figure 12 and 13. Of the 118 aircraft, 85 were identified as gliders and 33 as powered aircraft, both fixed and rotary wing. During the same period, 6 AEF also flew 19 flights from RAF Benson, of which 12 are included in the radar data. This does not include the accident flight, Figure 14. The majority of the 118 aircraft transited the area where the accident occurred. Between 1200 hrs and 1330 hrs, there were, at any one time, 15 to 25 aircraft operating within a 10 nm radius of RAF Benson; the accident location was about 8 nm to the west of RAF Benson.

Flight tracks of 118 aircraft between 1200 hrs to 1330 hrs (10 nm)

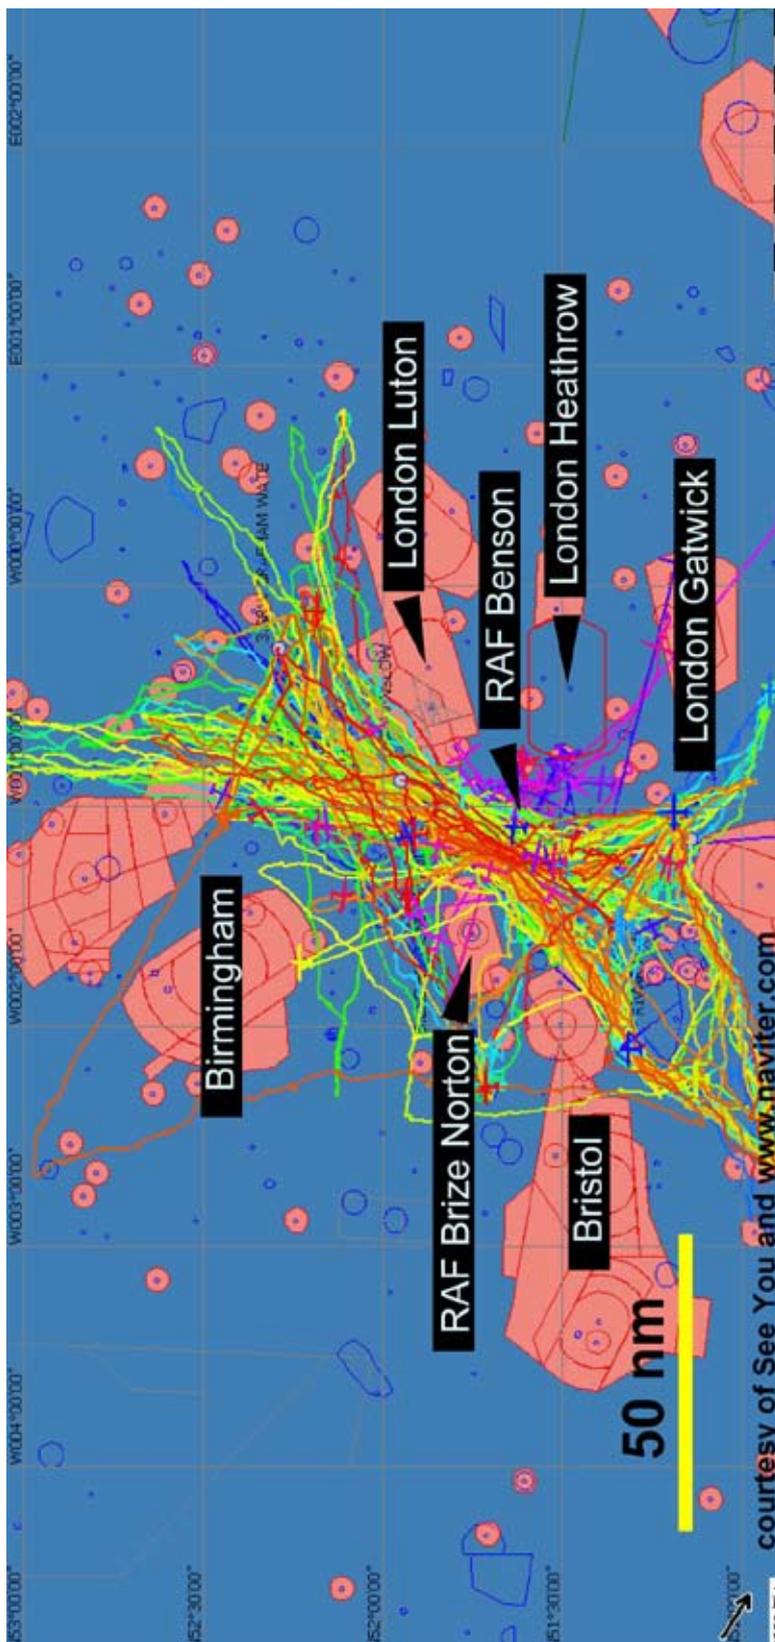
Figure 13

Flight tracks of 118 aircraft between 1200 hrs to 1330 hrs (50 nm)

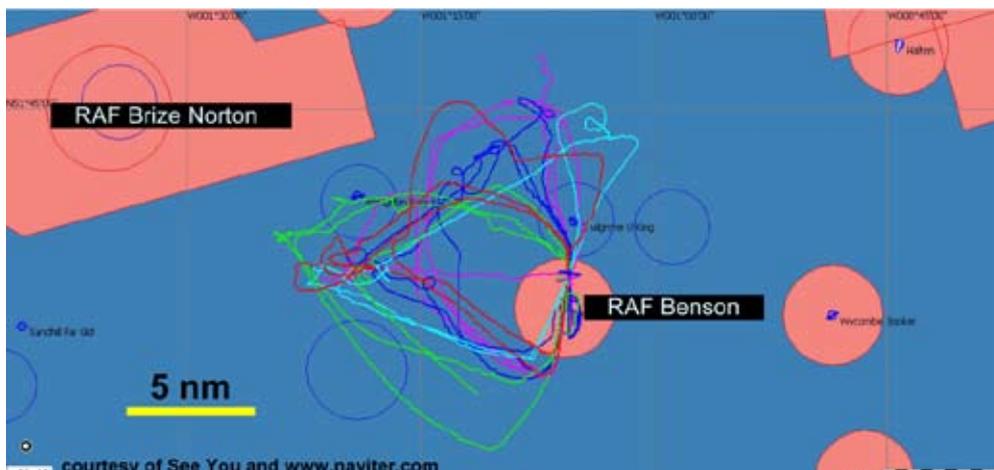
Figure 14

Tutor flights between 1200 hrs and 1330 hrs

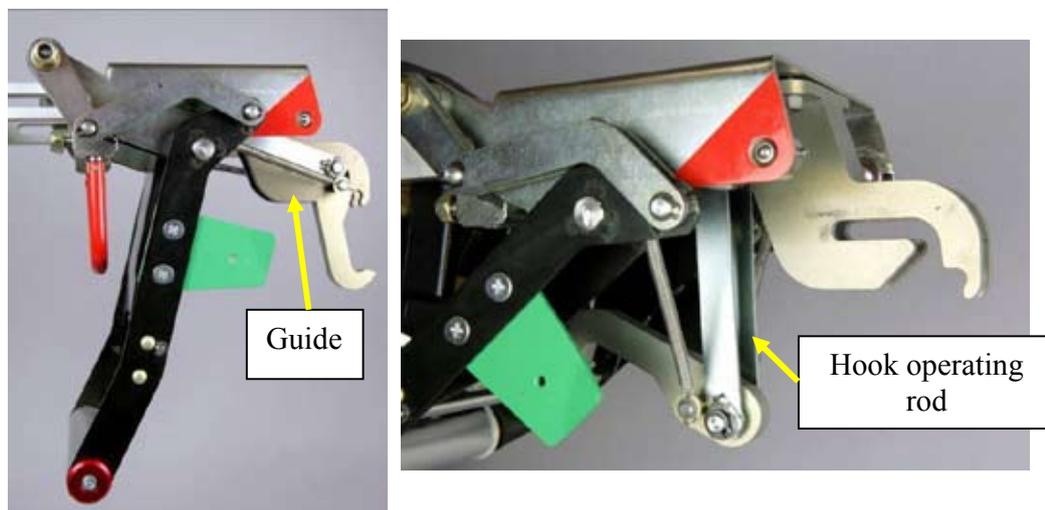
The salient features of the canopy operating mechanism are highlighted in Figure 3. Figure 16 shows the position of the hook and operating handle in the canopy 'open' and 'jettison' positions. In the open position, the hook is still retained in the hook guide, whilst in the jettison position, the operating handle moves further rearwards and the hook withdraws from the guide.

Open position

Jettison position

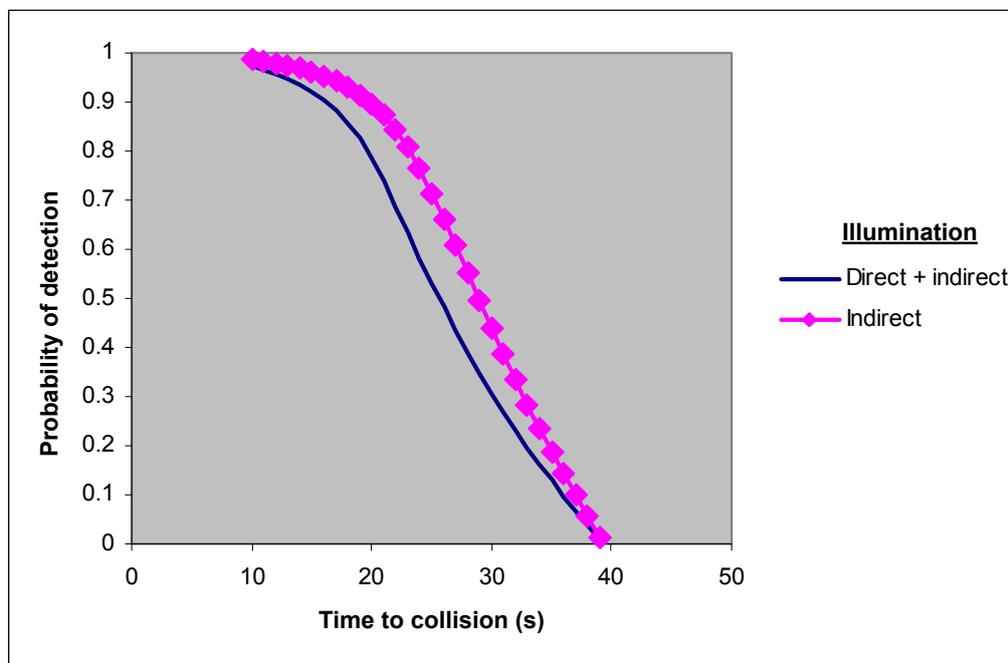
Figure 24

The model established that, 40 seconds prior to the collision, the glider would have been effectively invisible to the human eye. The probability of detection would increase to 50% at 25 seconds and 95% at 10 seconds prior to the collision, Figure 24.

Probability of detecting the glider
