SERIOUS INCIDENT

Aircraft Type and Registration:	ATR72-202, EI-SLG	
No & Type of Engines:	2 x Pratt and Whitney PW124B turboprop engines	
Year of Manufacture:	1990	
Date & Time (UTC):	15 March 2011 at 2130 hrs	
Location:	Near Edinburgh Airport	
Type of Flight:	Commercial Air Transport (Non-Revenue)	
Persons on Board:	Crew - 2	Passengers - None
Injuries:	Crew - None	Passengers - N/A
Nature of Damage:	None	
Commander's Licence:	Airline Transport Pilot's Licence	
Commander's Age:	45 years	
Commander's Flying Experience:	4,092 hours (of which 3,500 were on type) Last 90 days - 72 hours Last 28 days - 29 hours	
Information Source:	AAIB Field Investigation

Synopsis

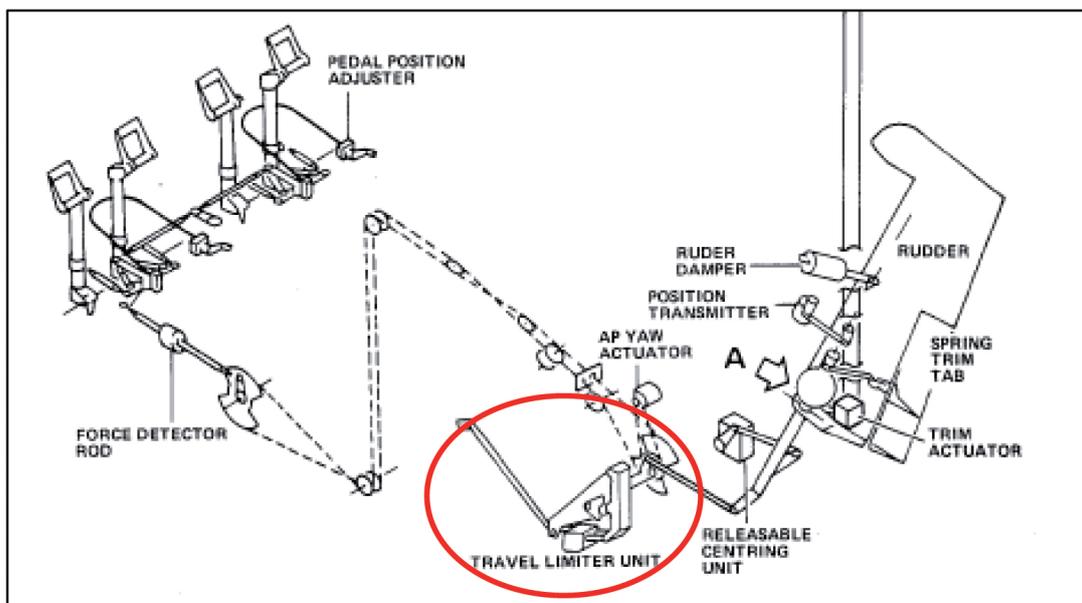
Figure 3

The rudder linkage on the ATR 72 is a mechanical system composed of quadrants, pulleys, rods and cables. The TLU, installed on the rudder rear quadrant shaft (Figure 3), reduces the range of available rudder deflection at airspeeds above 185 kt, in order to limit the structural loads on the rudder. In the full authority (or low speed) position, rudder deflection is not limited; in the reduced authority (or high speed) position, rudder deflection is mechanically limited by the TLU.

ATR 72 Rudder control system

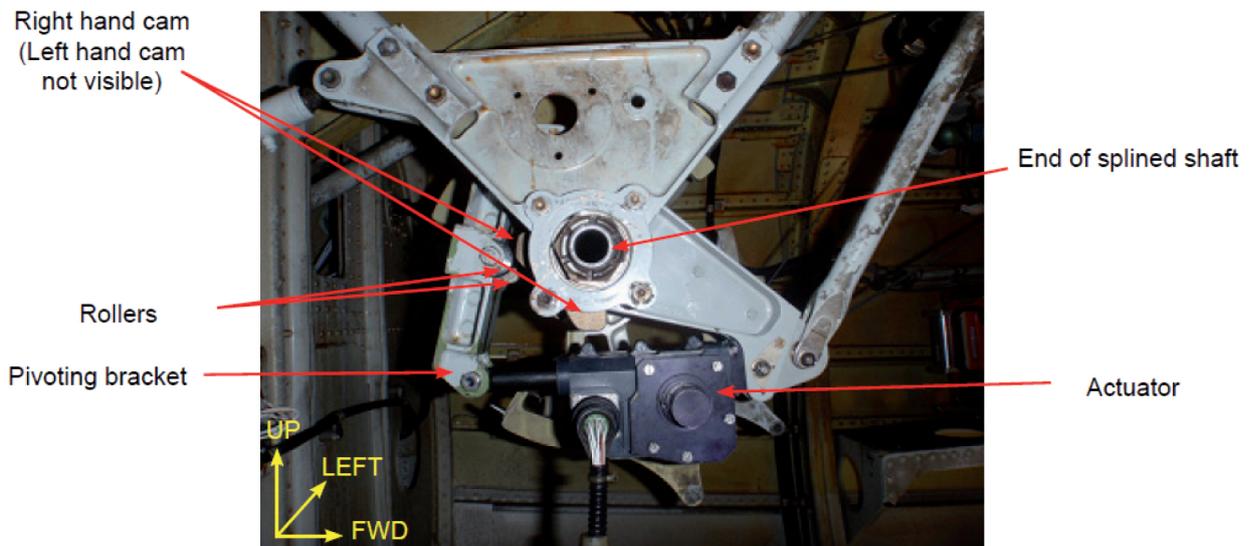
Figure 4

The TLU mechanism comprises an electrical actuator which drives a pivoting bracket on which two rollers are mounted (Figure 4). In the reduced authority position the actuator retracts, engaging the rollers in two v-shaped cams mounted on the rudder rear quadrant shaft, to limit the rudder deflection mechanically. In the full authority position the actuator extends, disengaging the rollers

Rudder Travel Limitation Unit

Upon examination of the TLU support arm, Cert A and the production manager concluded that the bearing housing was showing signs of wear which was allowing the bearing to migrate. However they considered the wear to be minor and unlikely to prevent the bearing from functioning correctly. As the aircraft was due to leave the hangar in four days, the production manager considered that there would be little chance of obtaining a replacement part without delaying the aircraft, but he did not perform a stock check to verify this. Instead, he advised Cert A to reinstall the TLU support arm and suggested the fitting should be 'peened' to prevent further movement of the bearing.
