APPENDIX A

Figure 1: Showing general layout of AS332L.

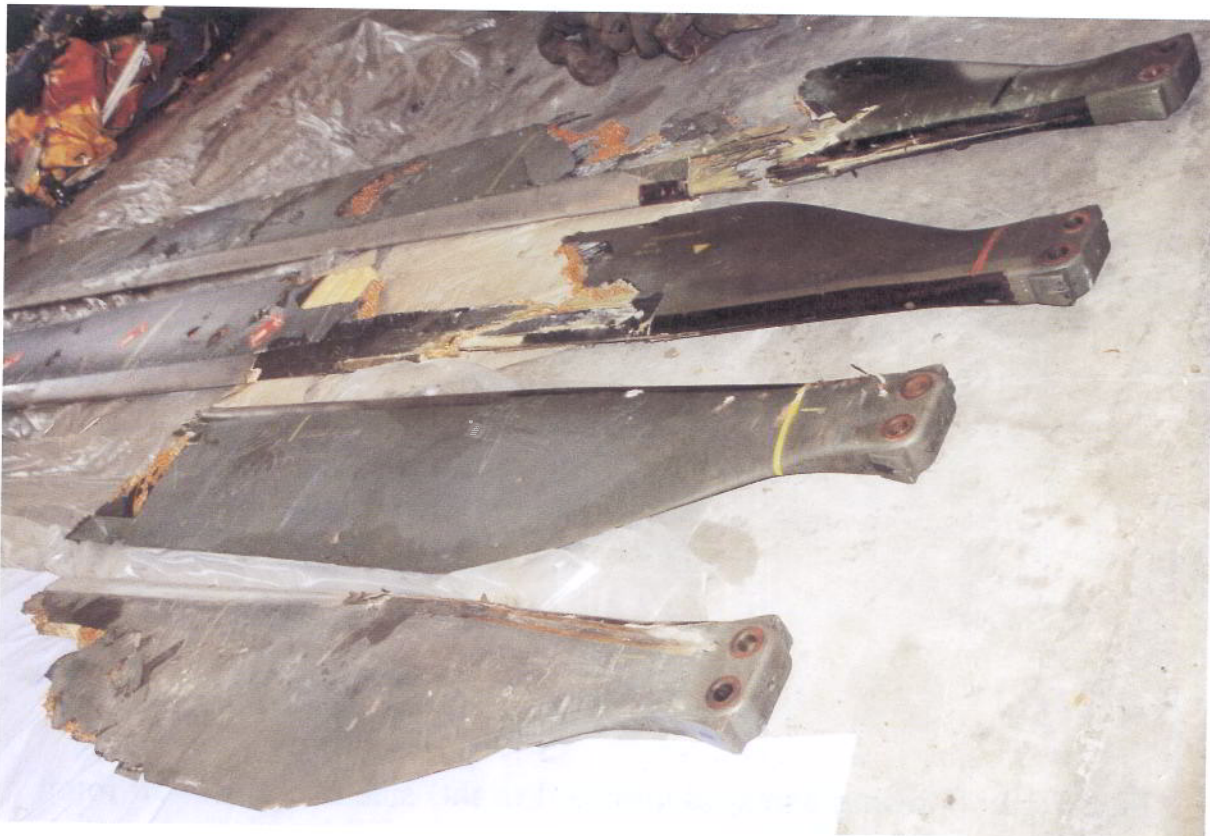
Figure 9A: Showing localised blade skin damage at overlap of leading edge anti-erosion shield sections due to related arcing on 'Black' MRB.

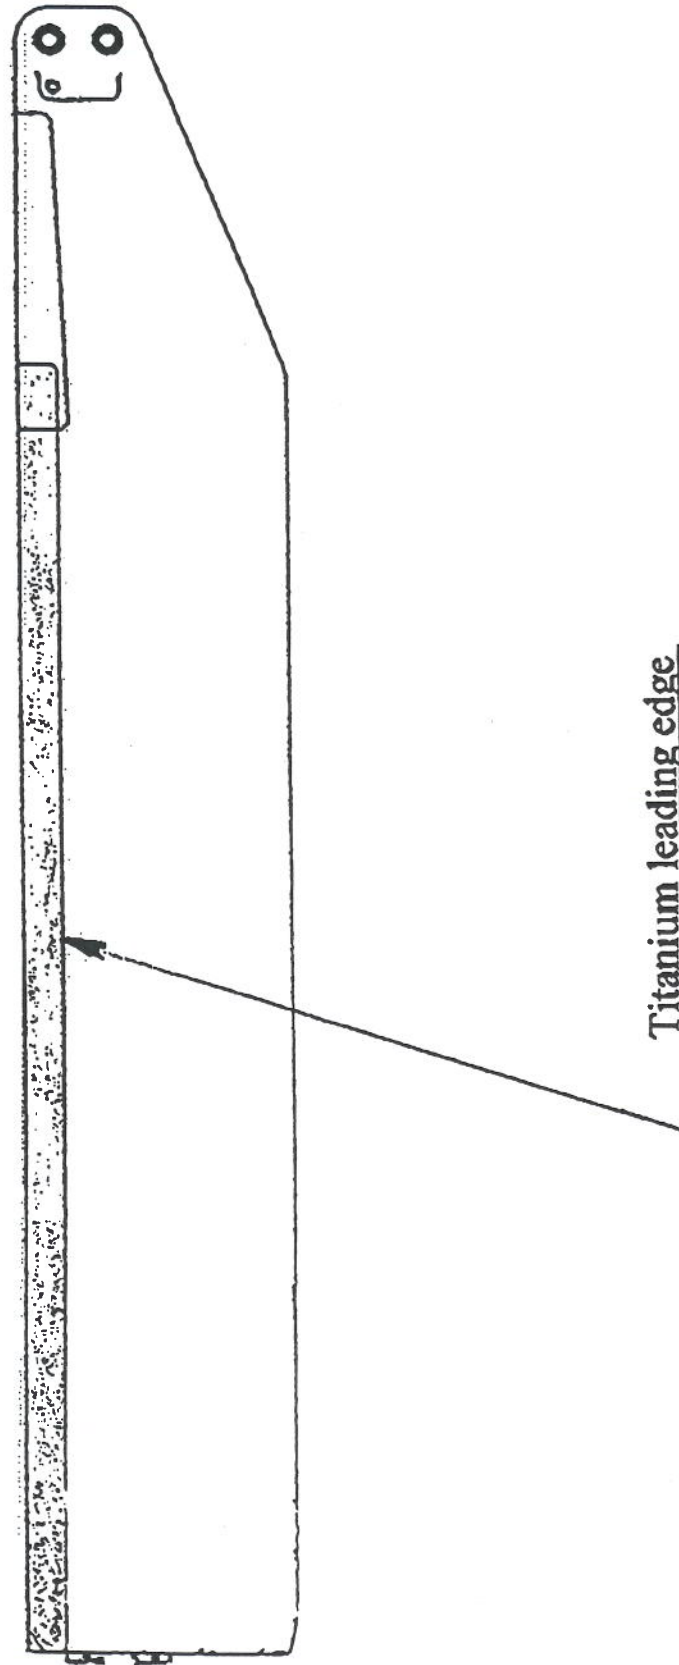
Figure 13A: Showing leading edge anti-erosion shield/conductor design on TRB p/n 332A.12.0020 before modification to improve lightning protection.

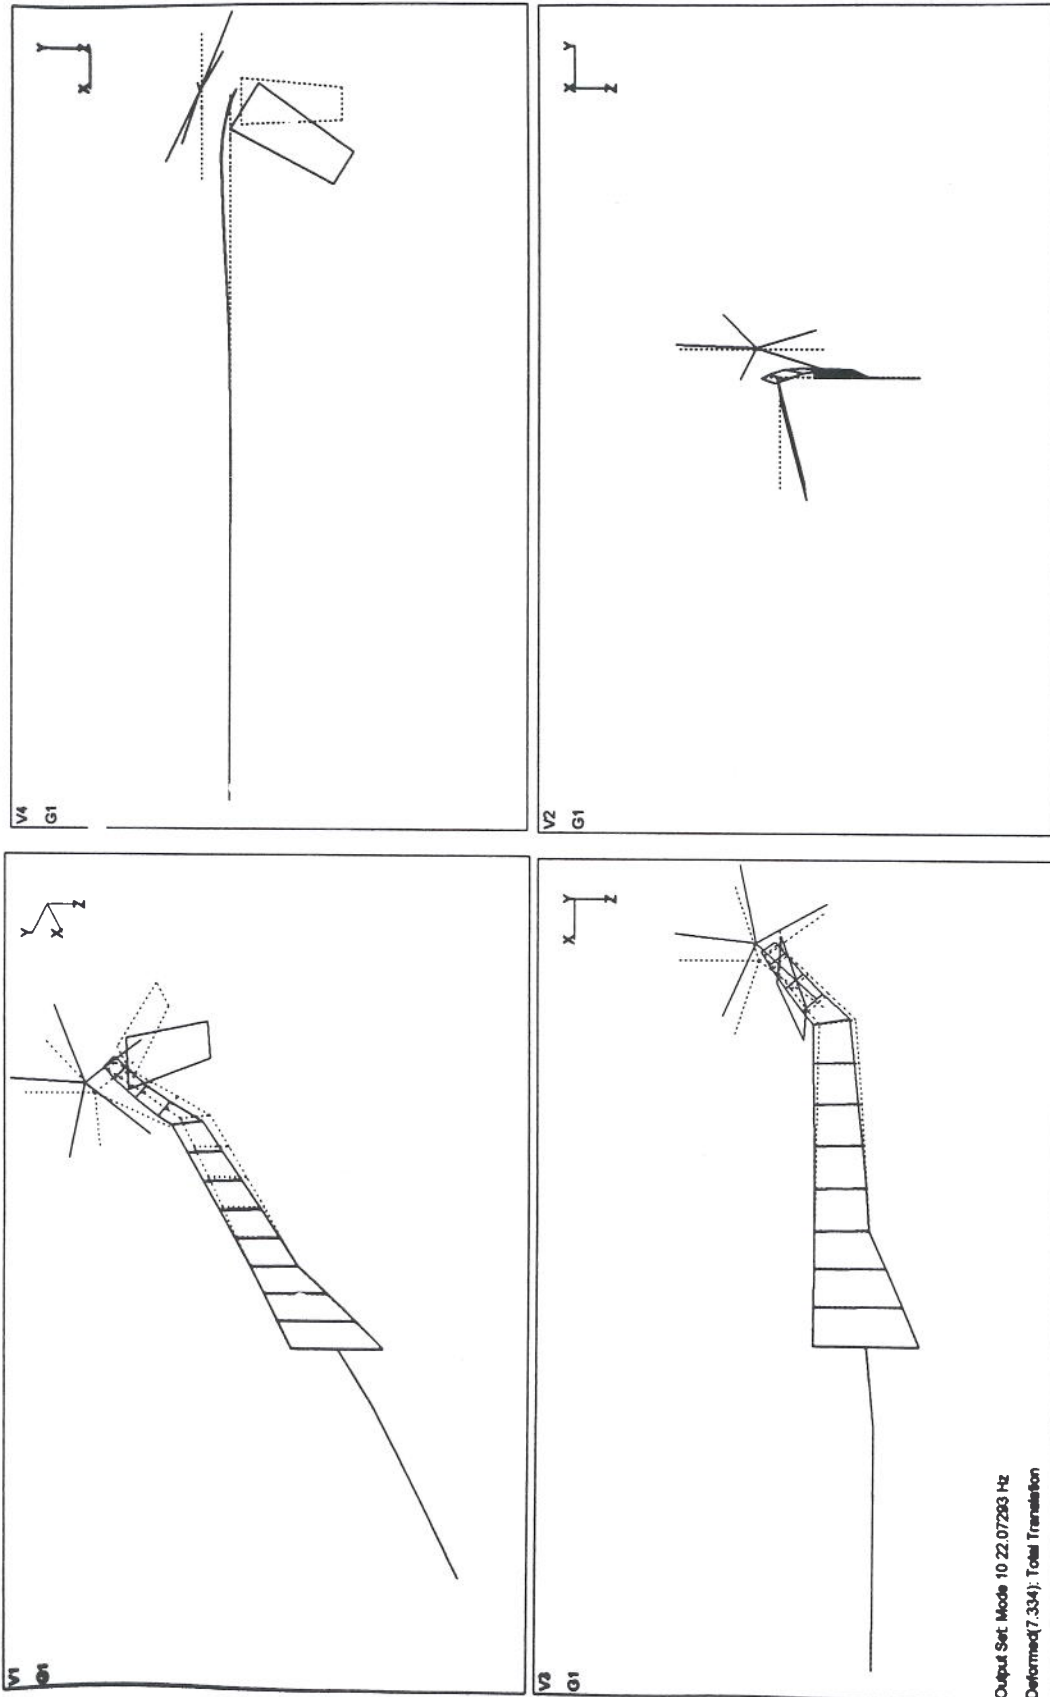
Figure 1: Showing predicted overtone vertical/lateral bending mode at 22.07Hz

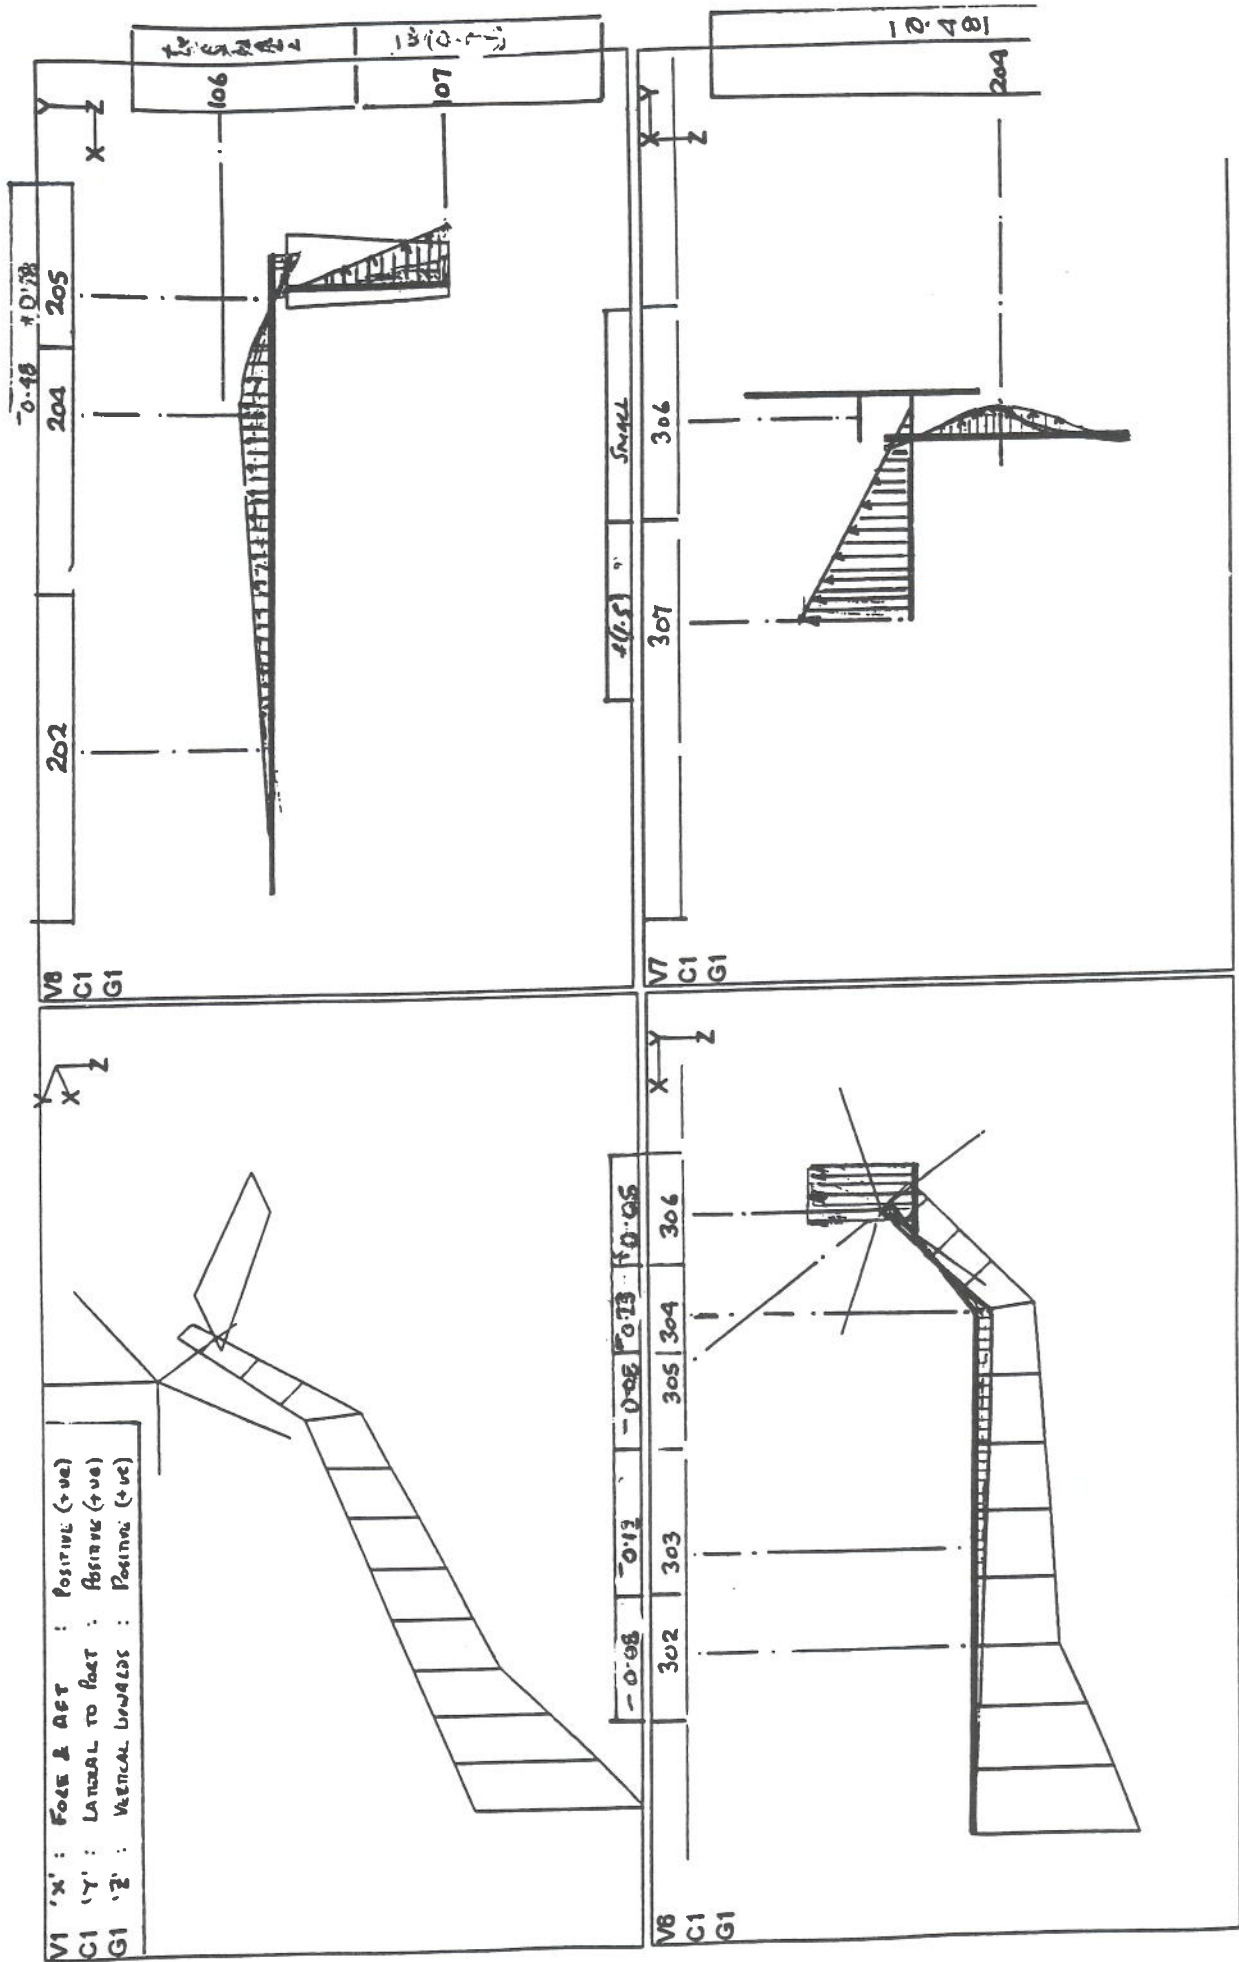
Figure 2: Showing measured overtone vertical/lateral bending and tail roll mode at 22.80Hz

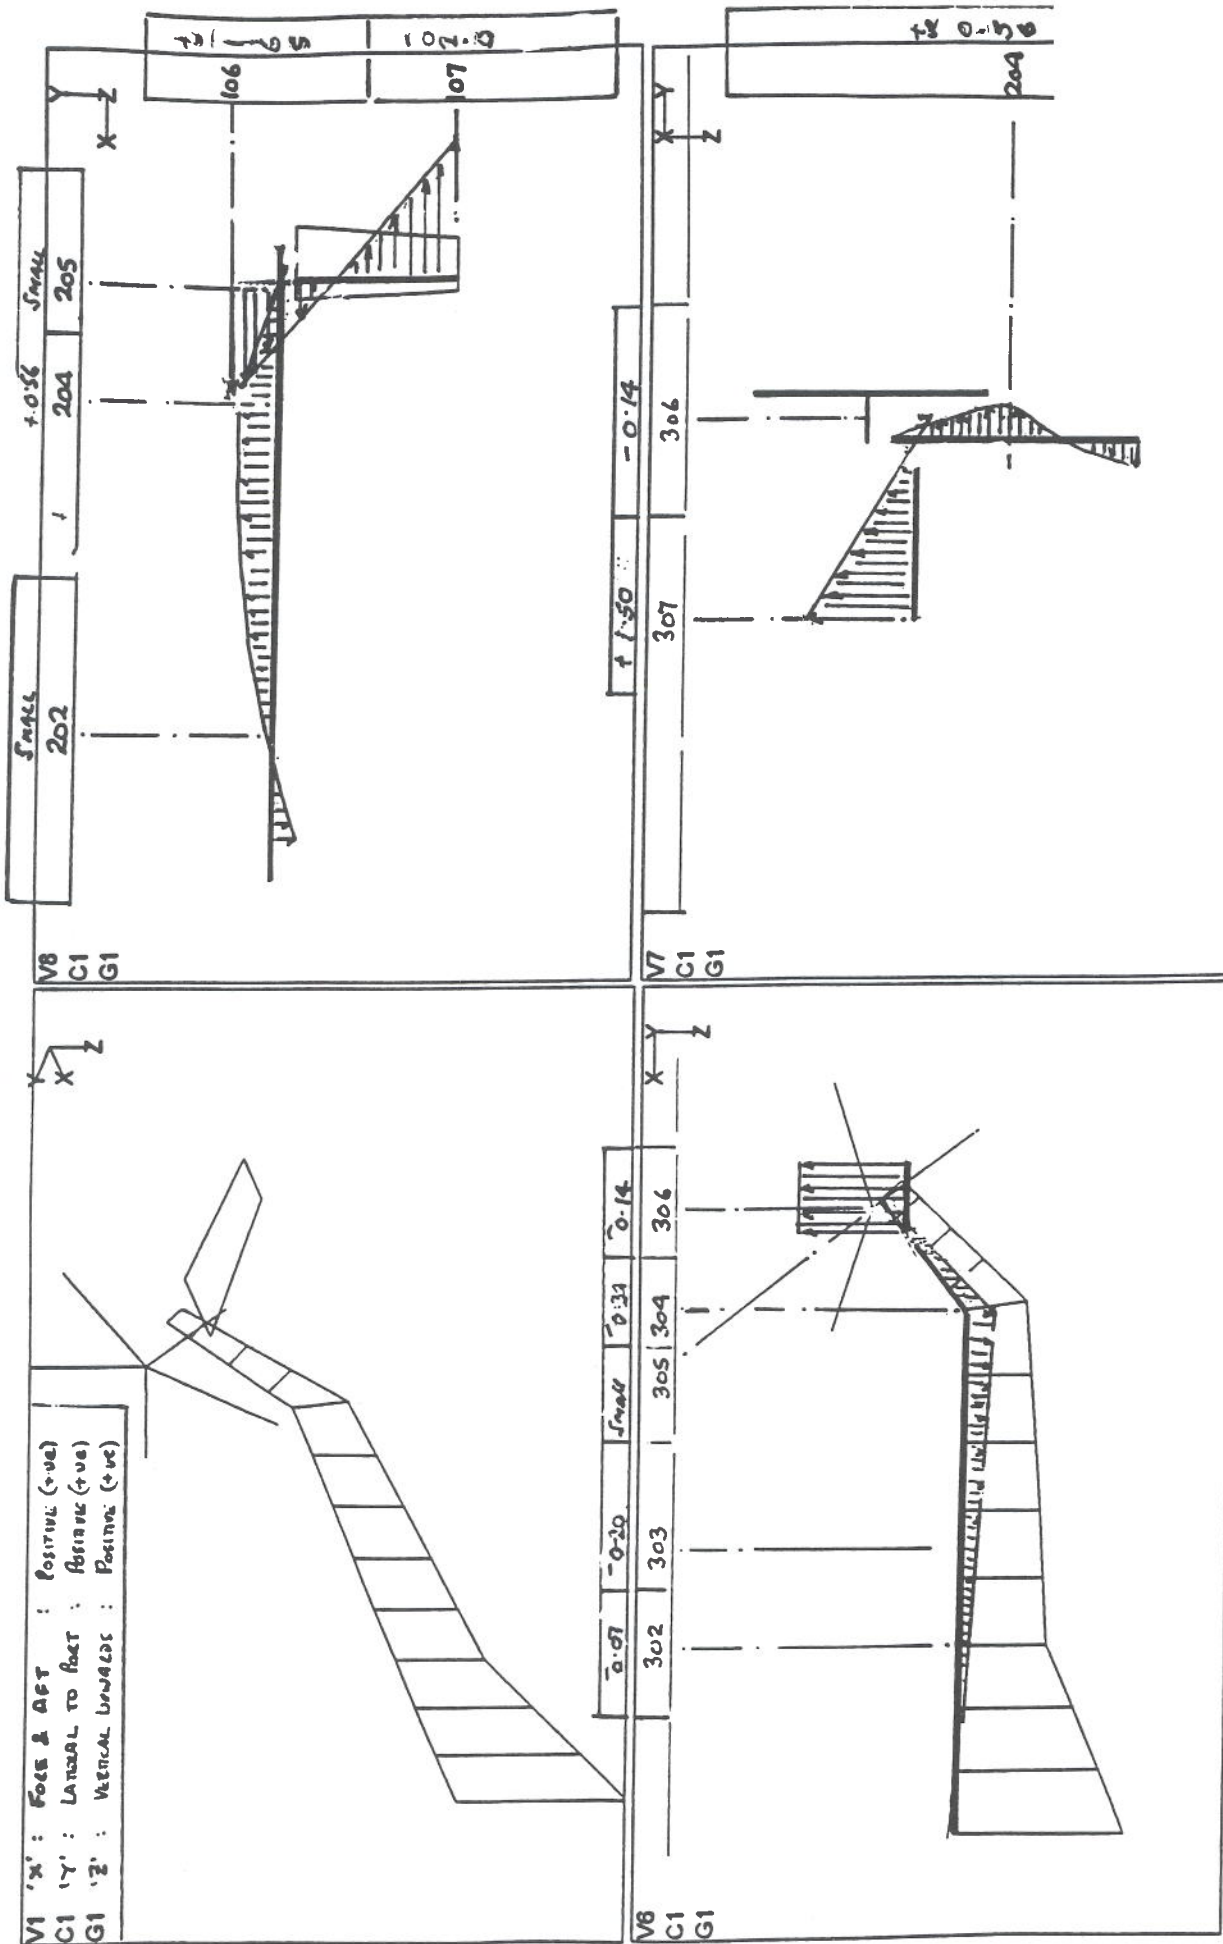
Figure 3: Showing measured overtone vertical/lateral bending with torsion/tailplane yaw mode at 20.80Hz

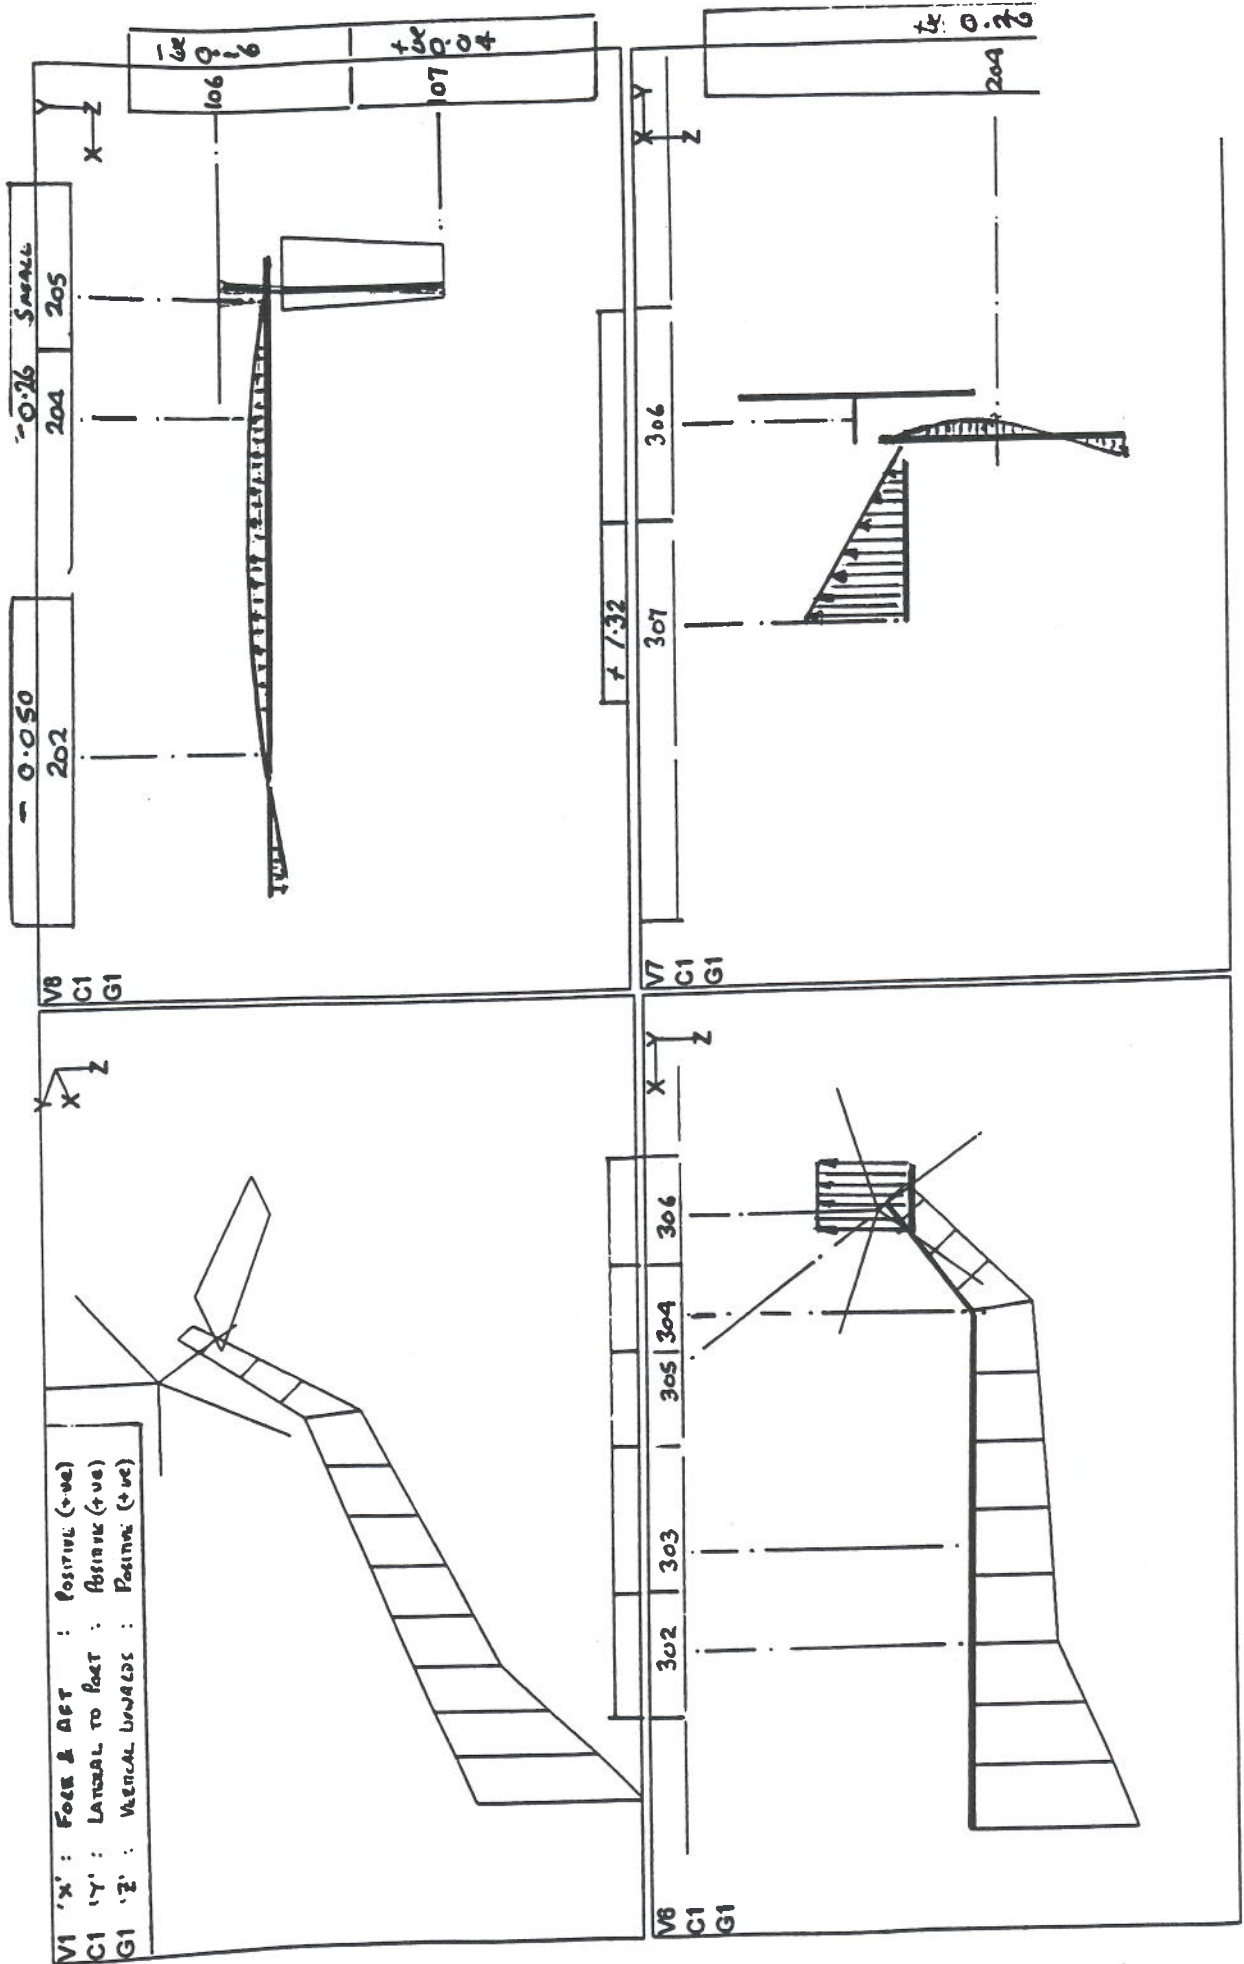
Figure 4: Showing measured overtone lateral bending/tail roll mode at 22.35Hz

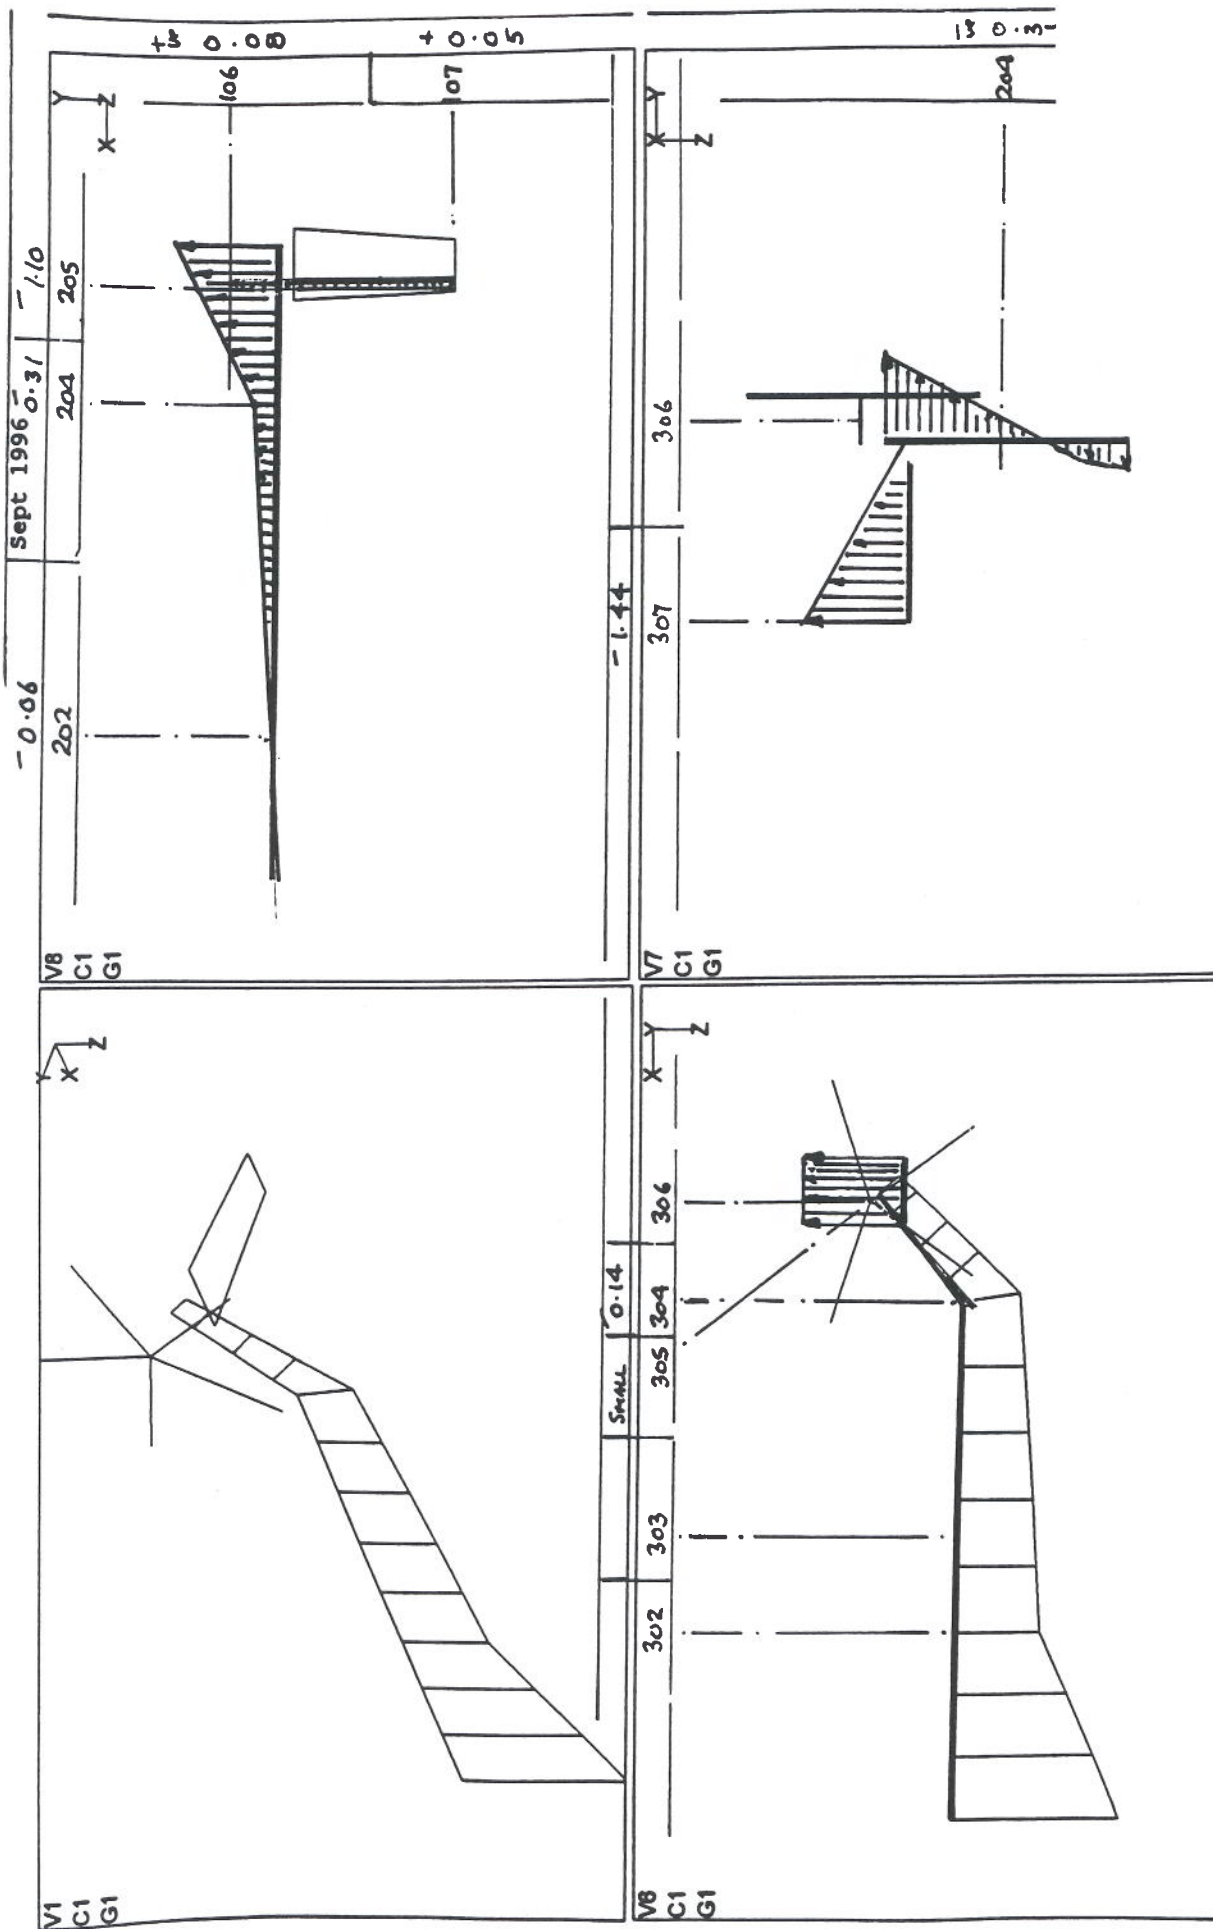
Figure 5: Showing measured lateral bending/tail roll mode at 23.35Hz

MEASURED			PREDICTED	
Mode 7:	20.80 Hz:	Overtone Vert/Lat/ Torsion/Tail Yaw		Aircraft Mode (not represented)
<b>21.56 HZ TAIL ROTOR EXCITATION FREQUENCY IN THIS POSITION</b>				
Mode 8:	22.35 Hz:	Backend Lateral Overtone		Aircraft Mode (not represented)
Mode 9:	22.80 Hz	:Overtone Vert/Lat/Tail Roll	Mode 4: 22.07 Hz:	Overtone Vert'l/Lateral
Mode 10:	23.35 Hz	Aircraft Mode Backend		Aircraft Mode (not represented)
