SERIOUS INCIDENT

Aircraft Type and Registration:	Eurocopter EC155B1, OY-HJJ	
No & Type of Engines:	2 Turbomeca Arriel 2C2 turbine engines	
Year of Manufacture:	2003 (Serial No: 6662)	
Date & Time (UTC):	6 November 2013 at 2023 hrs	
Location:	Clipper Gas platform, North Sea	
Type of Flight:	Commercial Air Transport (Passenger)	
Persons on Board:	Crew - 2	Passengers - 8
Injuries:	Crew - None	Passengers - None
Nature of Damage:	None	
Commander's Licence:	Airline Transport Pilot's Licence	
Commander's Age:	41 years	
Commander's Flying Experience:	2,240 hours (of which 1,160 were on type) Last 90 days - 120 hours Last 28 days - 44 hours	
Information Source:	AAIB Field Investigation

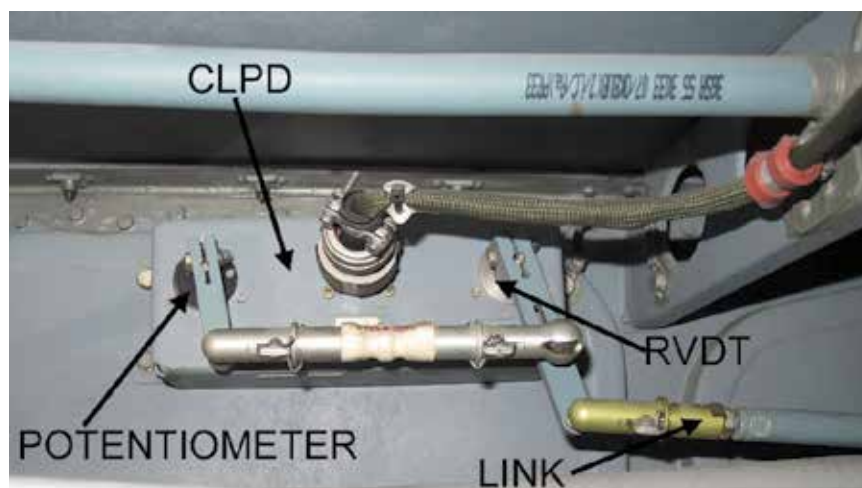
Figure 2

The APM receives a number of inputs from air data systems, gyroscopes, cyclic positions sensors, a yaw lever position detector and a collective lever position detector (CLPD). The CLPD is mounted to the airframe below the left collective and has a link that connects to the collective push-pull tube. As the collective is moved, the link moves and its linear displacement is converted to an angular displacement which is measured by an RVDT² and a potentiometer installed inside the CLPD (Figure 2). The RVDT provides collective position to the APM, while the potentiometer serves to monitor the RVDT. If the two disagree a TRIM and c caption will be illuminated in the cockpit, as well as a COLL LINK caption. If these captions remain on, the collective channel will not be available to the AFCS.

Collective Lever Position Detector (CLPD)

Examination of the collective control system revealed that the potentiometer inside the CLPD had become loose. When the collective was moved the body of the potentiometer moved slightly. The CLPD was removed which revealed that one of the three tongues which secured the potentiometer to the casing had become loose (Figures 4 and 5). This tongue should have engaged into the slot at the base of the potentiometer, but it had become loose and rotated out, enabling the body of the potentiometer to rotate slightly during collective movement. The other two tongues were still securely engaged in the slot.

The APM and CLPD were removed from the helicopter for further examination and replacement parts were installed. The operator carried out further checks on the flight control system and AFCS and no faults were found. All control movements were found to be smooth without binding. The over-torque checks were also completed with no faults found. The helicopter then underwent a test flight during which no anomalies or AFCS faults occurred; this flight included a departure with GA engagement in a similar flight condition to the incident flight. The helicopter was subsequently released back to service.
