**SERIOUS INCIDENT**

<b>Aircraft Type and Registration:</b>	Saab-Scania SF340B, G-LGNE
<b>No &amp; Type of Engines:</b>	2 General Electric CO CT7-9B turboprop engines
<b>Year of Manufacture:</b>	1989
<b>Date &amp; Time (UTC):</b>	17 January 2009 at 0830 hrs
<b>Location:</b>	Runway 24 at Benbecula Airport, W Isles, Scotland
<b>Type of Flight:</b>	Commercial Air Transport (Passenger)
<b>Persons on Board:</b>	Crew - 3                      Passengers - 10
<b>Injuries:</b>	Crew - None                      Passengers - None
<b>Nature of Damage:</b>	Abrasion of aluminium skin and mounting bracket
<b>Commander's Licence:</b>	Airline Transport Pilot's Licence
<b>Commander's Age:</b>	37 years
<b>Commander's Flying Experience:</b>	5,924 hours (of which 1,155 were on type) Last 90 days - 114 hours Last 28 days - 20 hours
<b>Information Source:</b>	AAIB Field Investigation

**Synopsis**

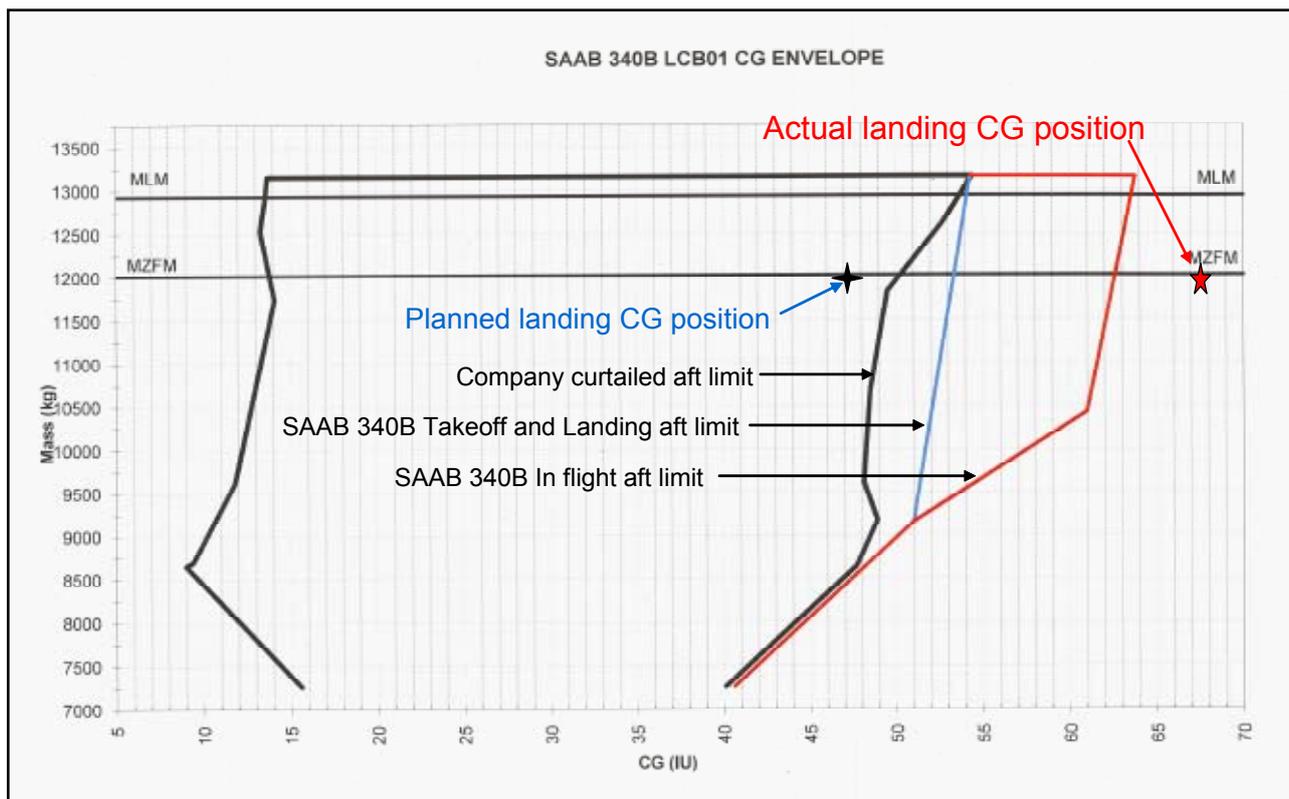
**Figure 2**

The aircraft had a maximum permitted takeoff mass of 13,155 kg; the mass and CG envelope for takeoff and landing is shown at Figure 2. The aircraft landing mass was 11,947 kg and the CG index with the passengers, baggage and freight as loaded on the incident flight was calculated as 67.5. Had the aircraft been loaded as per the final load plan, the landing mass would have remained the same, but the index would have been 47. With the aircraft as loaded, the CG position was significantly outside the aft limit for takeoff, landing and flight.

SAAB 340B CG position limits for takeoff, landing and flight
