INCIDENT

Aircraft Type and Registration:	Slingsby T67M260 Firefly, G-BYOB	
No & Type of Engines:	1 Lycoming AEIO-540-D4A5 piston engine	
Year of Manufacture:	1999	
Date & Time (UTC):	3 August 2007 at 1030 hrs	
Location:	Stapleford Tawney Airport, Essex	
Type of Flight:	Training	
Persons on Board:	Crew - 2	Passengers - None
Injuries:	Crew - None	Passengers - N/A
Nature of Damage:	Left brake pedals disconnected	
Commander's Licence:	Commercial Pilot's Licence	
Commander's Age:	58 years	
Commander's Flying Experience:	6,900 hours (of which 156 were on type) Last 90 days - 70 hours Last 28 days - 39 hours	
Information Source:	AAIB Field Investigation

Synopsis

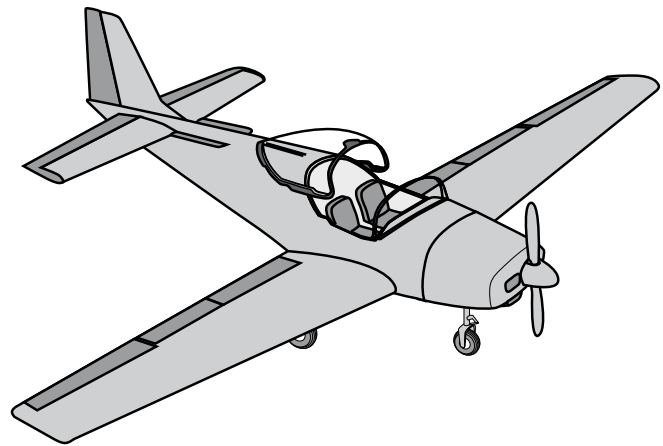
Figure 1

The Slingsby T67 Firefly is a single-engined low-winged monoplane, designed to be fully aerobatic (Figure 1). It is constructed principally of glass reinforced plastic (GRP) and fitted with a tricycle landing gear with a steerable nosewheel leg. Two side-by-side seats are provided. The
