INCIDENT

Aircraft Type and Registration:	Airbus A330-323X, N270AY
No & Type of Engines:	2 Pratt & Whitney PW4000 SER turbofan engines
Year of Manufacture:	2000
Date & Time (UTC):	29 May 2008 at 1025 hrs
Location:	Manchester Airport
Type of Flight:	Commercial Air Transport (Passenger)
Persons on Board:	Crew - 12 Passengers - 250
Injuries:	Crew - None Passengers - None
Nature of Damage:	Damage to main landing gear and brake pack; debris recovered from runway
Commander's Licence:	Airline Transport Pilot's Licence
Commander's Age:	60 years
Commander's Flying Experience:	14,650 hours (of which 2,390 were on type) Last 90 days - 58 hours Last 28 days - 26 hours
Information Source:	AAIB Field Investigation

Synopsis

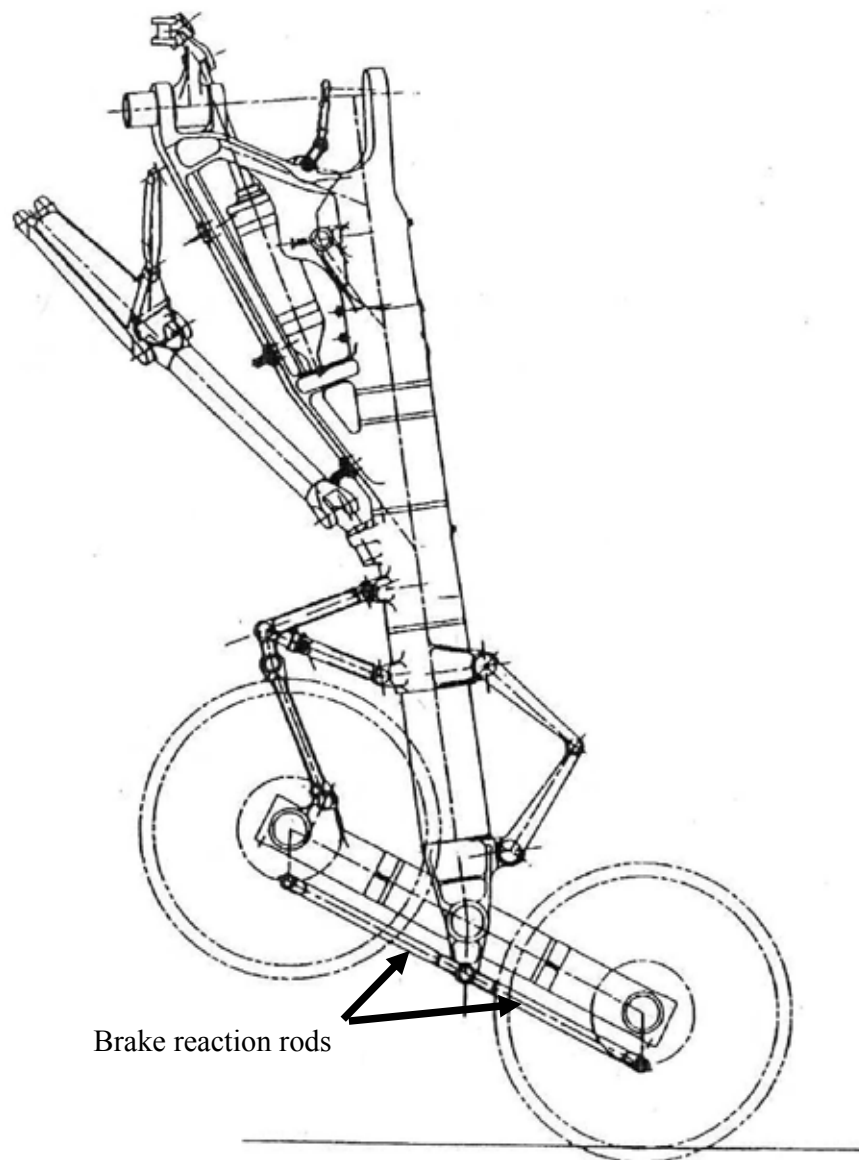
During brake operation, hydraulic pressure causes the pistons within the housing to apply axial pressure to the rotors and stators between thrust plates at either end of the heat pack. This results in a torque on the brake unit that is reacted by a steel rod attached, by means of a pin, to the brake housing at one end and a lug in the centre of the bogie beam at the other. The arrangement of these components can be seen in the diagram at Figure 1 and in the photographs of the aircraft at Figure 2, taken shortly after the incident.

Main landing gear shown in 'flying attitude'

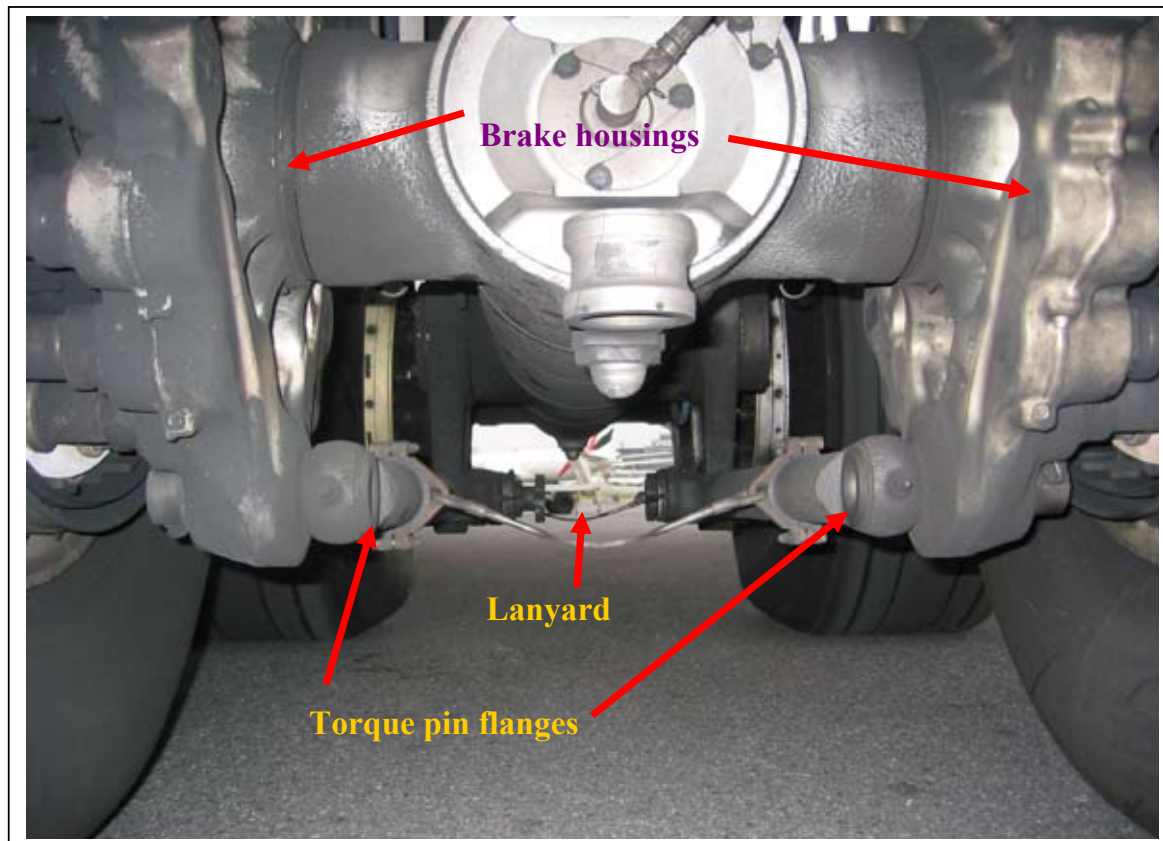
Figure 3 shows a photograph of the unaffected right landing gear of N270AY, showing the layout of the components described above.

View looking forward on intact right landing gear, showing layout of components
