ACCIDENT

Aircraft Type and Registration:	P&M Aviation Ltd Flight Design CTSW, G-VINH	
No & Type of Engines:	1 Rotax 912ULS piston engine	
Year of Manufacture:	2006	
Date & Time (UTC):	12 August 2009 at 1550 hrs	
Location:	Caird Park Golf Course, Dundee	
Type of Flight:	Private	
Persons on Board:	Crew - 1	Passengers - None
Injuries:	Crew - 1 (Minor)	Passengers - N/A
Nature of Damage:	Aircraft destroyed	
Commander's Licence:	National Private Pilot's Licence	
Commander's Age:	63 years	
Commander's Flying Experience:	136 hours (of which most were on type) ¹ Last 90 days - 20 hours Last 28 days - 13 hours	
Information Source:	AAIB Field Investigation

The pilot made a forced landing in a tree after the engine stopped near Dundee. The investigation identified flight planning as a contributory factor. One Safety Recommendation is made.

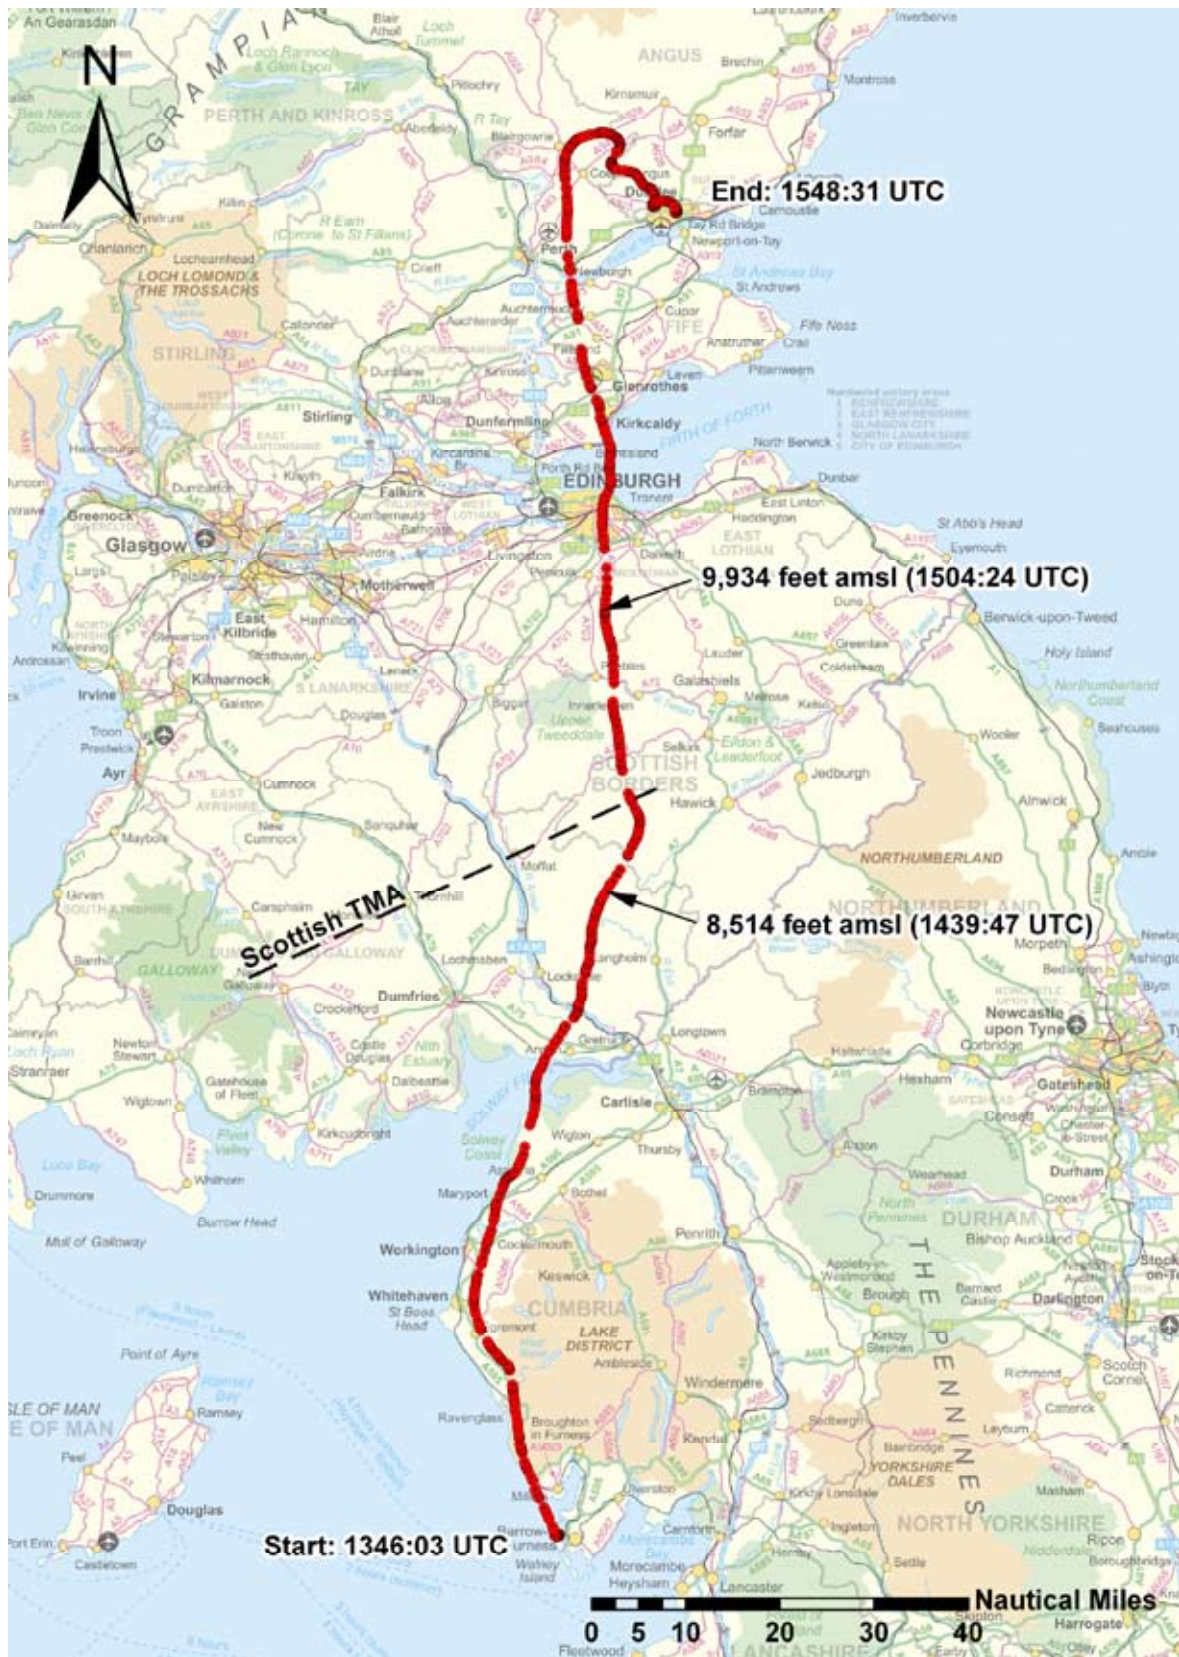
Figure 1

The aircraft began taxiing at 1346 hrs and took off at 1352 hrs, climbing initially to an altitude of between 1,600 ft and 2,000 ft. At 1425 hrs the aircraft commenced a further climb to 7,500 ft. This took 10 minutes and the pilot used "80% power". At 1435 hrs the aircraft made a further climb to 8,700 ft. During this climb the aircraft entered Class A airspace at FL85 over Eskdalemuir, exiting into Class D airspace as it crossed into the Scottish TMA approximately 10 nm further north (see Figure 1).

The aircraft's GPS track

The GPS unit had a complete log of the accident flight starting at 1346:03 hrs at Walney Airfield, Barrow-on-Furness, and ending at 1548:31 hrs at the Caird Park golf course, Dundee. The recorded track included altitude information and is presented at Figure 1. The highest altitude the aircraft reached was 9,935 ft amsl, at 1504:24 hrs, when it was approximately 15 nm south of Edinburgh.

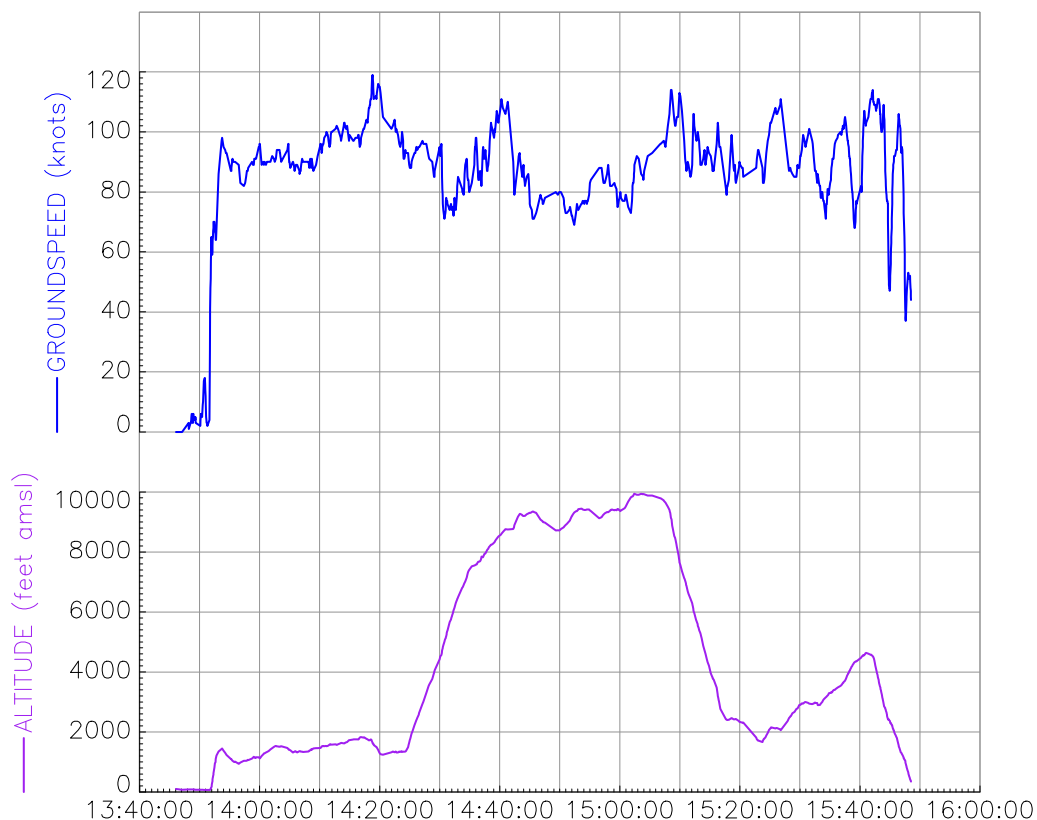
Figure 2

Altitude and groundspeed, averaged between consecutive points, are plotted in Figure 2. This shows a descent from 9,935 ft to 1,663 ft amsl, as the aircraft crossed the A91 north of Glenrothes, before it climbed again.

The aircraft's altitude and groundspeed

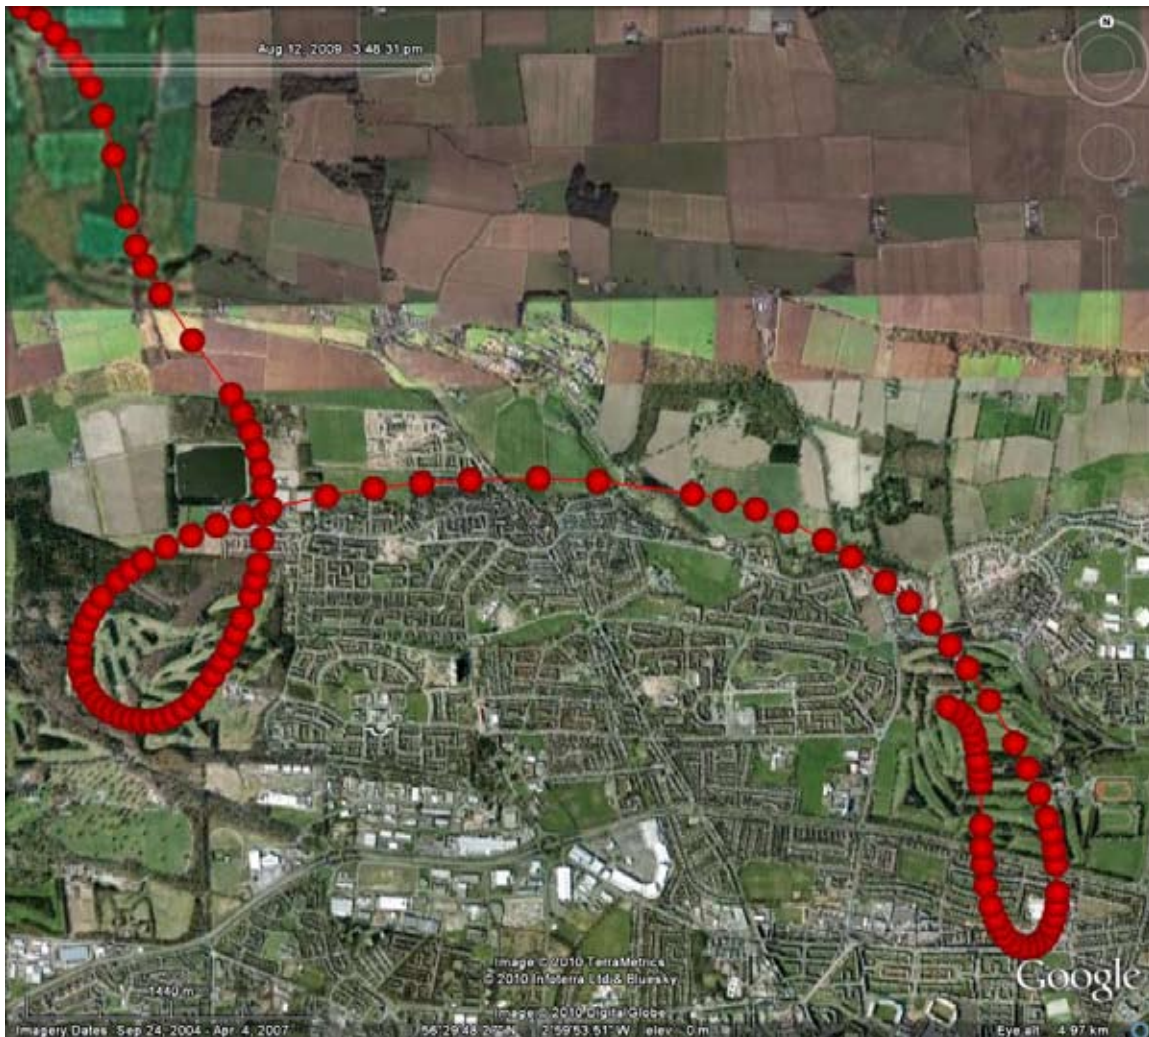
Figure 3

The final descent was at a rate of approximately 900 ft/min, reducing to 600 ft/min as the aircraft flew a descending turn, clockwise, through 270° (see Figure 3). The aircraft continued descending at about this rate until the final recorded GPS position, which placed the aircraft at 340 ft amsl (110 ft agl), close to the accident site.

Image of the aircraft's GPS track just prior to the accident
