INCIDENT

| Aircraft Type and Registration: | Jetstream 3202, G-BYRA | |
| Nature of Damage: | Mechanical failure of the right engine propeller reduction gearbox | |
| Information Source: | AAIB Field Investigation | |

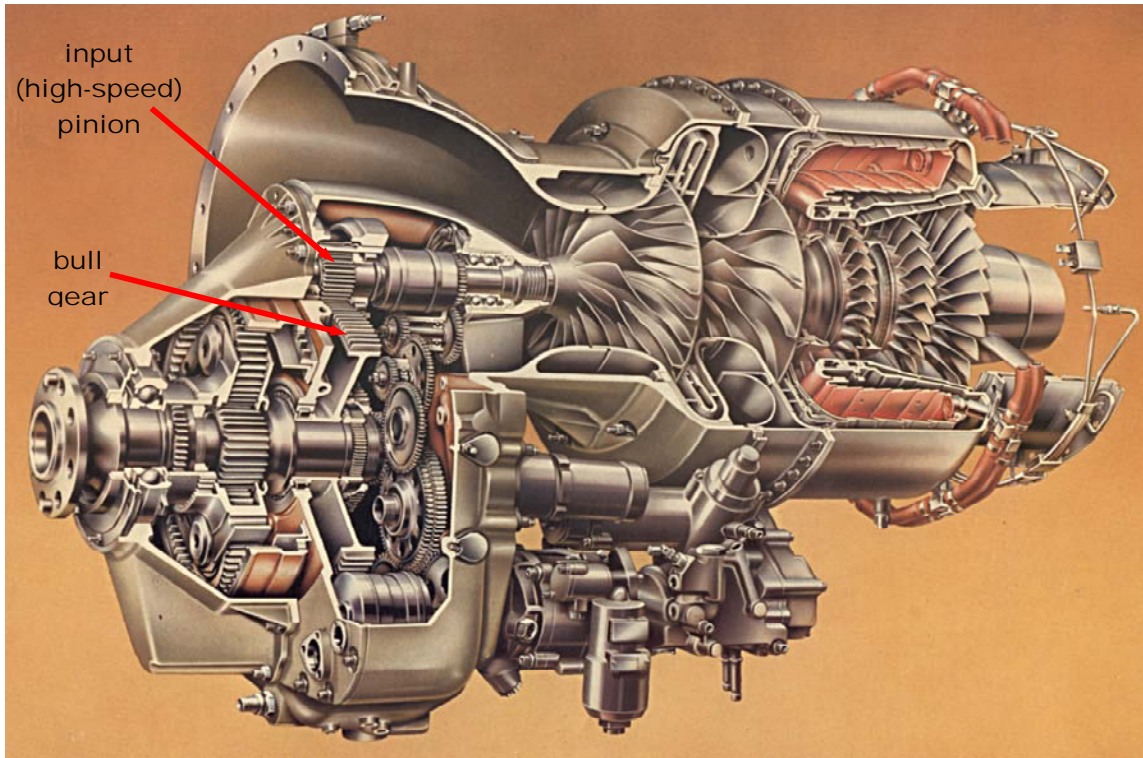
Figure 1 is a cut-away view of the TPE 331 series engine and gearbox of the type installed in G-BYRA. The 41,750 RPM rotational speed of the gas generator is reduced to 1,591 RPM at the propeller in two stages. The first stage reduction is achieved via a simple pair of straight-cut gears, comprising a high-speed (input) pinion mounted on the engine shaft driving a large bull gear. The second (epicyclic) stage reduction comprises a sun gear, formed integrally with the forward face of the bull gear, driving a set of planet gears which in turn drive the propeller shaft directly via a splined coupling to the planet gear carrier.

Figure 1:
Configuration of TPE 331 engine as installed on the Jetstream

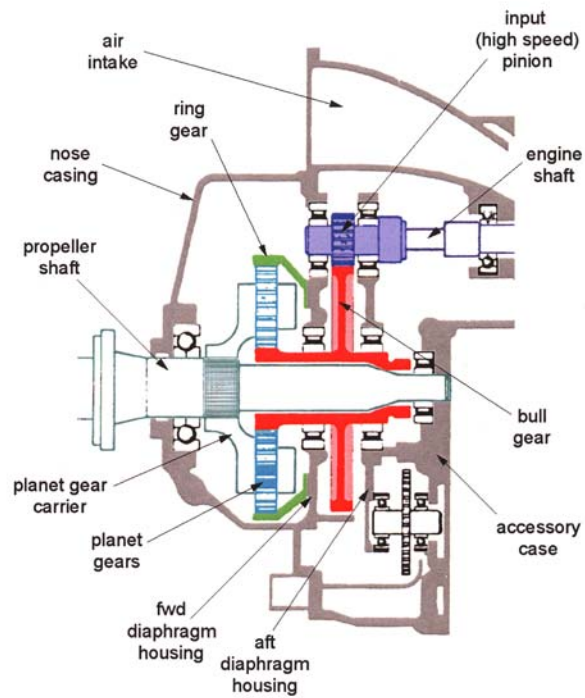
Figure 2 shows a schematic sectional view through the reduction gearbox. The input pinion (coloured dark blue) and bull gear (coloured red) are supported within a split aluminium housing within the gear casing known as the diaphragm; the two halves are manufactured as a matched set. The epicyclic second stage occupies the front half of the gear case cavity, formed by the nose casing. The ring gear of the epicyclic stage is anchored to the forward face of the diaphragm.

Figure 2:
Sectional view through gearbox (schematic)
