SERIOUS INCIDENT

Aircraft Type and Registration:	AS365N3 Dauphin II, G-REDG	
No & Type of Engines:	2 Turbomeca Arriel 2C turboshaft engines	
Year of Manufacture:	2010	
Date & Time (UTC):	18 April 2011 at 0837 hrs	
Location:	Norwich Airport	
Type of Flight:	Commercial Air Transport (Passenger)	
Persons on Board:	Crew - 2	Passengers - 5
Injuries:	Crew - None	Passengers - None
Nature of Damage:	None	
Commander's Licence:	Airline Transport Pilot's Licence	
Commander's Age:	37 years	
Commander's Flying Experience:	2,300 hours (of which 1,300 were on type) Last 90 days - 73 hours Last 28 days - 20 hours	
Information Source:	AAIB Field Investigation

Synopsis

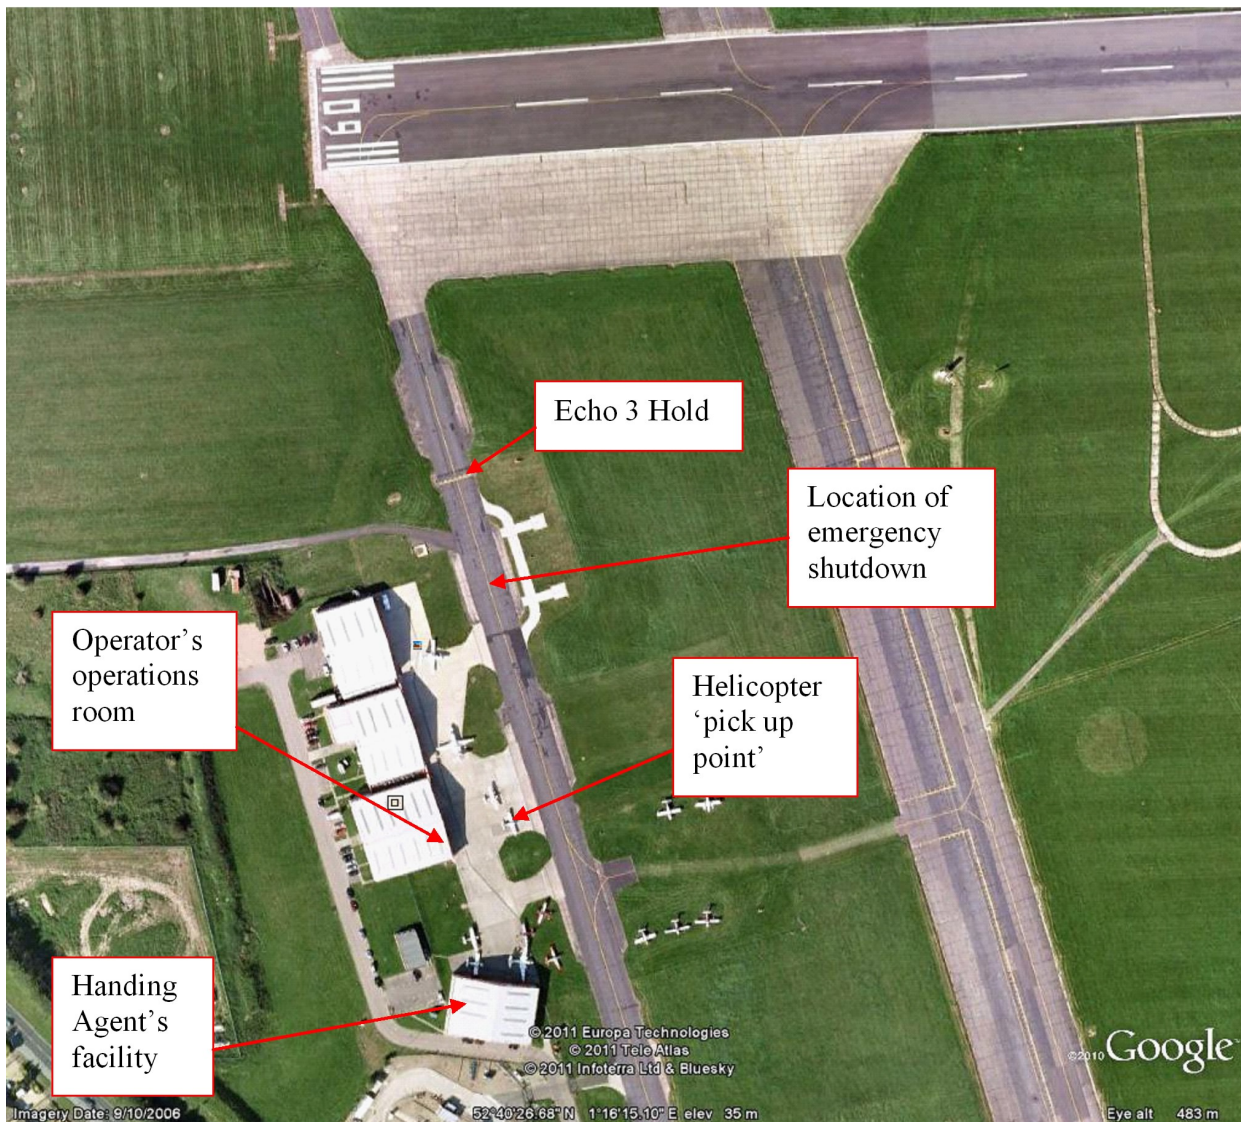
Figure 1

The crew had been tasked with a routine flight to convey passengers and freight to the Pickerill B oil platform, situated 52 nm offshore from Norwich Airport. The flight had been delayed by poor weather, but the helicopter was eventually towed from its hangar and placed on the 'pick up point' (Figure 1) facing east. The 0819 hrs actual weather report for the airport showed a 5 kt wind from 070°, with 3 km visibility.

Location of the incident

the door, removed the chocks, and then withdrew to the operations room in the hangar where he could monitor the helicopter during departure through the window (Figure 1 and 2).

taxiing northwards along Taxiway Echo to stop at holding point Echo 3 prior to taking off on Runway 09 (Figure 1). At the same time, an employee of the handling agent saw the helicopter from the handling agent's facility. He stated that whilst he had not noticed any smoke when the helicopter was on the 'pick up spot', as it taxied away, he saw blue/black smoke emanating from the exhaust of the No 1 engine, but no flames. He had also tried to contact the crew on the company frequency but with no success.
