ACCIDENT

Aircraft Type and Registration:	Eurocopter AS350B2 Squirrel, G-CBHL	
No & Type of Engines:	1 Turbomeca Arriel 1D1 turboshaft engine	
Year of Manufacture:	1992	
Date & Time (UTC):	15 September 2007 at 1505 hrs	
Location:	Lanark, Scotland	
Type of Flight:	Private	
Persons on Board:	Crew - 1	Passengers - 3
Injuries:	Crew - 1 (Fatal)	Passengers - 3 (Fatal)
Nature of Damage:	Helicopter destroyed	
Commander's Licence:	See text	
Commander's Age:	39 years	
Commander's Flying Experience:	965 hours (of which 490 were on type) Last 90 days - 50 hours estimated Last 28 days - 15 hours estimated	
Information Source:	AAIB Field Investigation

Synopsis

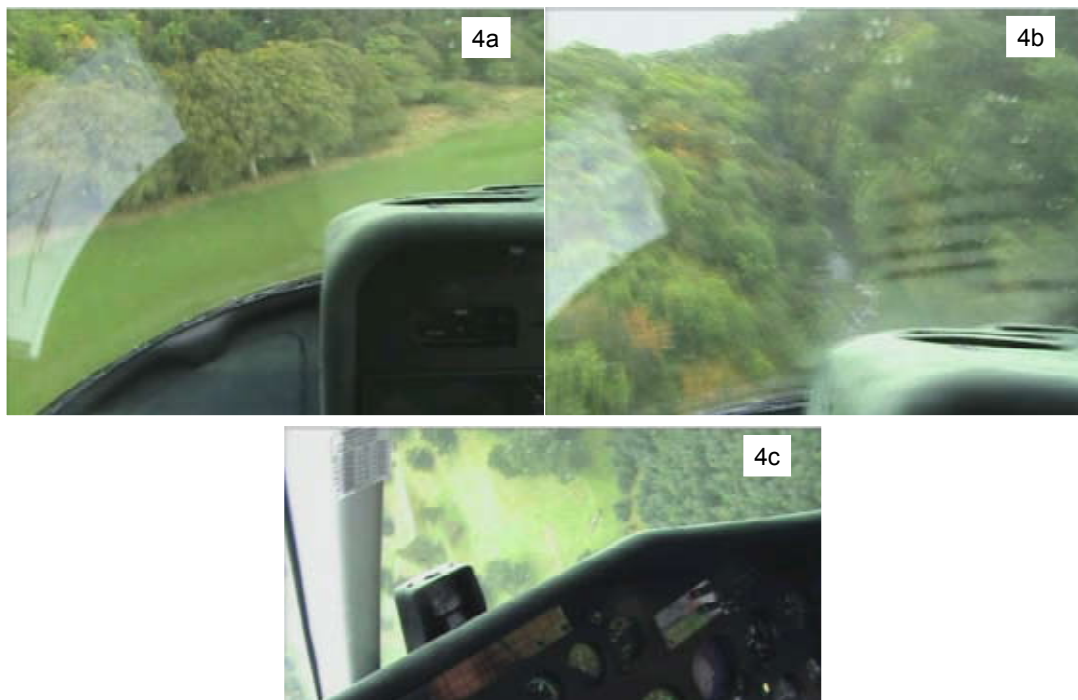
Figure 4

footage at between 20 ft and 30 ft. It then pitched nose-down and descended into the valley, coming into similar proximity to trees on each side and below. The pilot then flew a further zoom climb out of the valley, which was seen by witnesses on the ground. The passengers appeared to enjoy the manoeuvre, with laughs and shouts audible on the video. Figures 4a and 4b show full screen images from the video, of the helicopter approaching the valley, and in the valley just prior to the zoom climb.

The final recorded segment lasted 8 seconds, the first frame of which is shown at Figure 4c. The helicopter was flying at 110 kt in a steep (about 60° angle of bank) turn to the right, at about 440 ft above a shallow valley floor. It appears to have just started a climb, with a pitch attitude at 10° and greater than normal cruise power applied. The helicopter then rolled left, reaching an approximately upright attitude as the recording ended. Again, the video and accompanying audio appeared to show that the passengers were enjoying the experience.

Still images from the recorded video
