INCIDENT

Aircraft Type and Registration:	Boeing 757-204, G-BYAO	
No & Type of Engines:	2 Rolls-Royce RB211-535E4-37 turbofan engines	
Year of Manufacture:	1994	
Date & Time (UTC):	12 May 2005 at 1648 hrs	
Location:	Manchester Airport, Manchester	
Type of Flight:	Public Transport (Passenger)	
Persons on Board:	Crew - 8	Passengers - 234
Injuries:	Crew - None	Passengers - None
Nature of Damage:	Scrapes and wear to the rear of aircraft in vicinity of the tail scrape limiting device and auxiliary power unit access doors	
Commander's Licence:	Airline Transport Pilot's Licence	
Commander's Age:	48 years	
Commander's Flying Experience:	10,630 hours (of which 4,030 were on type) Last 90 days - 143 hours Last 28 days - 64 hours	
Information Source:	AAIB Field Investigation

Synopsis

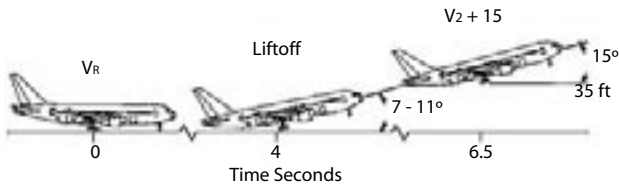
Typical Rotation, All Engines

The following figure shows typical rotation with all engines operating.

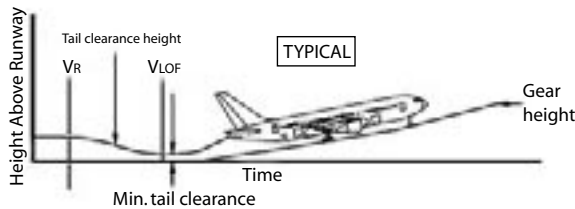
.....Typical Takeoff Tail Clearance

The following diagram and table show the effect of flap position on liftoff pitch attitude and aft fuselage clearance during takeoff. Additionally, the last column shows the pitch attitude for aft fuselage contact with wheels on runway and landing gear struts extended....
