AAIB Bulletin No: 2/95

Aircraft Type and Registration: Boeing 747-238B, G-VLAX

Nature of Damage: Forward right-hand body gear axle fractured

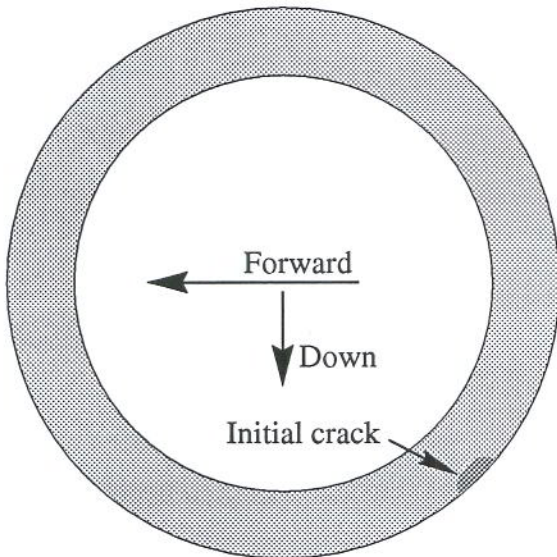
The axle, which was removed from the truck assembly under AAIB supervision, was found to have fractured completely across a section about 1½ inches from its mid-point, towards the end used as the No 9 stub axle; a position not visible even with the wheels and brakes removed. Metallurgical examination revealed that the initial 0.5% of the fracture had been principally by a stress corrosion mechanism followed by a short period of fatigue, with the remaining 99.5% being by overload.

The stress corrosion origin was at a position which was about 45° below and aft from the axle axis. It had initiated in the base steel of the axle, below the nickel fill layer, in one of the areas which had been blended during its last overhaul. In the same blended area, nearer to the axle mid-point, a succession of small, circumferentially orientated, intergranular cracks was found.
