<b>Aircraft Type and Registration:</b>	Vickers-Supermarine Spitfire PR.XI, G-PRXI (PL983)	
<b>No &amp; Type of Engines:</b>	1 Rolls-Royce Packard Merlin 266 piston engine	
<b>Year of Manufacture:</b>	1944	
<b>Date &amp; Time (UTC):</b>	4 June 2001 at 1455 hrs	
<b>Location:</b>	Near Rouen, Vallee de Seine Airport, France	
<b>Type of Flight:</b>	Private (aerial display)	
<b>Persons on Board:</b>	Crew - 1	Passengers - N/A
<b>Injuries:</b>	Crew - 1 (Fatal)	Passengers - N/A
<b>Nature of Damage:</b>	Aircraft destroyed	
<b>Commander's Licence:</b>	Private Pilot's Licence	
<b>Commander's Age:</b>	56 years	
<b>Commander's Flying Experience:</b>	1,926 hours (of which about 48 were on type)	
<b>Information Source:</b>	See below

*The following is an account of an accident that occurred in France and which was subject to an investigation by the Bureau d'Enquetes et d'Analyses pour la Securite de l'Aviation Civile (BEA) and the French judiciary. The AAIB were asked to conduct and oversee a strip inspection of the Rolls-Royce Packard Merlin engine on their behalf. The findings of this examination are considered sufficiently important that they should be promulgated within the United Kingdom, at

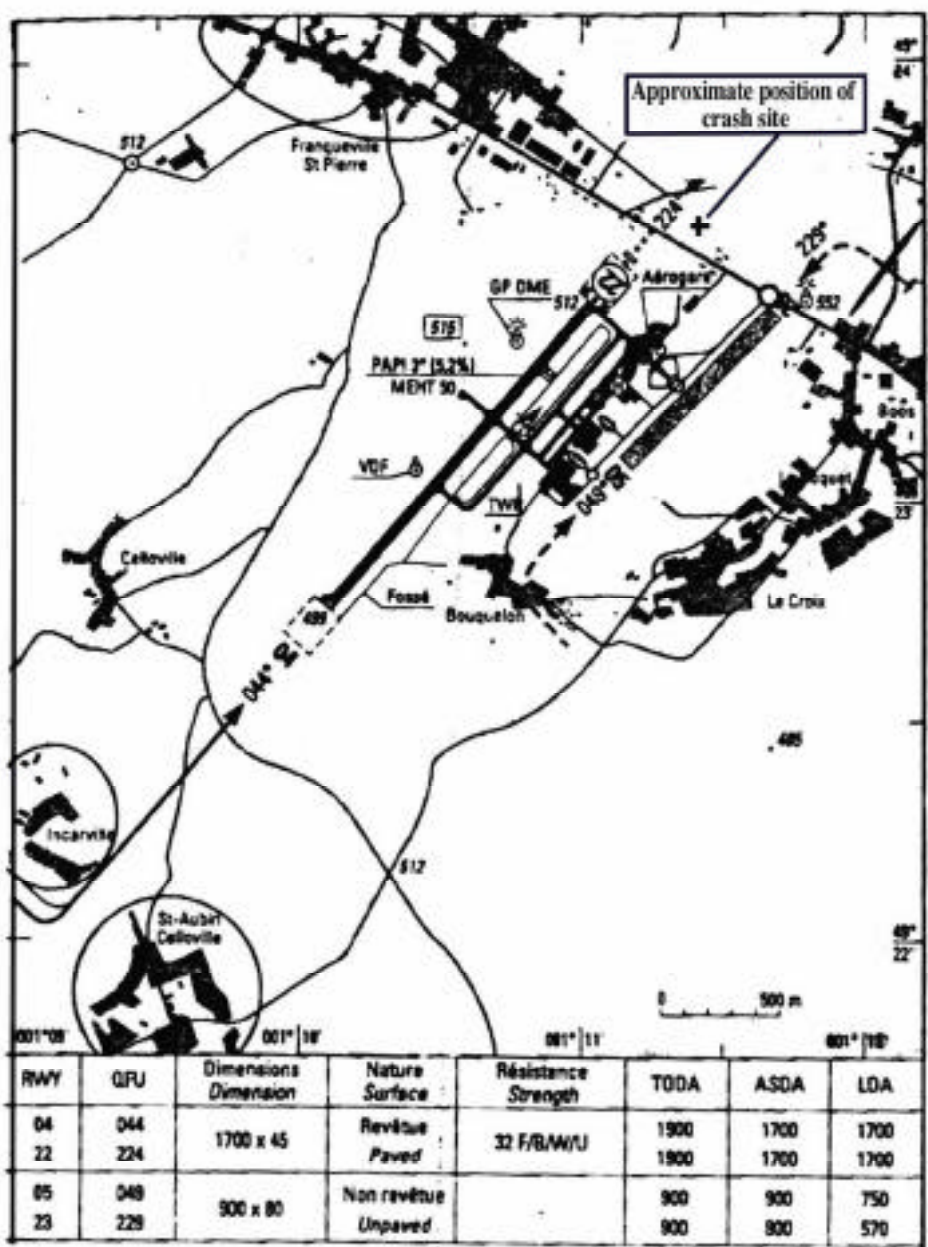
Figure 1

Rouen, Vallee de Seine Airport has a main, paved, Runway 04/22 and a shorter, grass Runway 05/23 (Figure 1). During the pre-display briefing, pilots were advised to make use of the latter in case of emergency.
