Rail Accident Investigation Branch

Rail Accident Report

Class investigation into rail breaks on the East Coast Main Line

Report 24/2014
November 2014

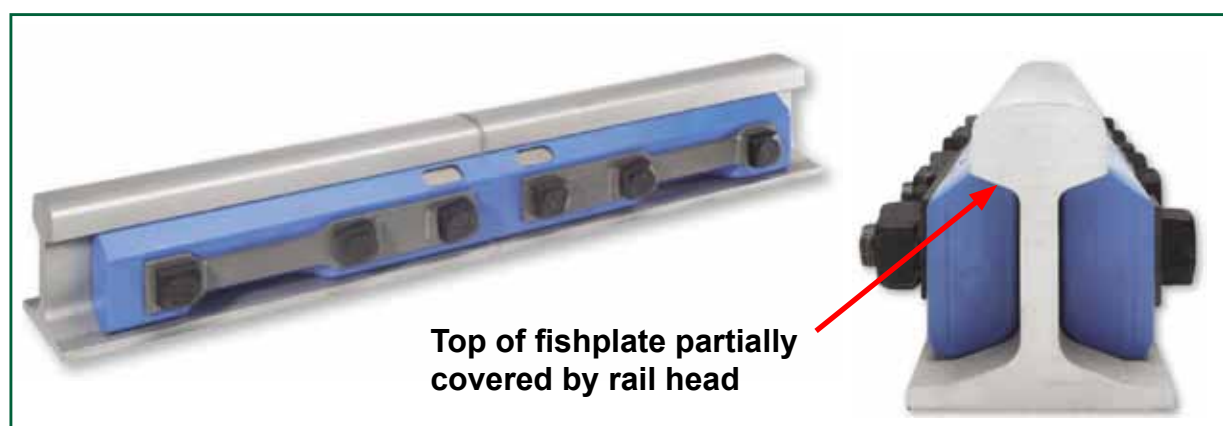
Figure 5: Coronet joint (images courtesy of L B Foster)

- 18 Insulated block joints act as a barrier to electrical currents and allow the rails on each side of the joint to form separate electrical circuits (*track circuits*). These circuits are used by the signalling system to determine the location of trains. The incident joint was of the *Coronet* type and comprised a layer of plastic insulating material between the rail ends together with a covering of insulating material over the steel plates, known as a *fishplates*, which connect the rails. The fishplates were secured to the rails by three bolts on each side of the joint. The bolts passed through holes formed in the plates and the rail, and were intended to secure the fishplates to both rails in a rigid connection (figures 4 and 5).

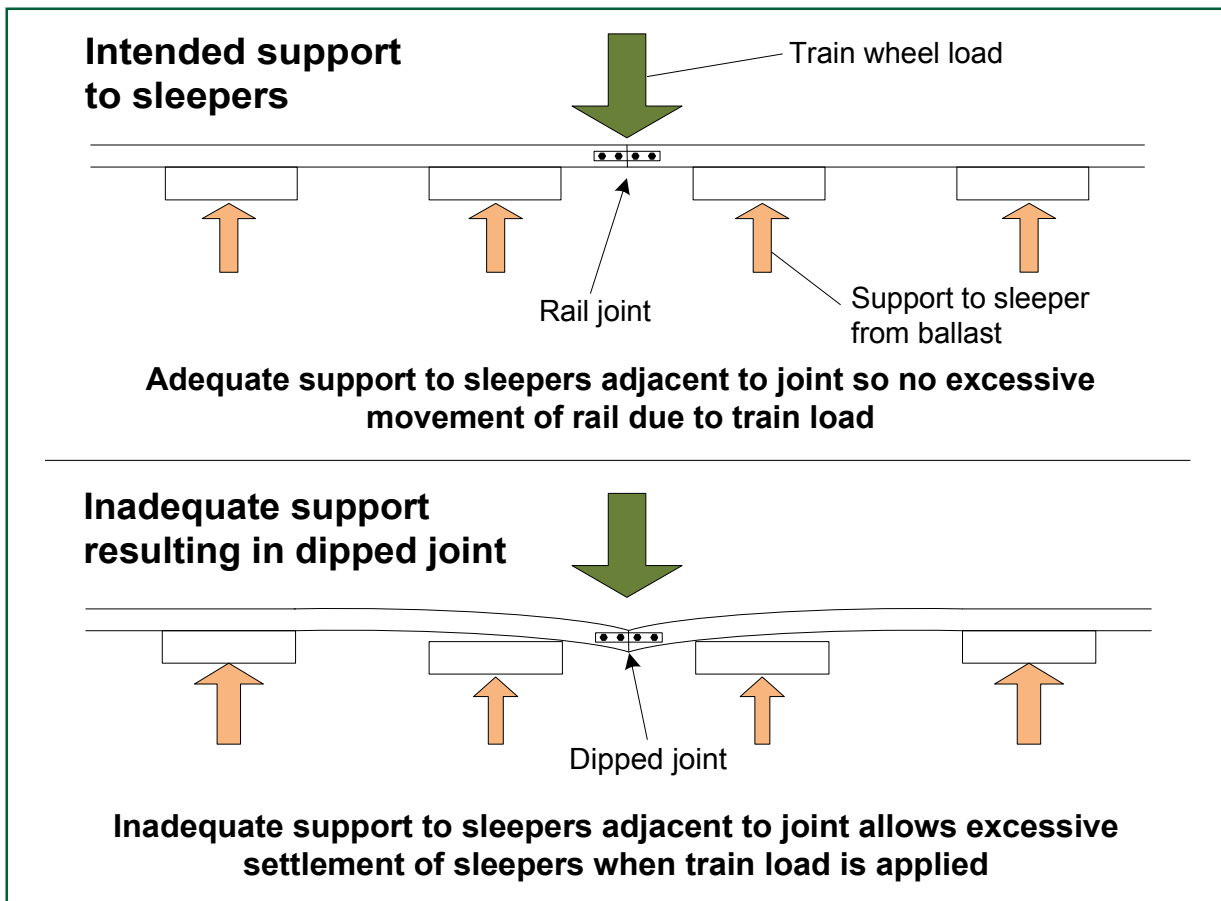
Figure 6: Effect of inadequate support from ballast

- inadequate support to sleepers from the underlying *ballast* meant that part of the train loads intended to be carried by these sleepers were actually carried through the rail to adjacent, better supported, sleepers in a manner which caused additional bending at the joint (figure 6);

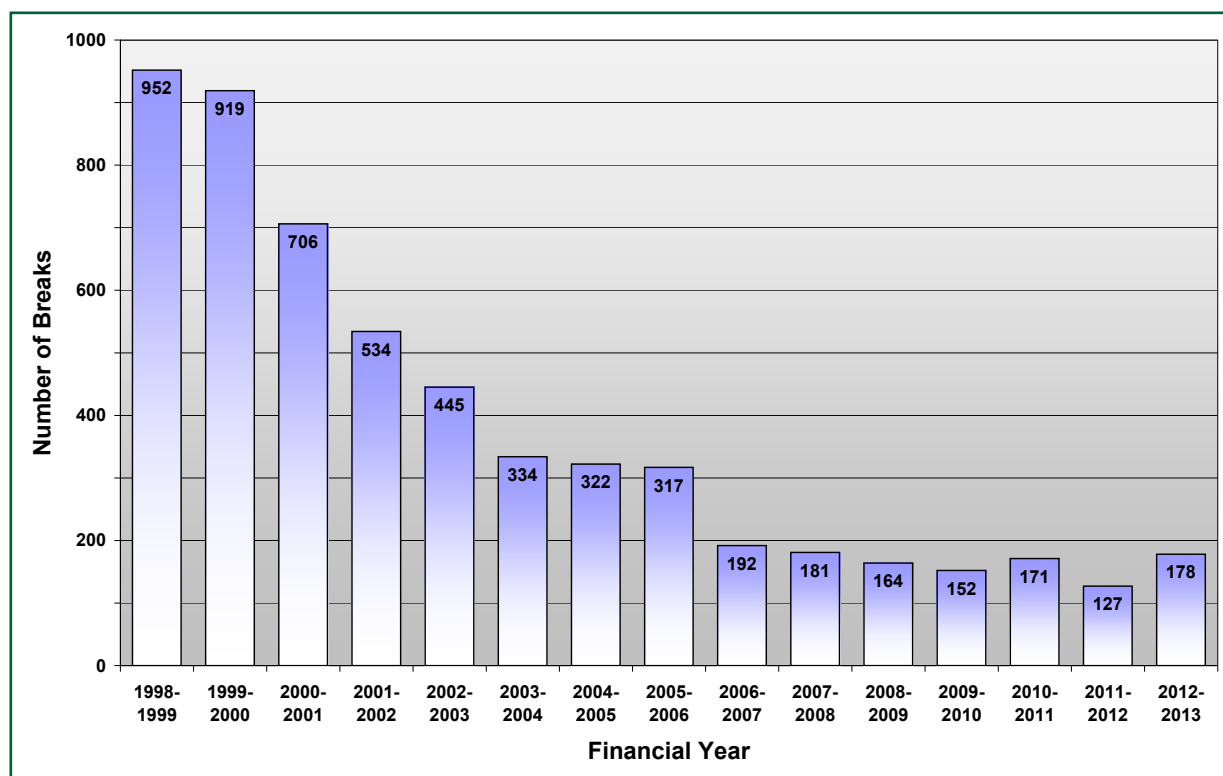
Figure 13: Rail breaks on Network Rail infrastructure 1998 to 2013

- 37 The number of rail breaks on Network Rail infrastructure has reduced from more than 900 each year in the late 1990s to an average of about 160 each year in the period 2009 to 2013 (figure 13). The improvement has taken place while the amount of rail traffic² increased by about a third.
- 38 The reduction coincides with significant amounts of new rail being installed in the late 1990s and early 2000s, the introduction of improved ultrasonic testing techniques between 2000 and 2003, and the introduction of enhanced requirements for dealing with dipped joints in 2005. Subsequent enhancements to Network Rail's rail break management strategy are discussed later in this report.

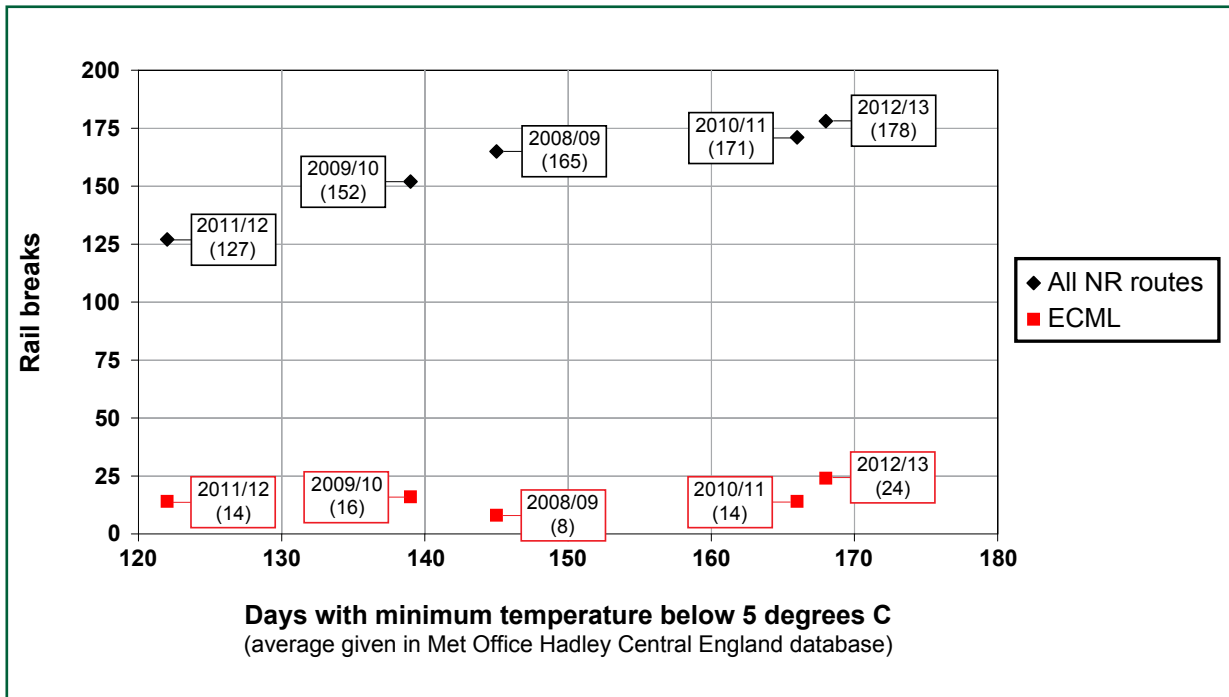
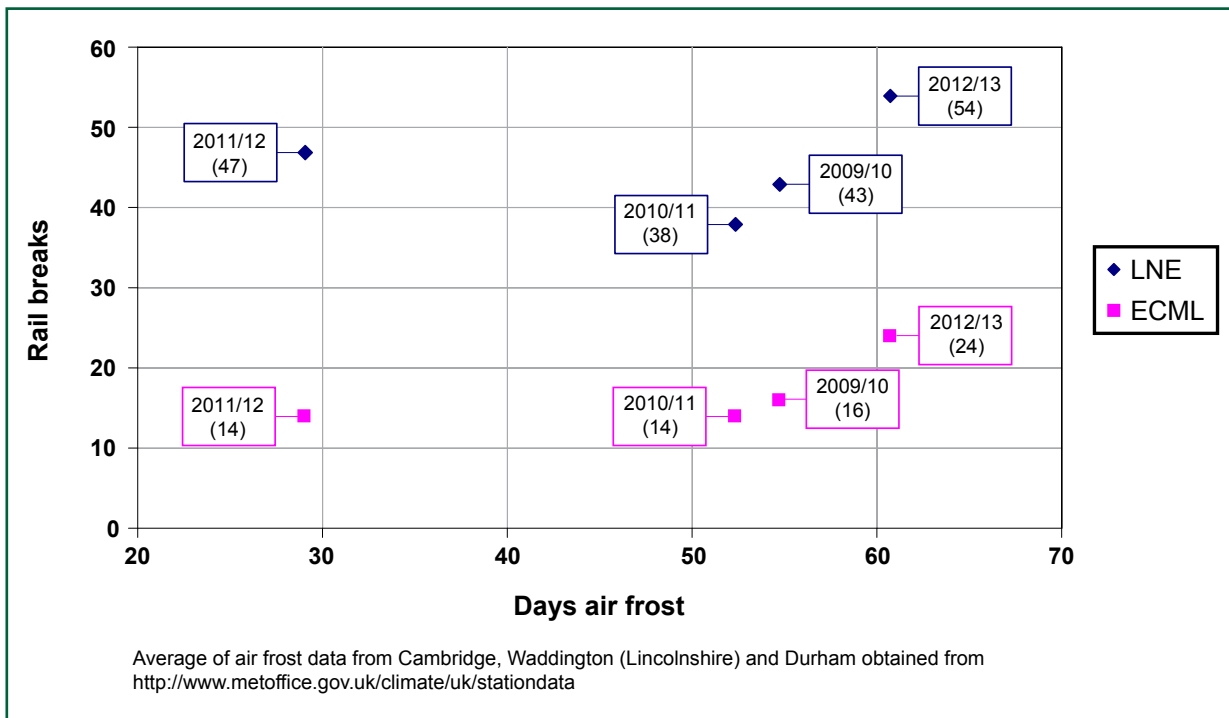
- 41 Data covering all Network Rail infrastructure (figure 14) shows that rail breaks are more common in colder weather. This is a predictable effect because tension develops in rails during cold periods when fixings restrict rail contraction. This is particularly relevant to continuous welded rail, the type now generally used on all main lines, because this is designed, installed and fixed in a way which results in most of the rail being subject to tension at temperatures below 27°C, with the amount of tension increasing as temperature falls. If not in tension at these temperatures, there is a greater amount of rail compression on hot days and thus a greater risk of rails buckling.

42 Although figure 14 shows that rail breaks increase with lower temperatures on a nationwide basis, this is not consistently true for the ECML, or for the Network Rail London North & Eastern (LNE) route which includes the ECML. This is demonstrated when LNE rail break data is plotted against average temperature data for central England (the values used with the nationwide rail break data) and when both LNE and ECML data is plotted against temperature data relating to eastern England (figures 14 and 15).

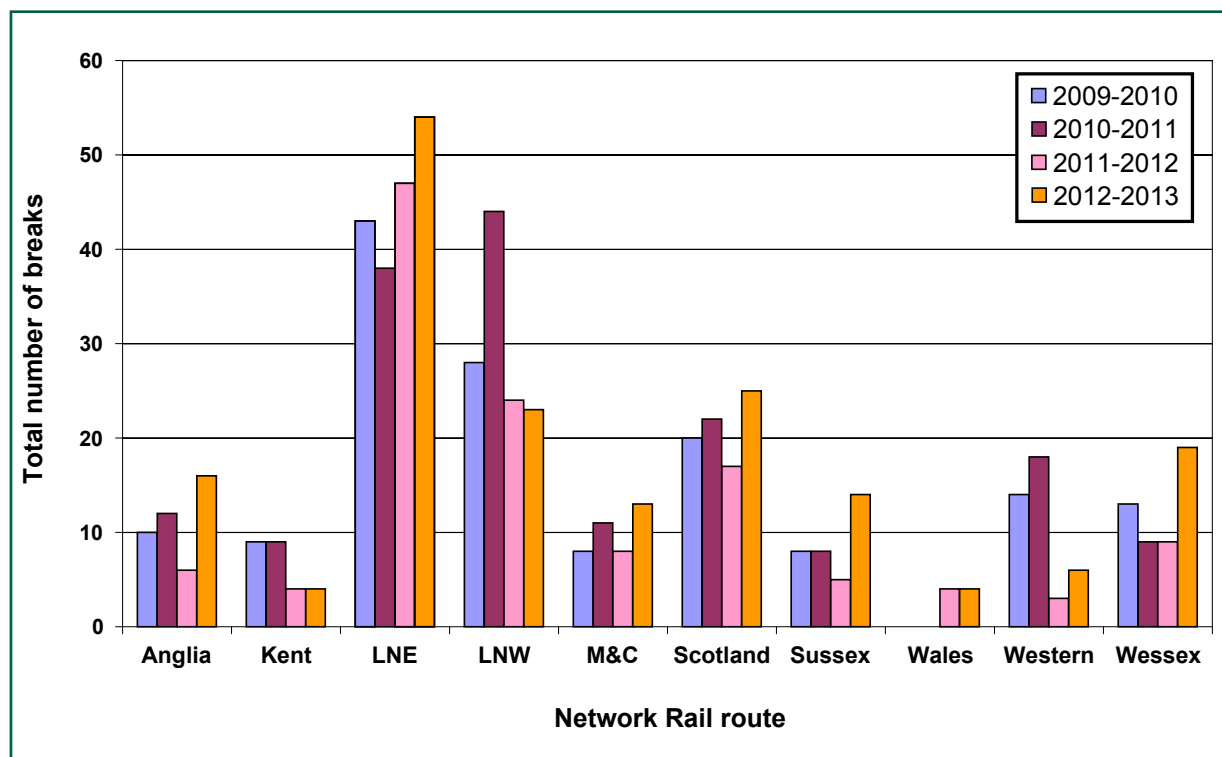
Figure 16: Rail breaks 2008 to 2013, all Network Rail routes

- 44 There were 629 rail breaks on Network Rail infrastructure in the four year period from April 2009 to March 2013. Of these, 186 breaks occurred on the LNE route, more than on any other route. The number of rail breaks on the LNE route exceeded those on all other routes in all of these years except in 2010/2011 when London North Western had more (figure 16). The number of rail breaks on LNE increased from 38 in 2010/2011 to 47 in 2011/12 and to 54 in 2012/13. When considering this increase, it should be noted that the number of breaks on other routes also show significant fluctuations and that the amount of rail traffic was increasing throughout this period (paragraph 49).

129 Network Rail reports that the number of rail breaks on LNE route reduced from 54 in 2012/13 (figure 16) to 28 in 2013/14. The proportion of Network Rail infrastructure rail breaks occurring on LNE route in the same period reduced from 30% to 22%. The number of rail breaks on ECML reduced from 24 in 2012/13 to 14 in 2013/14 with the number of breaks at rail ends (the location where breaks are most likely to cause a derailment) reducing from 4 to 1 (figure 43). Although it is possible that external factors, for example weather conditions, contributed to the improved performance on LNE route and ECML, it is probable that part of the improvement is a consequence of implementing the measures described in paragraph 128. Network Rail has stated that it is currently taking the following actions which have the potential to reduce the likelihood of rail breaks:

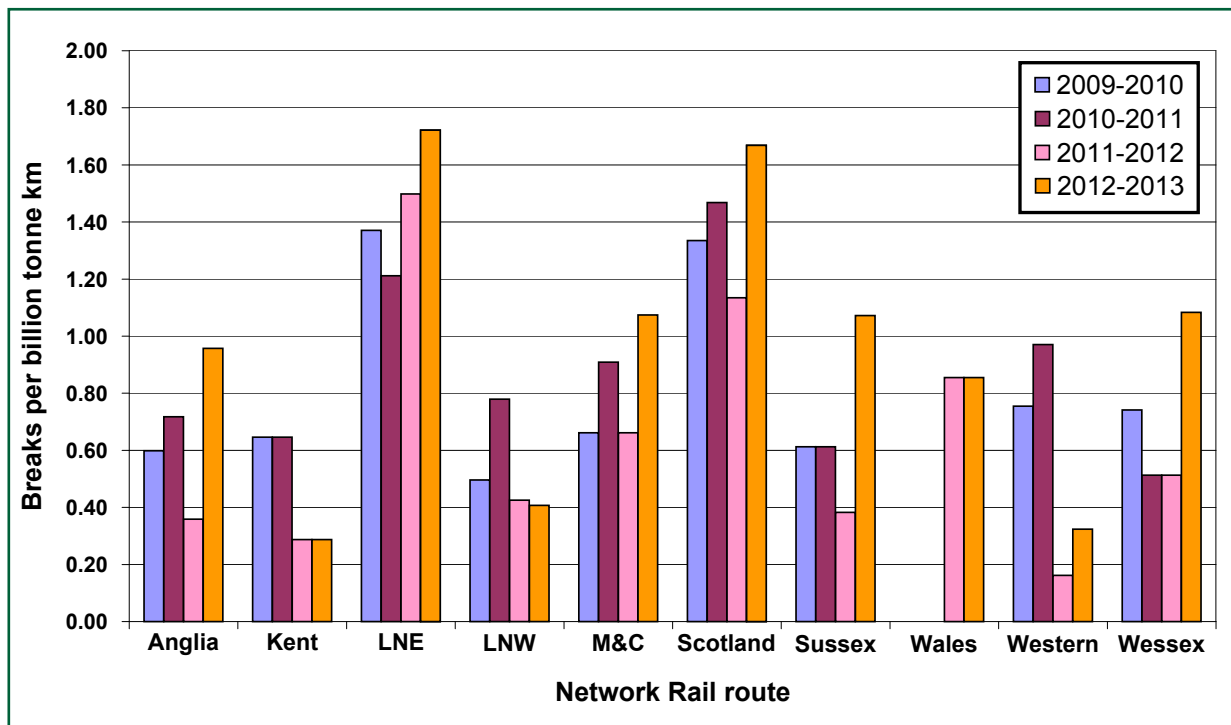
Figure 17: Normalised rail breaks 2009 to 2013, all Network Rail routes

- 47 The normalised data for all Network Rail routes is presented in figure 17 in terms of breaks per billion tonne kilometres⁴. Averaged over the four year period from 2009 to 2013, the LNE route (including the ECML) has the highest number of breaks (1.45 per billion tonne kilometres) with Scotland (1.40 breaks per billion tonne kilometres) being the next highest and most routes lying in the range 0.53 to 0.83 breaks per billion tonne kilometres.

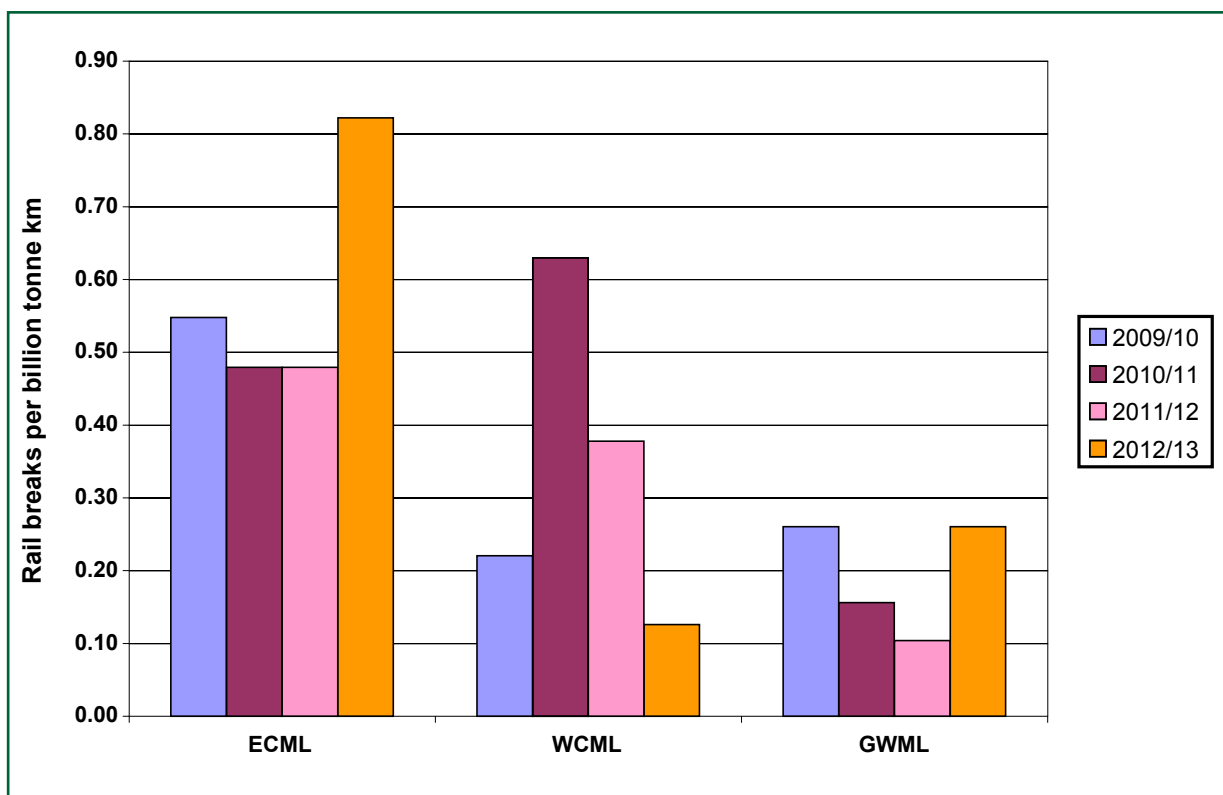
Figure 18: Mainline rail breaks (normalised)

- 48 Similar data covering only the three main lines is shown in figure 18. This shows that, averaged over the four year period, rail breaks on the ECML were significantly more common than on WCML and GWML (0.58, 0.34 and 0.20 breaks per billion tonne kilometres respectively). All these values are significantly lower than the average values for other lines in the same routes (paragraph 47).

- 82 Evidence from Copmanthorpe and Hambleton shows that dip measurement data sometimes provides indications of a potential break. For this reason an enhanced response to dip measurements forms part of Network Rail's plan to deal with rail breaks on the ECML (paragraph 128 and 129). An enhanced response to dip measurement (reducing the dip value at which action is triggered) was implemented on the WCML in 2011 and Network Rail has stated that this has contributed to the subsequent reduction of rail breaks on this line shown in figure 18.

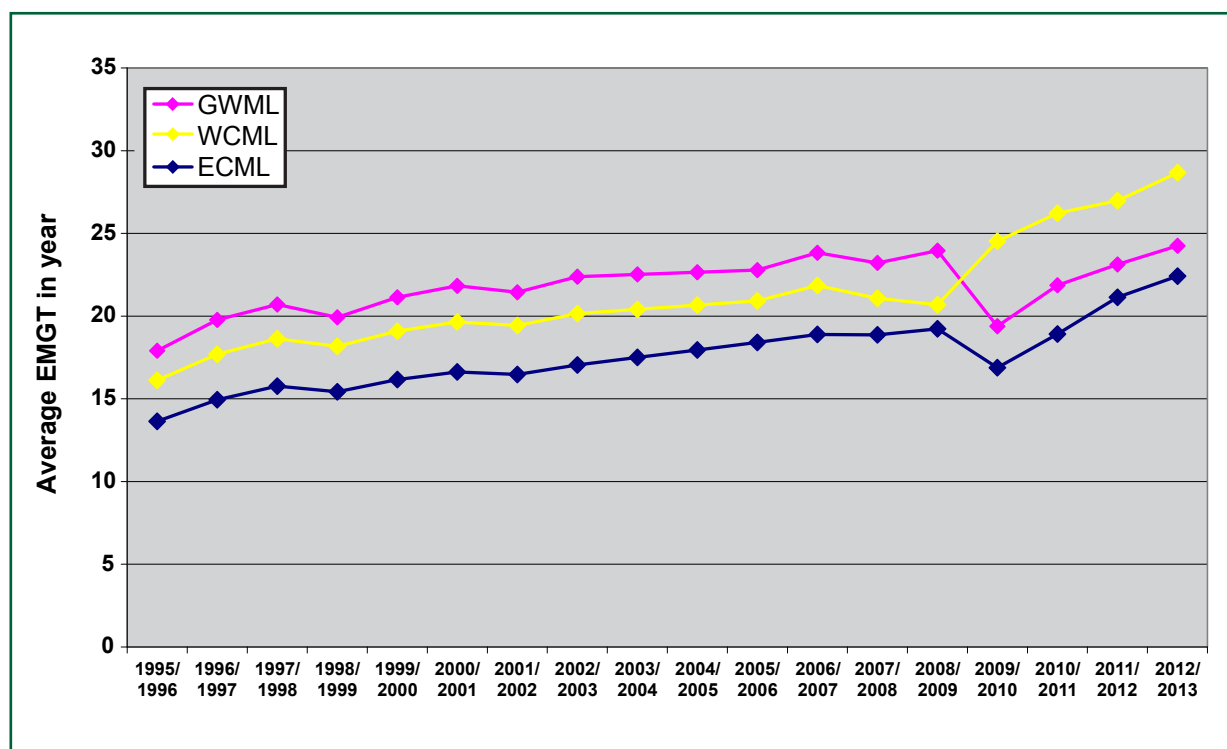
Figure 19: Mainline traffic

49 It is probable that some of the variation between successive years is a consequence of changes in the amount of rail traffic which are shown on figure 19. Traffic levels were generally increasing from 2009 to 2012, a feature which would tend to increase the likelihood of rail breaks.

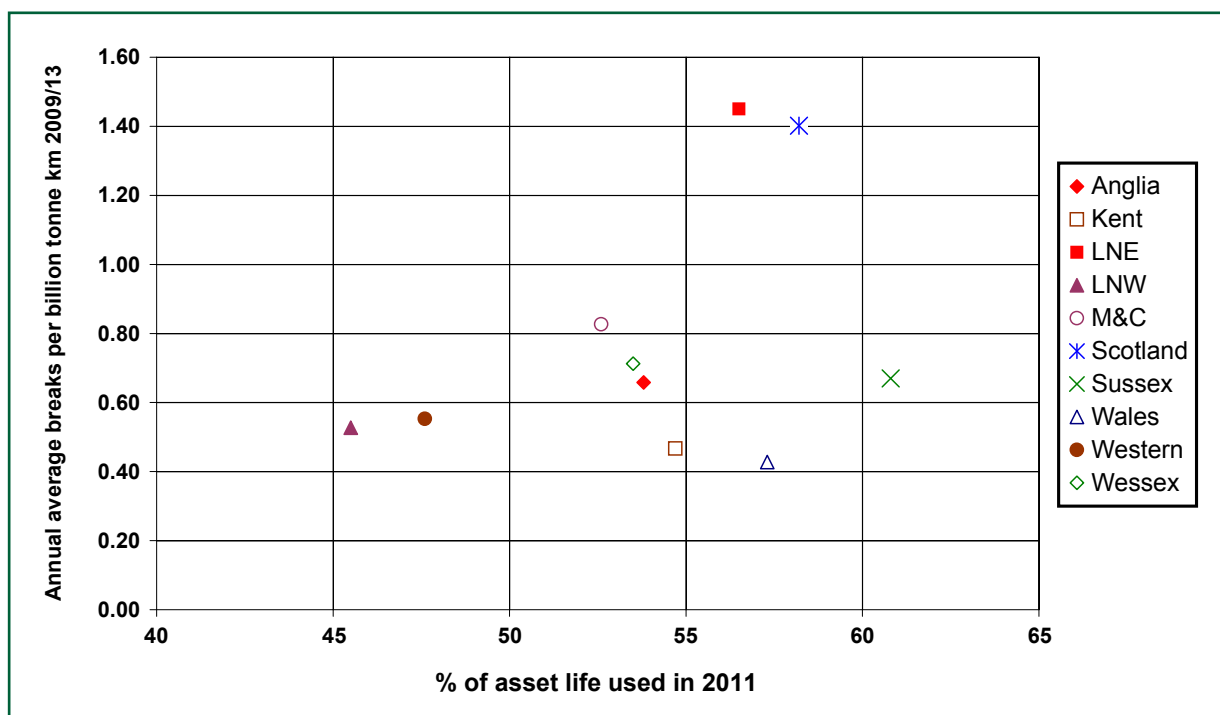
Figure 20: Route track asset used compared to rail breaks

- The cumulative amount of traffic carried increases as track becomes older.
- 51 Network Rail has compared the age of existing rails, sleepers, ballast and other trackwork components with the design life given in standard NR/L2/TRK/2102 to estimate the proportion of the track life which has been expended within each route. Data for each Network Rail route, plotted in figure 20, shows a tendency for a greater frequency of rail breaks per billion tonne kilometres on routes with older track, an indicator that track age is a major influence on rail break occurrence. However, the wide scatter on the graph also suggests that track age is not a complete explanation of rail break occurrence.

- 52 The graph shows that LNE route has the greatest occurrence of rail breaks and is amongst the routes with the oldest track. Rail break occurrence on the LNE route is notably higher than on the London North Western and Western routes. As all routes contain a significant length of secondary lines, the RAIB has made a more detailed study of data relating only to the main lines (ECML, WCML and GWML).

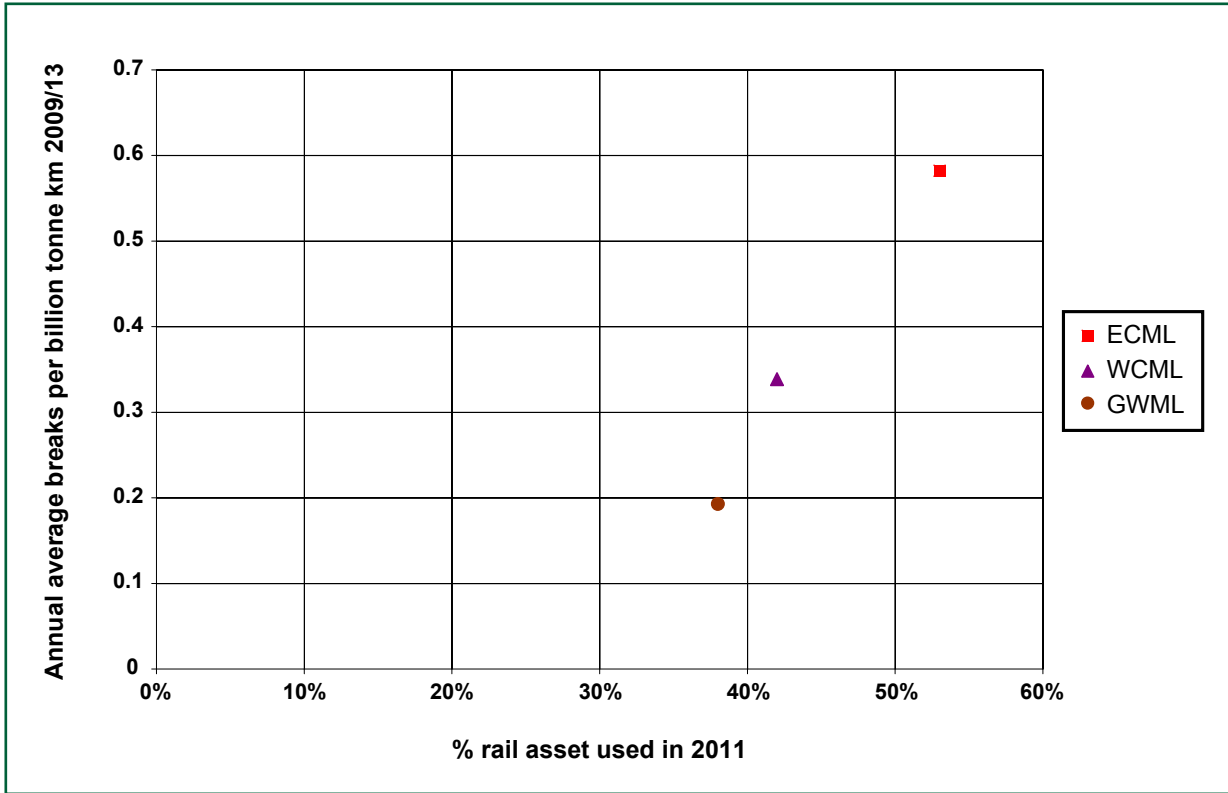
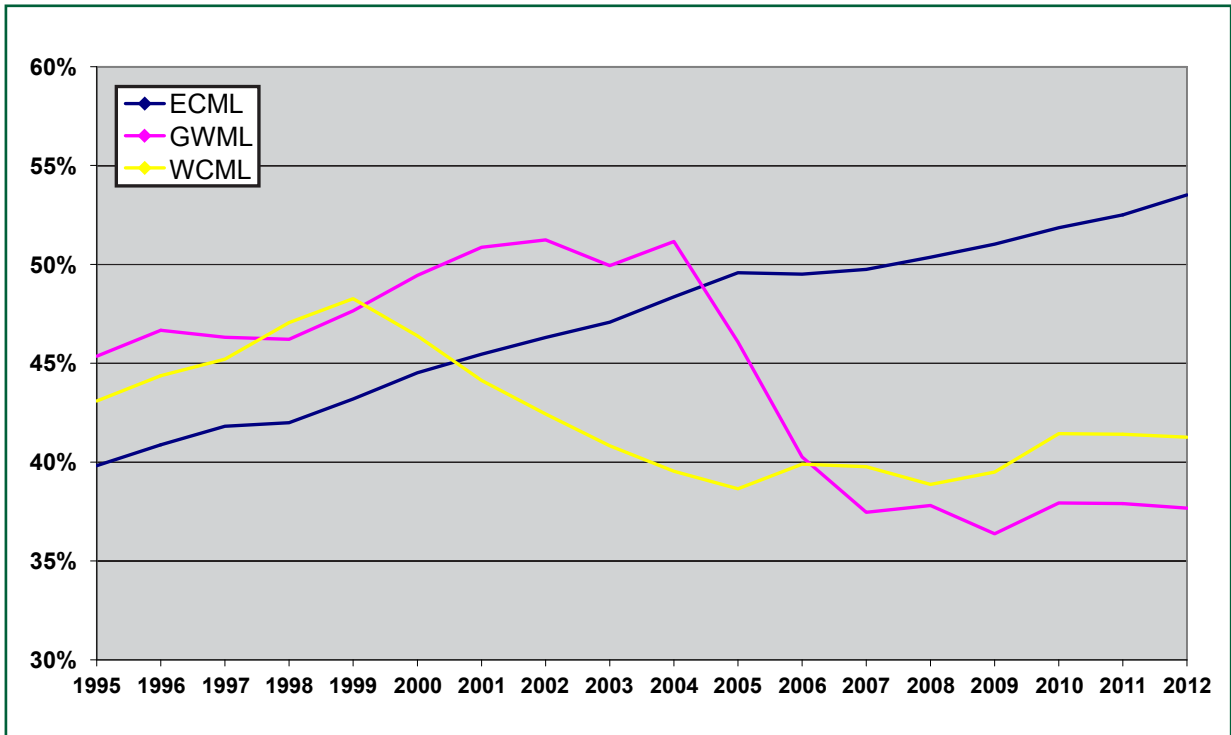
- 53 Considering track used life in 2011, the mid-point of the 2009 to 2013 period covered by the rail break statistics, approximately 53% of the track life had been used on ECML compared to 42% on WCML and 38% on GWML. The data plotted in figure 21 suggests an increased likelihood of rail break occurrence as the proportion of track used life increases. The asset used data reflect the substantial amount of track renewal work carried out on WCML and GWML between 1999 and 2007 together with subsequent renewal work which maintained an approximately steady state age profile on these lines until (and beyond) 2011. Renewal work on ECML between 1999 and 2011 was insufficient to maintain steady state conditions and the proportion of track asset used rose from 43% to 53% (figure 22).

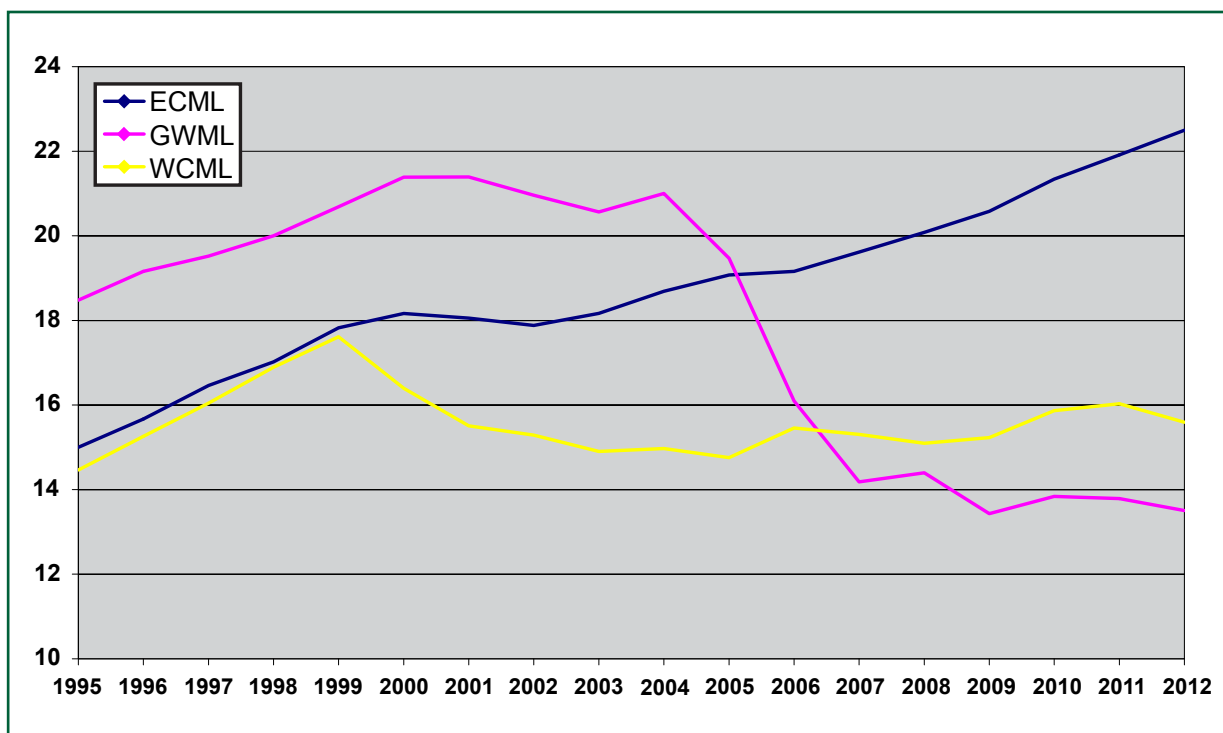
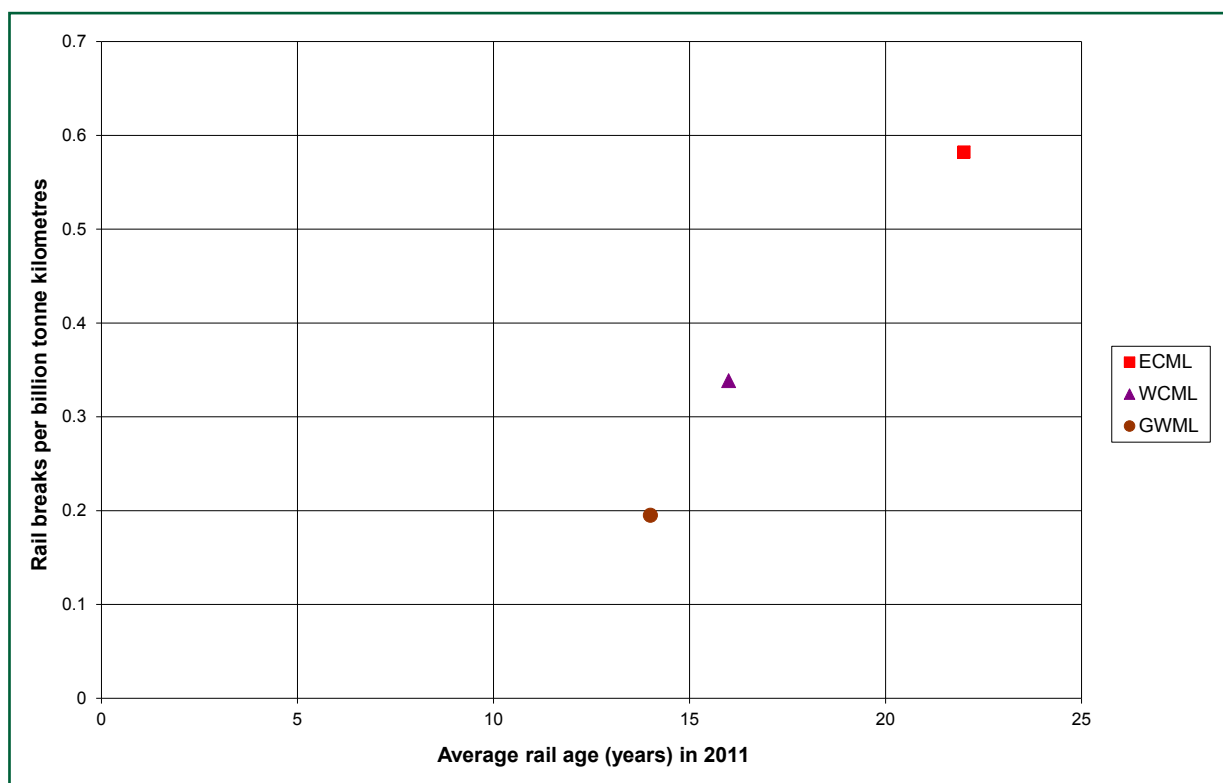
- 54 A similar pattern is apparent when rail age is considered. The increasing average age of rail on ECML, and the decreasing age on WCML and GWML, from 1999 to (and beyond) 2011 is presented in figure 23. This shows that, in 2011, the ECML average rail age was 22 years with corresponding values of 16 years on the WCML and 14 years on the GWML. The correlation between increasing rail age and increasing rail break occurrence is shown on figure 24.

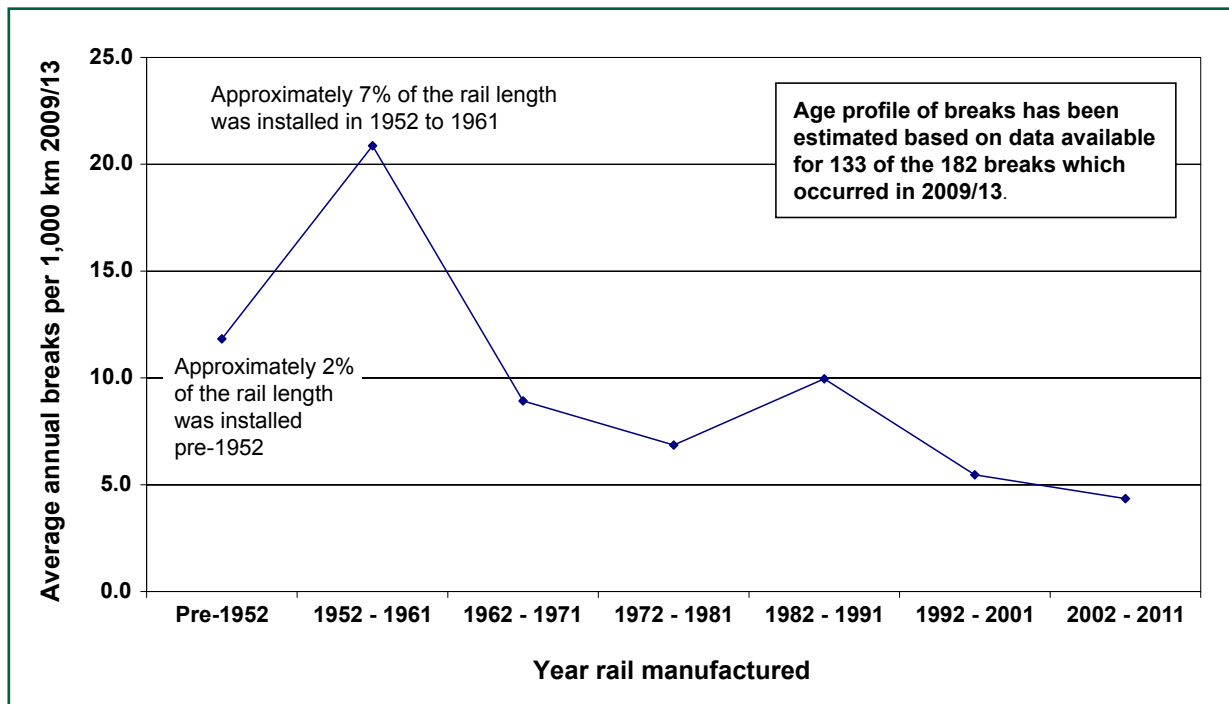
Figure 25: LNE rail breaks related to year of manufacture

- 55 Further evidence of the effect of rail age is provided by considering the relationship of rail breaks to rail age on the LNE route (figure 25). This shows a tendency for a lesser occurrence of breaks in newer rail using data unaffected by any differences between operation and maintenance practices on different routes. The value plotted for pre-1952 rail is unlikely to reflect performance of rail carrying significant amounts of traffic. It relates to only 2% of the route length and probably relates to rail in lightly used areas.

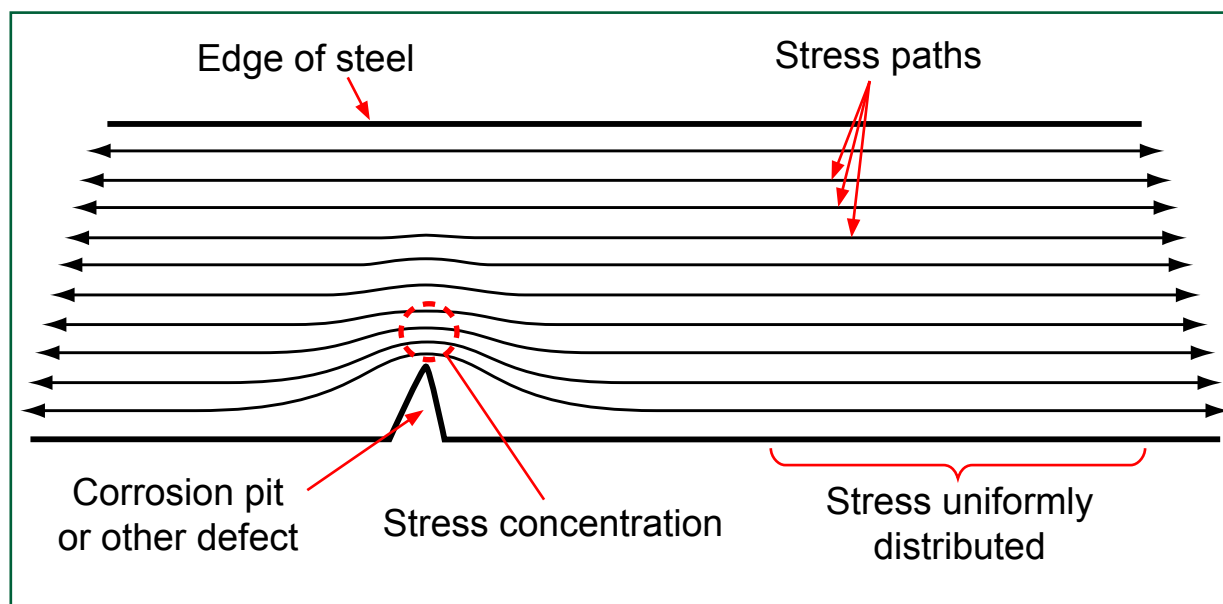
Figure 26: Stress concentration feature

- 60 Cracks are normally initiated at a location where a defect or localised weakness acts as a stress concentration feature. This can be a surface irregularity, such as an irregularity on the edge of a bolt hole, a pit caused by surface corrosion, or a defect within a rail or weld. The mechanism is illustrated in figure 26.

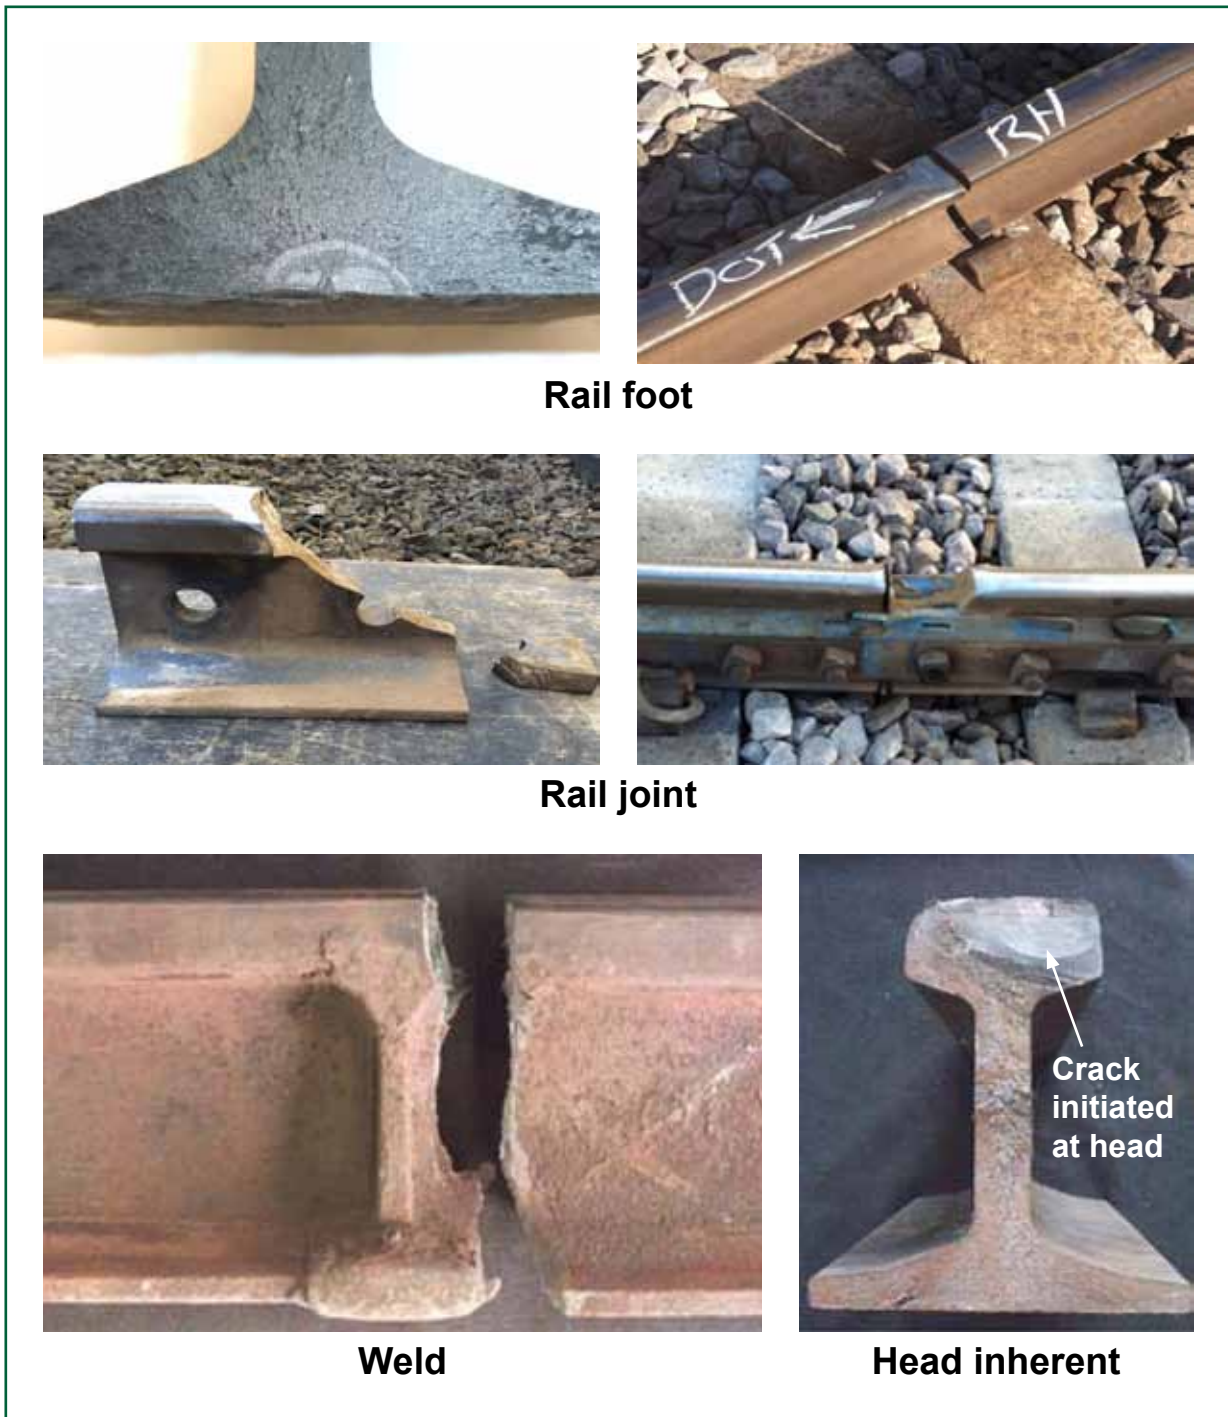
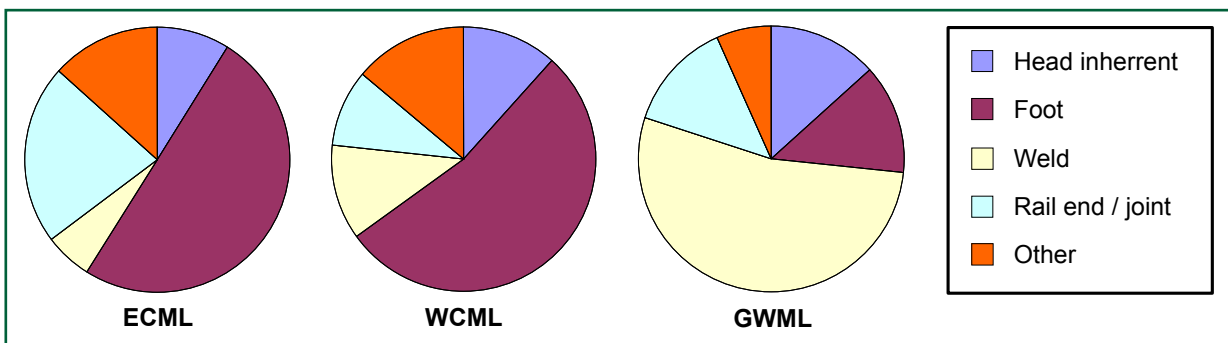
- 62 Rail breaks are classified by Network Rail based on the location of the break. Most are classified as occurring in the rail head, the rail foot, at a weld joining two pieces of rail, or at the end of a rail where fishplates join two rails (figure 27).
- 63 The distribution of breaks by type is shown in figure 28. The distribution is generally similar for the ECML and the WCML. The GWML has a greater proportion of breaks at welds and considerably lower proportion of breaks in the rail foot compared to the ECML. The RAIB has not established the reasons for this and further investigation of this issue is unlikely to affect the recommendations made in this report.

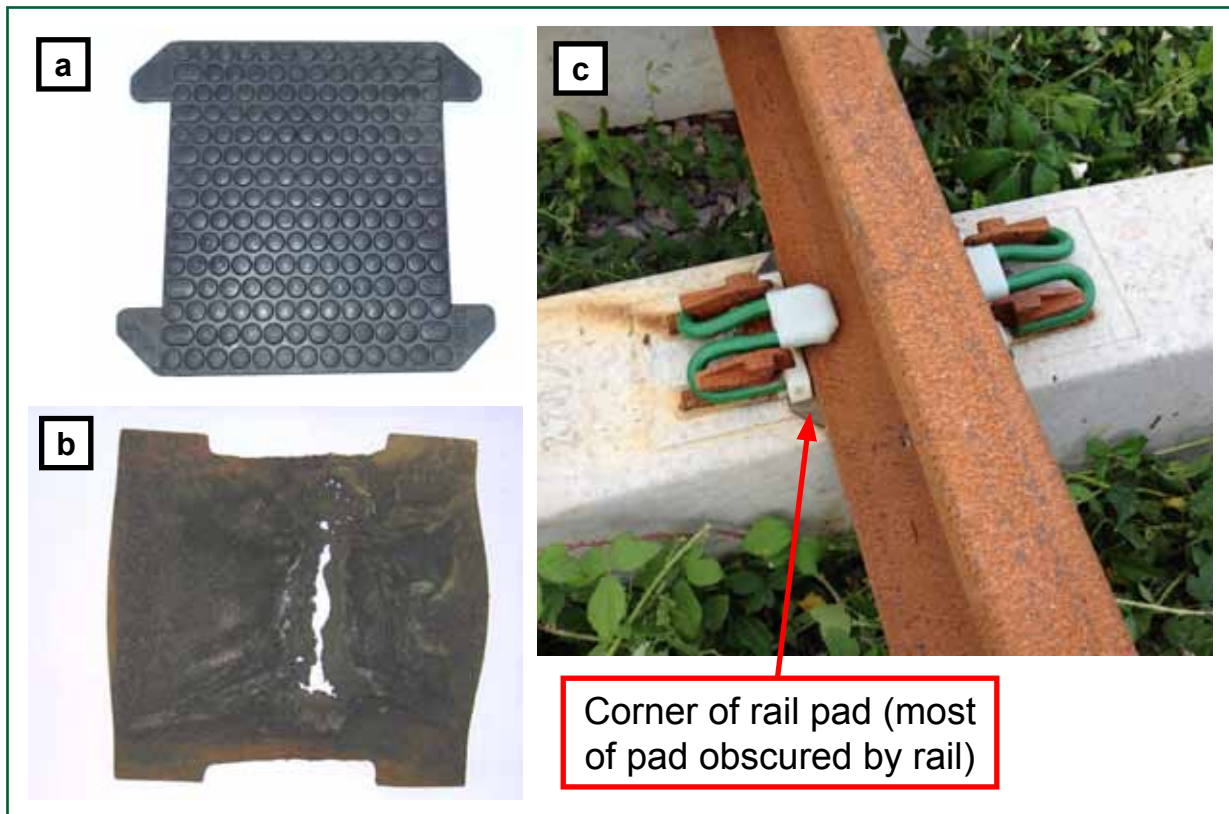
Figure 29: Rail pads in (a) new condition, (b) worn condition and (c) fitted beneath rail

- 65 Network Rail standard NR/L2/TRK/001(modules 3 and 5) requires replacement of rail pads where necessary with section managers (track) being responsible for identifying missing or ineffective pads during their quarterly visual inspections of the track. However, although missing pads can be observed during inspections, degraded pads cannot always be identified as the area visible to inspection staff can appear to be intact (figure 29) when the area beneath the rail is degraded. Network Rail is investigating whether equipment, already fitted on the UTU to assess the shape of, and any movement of, the rail head, can be used to identify areas where the rail has moved from its expected position. Such movement can be due to lack of support from worn or missing pads. Replacement of pads forms part of Network Rail's plan to deal with the relatively high level of rail breaks on the ECML (paragraphs 128 and 129).

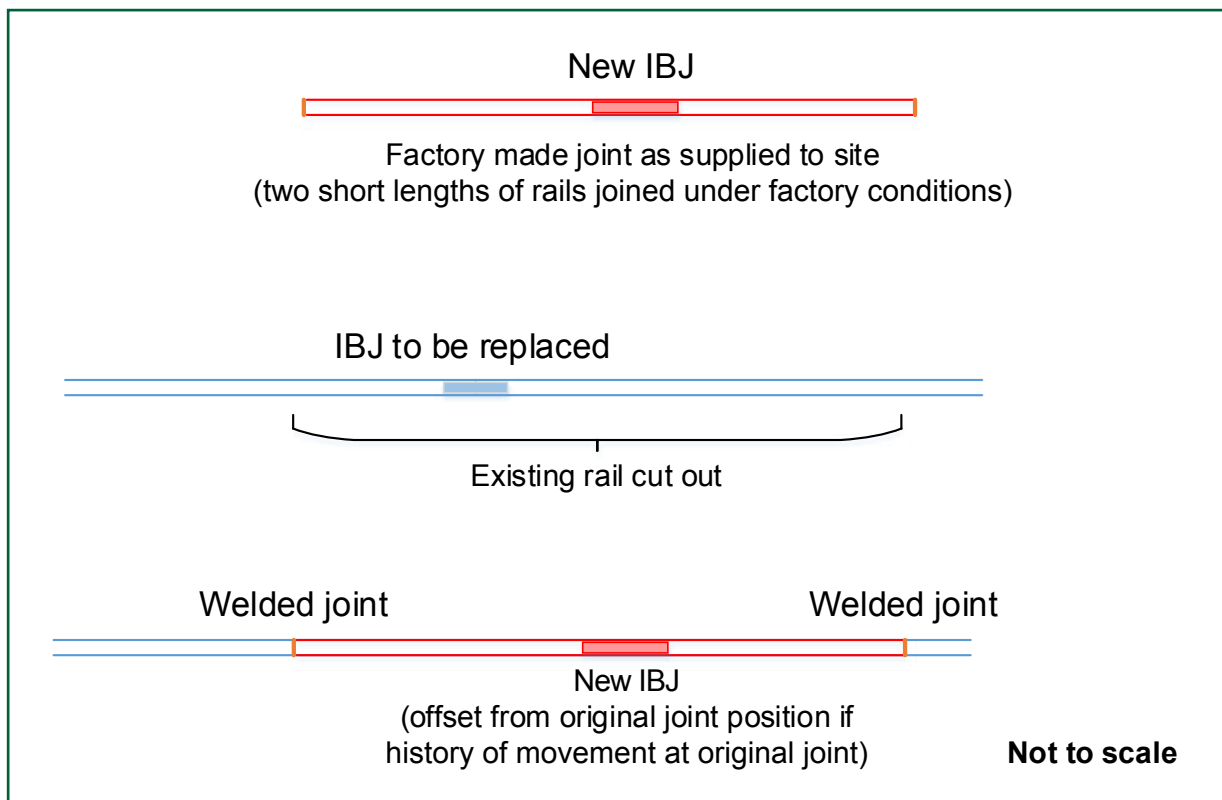
Figure 30: Installing factory made insulated block joint (IBJ)

- 70 Insulated block joints can be made up on site or under factory conditions. If made off site, two short lengths of rail are joined together in carefully controlled conditions to form a joint which is stronger than one made on site (reasons for this include a greater accuracy when drilling bolt holes, better preparation of metal surfaces by grit blasting, including a cold expansion process when forming bolt holes, and control of both temperature and humidity while adhesive cures). Factory made joints are now generally preferred by Network Rail and are installed by replacing a length of existing rail, or an existing joint, with the factory made component. The outer ends of this component are welded to the adjacent sections of track giving a robust connection (figure 30).

- 71 Replacement of site made joints with factory made joints, and elimination of unnecessary joints such as the Hambleton insulated block joint (paragraph 28), forms part of Network Rail's plan to deal with rail breaks on the ECML (paragraph 128).
