Rail Accident Investigation Branch

Rail Accident Report

Class investigation into rail breaks on the East Coast Main Line

Report 24/2014
November 2014

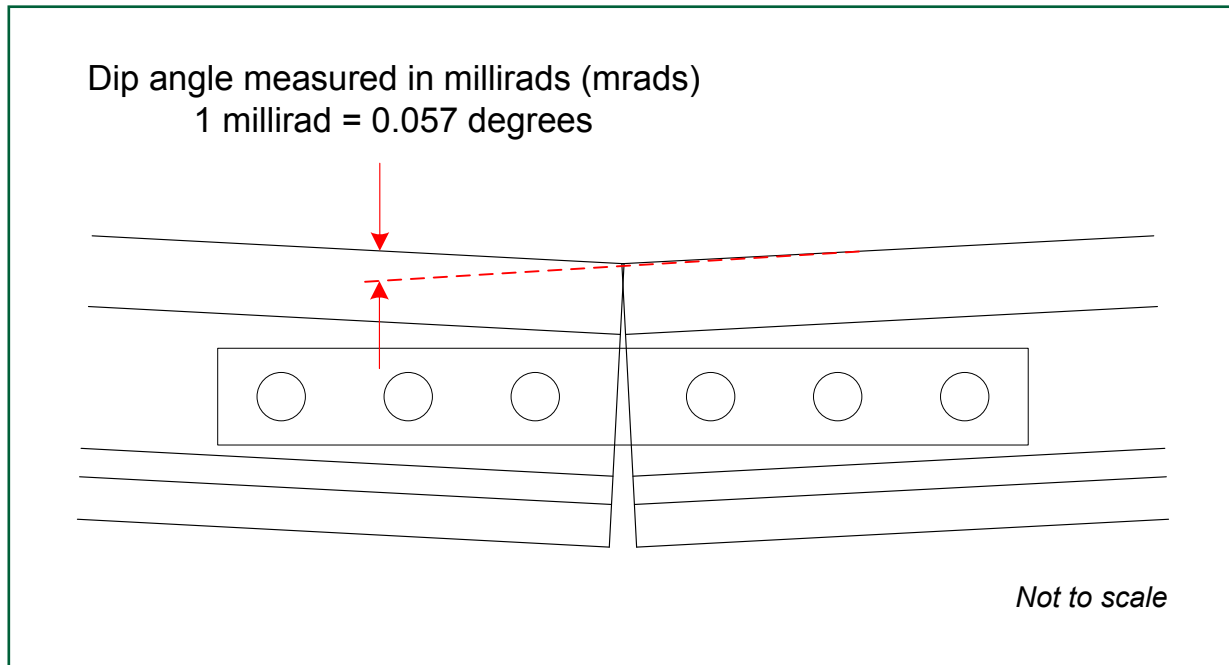
Figure 31: Dip angle measured at dipped joint

- 73 Network Rail standard NR/L2TRK/L2/001/mod11, 'Inspection and maintenance of permanent way', version 5 was applicable at the time of all three incidents detailed in this report. This, and version 6 which applied from 2 February 2013, require the actions shown in table 2 to be taken in response to dips found on track with a maximum line speed of 90 mph and above (the line speed category applicable at all three incidents). Dips are measured as shown on figure 31.

- 74 Joint dip angles at Copmanthorpe and Hambleton were generally recorded by the track geometry recording train at four weekly intervals before the broken rails were discovered. The recording intervals were in accordance with Table 1 of Network Rail standard NR/L2/TRK/001/mod11 which requires a 'normal planning interval' of four weeks and a 'maximum interval' of ten weeks. The results are shown on figure 32.

- 75 The dip values at Copmanthorpe exceeded the 30 mrads action limit when measured on 10 September, 15 October and 12 November, the last three occasions that measurements were taken before the broken rail was discovered. On each occasion, the track was lifted and packed within three days. The track was also lifted and packed on two other occasions in October and November after visual inspections identified the dip. All lifting and packing was carried out using shovel packing except one instance in November when powered hand tools were used (Table 1).

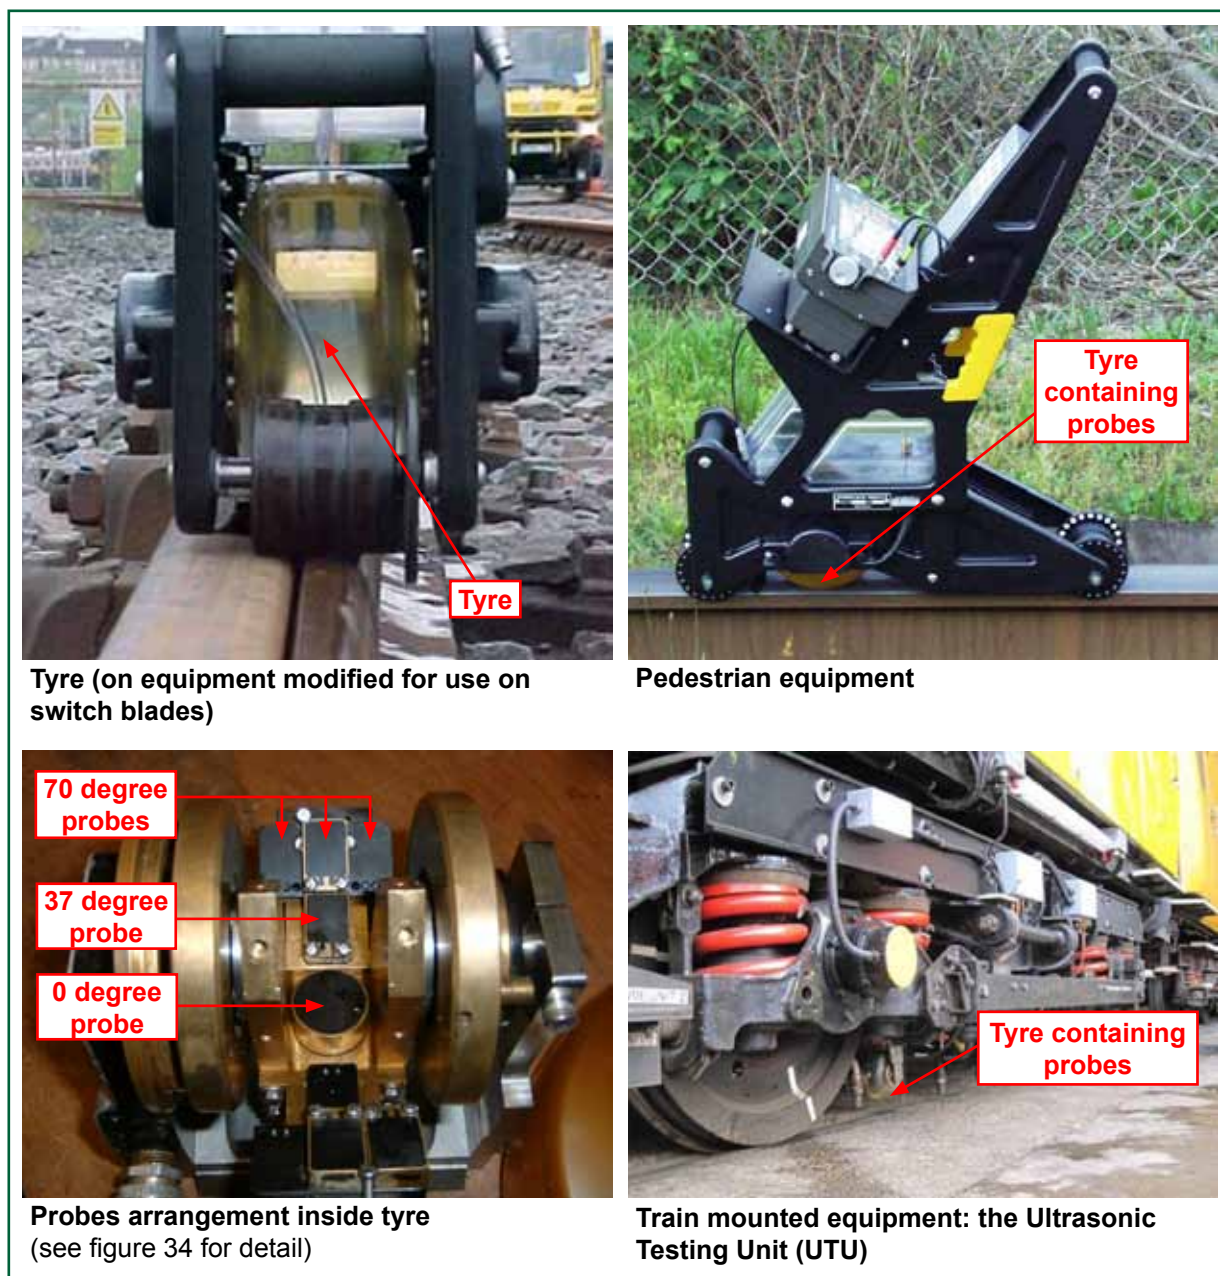
Figure 33: Ultrasonic testing equipment (images copyright Sperry)

- 90 Network Rail uses train mounted ultrasonic equipment (the UTU) and ultrasonic equipment mounted on a small trolley pushed along the rail by a person (pedestrian equipment). These are illustrated in figure 33. On most track, the UTU is used to identify areas of concern and pedestrian equipment, which travels much slower, is used to evaluate these areas in detail. Pedestrian equipment is also deployed at *switches*, at *crossings*, on lines not tested by the UTU and to investigate some locations where the track geometry recording train has identified dipped joints.

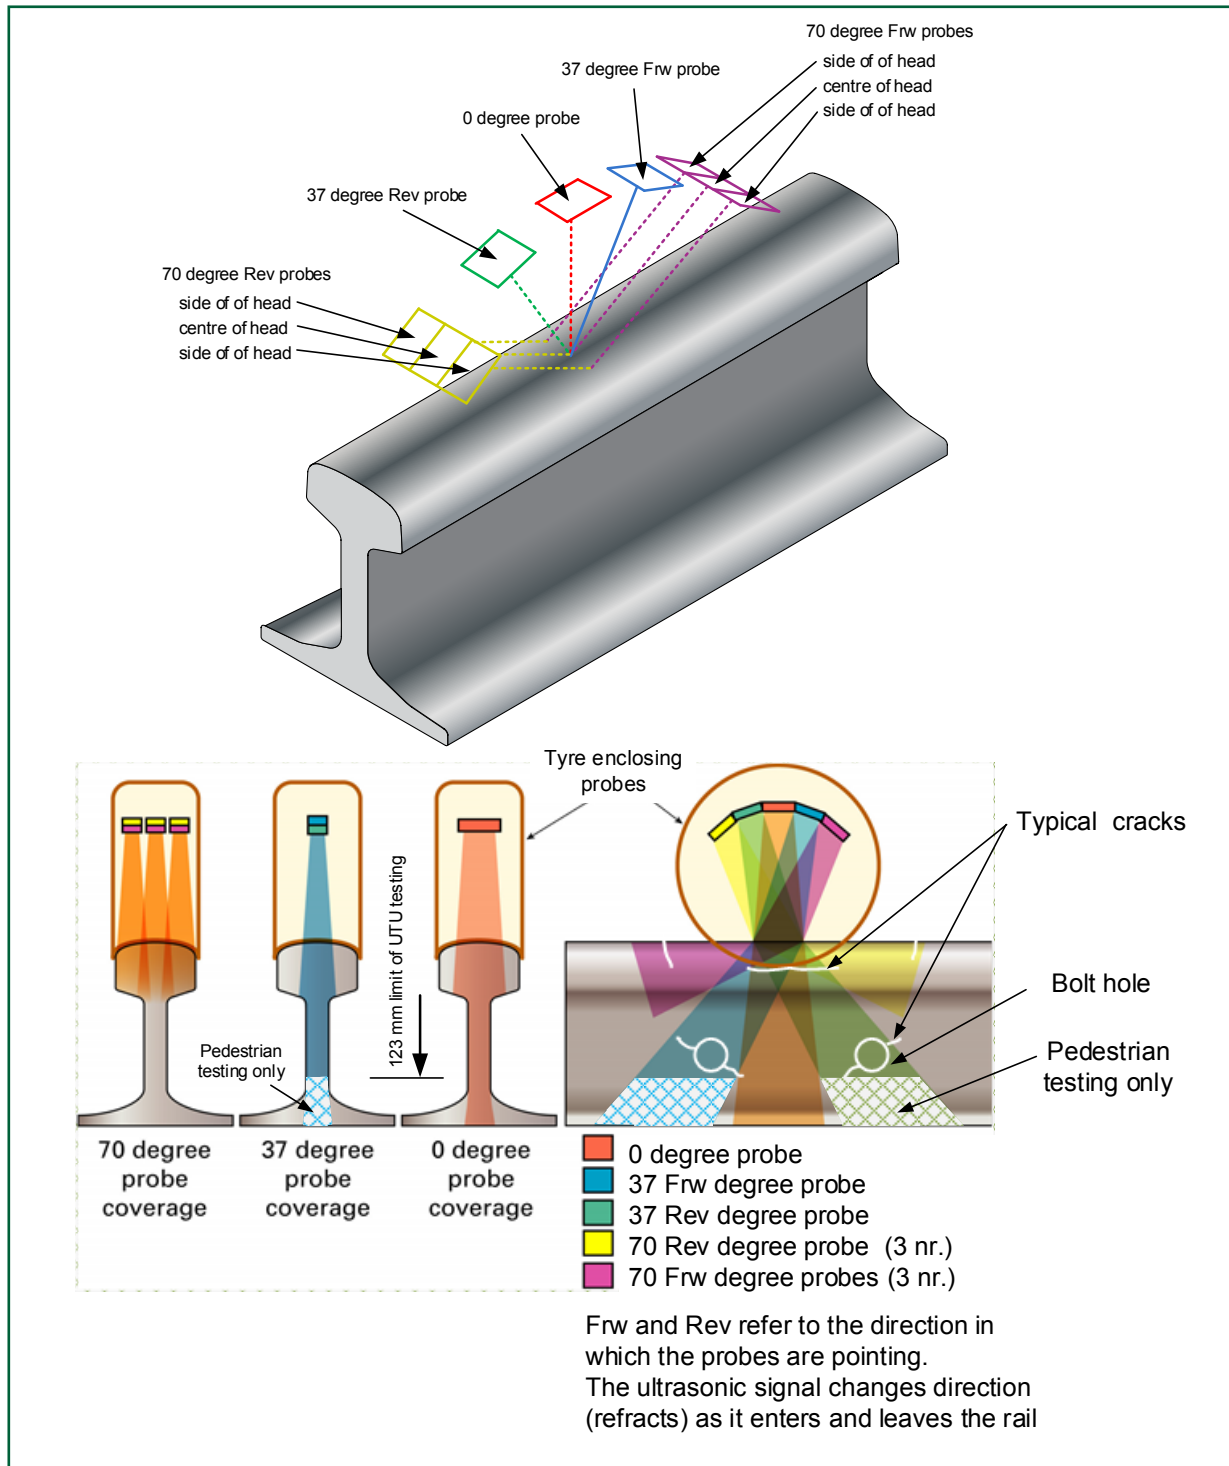
Figure 34: Ultrasonic probe arrangements (copyright Sperry)

- 91 The UTU uses nine probes to direct ultrasonic waves towards different parts of the rail (figure 34). Six of these, designated the 70 degrees probes, are primarily intended to detect cracks in the rail head. Two, designated the 37 degrees probes, are intended to detect cracks in the rail head and the upper part of the rail web. The ninth, pointing directly downwards and designated the 0 degree probe, responds to cracks in the rail head and rail web. It also detects the waves which are normally reflected from the rail bottom and this can be used as part of the process to verify that the UTU is operating correctly⁵.

- 92 Taken together the UTU probes should identify cracks (provided that they are of sufficient size) in any part of the rail except:
- at depths more than 123 mm below the rail head; a limitation which means that cracks are not found if they are in the lower part of the web or in any part of the foot (paragraph 96); and
 - a zone immediately below bolt holes (where any cracks are unlikely to grow because stresses in the steel are relatively low).

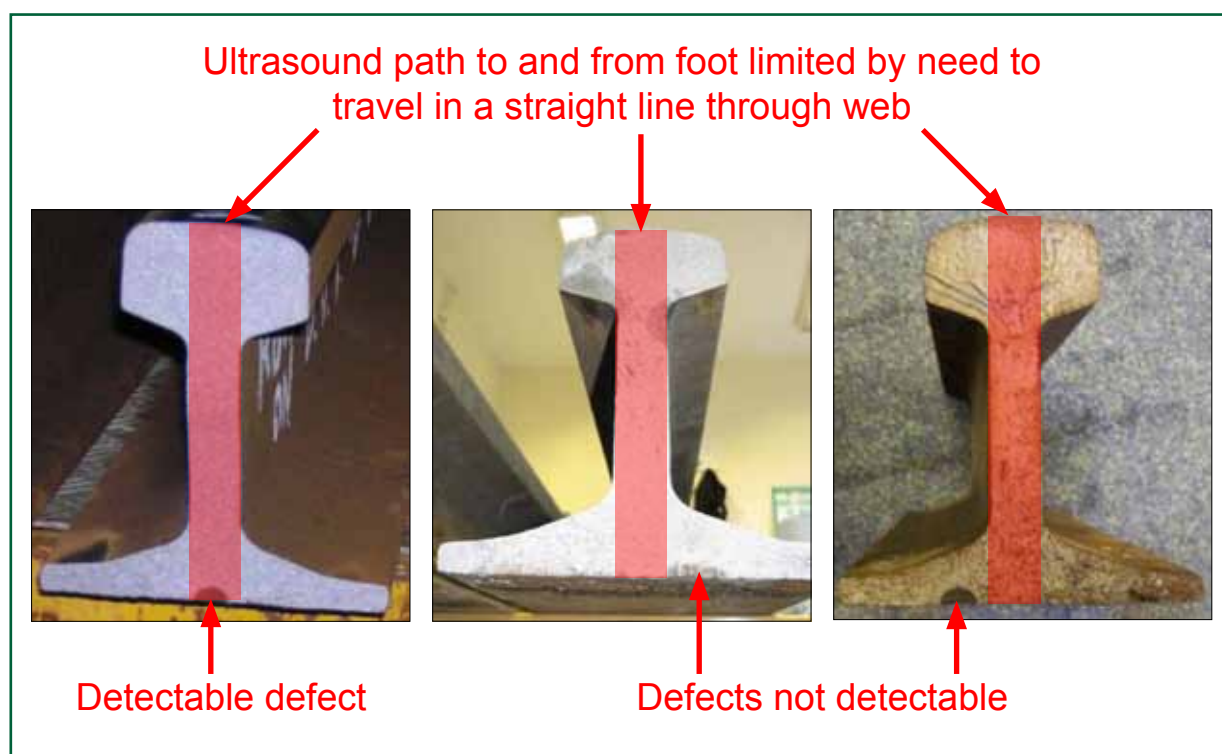
Figure 35: Limited extent of crack detection in rail foot

- 95 Cracks in the central part of the rail foot can, provided that they are large enough, be detected using the pedestrian equipment. Neither the pedestrian equipment, nor the enhanced UTU equipment (paragraph 129) can detect rail foot cracks outside the central part of the rail foot because the ultrasonic signal must pass through the rail web (figure 35).

- 96 Cracks more than 123 mm below the rail head are not reported when using the UTU in accordance with current Network Rail procedures which permit the UTU to operate at speeds of up to 50 mph (80 km/h). It means that cracks in the bottom 36 mm of new BS113A rail, and within the bottom 49 mm of new CEN60 rail, are not reported.

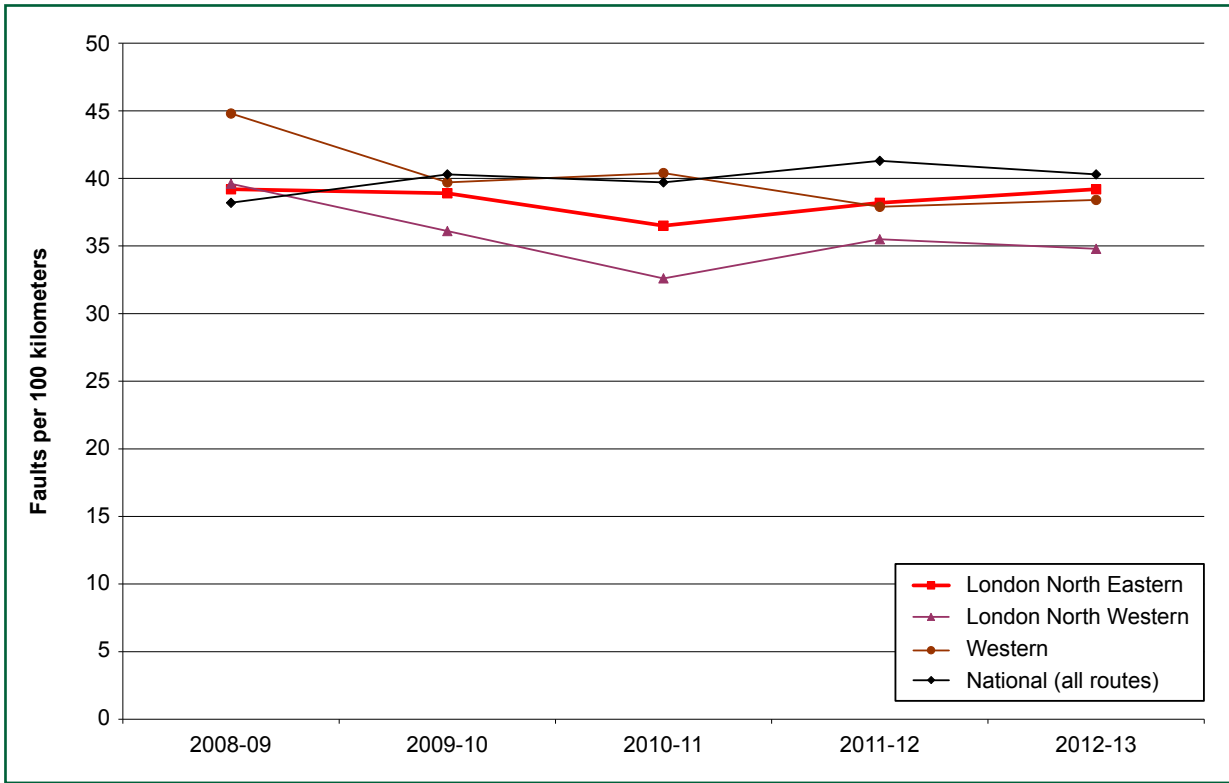
Figure 36: Track geometry faults 2008 to 2013, all lines

- Track geometry faults per 100 kilometres⁷ on all lines within the LNE route occurred at a broadly consistent rate from 2008/09 to 2012/13, typically 4% below the average rate for all routes; the rate on LNE was typically about 6% higher than on the LNW route and started about 6% lower than on the Western route but approximately matched this route in the final two years (figure 36).

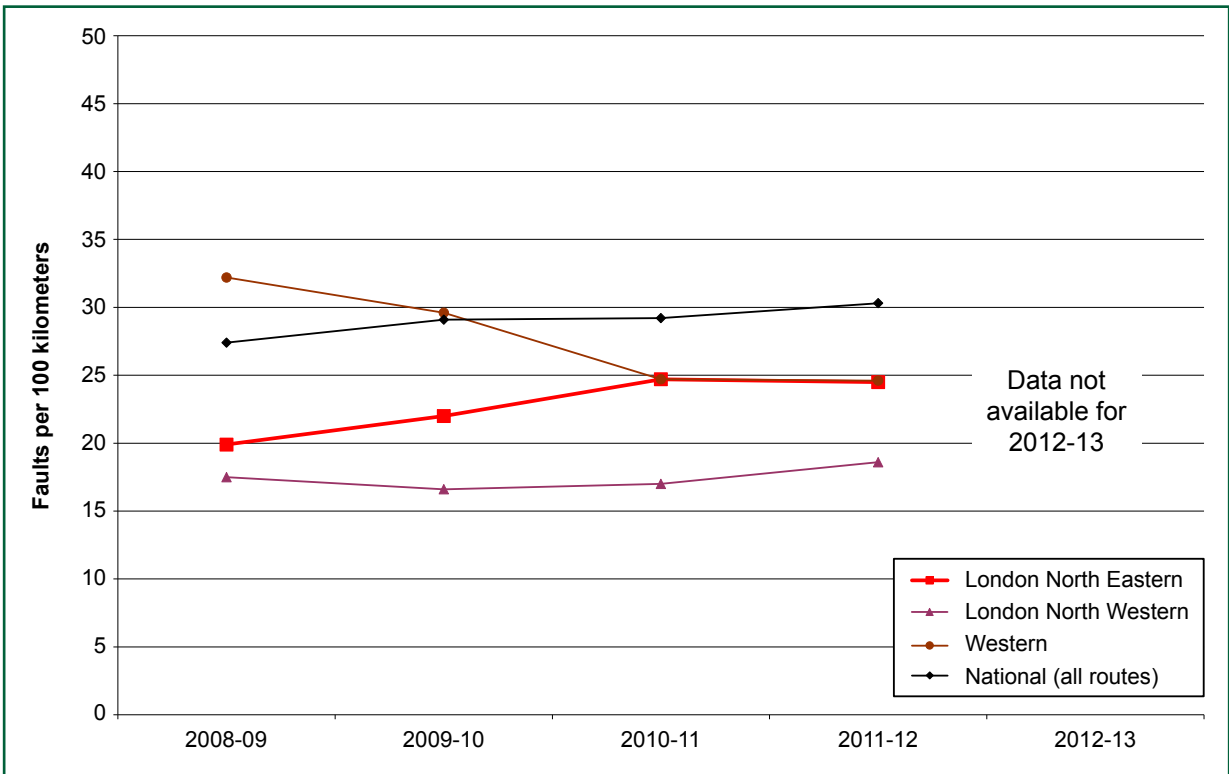
Figure 37: Track geometry faults 2008 to 2013, primary and key lines

- Track geometry faults per 100 kilometres for LNE/ECML primary and key lines rose by about 23% between 2008/09 and 2011/12 (later data is not available) compared to a 10% rise in the average for all primary and key lines; the fault rate on LNE/ECML lines was typically 20% less than the average for all primary and key lines, 18% less than those on Western/GWML tracks and 31% more than those on LNW/ WCML lines (figure 37).

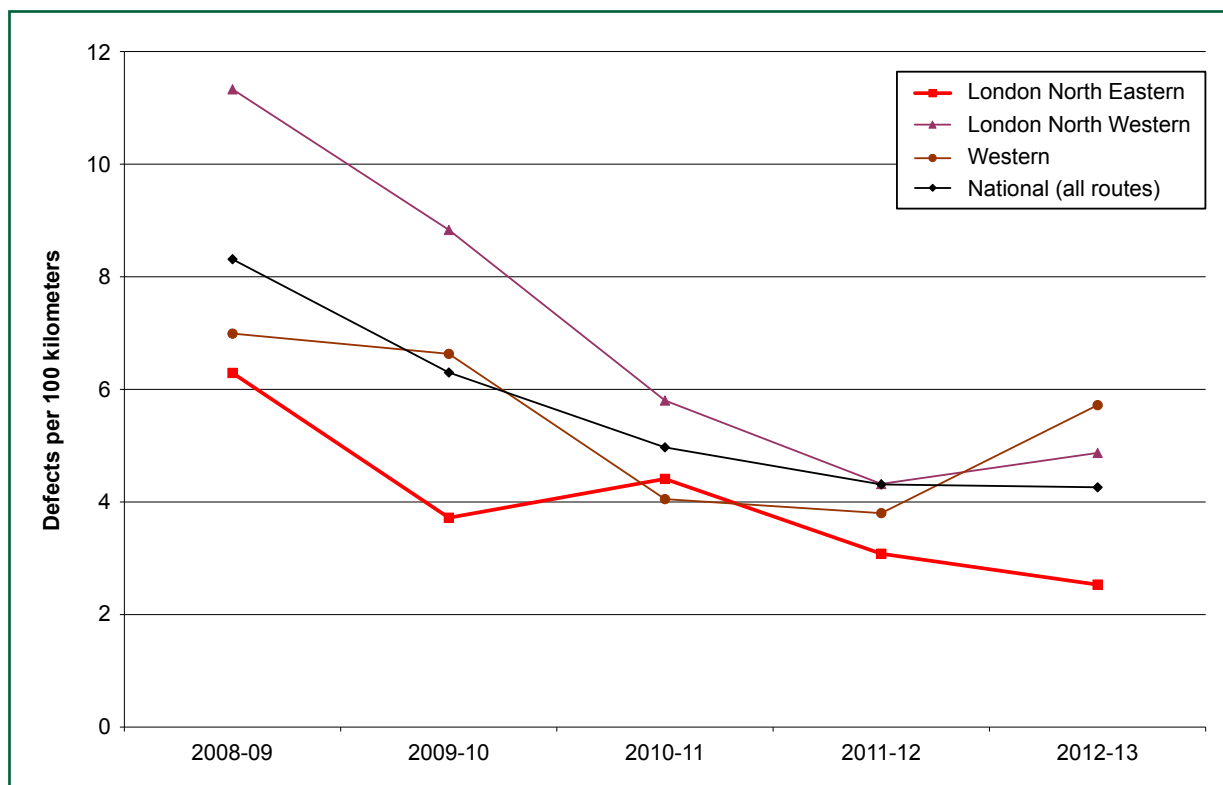
Figure 38: Immediate action defects, primary and key lines, 2008 to 2013

- Defects per 100 kilometres requiring the immediate imposition of an emergency restriction on primary and key lines fell significantly between 2008/09 and 2012/13 with the LNE/ECML rate falling by 60% and the national average reducing by about 50%; the rate on LNE/ECML tracks was typically 30% below the national average, 25% less than on Western/GWML and 40% less than on LNW/ WCML (figure 38).

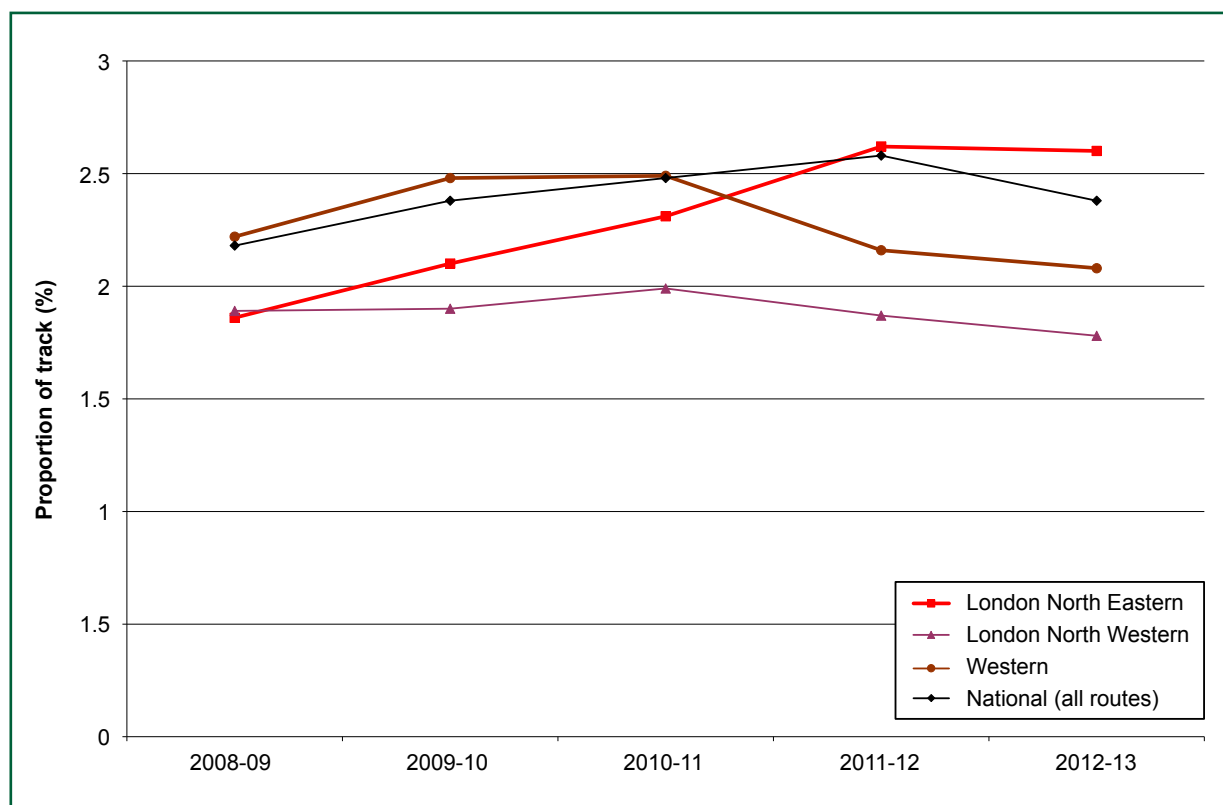
Figure 39: Very poor track geometry 2008 to 2013, all lines

- The proportion of track on the LNE route with very poor geometry⁸ rose by about 40% between 2008/09 and 2011/13 compared to a national rise of about 10%; the proportion on the LNE route rose from 15% below the national average to 10% above between 2008 and 2013 by when it was 46% higher than on the LNW route and 25% higher than on the Western route (figure 39).

- 102 Network Rail has stated that maintenance of the ECML has been undertaken in accordance with the standards which applied throughout its infrastructure. This statement is supported by the data for track geometry faults and defects requiring immediate imposition of an emergency speed restriction (figures 36 and 38). However, changes to maintenance practices cannot be ruled out as a possible cause of the significant deterioration in the proportion of LNE route with very poor geometry, and the increase in the occurrence of geometry faults, on the principal and key tracks (mainly the ECML) within this route (figures 37 and 39). The very poor geometry is relevant to rail breaks because it leads to increased dynamic loads from trains and thus an increased likelihood of rail breaks.

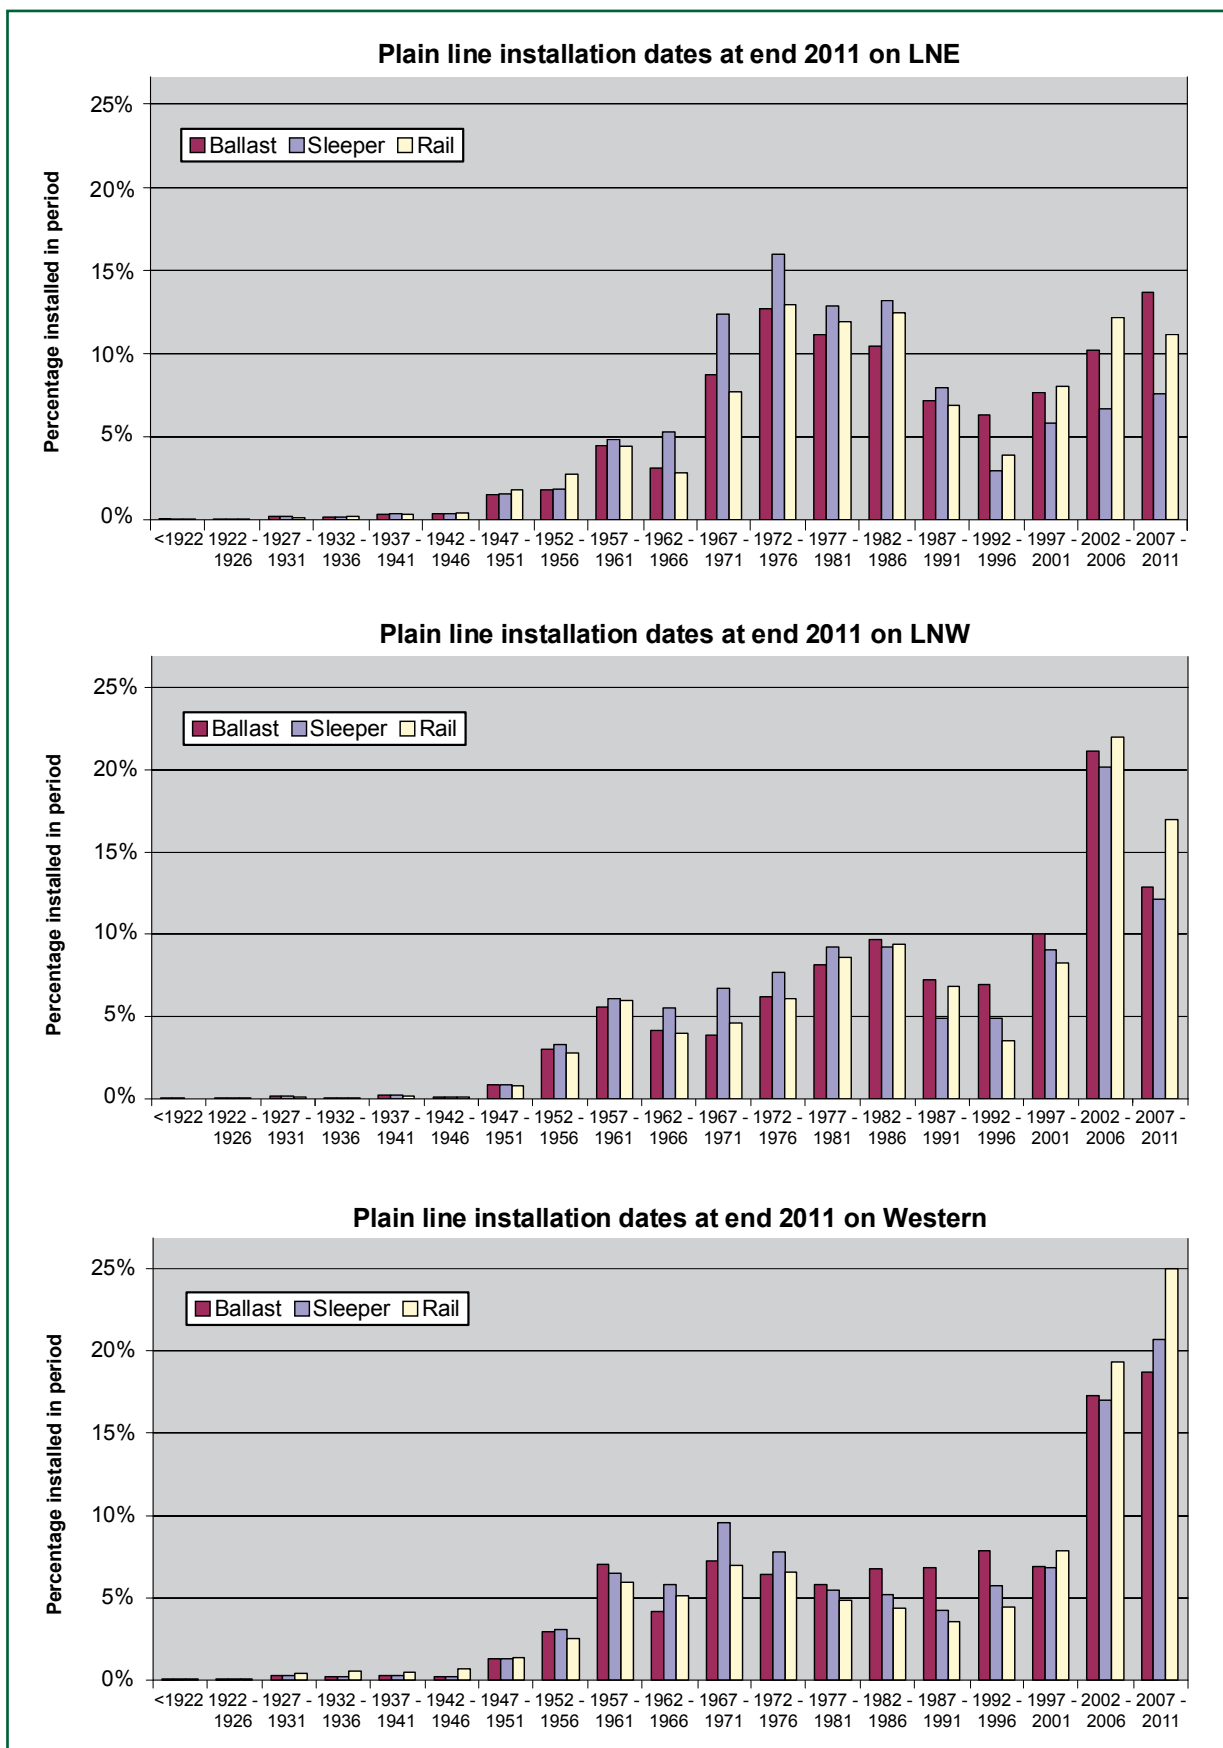
Figure 40: Plain line installation dates on selected routes

- 103 Although maintenance practices are a possible factor in the occurrence of rail breaks, it is probable that the age of trackwork has a significant effect on track geometry and is thus a factor in both deterioration of LNE track geometry and in the inferior geometry when compared to LNW and Western routes. Trackwork age is also a probable factor in the increasing occurrence of geometry faults on principal and key tracks on the LNE route. The greater occurrence of pre-1987 rail, ballast and sleeper on the LNE route, compared with the LNW and Western routes, is shown in figure 40. This data reflects the low levels of rail replacement across the national rail network in the mid 1990s⁹.

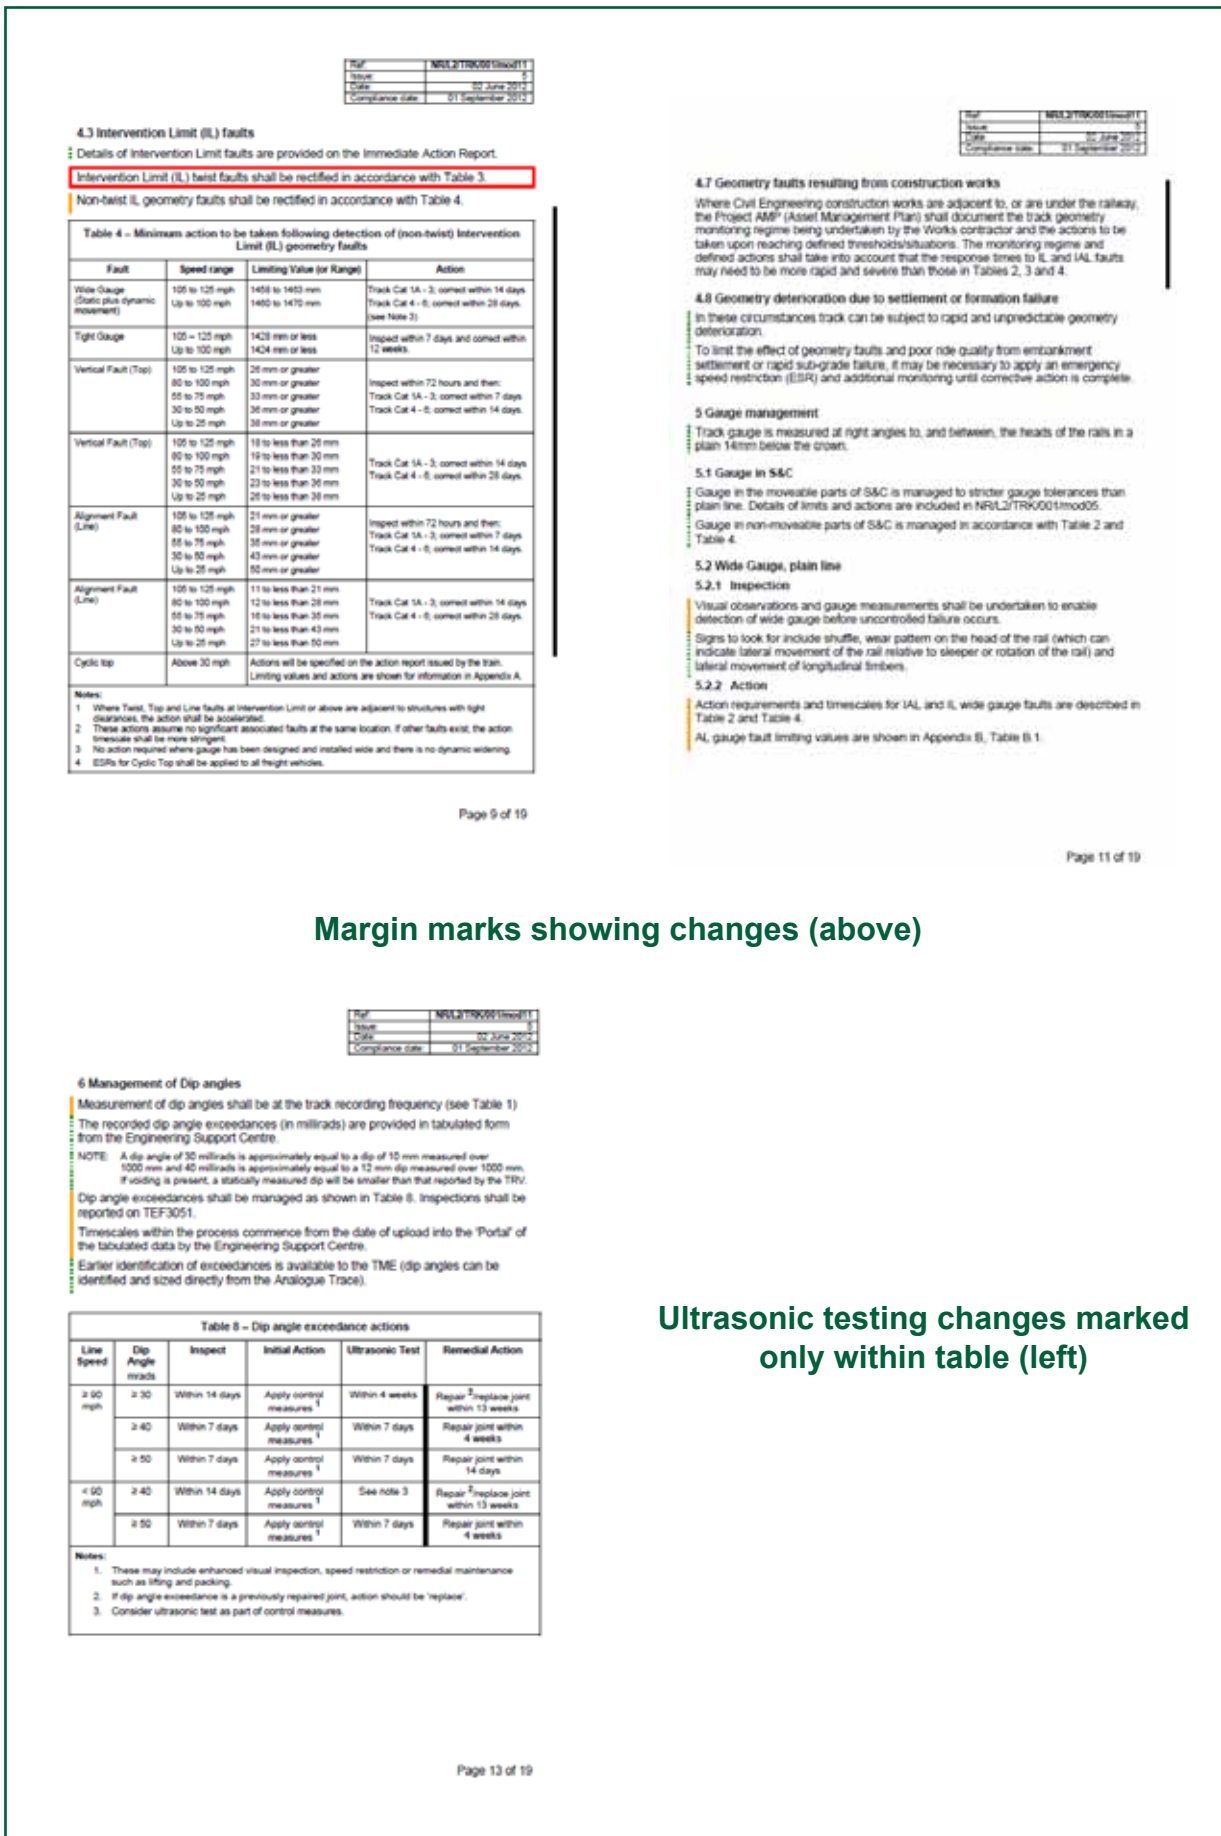
Figure 42: Change markings in version 5 of standard NRL2/TRK/001

- 113 Both the Track Maintenance Engineer and Section Manager (track) had been briefed on changes introduced by version 5 of the document. The new version introduced a significant number of changes and a non-standard process was used to brief these. The briefing documentation did not highlight the new ultrasonic testing requirement. This had been added in a part of the standard where old requirements were being presented in a new format (a flow chart had been changed to a table). The additional requirement was marked only by a thickening of the linework within part of the new table. Unlike other changes in the standard, there was no margin mark to highlight the change (figure 42).

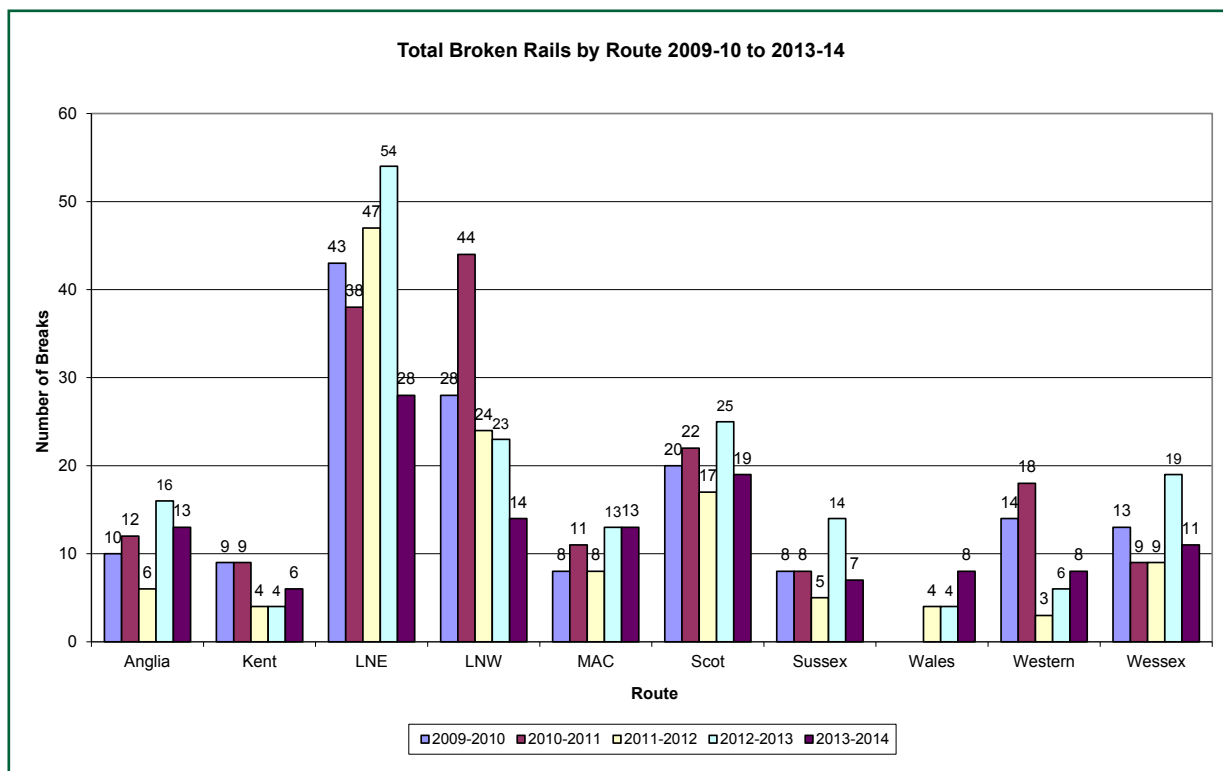
Figure 43: Total broken rails by route 2009-10 to 2013-14

129 Network Rail reports that the number of rail breaks on LNE route reduced from 54 in 2012/13 (figure 16) to 28 in 2013/14. The proportion of Network Rail infrastructure rail breaks occurring on LNE route in the same period reduced from 30% to 22%. The number of rail breaks on ECML reduced from 24 in 2012/13 to 14 in 2013/14 with the number of breaks at rail ends (the location where breaks are most likely to cause a derailment) reducing from 4 to 1 (figure 43). Although it is possible that external factors, for example weather conditions, contributed to the improved performance on LNE route and ECML, it is probable that part of the improvement is a consequence of implementing the measures described in paragraph 128. Network Rail has stated that it is currently taking the following actions which have the potential to reduce the likelihood of rail breaks:

- a. Trialling equipment which has been installed on all four UTUs in order to test the full depth of the rail to identify rail foot defects, or indicators that there is a relatively high risk of such defects (paragraph 97).
- b. Trialling eddy current based wheel probes which have been fitted to all UTUs to measure the length and depth of surface defects. It is intended to activate the equipment on all UTUs when appropriate action thresholds have been established from trials currently involving one UTU. It is anticipated that this will automate a current procedure which relies on pedestrian visual and ultrasonic procedures.
- c. Procuring mobile maintenance units (trains which incorporate a mobile covered area with lighting and storage facilities) to allow more efficient implementation of on-track work including pad replacement.
