**Entry of a confined space on board
the cargo ship
SUNTIS
in Goole Docks, Humberside
on 26 May 2014
resulting in three fatalities**

MAIB SAFETY BULLETIN 3/2014

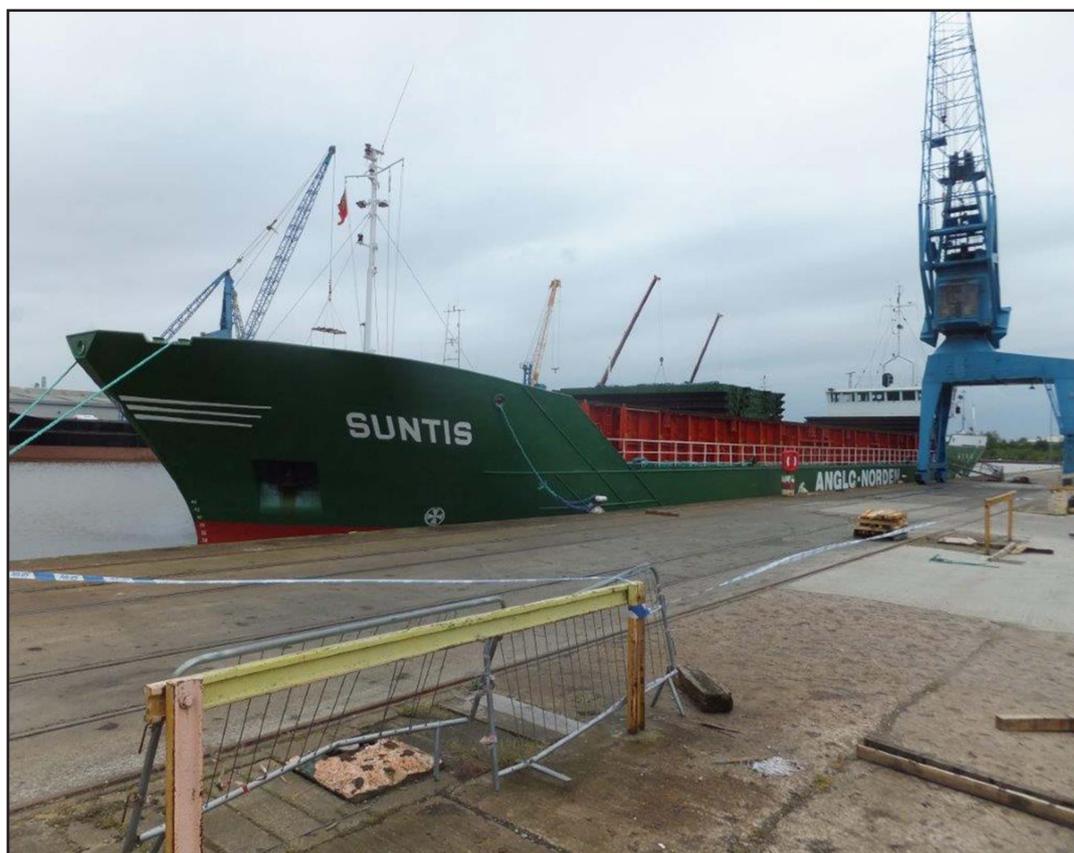
At approximately 0645 (UTC+1) on 26 May 2014, three crew members on board the cargo ship, *Suntis*, were found unconscious in the main cargo hold forward access compartment, which was sited in the vessel's forecabin (f'ocsle). The crew members were recovered from the compartment but, despite intensive resuscitation efforts by their rescuers, they did not survive.

The Fire and Rescue Service analysis of the atmosphere after the accident showed normal readings (20.9%) of oxygen content at the access hatch; the readings reduced to 10% just below main deck level inside the hatch opening and to between 5% and 6% at the bottom of the ladder into the compartment (**Figure 2**). Such low levels of oxygen cannot support life. Anyone exposed to such levels will faint almost immediately, followed by convulsions, coma and respiratory seizure within a few minutes. It is likely that the timber cargo caused the deprivation of oxygen in the cargo hold and access compartments.

- The atmosphere within an enclosed space, such as a ship's cargo hold can change rapidly and become lethal dependent on the conditions inside and what is being stored or transported (as the tragic circumstances above illustrate).
- **NEVER** enter a confined space if safer alternatives for carrying out the work are available. If entry into a confined space is unavoidable, robust procedures should be put in place which should include emergency arrangements. These are often referred to as "Safe System of Work" or "Permit-to-Work".
