Report on the investigation of
carbon monoxide poisoning
on board the fishing vessel

Eshcol

resulting in two fatalities

on 15 January 2014

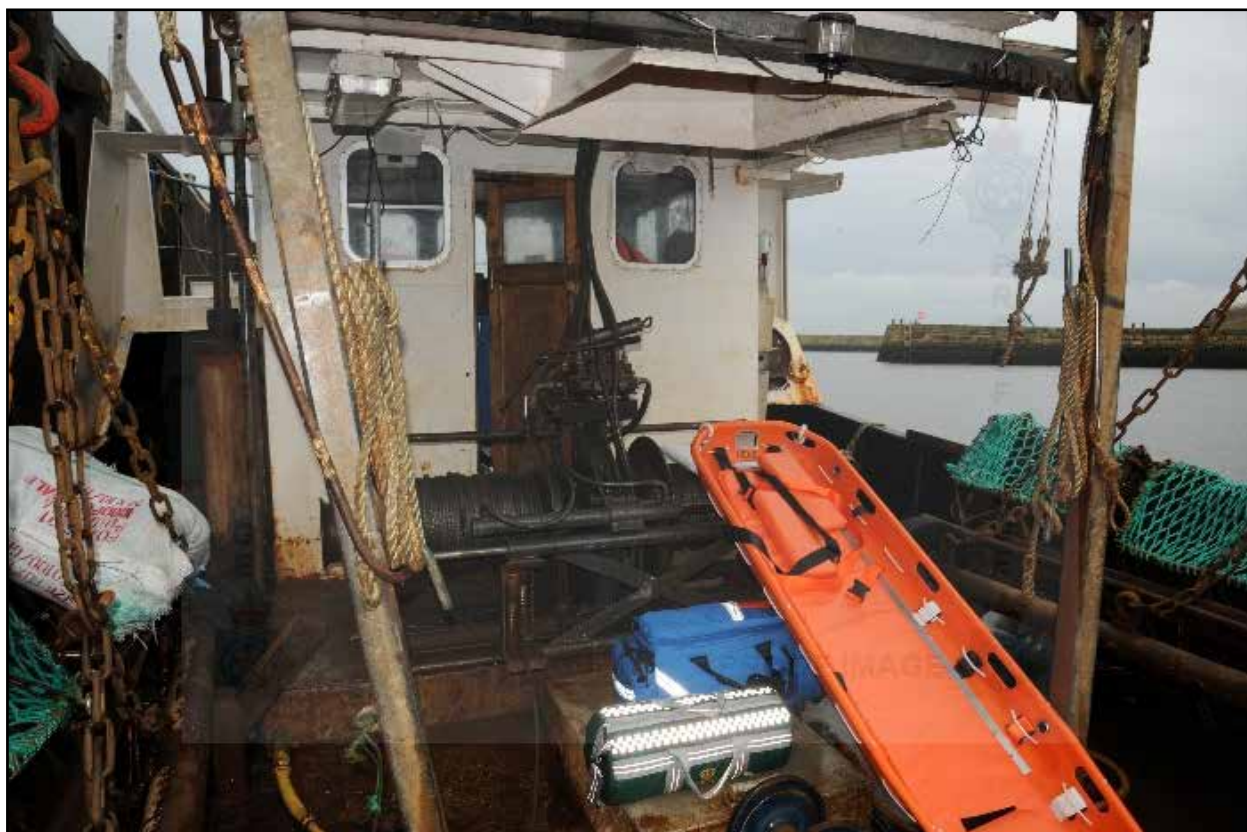
Figure 4: Wheelhouse doorway

Access to *Eshcol*'s wheelhouse was via a door from the working deck (**Figure 4**). The wheelhouse, was above the engine room and contained a liquid petroleum gas (LPG) cooker which housed two hob rings on the top, a grill and an oven. A grill pan and several roasting tins were kept inside the oven space. The cooker was installed in the port aft corner of the wheelhouse, close by the door and next to a sink (**Figure 5**). The cooker was also below a window that could be opened.

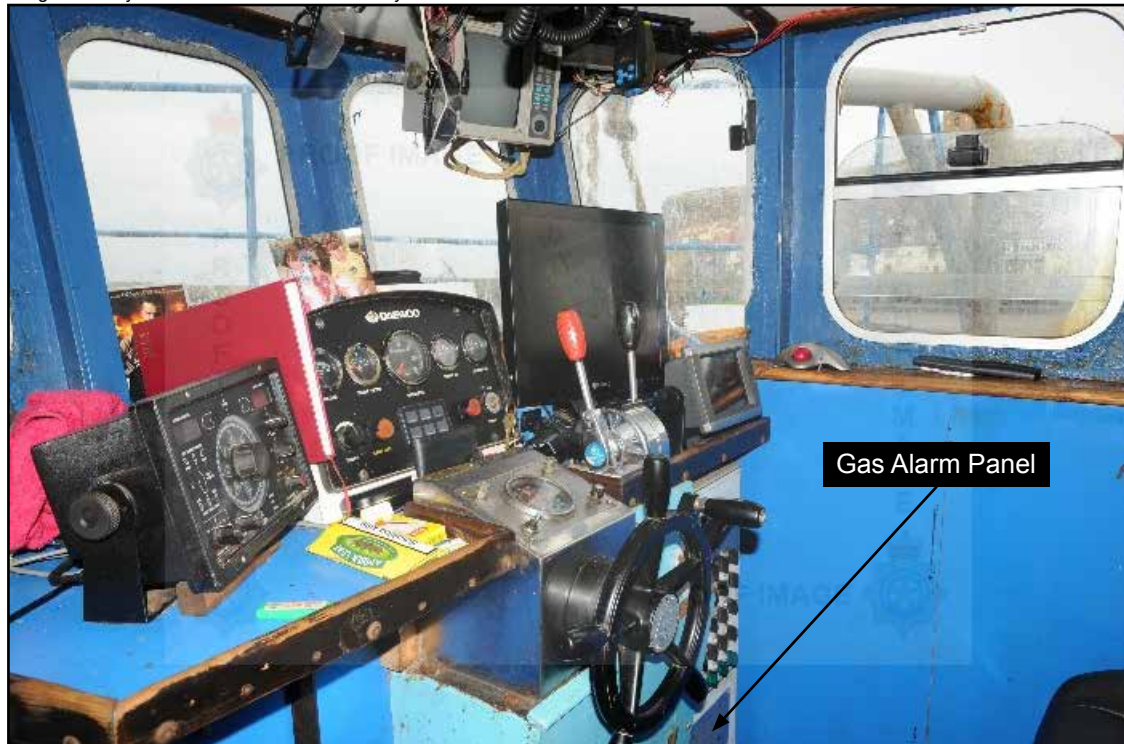
Figure 6: Wheelhouse control console

The helm, engine controls, navigational equipment, fish-finder, electrical distribution panel and gas alarm panel were sited on the starboard forward corner of the wheelhouse (**Figure 6**). A chair by the control console was fixed to the deck. The wheelhouse also contained a television.

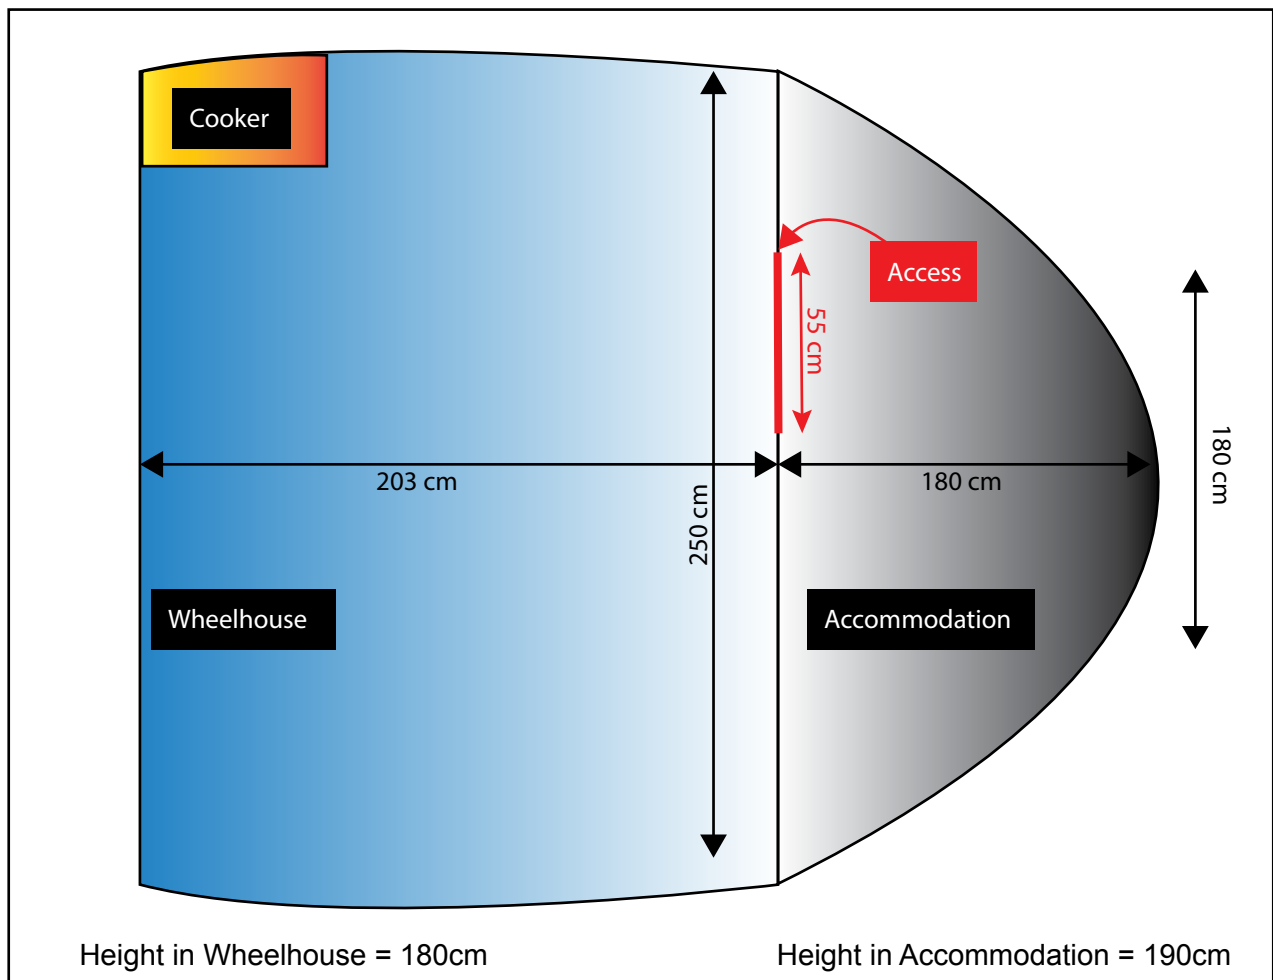
Figure 7: Diagram of wheelhouse and sleeping area

The sleeping area was forward of the wheelhouse (**Figure 7**). Access to the sleeping area from the wheelhouse was via an opening (55cm wide, 90cm high) in the wheelhouse's forward bulkhead (**Figure 8**). The deck of the sleeping area was approximately 50cm below the level of the deck in the wheelhouse.

The volume of the vitiation chamber used for the tests was 17.5m³ whereas the volume of the wheelhouse and sleeping area on board *Eshcol* was approximately 15.3m³ (**Figure 7**). Therefore, even less time would have been required for the concentration of CO to reach these levels on board *Eshcol*²⁰. As the wheelhouse and sleeping area were connected by a large open access (**Figure 8**), they were effectively a single compartment.

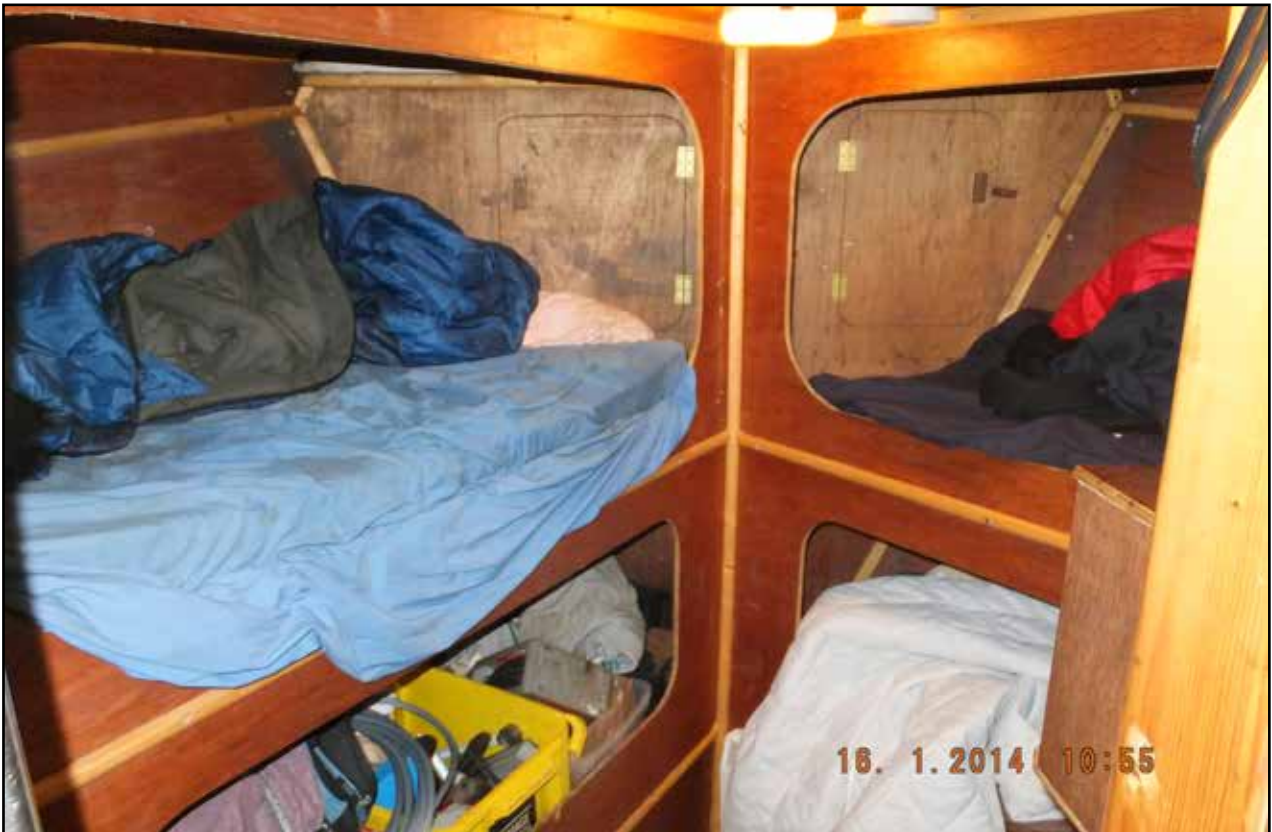
Figure 9: Bunk arrangement

The sleeping area contained two bunks on each side (**Figure 9**). The upper bunks and the lower bunk on the starboard side were used by *Eshcol*'s crew. The port, lower bunk was used for storage (**Figure 10**).

Although *Eshcol* was fitted with four bunks in the sleeping area forward (**Figure 9**) the vessel was not appropriately equipped for crew to live onboard. The sleeping area was cramped and was also used to store equipment. There was no toilet or refrigerator on board, and the crew's only washing facility was the sink in the wheelhouse.

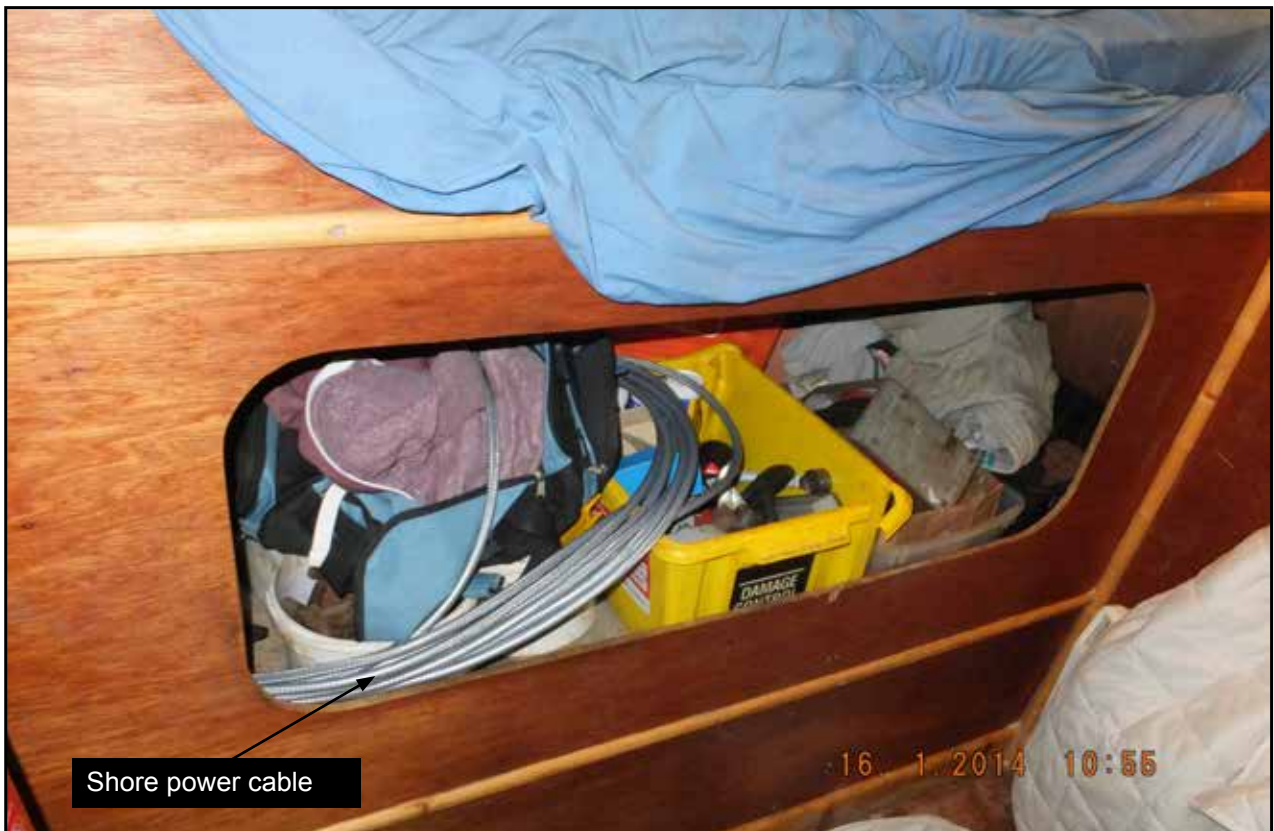
Figure 10: Stores on bunk

The domestic power sockets in the wheelhouse and sleeping area were intended for use with a 240V alternating current (AC) supply. This could be provided from shore via a dedicated power cable or by the vessel's generator. The generator supplied 240V direct current (DC) that was converted to AC by an inverter. The shore power cable was stored on the lower bunk on the port side (**Figure 10**).

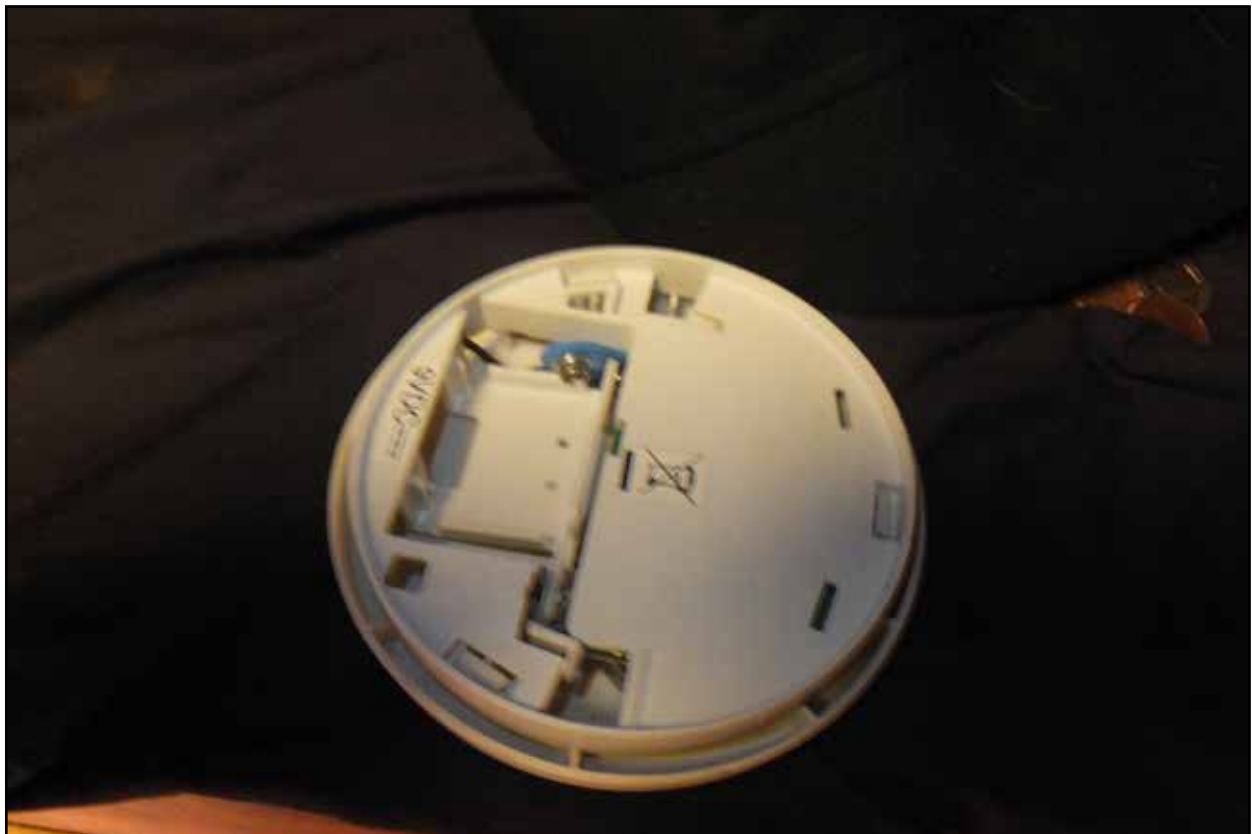
Figure 16: Smoke detector in sleeping area

- The battery had been removed from the smoke detector fitted in the sleeping area (**Figure 16**). Although this might have been because the battery needed to be replaced, it is also possible that it was done to prevent the sensor from alarming due to cigarette smoke. In any event, the detector was rendered useless.

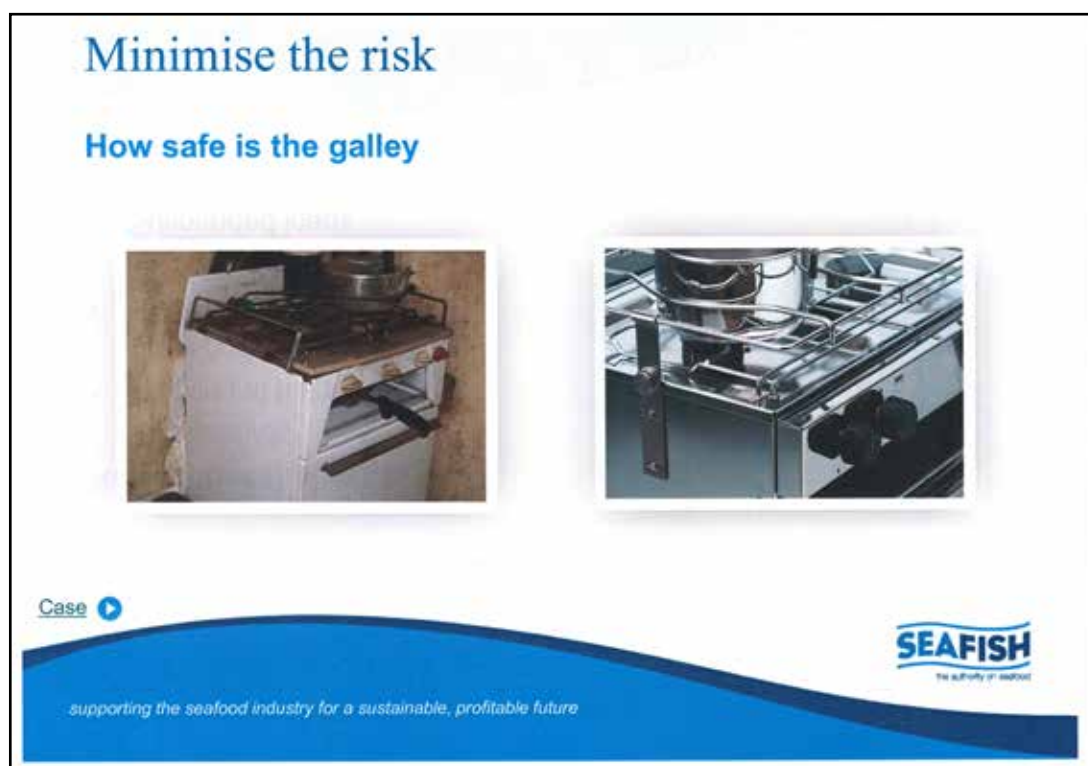
Figure 17: Presentation slide from the Seafish health and safety course

In support of each of the mandatory courses, Seafish issues a digital presentation to its trainers. The presentation for the health and safety course includes a slide on 'How Safe is the galley' (**Figure 17**), but the course does not specifically cover the risks of using gas or other fossil-burning fuels on board. The presentation for the safety awareness course includes slides covering 'working below deck' which prompt instructors to refer to the guidance regarding the dangers of CO poisoning. However, the presentation does not specifically cover the risk of CO poisoning from domestic appliances.

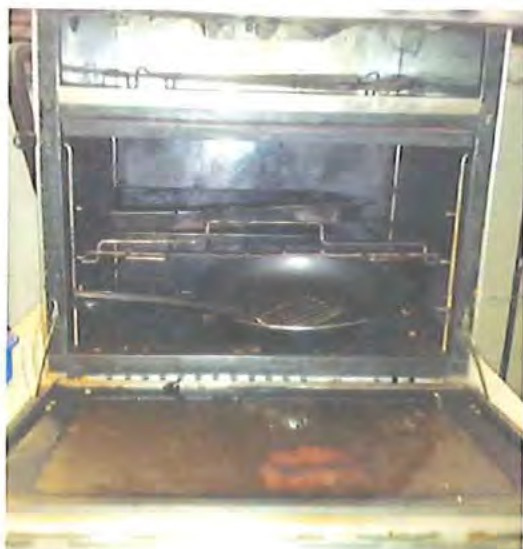
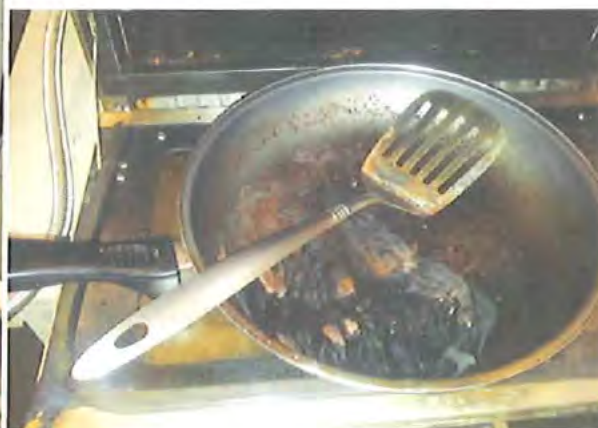
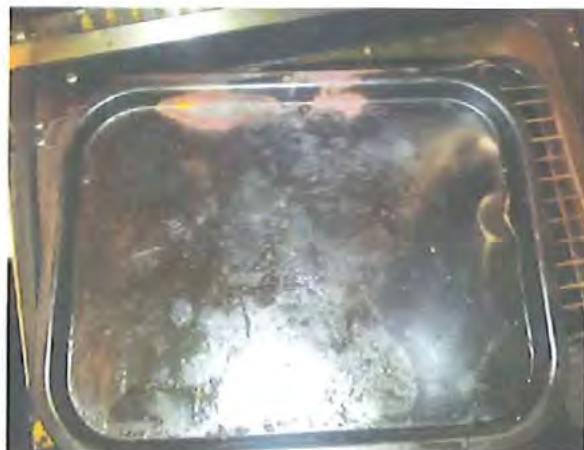
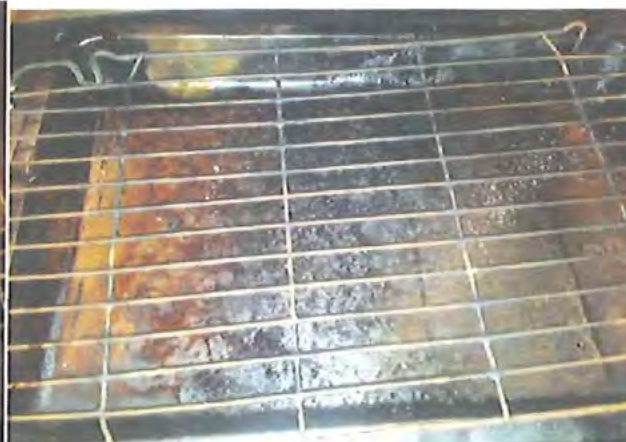
The grill pan and a frying pan were within the oven cavity. It is possible that the frying pan was used under the grill. The photographs shows that the grill pan and grill tray have not been used, however; there is some oil residue in the frying pan which suggests it had been used. Could have been used either under the grill or on the hobs,

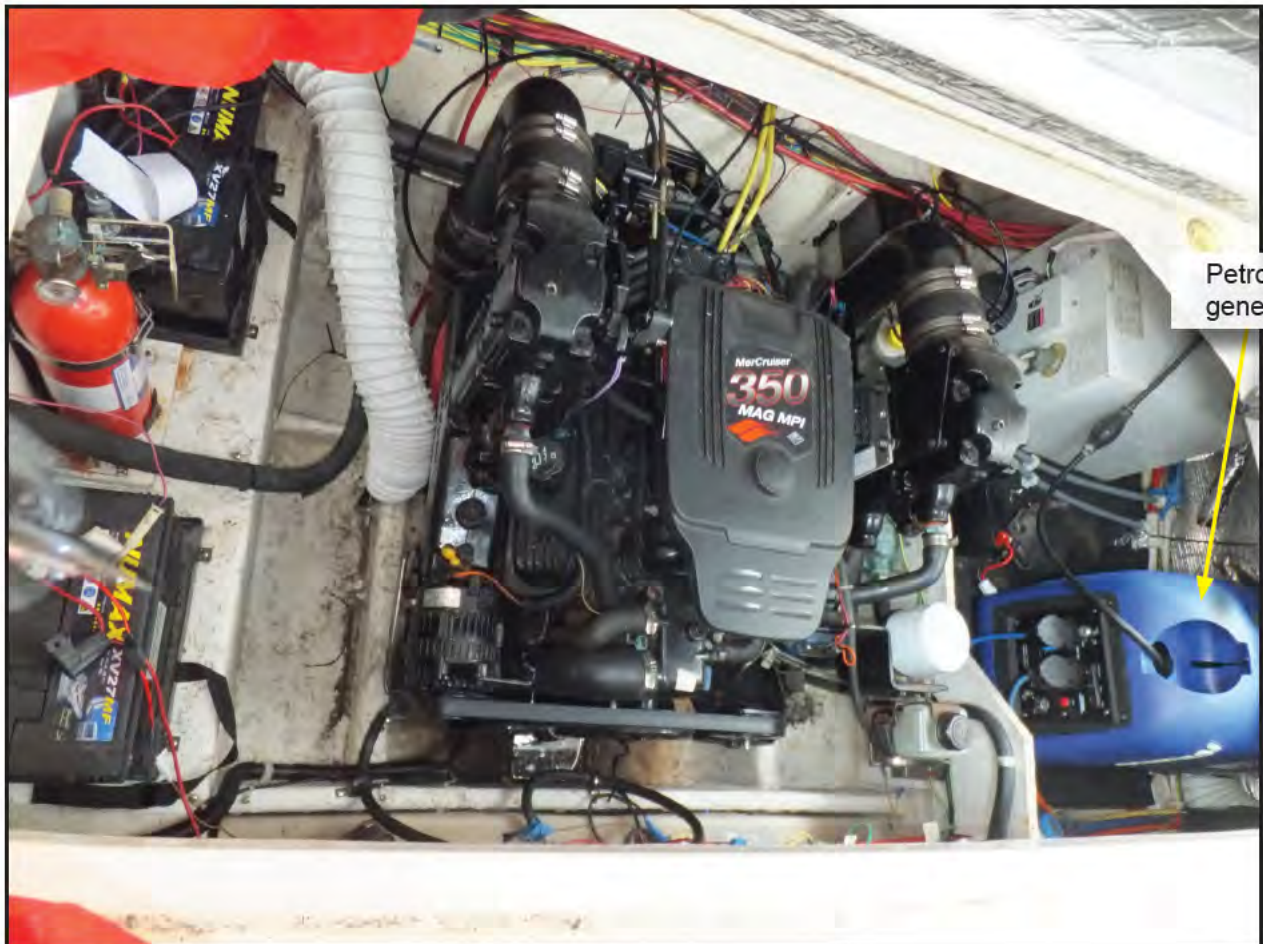
Figure 1

A “suitcase” type portable petrol-driven generator (**Figure 1**) had been installed in the motor cruiser’s engine bay to supply the boat with 240v power. The generator had been fitted with an improvised exhaust and silencer system which had become detached from both the generator and the outlet on the vessel’s side (**Figures 2 and 3**). As a result, the generator’s exhaust fumes filled the engine bay and spread through gaps in an internal bulkhead into the aft cabin where the mother and daughter were asleep. When the owner of the boat awoke in the boat’s forward cabin, he was suffering from carbon monoxide poisoning but was able to raise the alarm. The mother and daughter could not be revived.

The boat’s carbon monoxide sensor system did not alarm because it was not connected to a power supply.

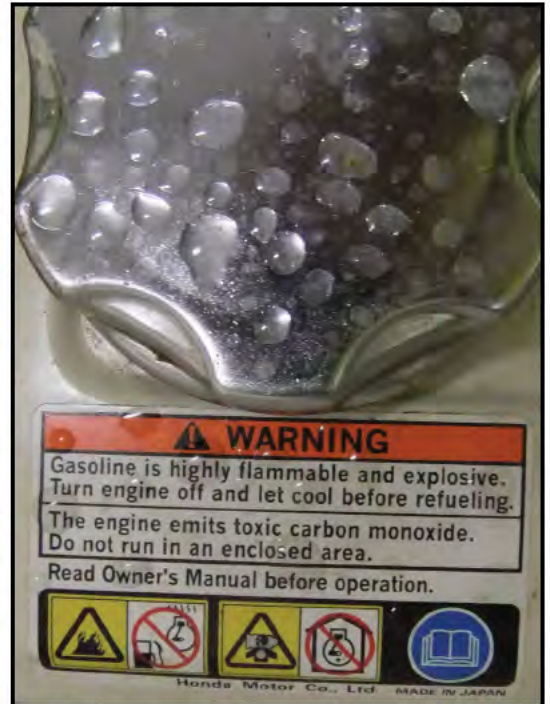
Figure 2: Warning notice on pump

The fish hold had no forced ventilation system and the hatches, except for a small access hatch, were closed. The pump was labelled 'The engine emits toxic carbon monoxide. Do not use in an enclosed space' (**Figure 2**).

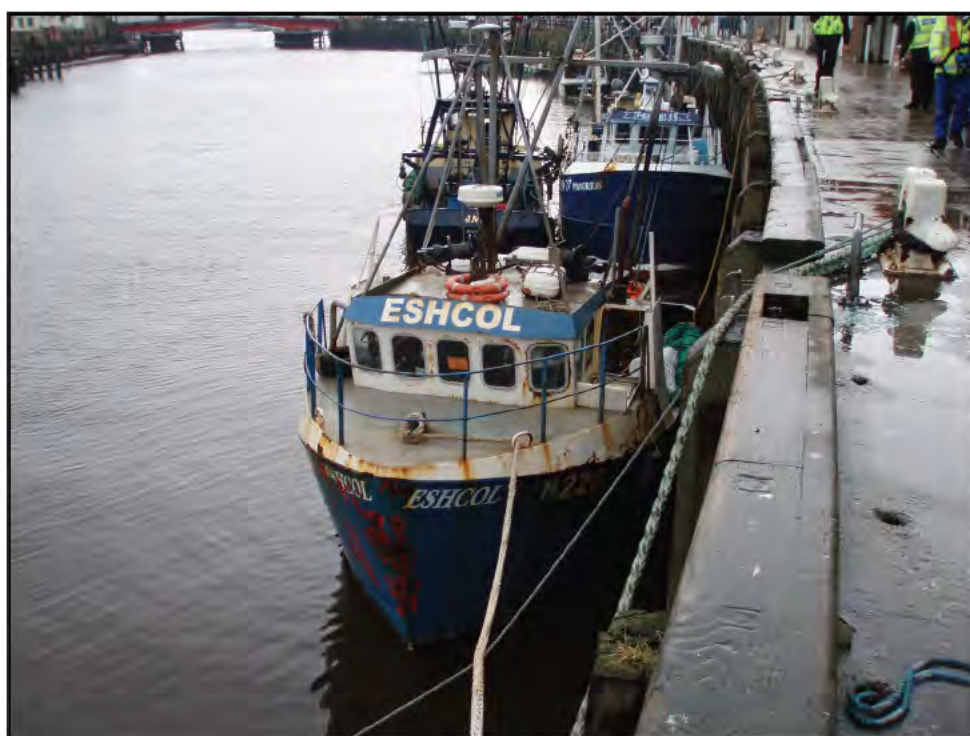
Carbon monoxide poisoning on board the scallop-dredger *ESHCOL* in Whitby, North Yorkshire on 15 January 2014 resulting in two fatalities

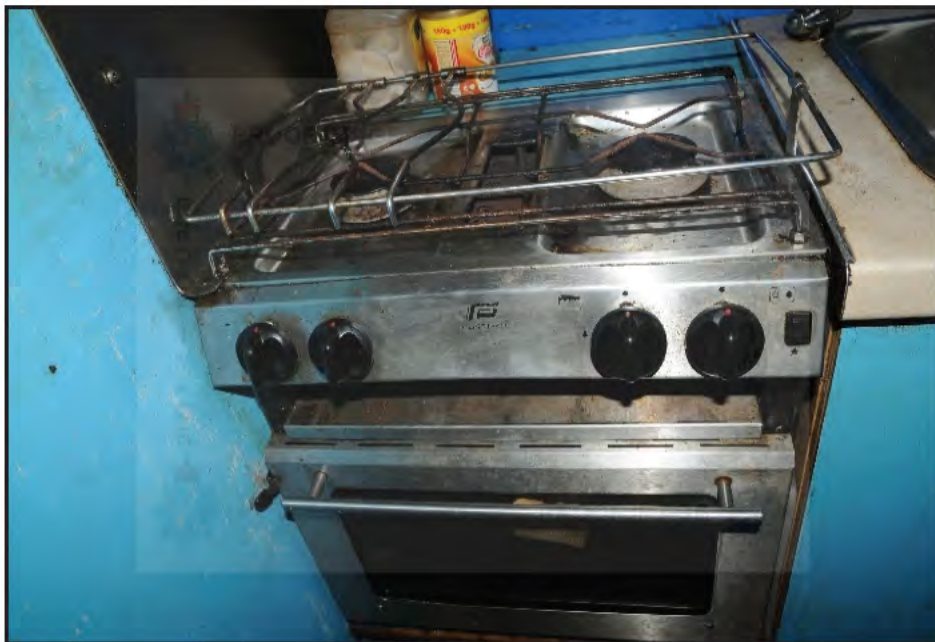
Figure 1

Before going to bed, the skipper (aged 26) and the crewman (aged 21) had lit the grill of a butane gas cooker fitted in the wheelhouse (**Figure 1**) in order to warm both the wheelhouse and the adjacent sleeping area. When they were not seen as expected the following morning, crewmen from fishing vessels tied up close by forced open the wheelhouse door. The gas grill was still lit (**Figure 2**) and the wheelhouse was full of fumes; the two men were dead in their bunks.

Eshcol was not fitted with a carbon monoxide alarm.
