Report on the investigation of the collision of

Rickmers Dubai

with the crane barge

Walcon Wizard

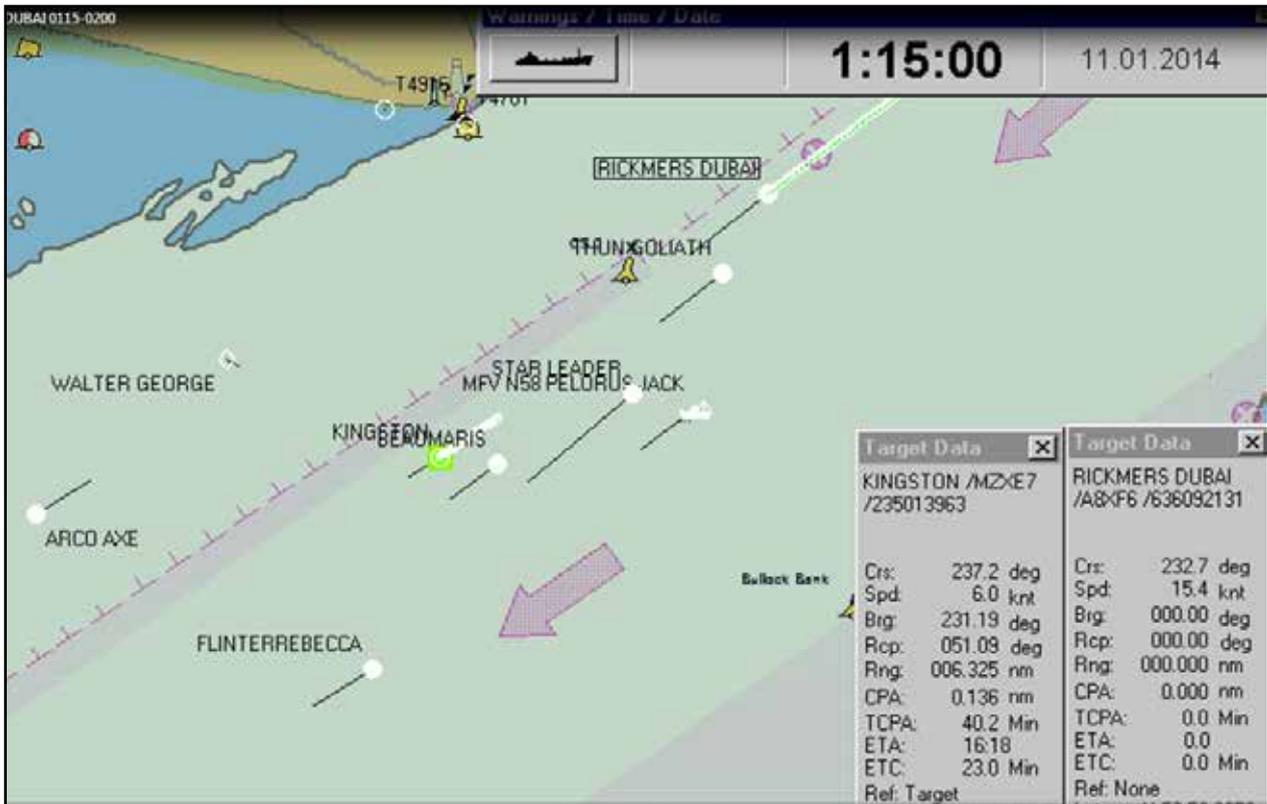
Figure 1: CNIS display at 0115

At 0115¹ on 11 January 2014, the multi-purpose cargo ship *Rickmers Dubai* was transiting the south-west lane of the Dover Strait Traffic Separation Scheme (TSS). The vessel was on passage from Hamburg, Germany, to Genoa, Italy, with cargo in its hold and on deck. *Rickmers Dubai* was making good a course over the ground (COG) of 233° at a speed over the ground (SOG) of 15.4 knots (kts) (**Figure 1**).

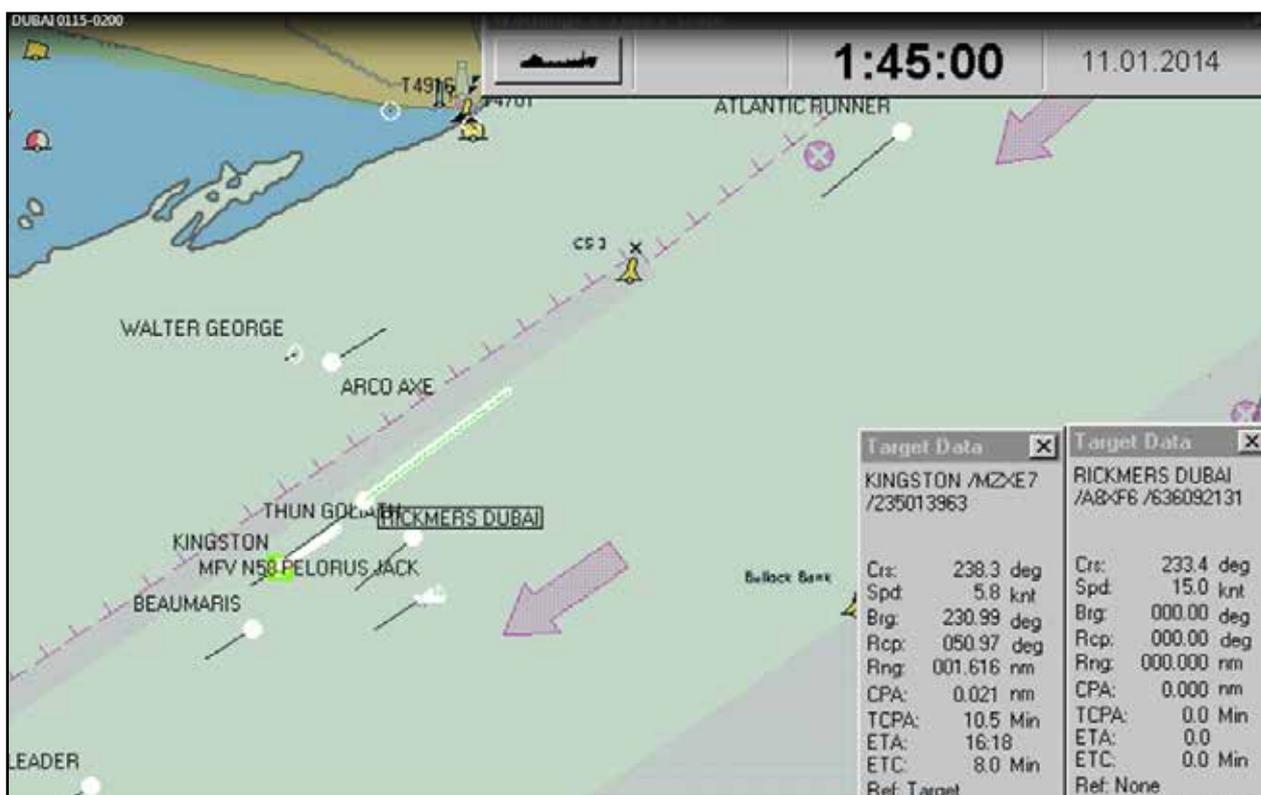
Figure 2: CNIS display at 0145

At 0145, the distance between *Rickmers Dubai* and *Kingston* had reduced to 1.6nm and the CPA of the vessels was 40m (**Figure 2**). At about this time, *Kingston*'s wheelhouse watchkeeper became aware of the cargo ship approaching on the tug's starboard quarter. He assessed that, although the cargo ship was close, it would pass clear down the starboard side of *Walcon Wizard* and *Kingston*. The watchkeeper noticed that the automatic identification system (AIS) data included the

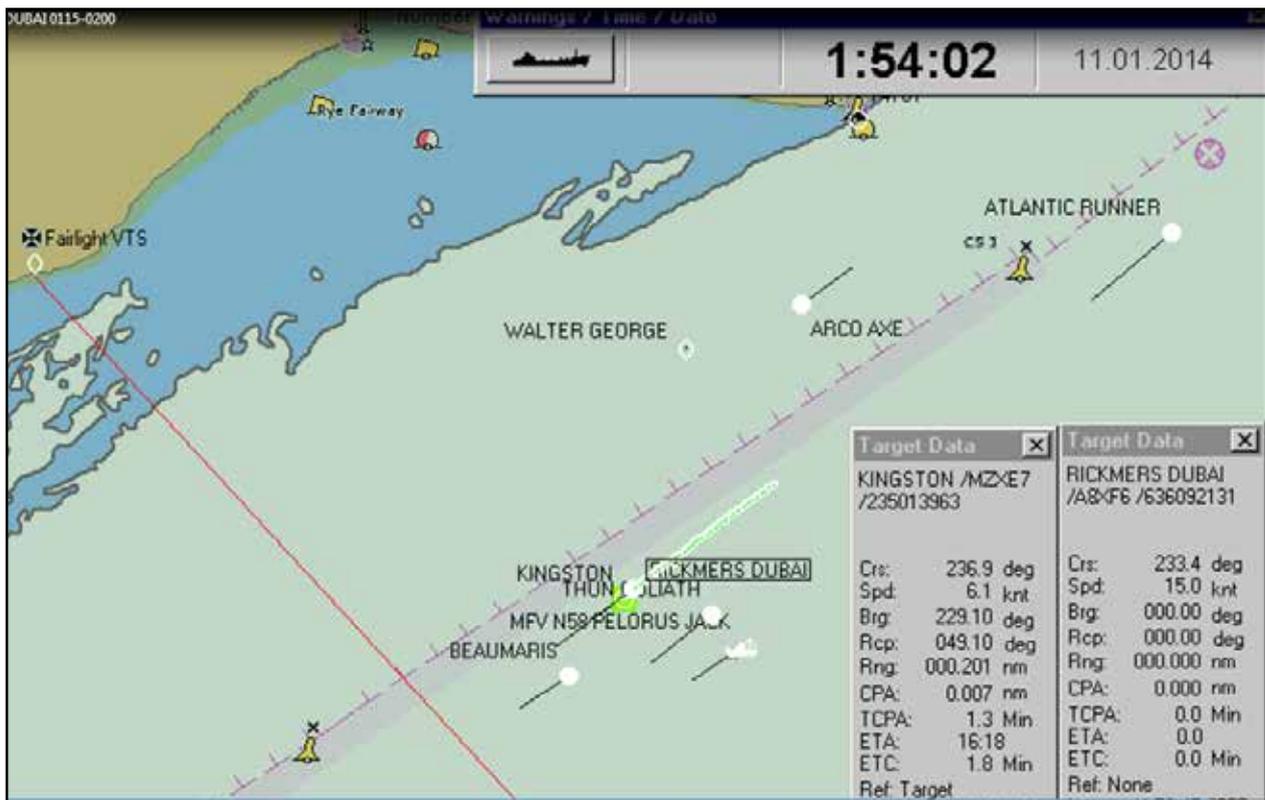
Figure 3: CNIS display at 0154

Shortly after, *Rickmers Dubai's* second officer, who was the officer of the watch (OOW), saw *Kingston's* lights very fine off the cargo ship's port bow. At 0154, he adjusted the autopilot to port in order to overtake the tug on its port side (Figure 3). Seconds later, *Rickmers Dubai* collided with *Walcon Wizard*. It then passed between the crane barge and the tug, catching on the towline as it did so.

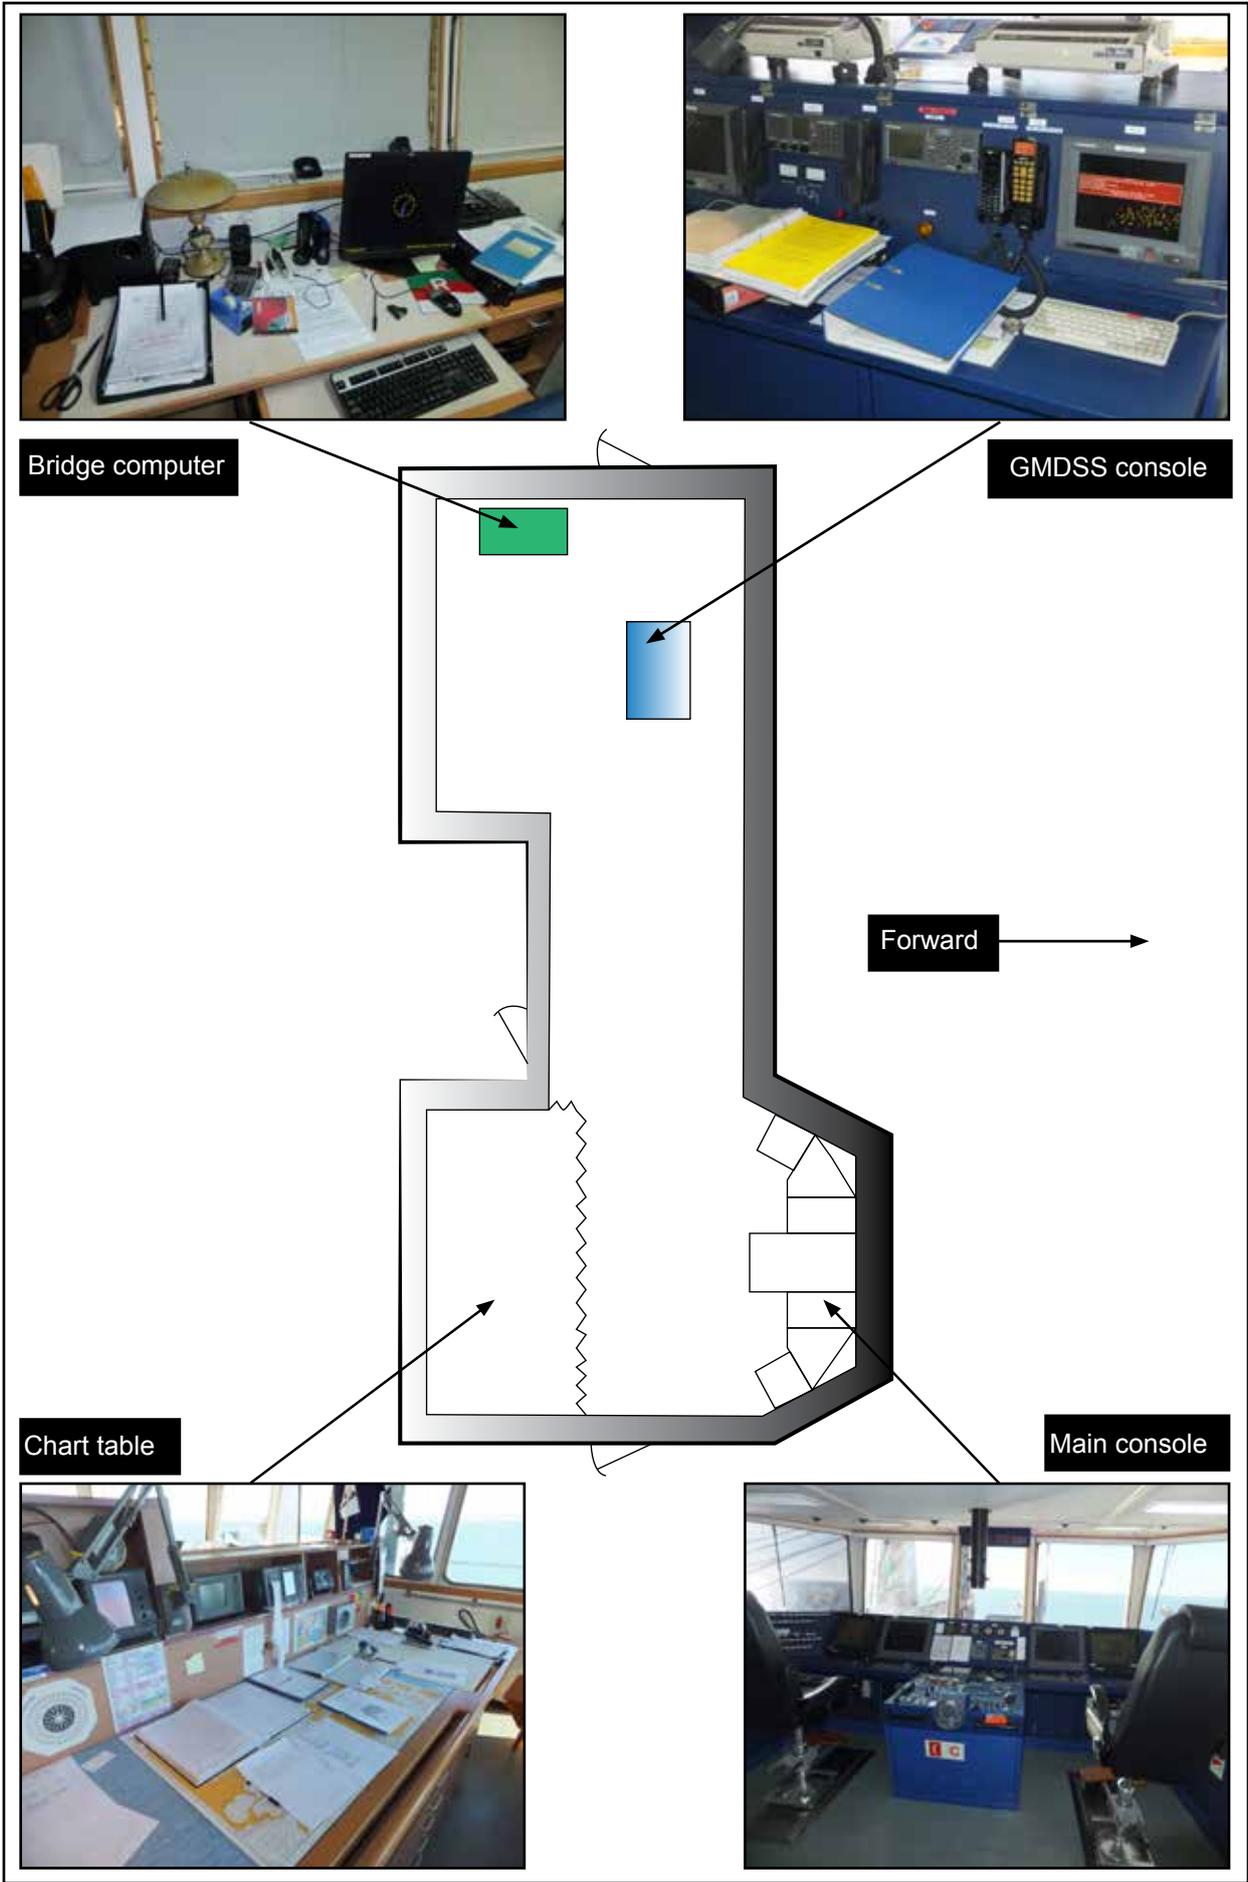
Figure 7: Rickmer's Dubai - bridge layout

The main navigation and control console on *Rickmers Dubai*'s bridge was offset to starboard (**Figure 7**) to improve the view ahead, which was partially obscured by deck cranes on the vessel's port side (**Figure 8**). The console had navigation stations at each end, which were fitted with ECDIS and radar displays. The vessel's primary means of navigation was ECDIS and no paper charts were carried.

- Recorded music was being played throughout on the computer sited on the port side of the bridge (**Figure 7**).

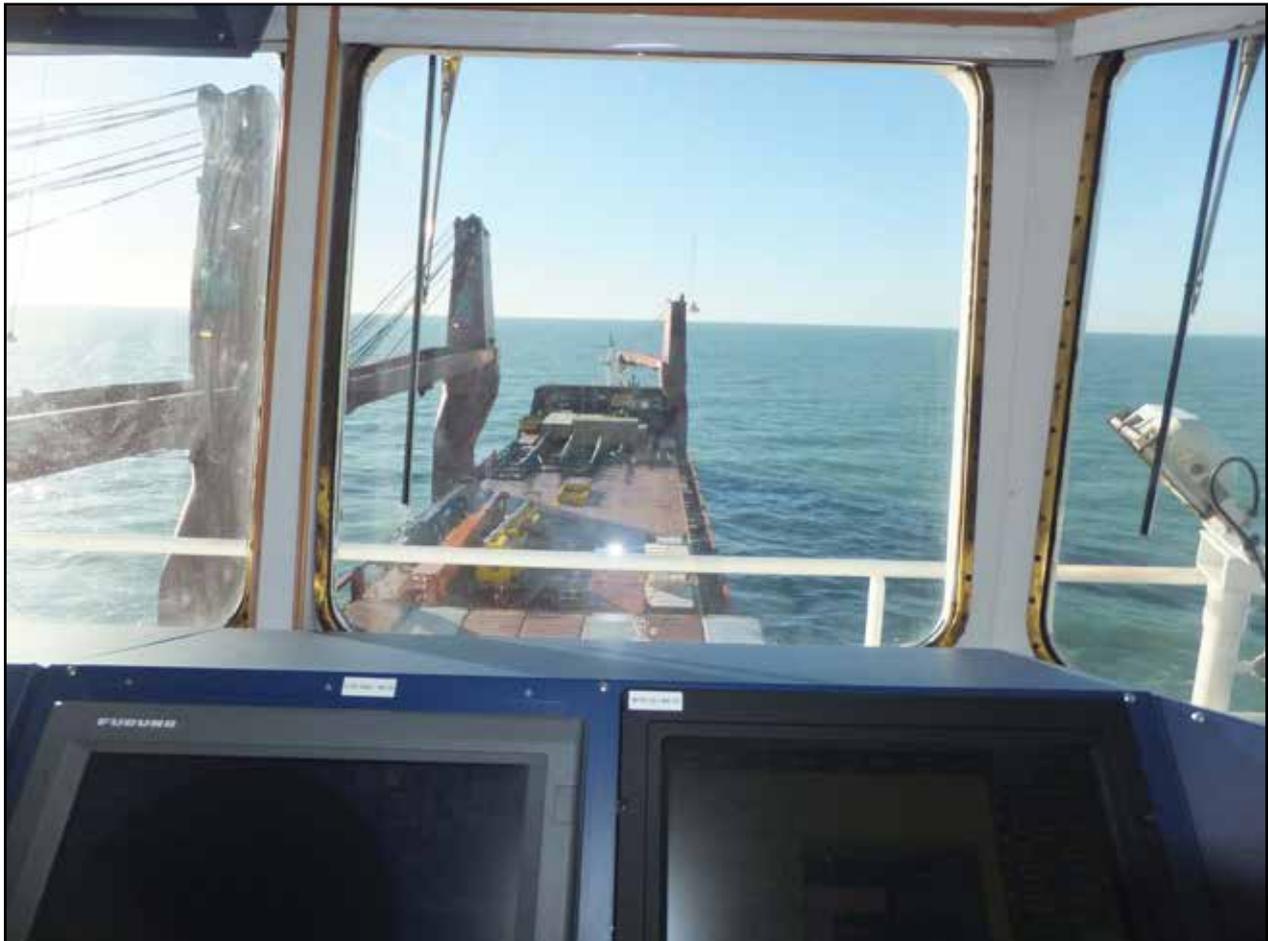
Figure 8: *Rickmer's Dubai* - view ahead from navigation console

Before the collision, the radar targets associated with *Kingston* and *Walcon Wizard* were clearly painting on the X-band radar display on *Rickmers Dubai*'s bridge for nearly 55 minutes (**Figure 9**). Also, as the cargo ship was closing the tug and tow with a speed advantage of approximately 9kts (**Figures 1, 2 and 3**), and the range of the lights fitted on board *Walcon Wizard* was 3nm, the aft lights on the tow would have been visible from *Rickmers Dubai* for at least 20 minutes before the collision. Therefore, *Rickmers Dubai*'s OOW had ample time to detect, assess and take avoiding action. However, it is evident from his alteration to port when only 2 cables from the tug, and his failure to see *Walcon Wizard* at all, that the OOW had not been keeping a proper lookout and had only seen the tug just before he altered. Although at the time of the alteration the barge's lights were possibly obscured by the port side deck cranes (**Figure 8**), they would have been clearly visible beforehand despite the moderate to rough seas.

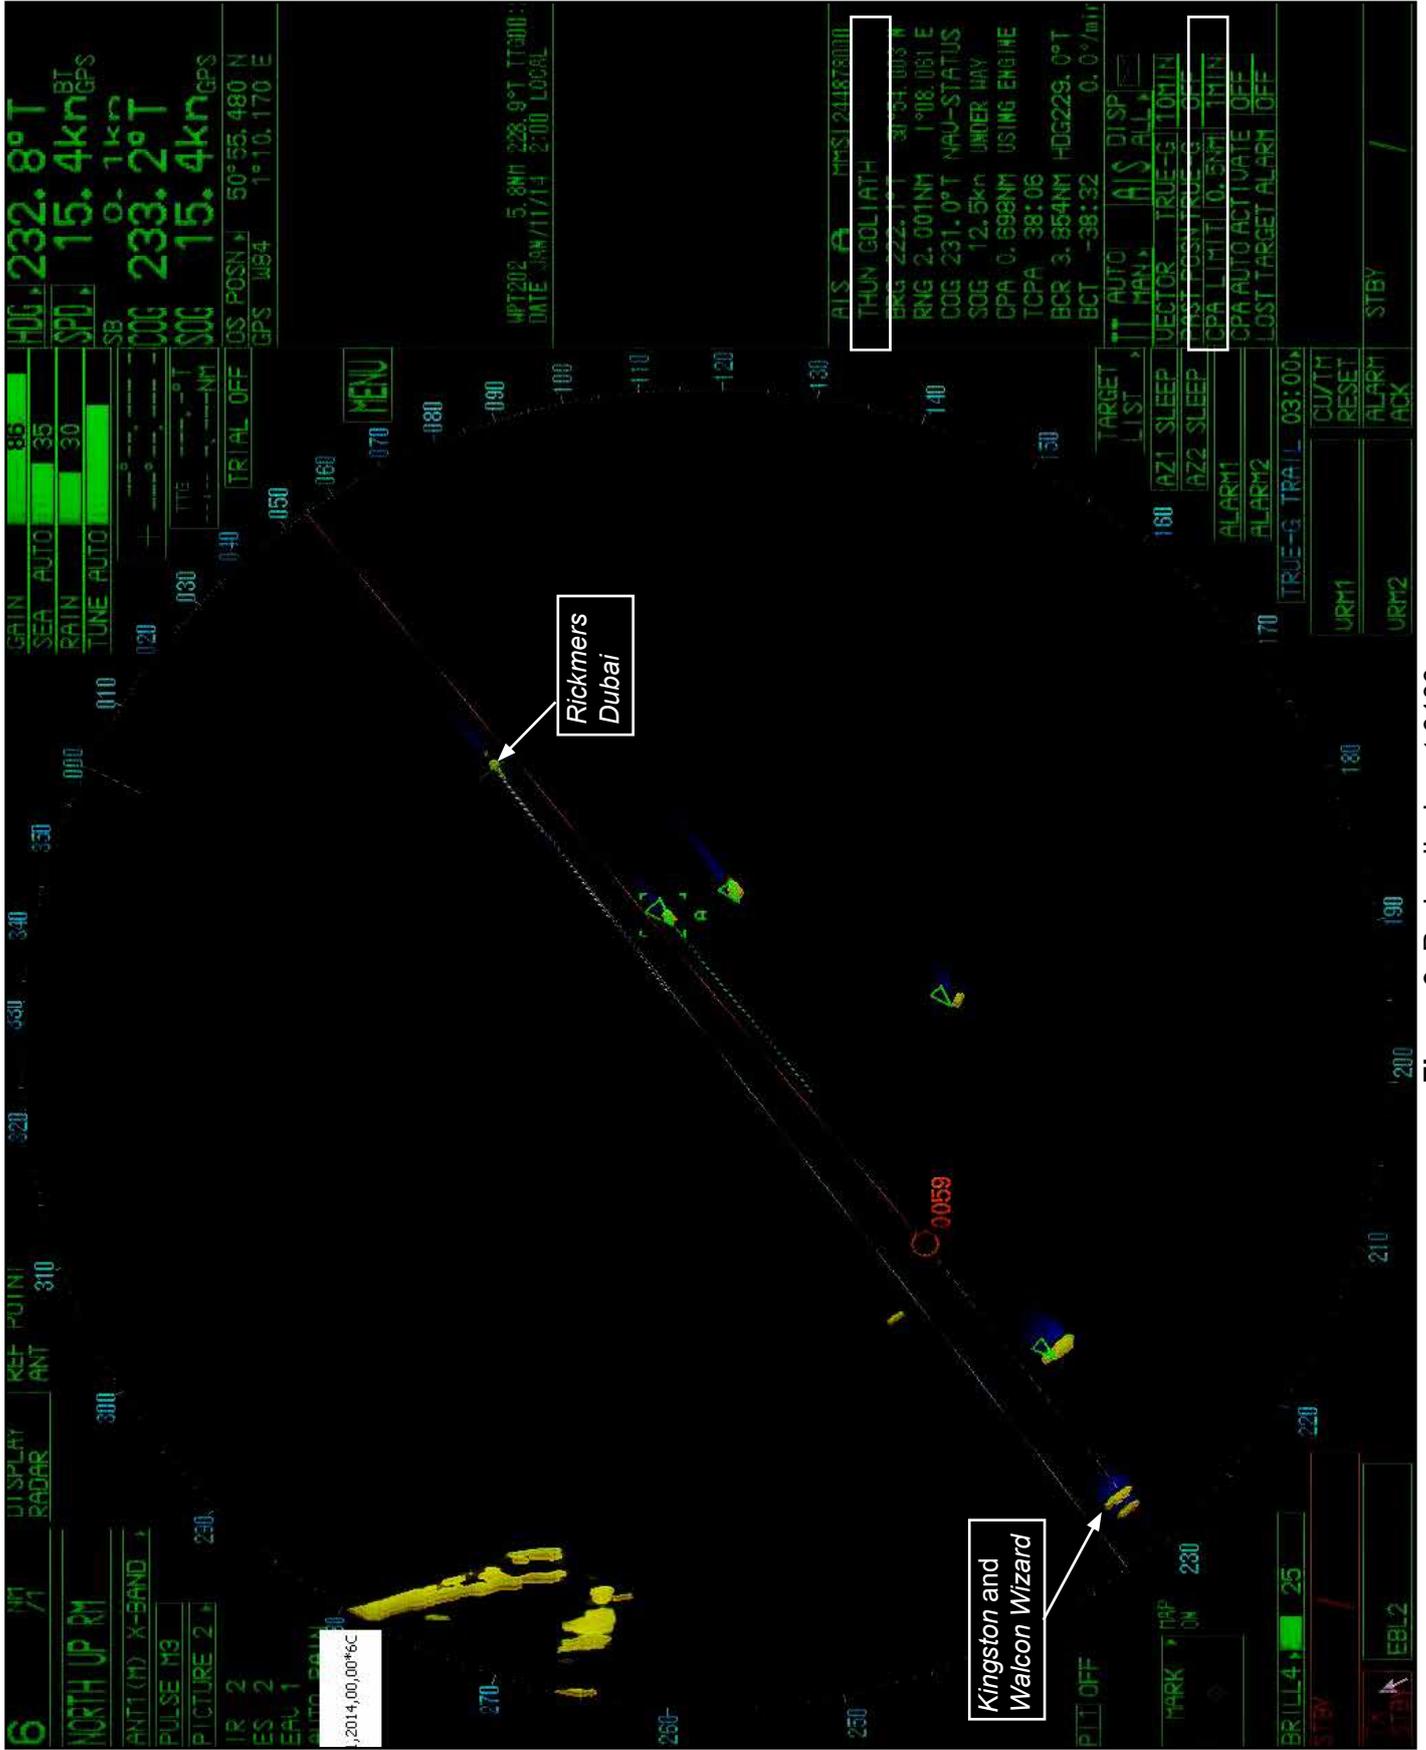
Figure 9: Radar display at 0100

- The X-band radar display was set to the 6nm range scale and the origin was offset to the north east in order to extend the view ahead. By 0100, the radar targets of both *Kingston* and *Walcon Wizard* were visible at a range of 10nm (**Figure 9**).

- The radar targets associated with *Kingston* and *Walcon Wizard* merged between 0147 and 0150 when at a range of about 1nm (**Figure 10**).
- A radar alarm of 5 cables/1 minute was set on the ARPA for operator selected targets only (**Figures 9 and 10**).

- *Thun Goliath* was the only AIS target selected after midnight (**Figures 9 and 10**).
- No radar targets were acquired using ARPA.
- The vessel had been on a steady course and speed since 0100 and was approximately 3 cables to the north of its intended track.

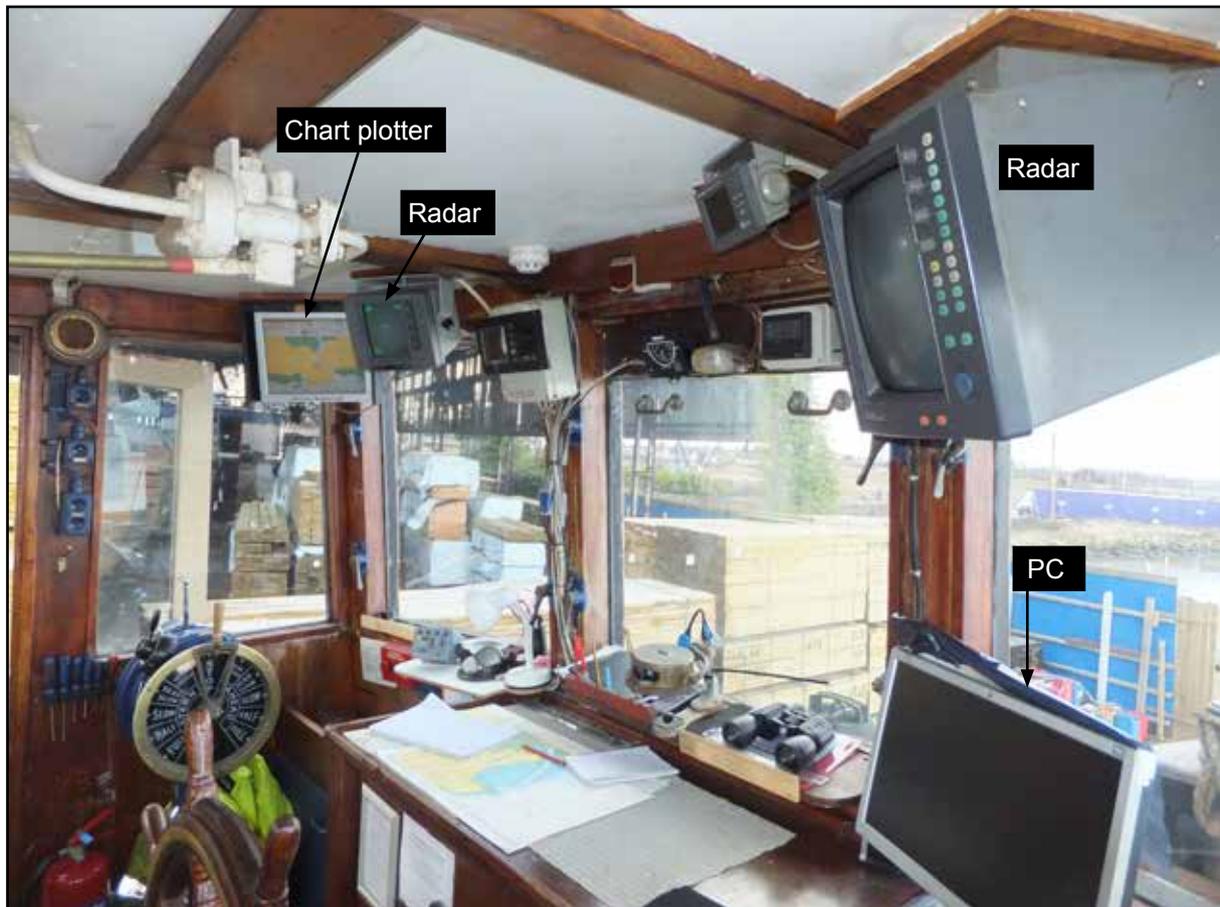
Figure 11: *Kingston* - wheelhouse

Kingston's wheelhouse was small, with one seat positioned on the centreline. Navigation equipment (**Figure 11**) included:

The master had installed his own personal computer in the wheelhouse, which contained an electronic chart system showing AIS information; the AIS receiver's antenna was temporarily positioned on the wheelhouse roof. *Kingston* was not fitted with an AIS transmitter.

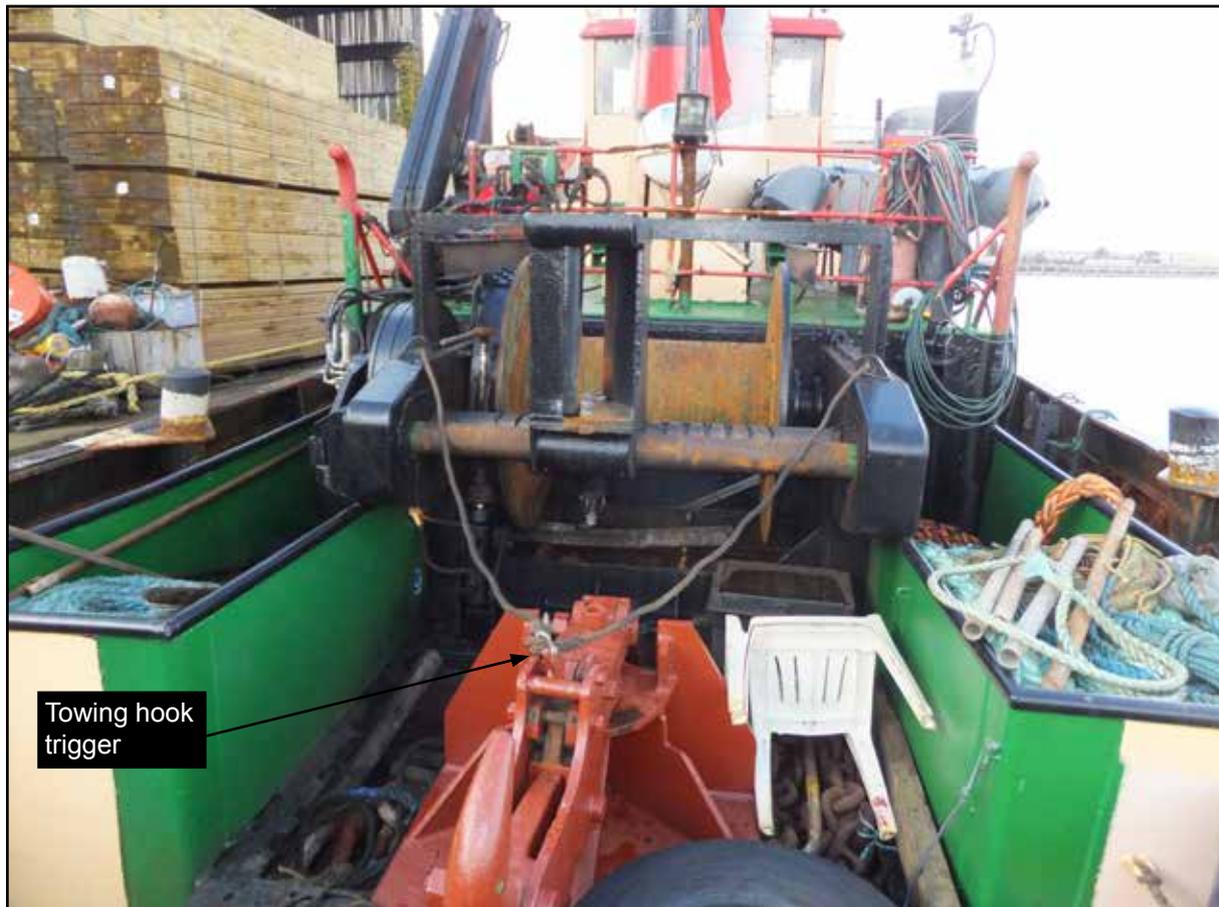
Figure 12: *Kingston* - towing hook release arrangement

At build, *Kingston* was fitted with a towing hook, but when the towing winch was fitted, the towing hook was re-sited further aft. The towing hook was able to be released by a trigger that could be activated by attached ropes that were led to positions just aft of the wheelhouse on the port and starboard sides (**Figure 12**).

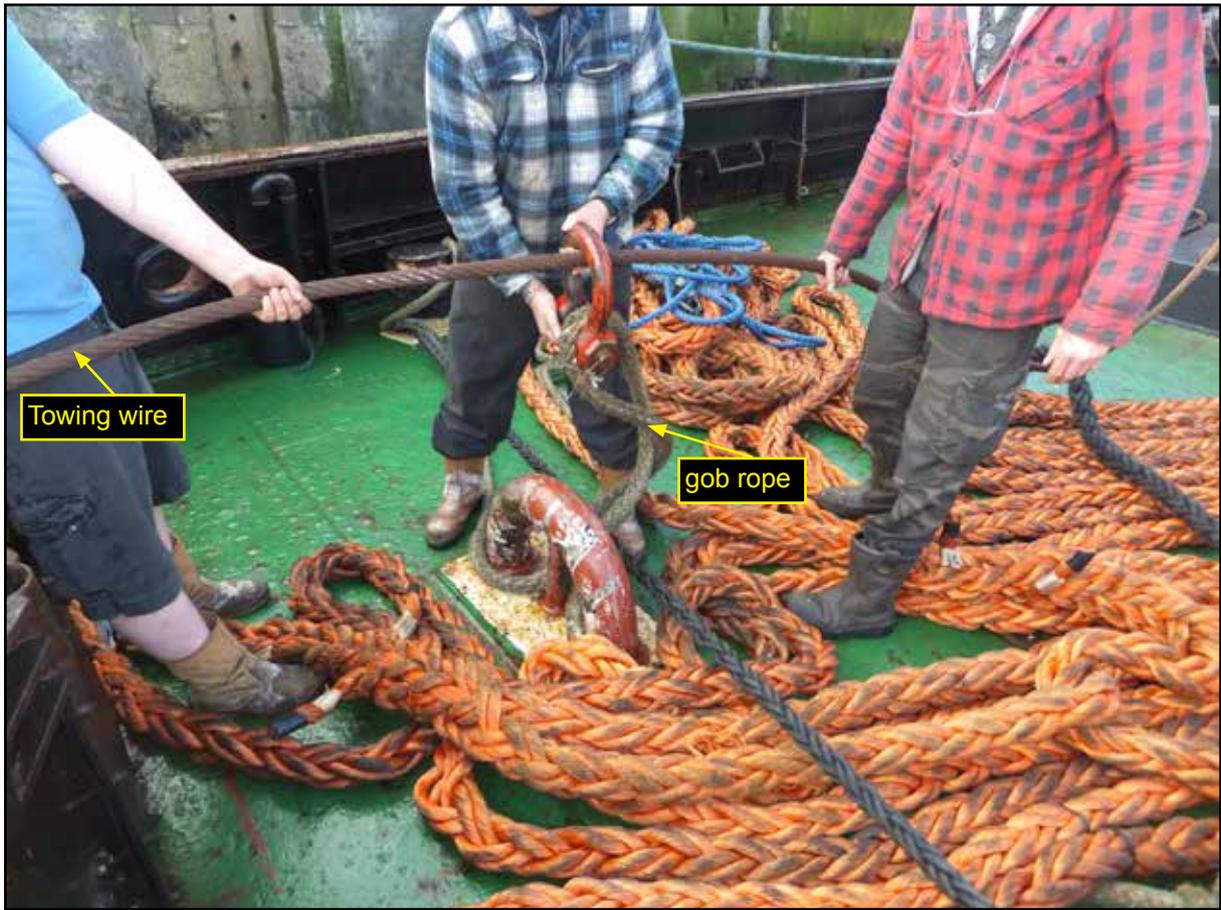
Figure 13: Kingston - gob rope arrangement

For the passage from Ipswich to Southampton, the towline was secured to *Kingston's* towing winch. This was usual practice when towing on passage where a longer tow was required. The towline was passed from the tow winch through a gob arrangement at the aft end of the deck. The gob arrangement consisted of a gob shackle and a gob rope³ secured to bollards either side of the aft deck via a fairlead welded to the deck on the centreline (**Figure 13**). A protective sleeve was fitted over the towline immediately aft of the gob shackle in order to prevent the wire from chafing on the aft deck. There was no formal record of inspection or certification for the gob rope.

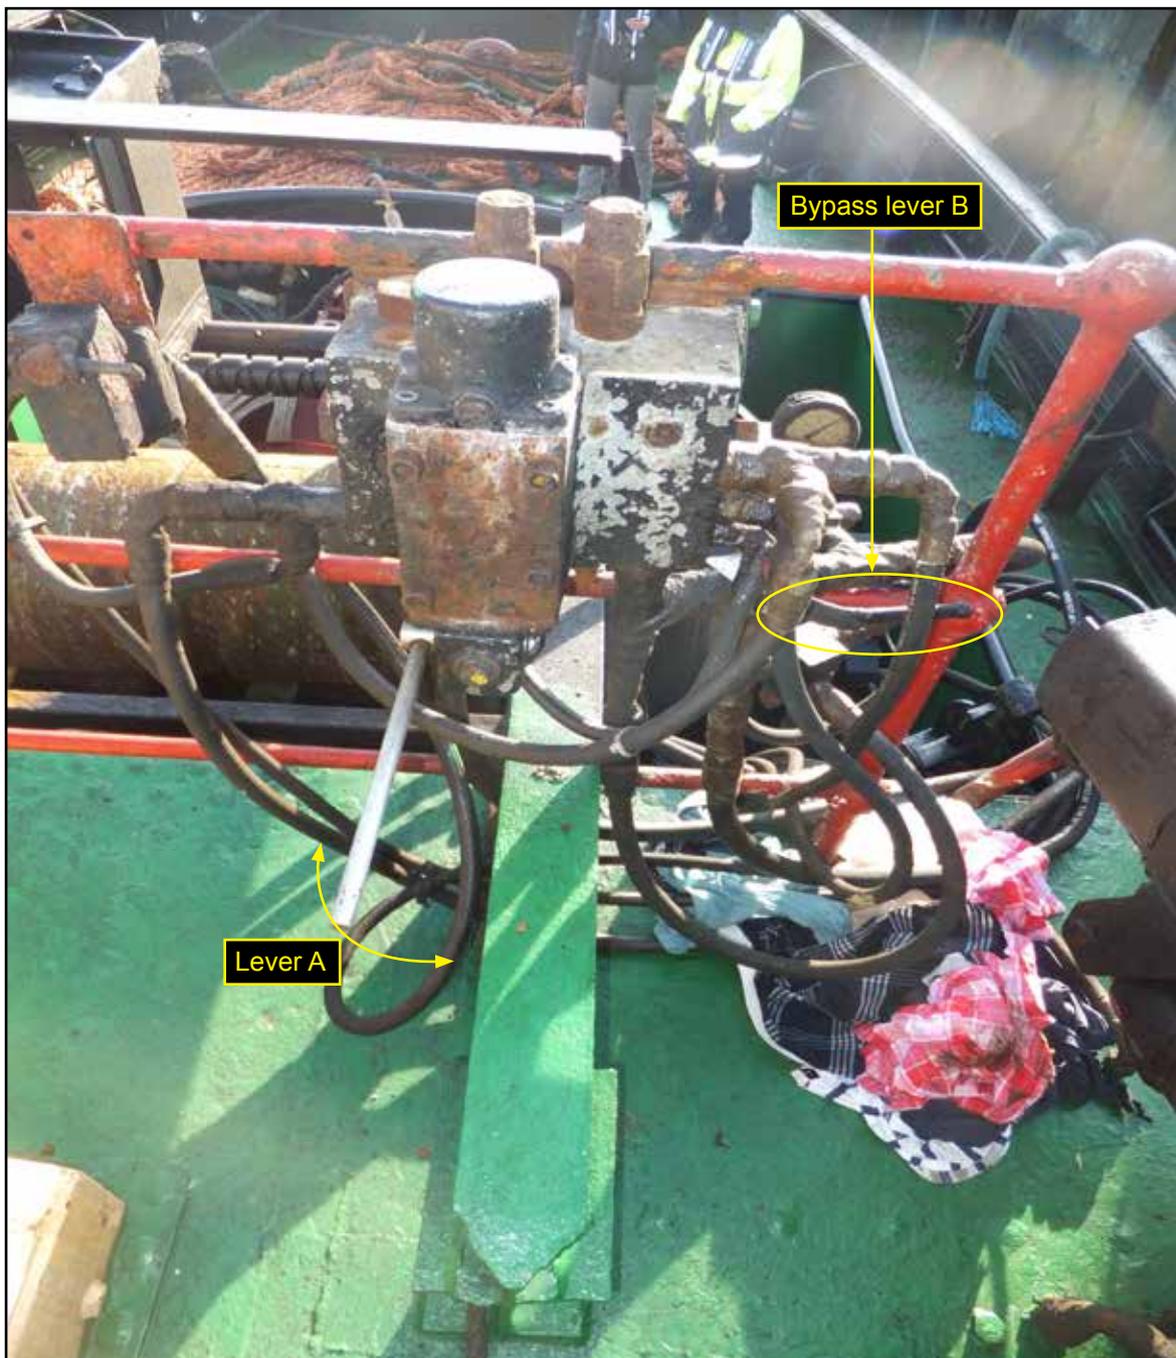
Figure 15: *Kingston* - towing winch hydraulic controls

The towing winch was controlled from the aft end of the working deck (**Figure 15**). With the spring-loaded lever (A):

To release the tow in an emergency, the instructions were to lift the bypass lever and then manually loosen the brake in a clockwise direction until the wire veered. The instructions noted the emergency procedure could be followed without the hydraulics being switched on, but that about £10,000 of damage to the winch could result.

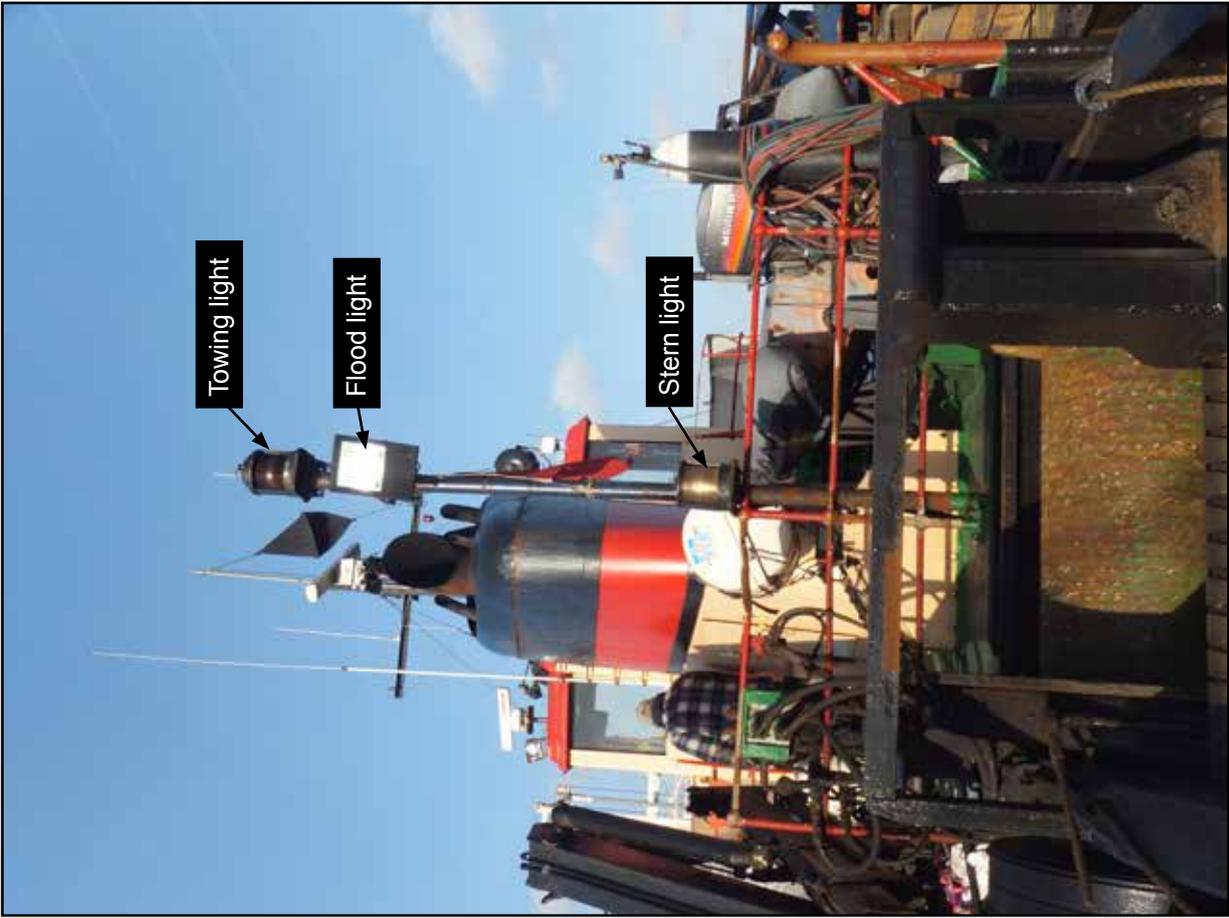
Figure 16: Kingston - lights aft

At the time of the accident, *Kingston* was displaying side lights, three masthead lights in a vertical line, a stern light and a towing light above the stern light (**Figure 16**). A flood light, shining aft, also illuminated the towline.

When *Rickmers Dubai*'s OOW saw *Kingston*'s lights ahead, it is evident that he did not associate the tug's lights with a vessel engaged in towing. This was possibly because although *Kingston* was showing a towing light above its stern light, these lights were potentially difficult to see due to the glare from the floodlight sited between them (Figure 16). In addition, the three masthead lights indicating a tow over 200m in length would not have been visible from astern⁹. Consequently, as the tug was also not displaying lights to indicate that it was restricted in its ability to manoeuvre, and the OOW did not see *Walcon Wizard*, his avoiding action was based on his assumption that *Rickmers Dubai* was overtaking a single vessel, not a tug and its tow.
