Capsize and foundering of the beam trawler *SALLY JANE* Christchurch Bay 17 September 2013

SUMMARY

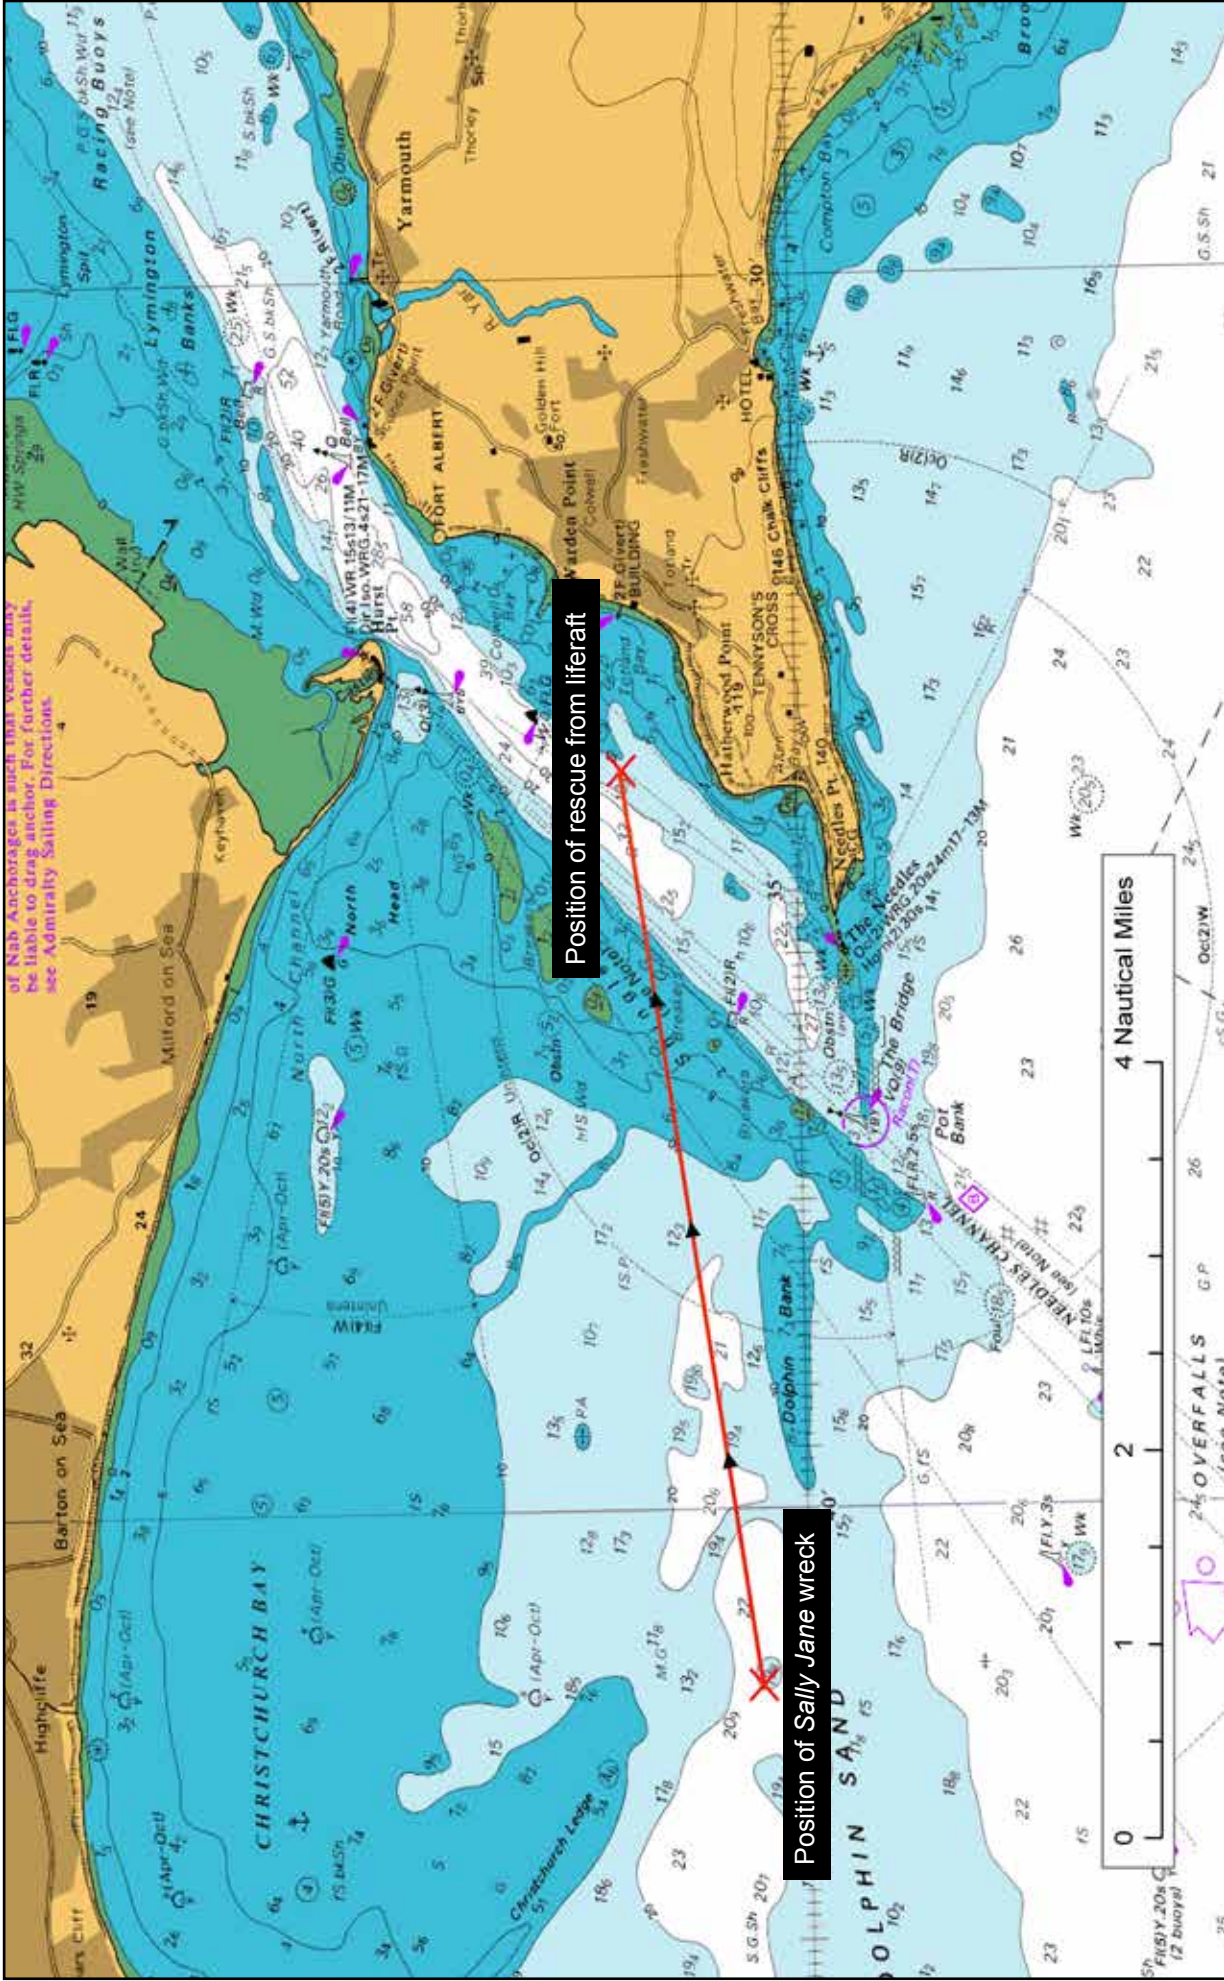
The skipper was dressed only in his boxer shorts and the mate in light clothing. They soon became cold and huddled together to keep warm. The liferaft continued to drift to the east over the Shingles bank. *Sally Jane*'s bow remained visible above the sea surface for a short period but the vessel eventually foundered. Diesel fuel oil was later seen in the vicinity.

Figure 1: Extract of chart BA 2045 showing direction of drift of liferaft

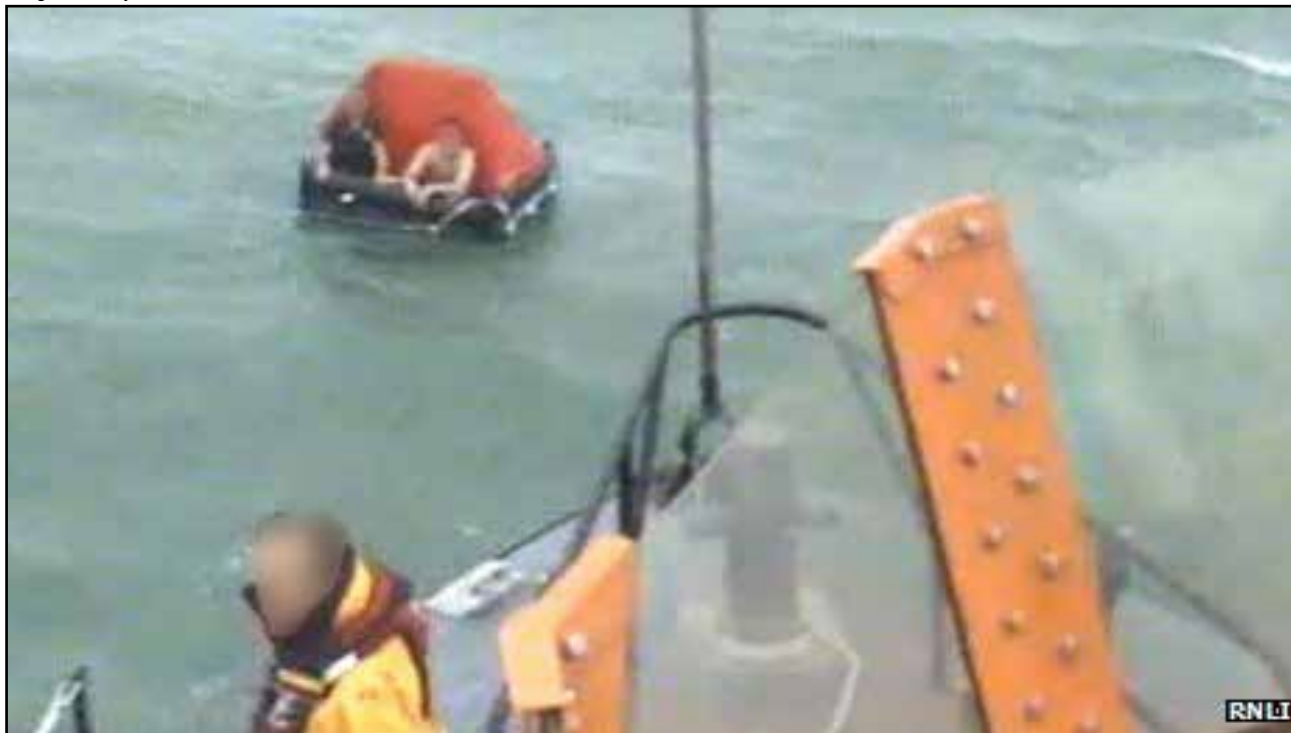
Just before 0800, the skipper set off a red hand-held flare. The flare was seen by a member of the public ashore who telephoned the coastguard. The Royal National Lifeboat Institution (RNLI) all-weather lifeboat (ALB) from Yarmouth, Isle of Wight and a rescue helicopter were tasked to investigate. *Sally Jane*'s skipper released the two remaining red flares and the ALB located the liferaft in Totland Bay (**Figures 1 and 3**) at about 0833. The skipper and the mate were recovered on board the ALB; both were suffering from mild hypothermia.

Figure 3: Recovery of *Sally Jane*'s crew from liferaft
