The sinking of the DUKW amphibious vehicle **WACKER QUACKER 1** in Salthouse Dock, Liverpool on 15 June 2013

The fire on board the DUKW amphibious vehicle **CLEOPATRA** on the River Thames, London on 29 September 2013

MAIB SAFETY BULLETIN 3/2013

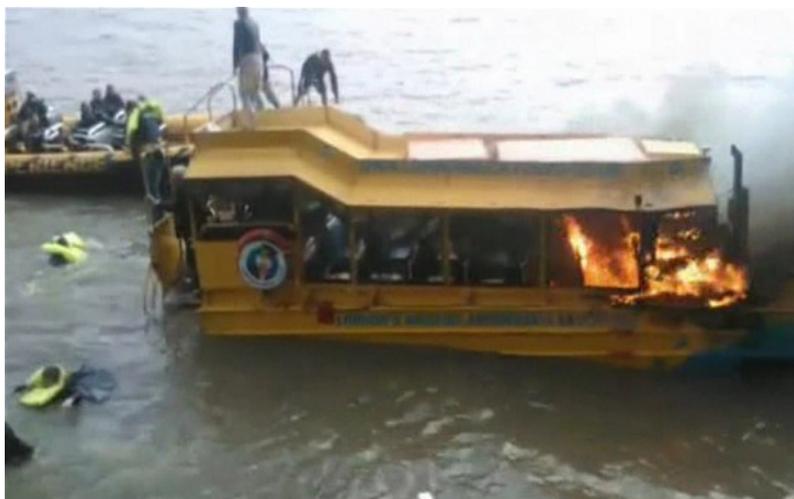
The ongoing MAIB fire investigation has established that the seat of the fire was located under the crew seating platform close to a drive shaft coupling. Foam in the area was found to be heavily contaminated with grease and had fuelled the fire, generating thick black smoke.

"There was no obvious ignition source in the vicinity of the buoyancy foam, and therefore the most likely cause of fire was the action of the rotating drive shaft (or other moving parts) on the oil contaminated surfaces of the buoyancy foam blocks."

In addressing recommendation 2013/221, ensure that the means used by DUKW operators to achieve the required standard of buoyancy and stability for their vessels does not adversely impact on their safe operation. Furthermore, these vessels should not be permitted to operate until satisfactory levels of safety can be assured under all feasible operating conditions.
