Report on the investigation of
the fatality of an able seaman
on board ro-ro cargo ship

Tyrusland

in Tripoli, Libya

on 15 May 2013

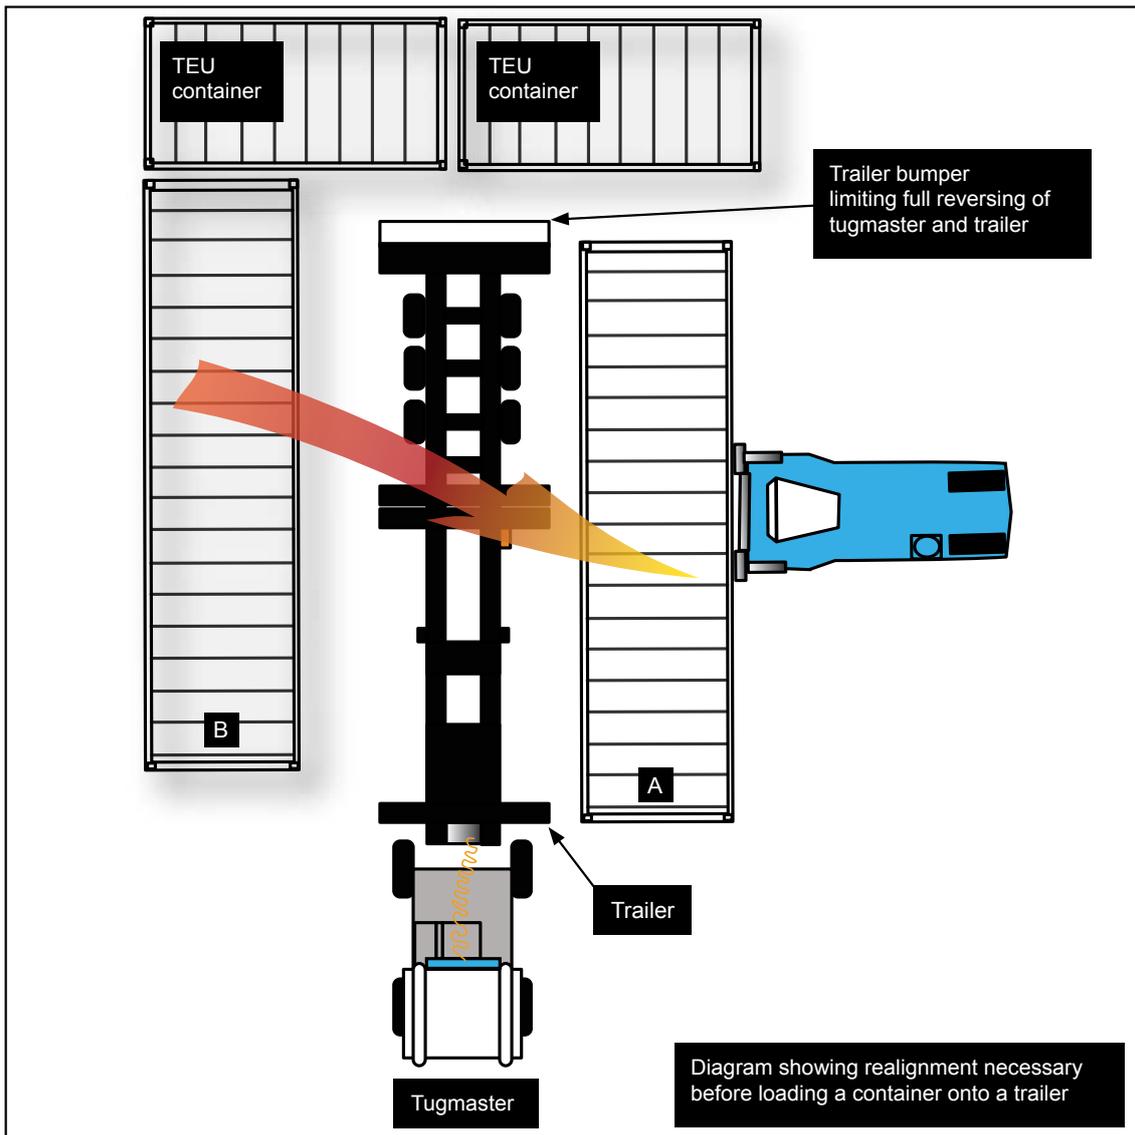
Figure 4: Diagram showing necessary container realignment

The trailer waiting to be loaded at the time of the accident was also fitted with a steel rear bumper (**Figure 3**) primarily for physical protection. However, when there were obstructions to the rear (as was the case in this accident) the bumper prevented the trailer from being reversed fully in line with the container being discharged. This required the fork-lift truck driver to realign the container before loading it onto the trailer (**Figure 4**).

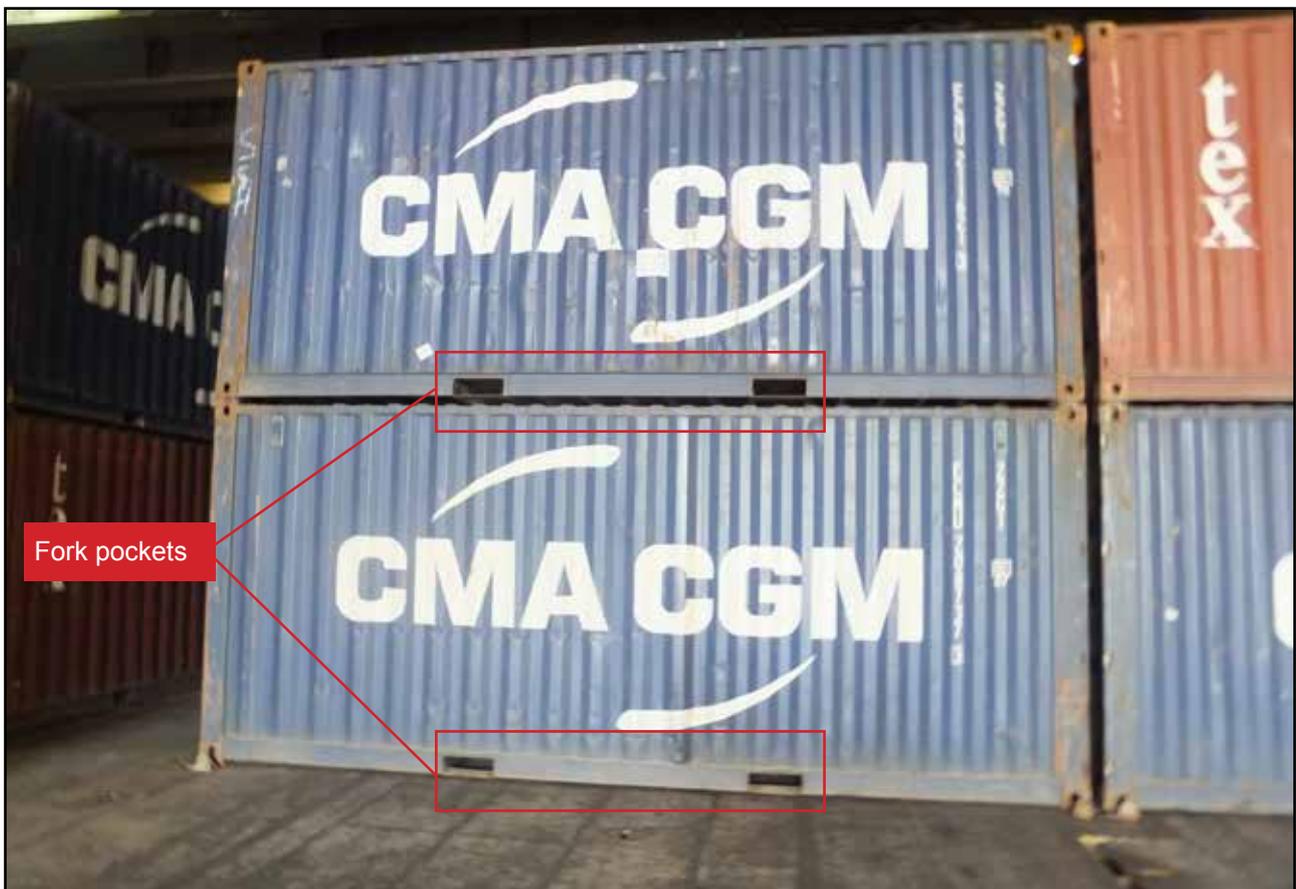
Figure 5: TEU container fork pockets

Tyrusland was transporting cargo loaded inside FEU and TEU containers. The cargo departure plan for 14 May 2013 is at **Annex B** and shows the location of the accident. A key feature of the TEU containers was the fork pockets built into their lower structure (**Figure 5**). No such pockets were fitted to the FEU containers, whose lower edges were easily damaged if the containers were lifted using a fork-lift truck (**Figure 6**).
