## **MV FINNARROW**

### **Contact with berth and subsequent flooding**

#### **Holyhead, UK**

#### **16 February 2013**

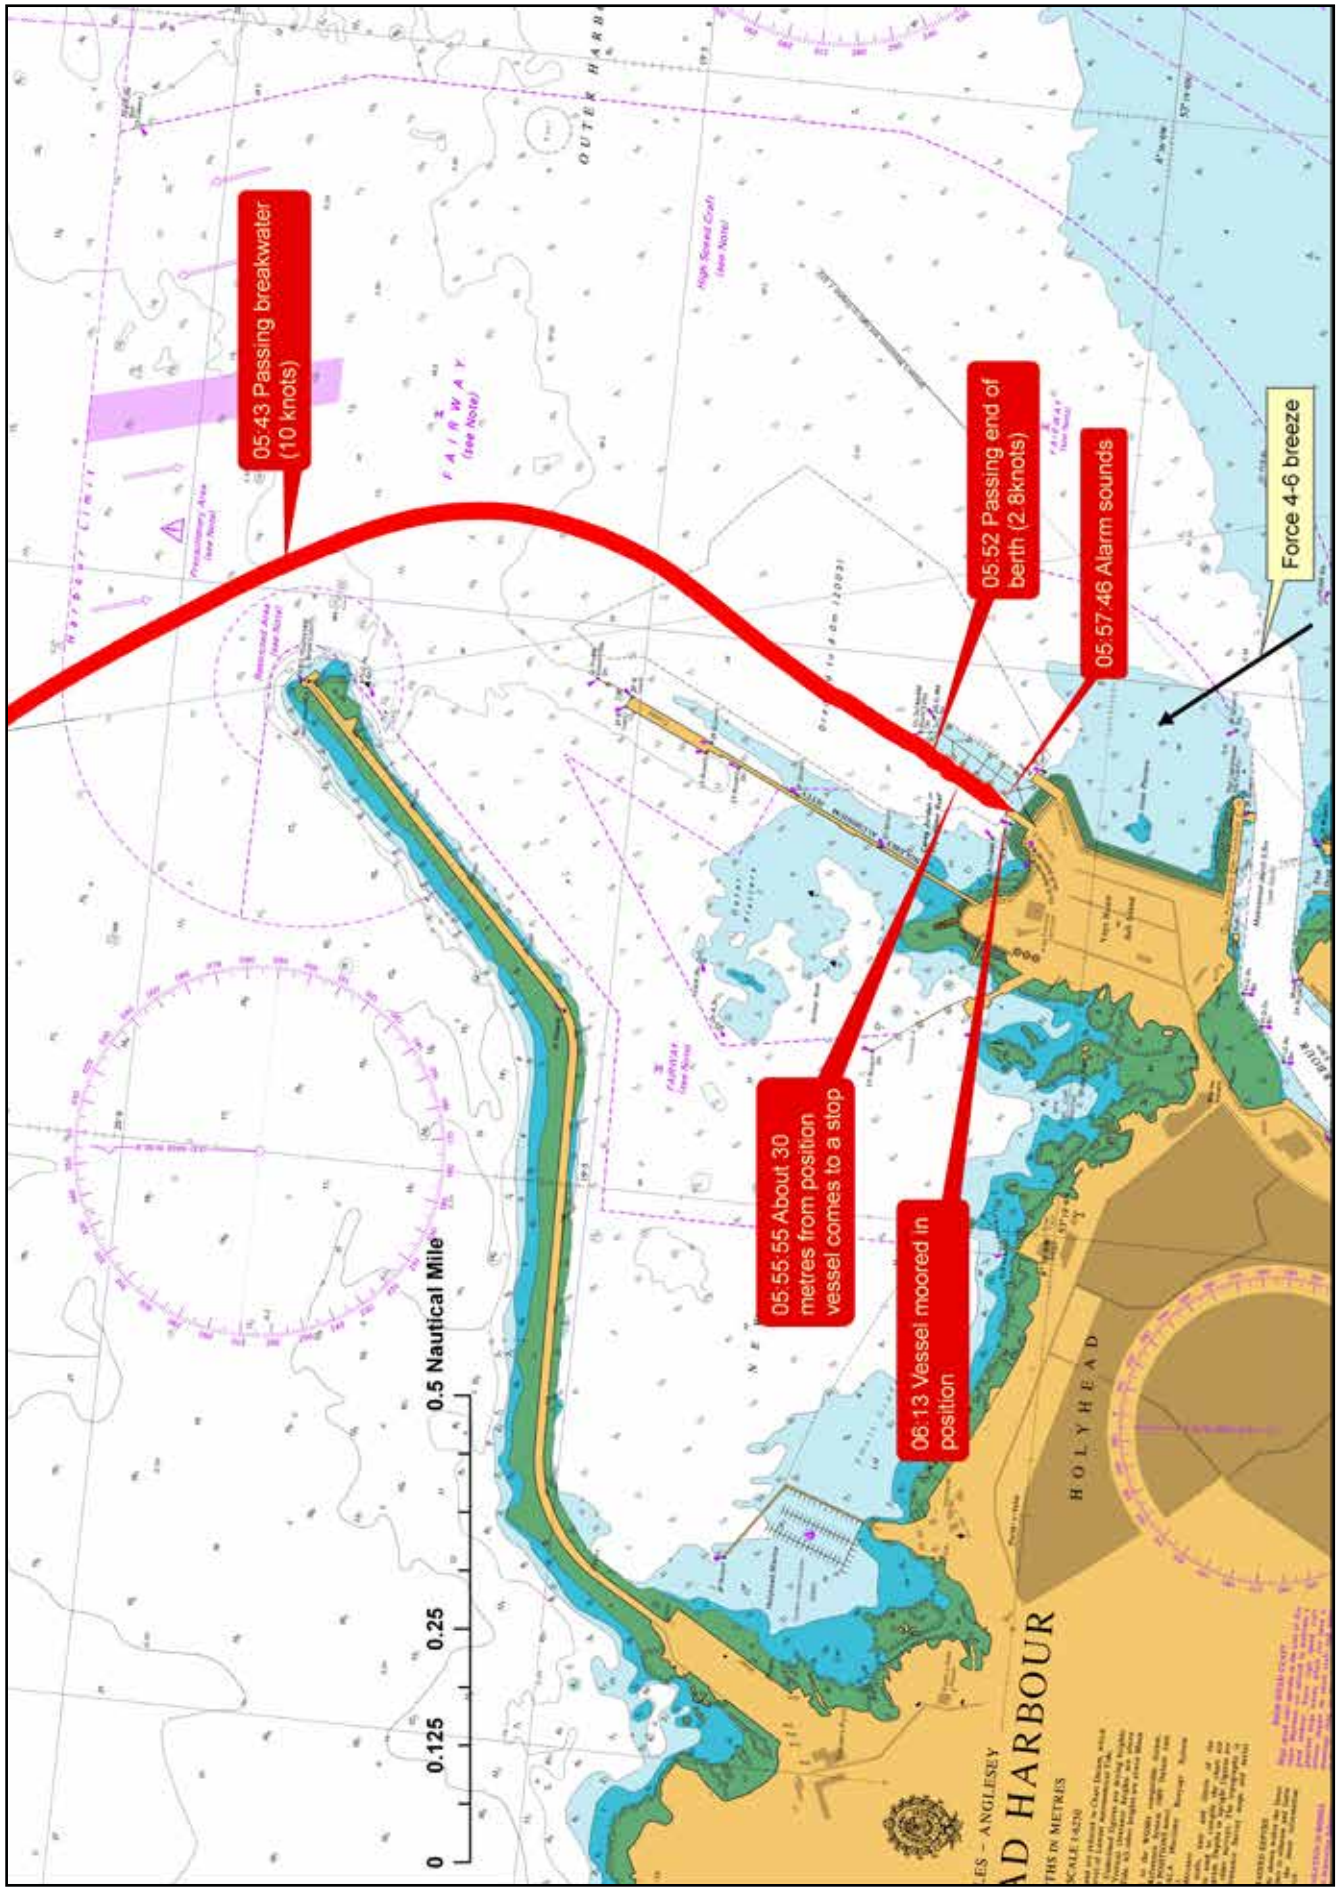
Figure 2: Finnerrow's track

At 0543, with additional steering motors and the bow thrusters running, and control transferred to the port bridge wing console, the day master manually steered the vessel around the end of the breakwater towards berth 3 (**Figure 2**). The chief officer stood half-way between the port bridge wing console and the centre console holding a UHF<sup>2</sup> radio, ready to communicate with the mooring teams.
