MV FINNARROW

Contact with berth and subsequent flooding

Holyhead, UK

16 February 2013

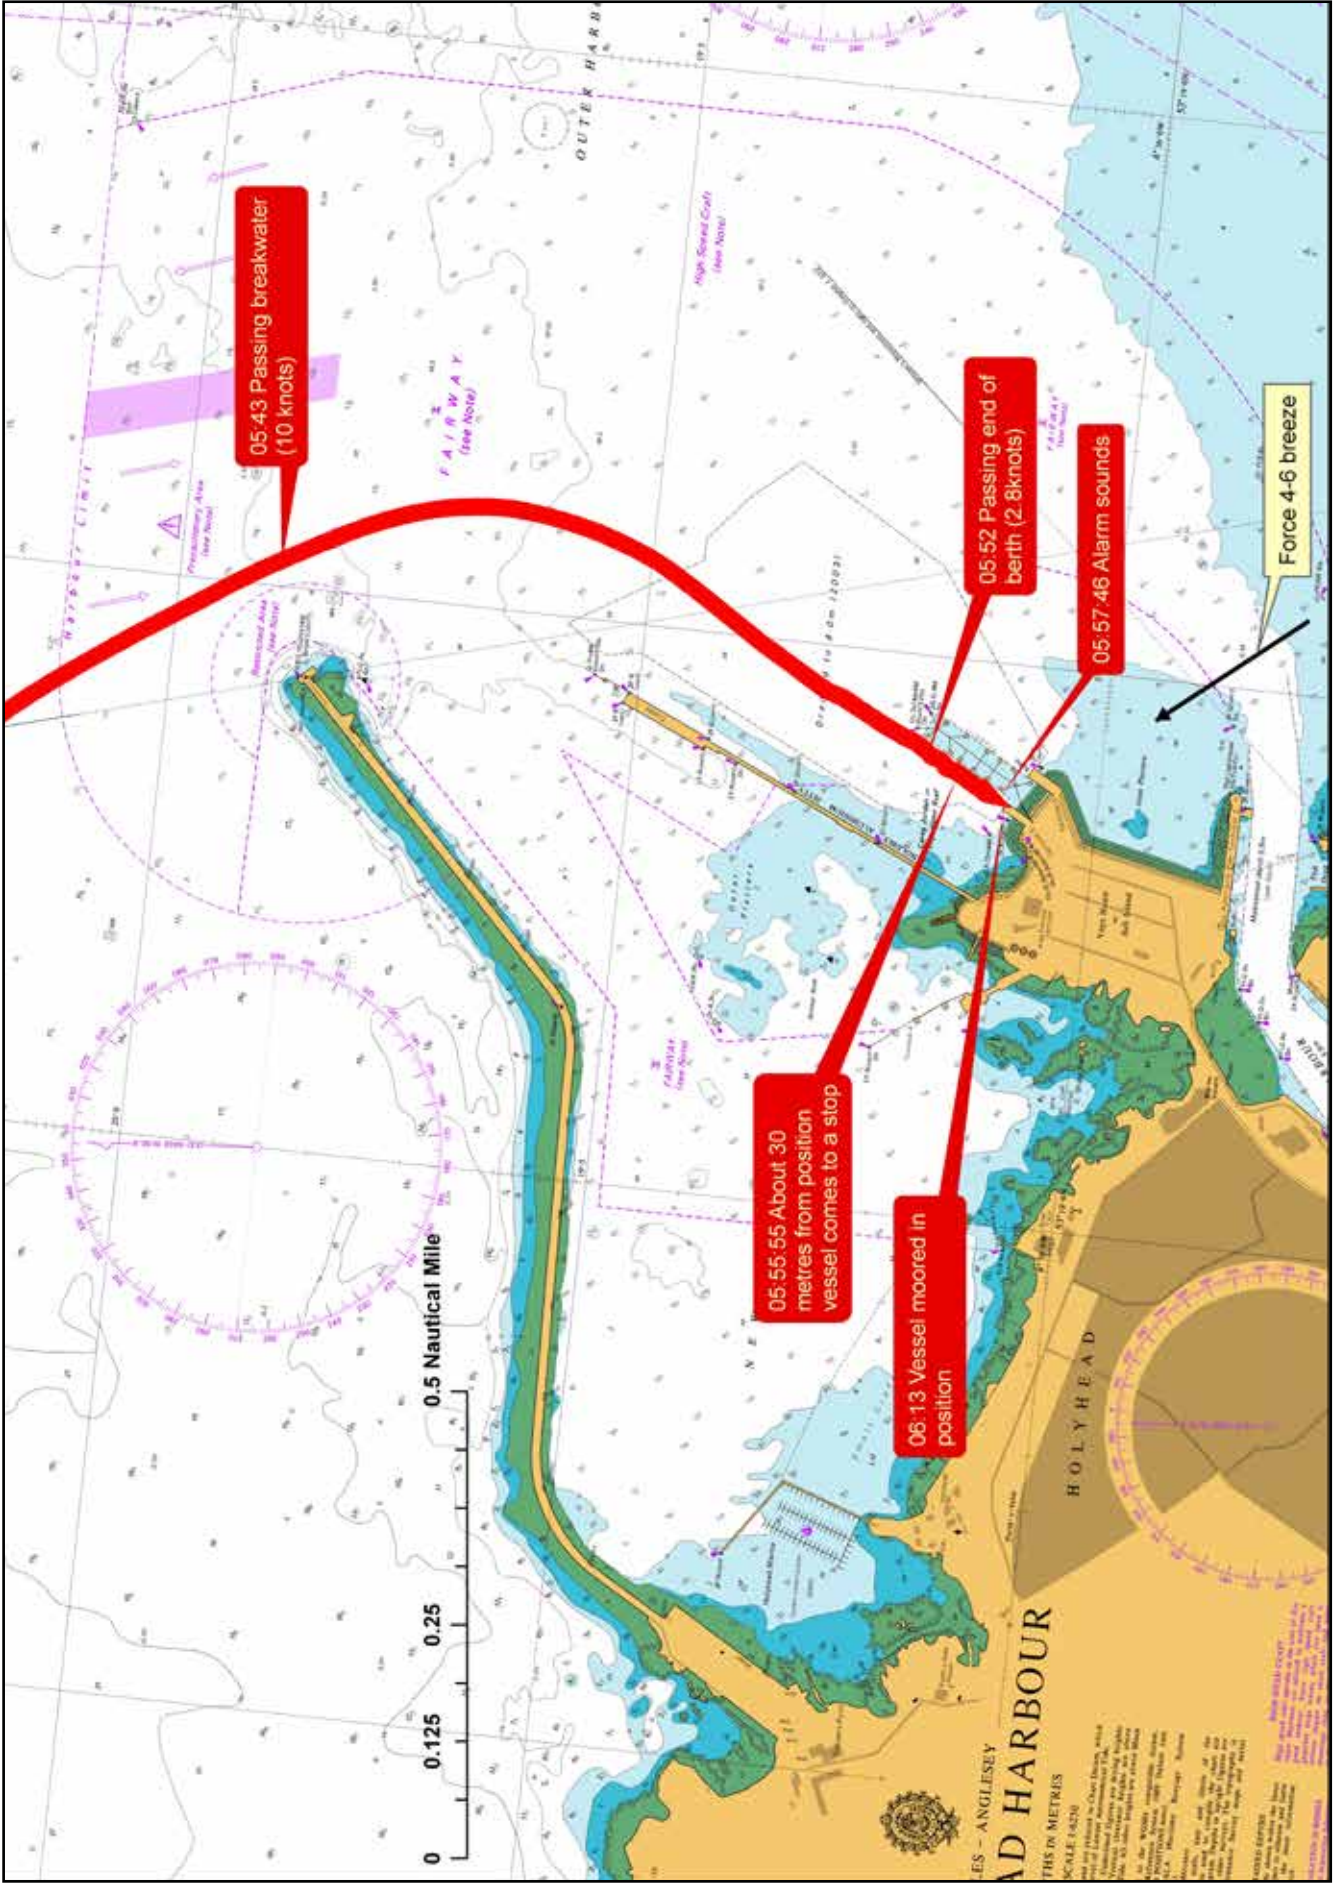
Figure 2: Finnerrow's track

At 0543, with additional steering motors and the bow thrusters running, and control transferred to the port bridge wing console, the day master manually steered the vessel around the end of the breakwater towards berth 3 (**Figure 2**). The chief officer stood half-way between the port bridge wing console and the centre console holding a UHF² radio, ready to communicate with the mooring teams.
