Report on the investigation of
the loss of a crewman overboard

from the motor tug

Endurance

2.3 miles west-south-west of Beachy Head,

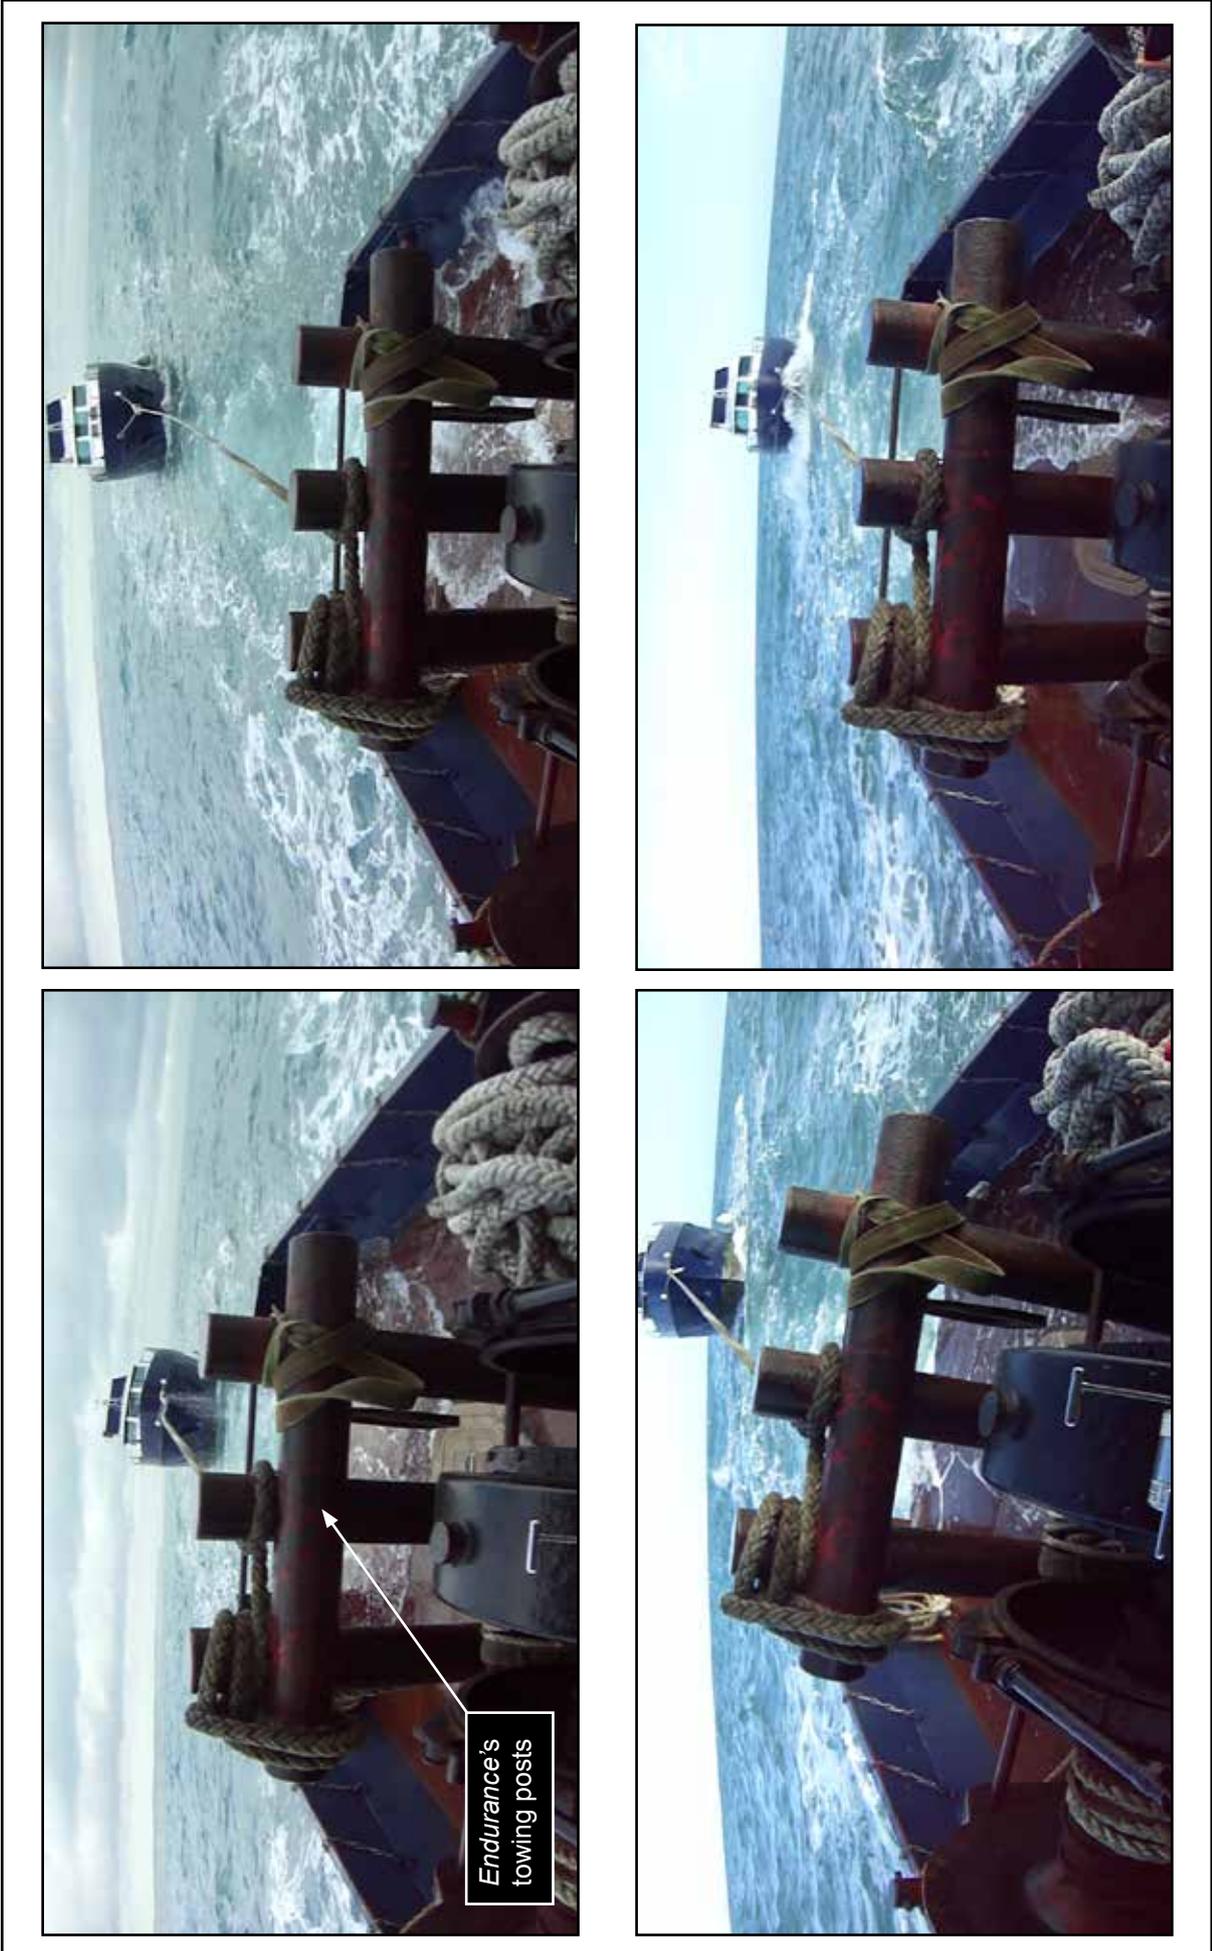
Figure 7: Stills from video footage taken of Sirius M under tow after leaving Dover

In this case, the chafing would have been exacerbated by the snatching of the towline. The towline was less than 20m in length, which was insufficient to provide the catenary required for the towline to absorb the dynamic loading induced by the choppy seas (**Figure 7**). As *Sirius M* was not manned, *Endurance's* skipper had no way of monitoring the condition of the towline when the vessels were underway. The towline was possibly in a reasonable condition when inspected by the skipper in Dover. However, it is likely to have deteriorated quickly in the worsening conditions experienced during the evening of 4 February.

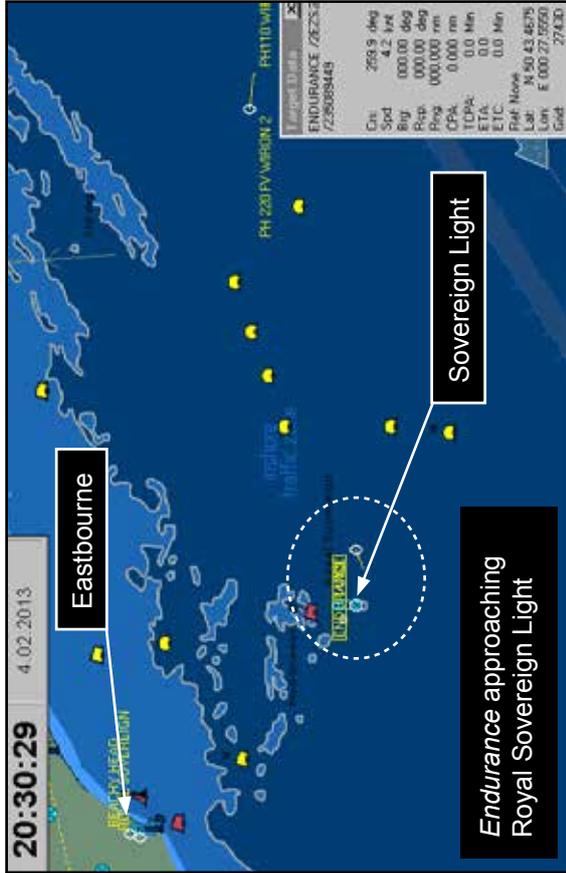
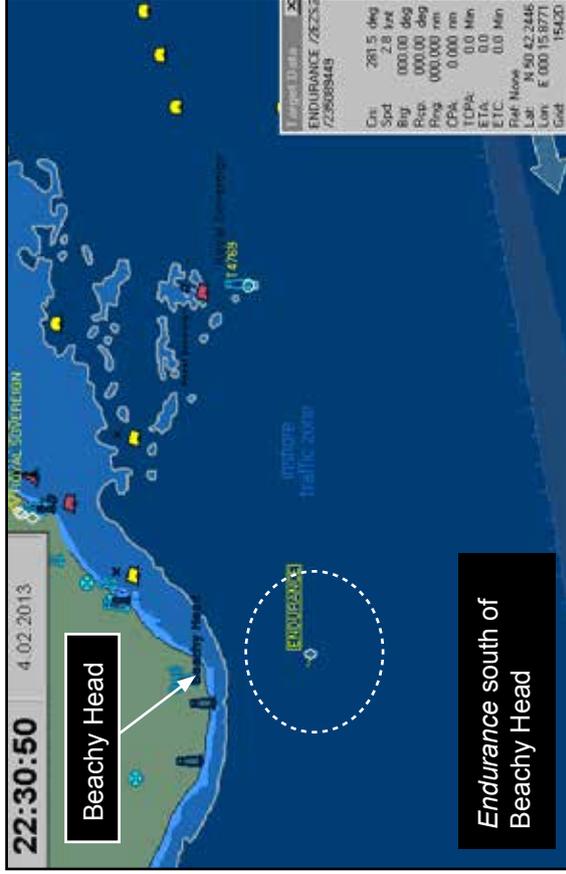
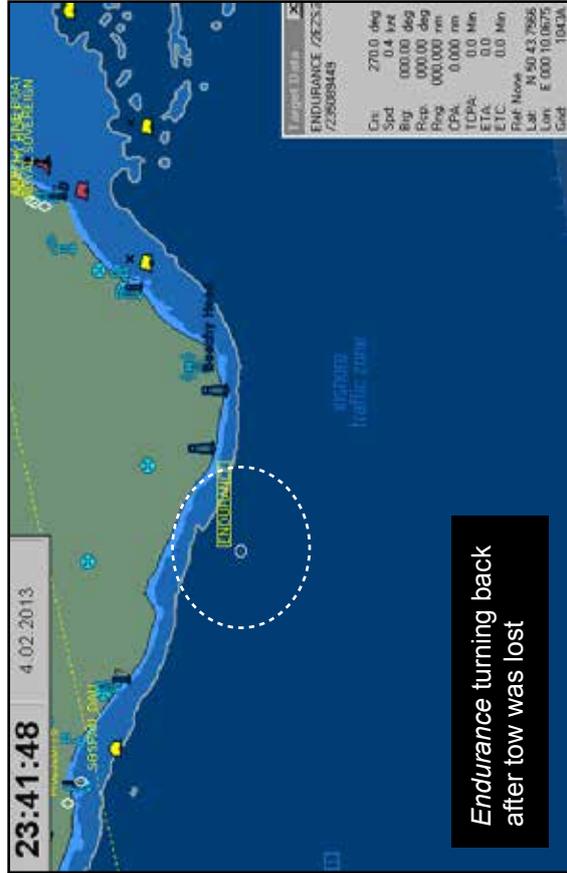
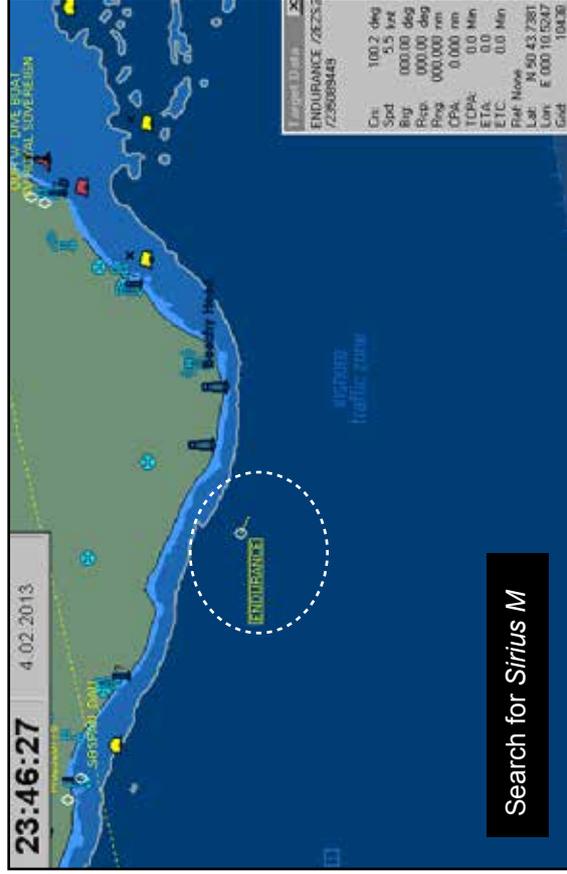
At about 2030, *Endurance* passed the Sovereign Light (**Figure 8**). By then, the weather conditions had worsened and both the skipper and Steven felt sea-sick. The men discussed aborting the passage and seeking refuge in Eastbourne. Despite being tired and finding the conditions uncomfortable, they both wanted to get the job done, so the skipper made the decision to press on to Brighton.

Figure 8: Endurance's passage off Beachy Head

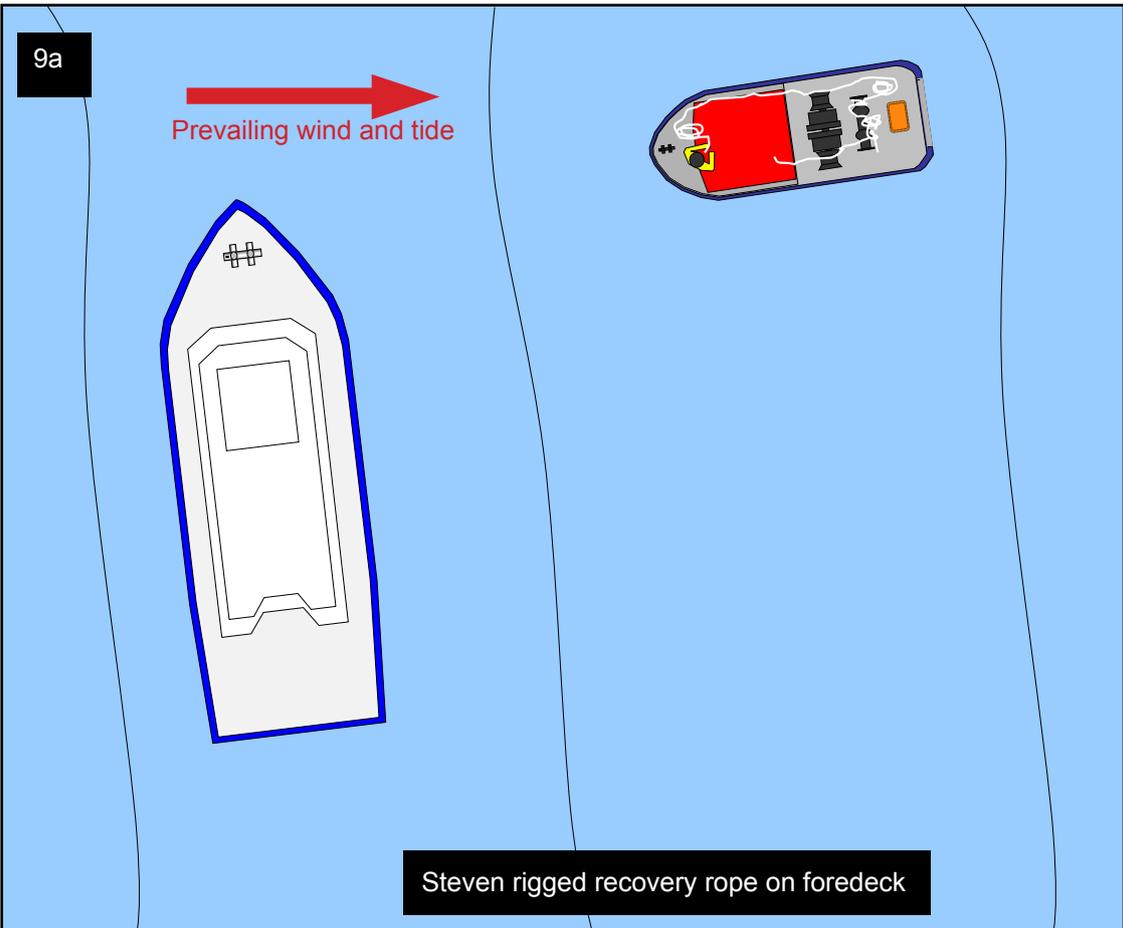
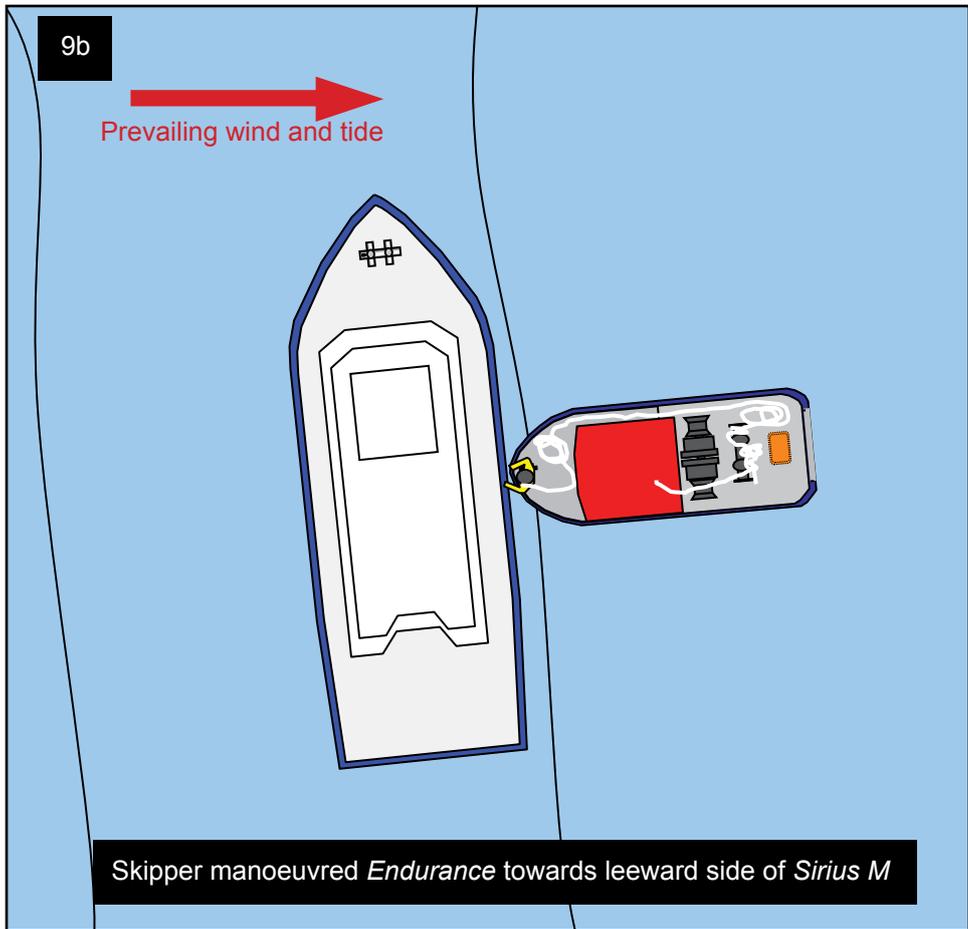
Steven went on deck and recovered the remains of the parted tow rope back on board. When he returned to the wheelhouse, the skipper manoeuvred *Endurance* head on to the waves close to *Sirius M*. The skipper and Steven then discussed how they could re-connect the tow and agreed that Steven would take another towline across to *Sirius M*.

Figure 9a and 9b: Attempt to reconnect the tow

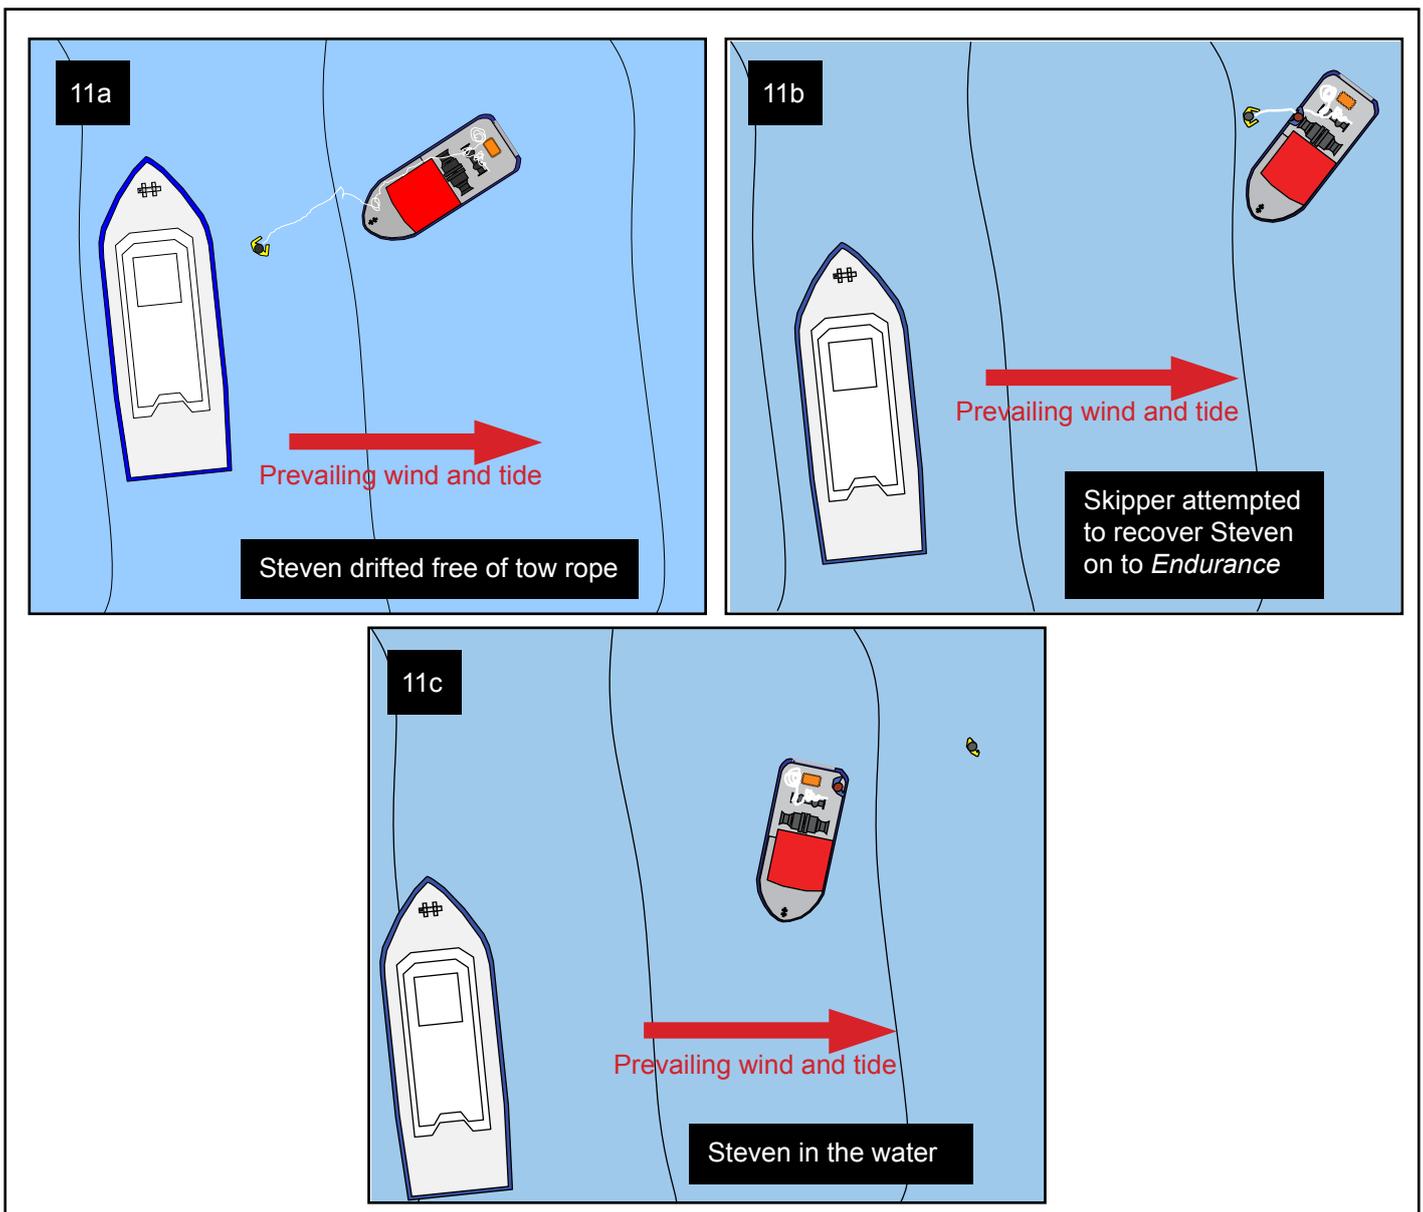
Figure 11a, 11b and 11c: Attempted recovery of Steven from the water

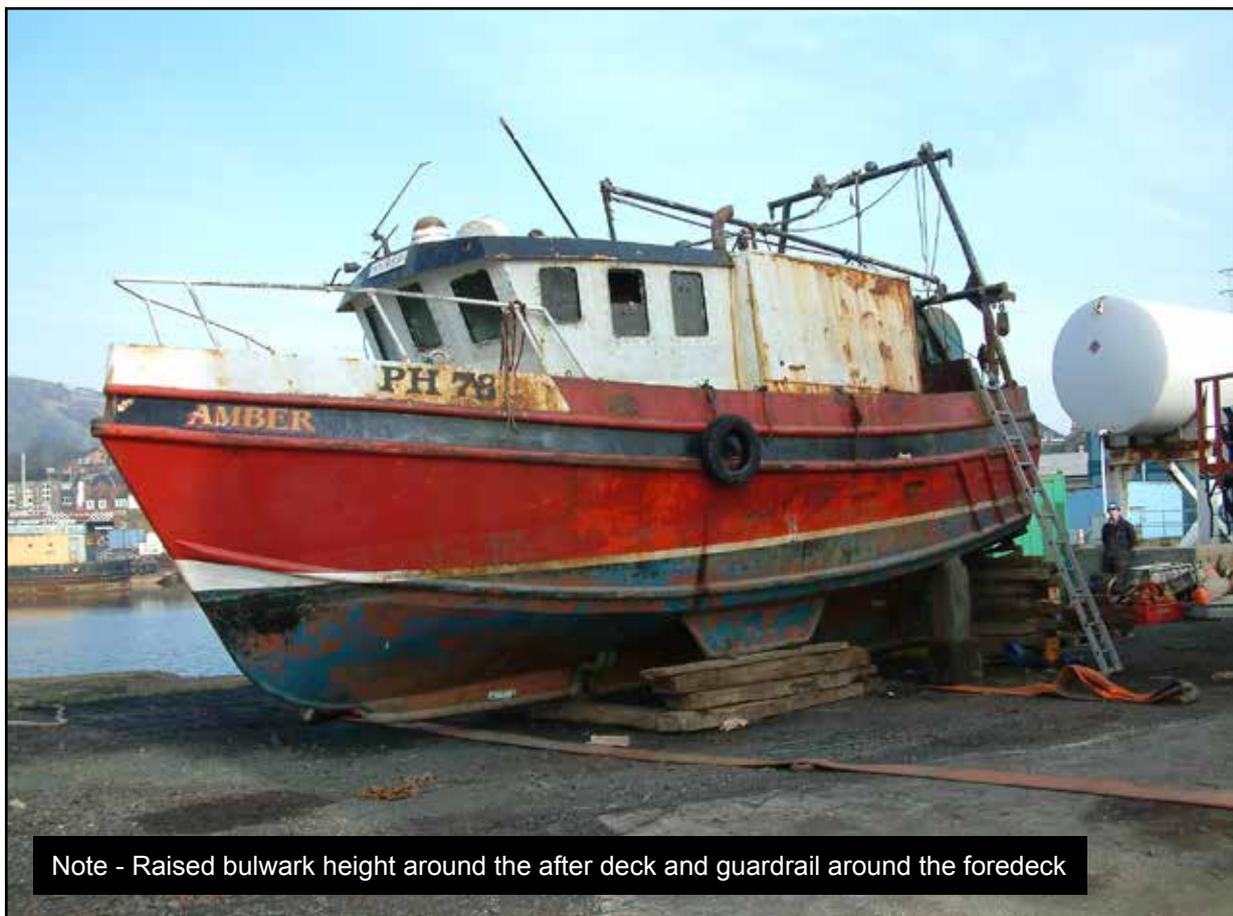
Built as a fishing vessel in 1989, *Endurance* was 9.95m in length and had a steel hull. In 2003, then named *Amber*, the vessel's fishing net snagged on a rock and the vessel sank in the Firth of Forth, Scotland, with the loss of its skipper¹⁰. *Amber* was salvaged (**Figure 14**) by the vessel's insurers. In 2007, the vessel was bought by a London-based company and was used as a workboat to move pontoons around London's West India docks. In 2008, the vessel flooded and sank while berthed alongside on the River Thames but was again salvaged (**Figure 15**).

Figure 14: Salvaged fishing vessel *Amber* in 2003

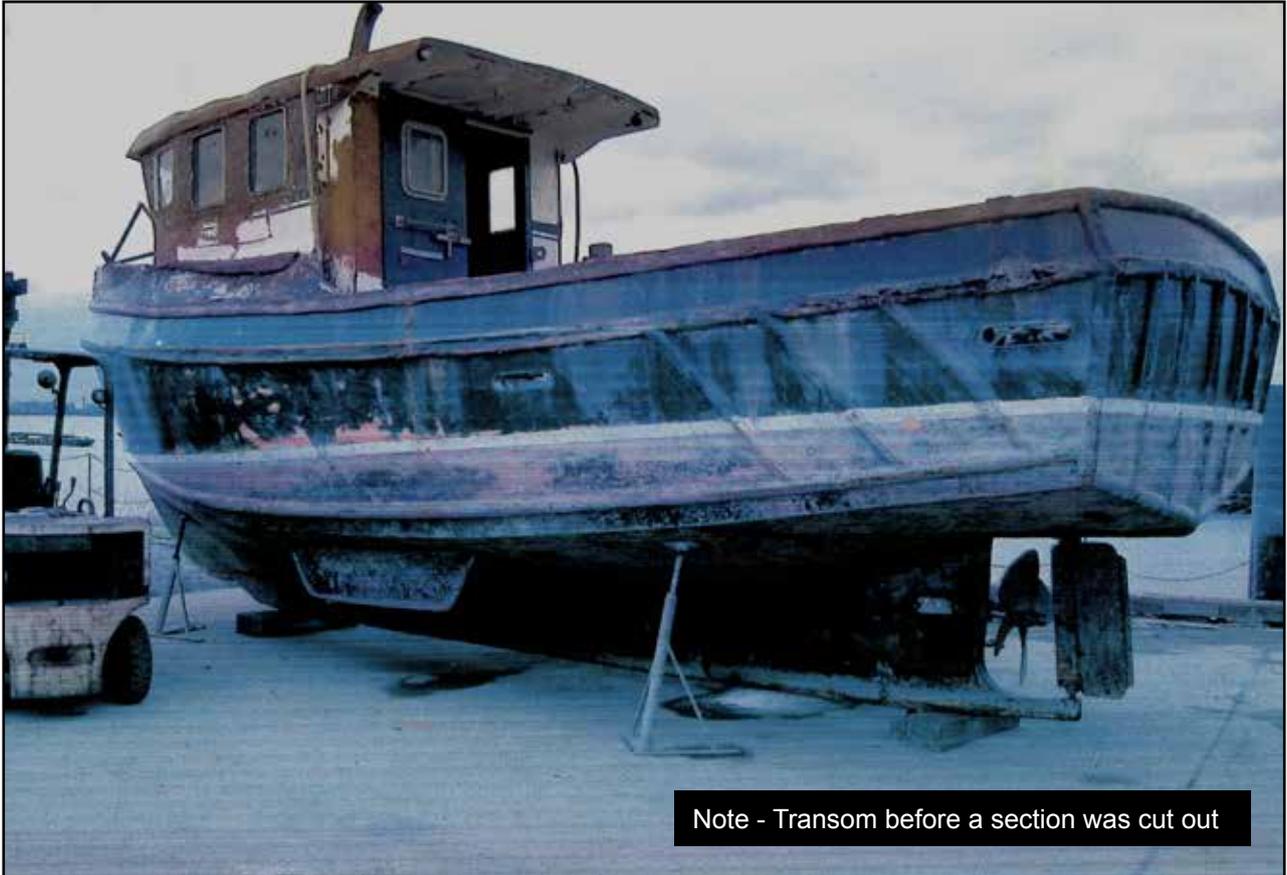
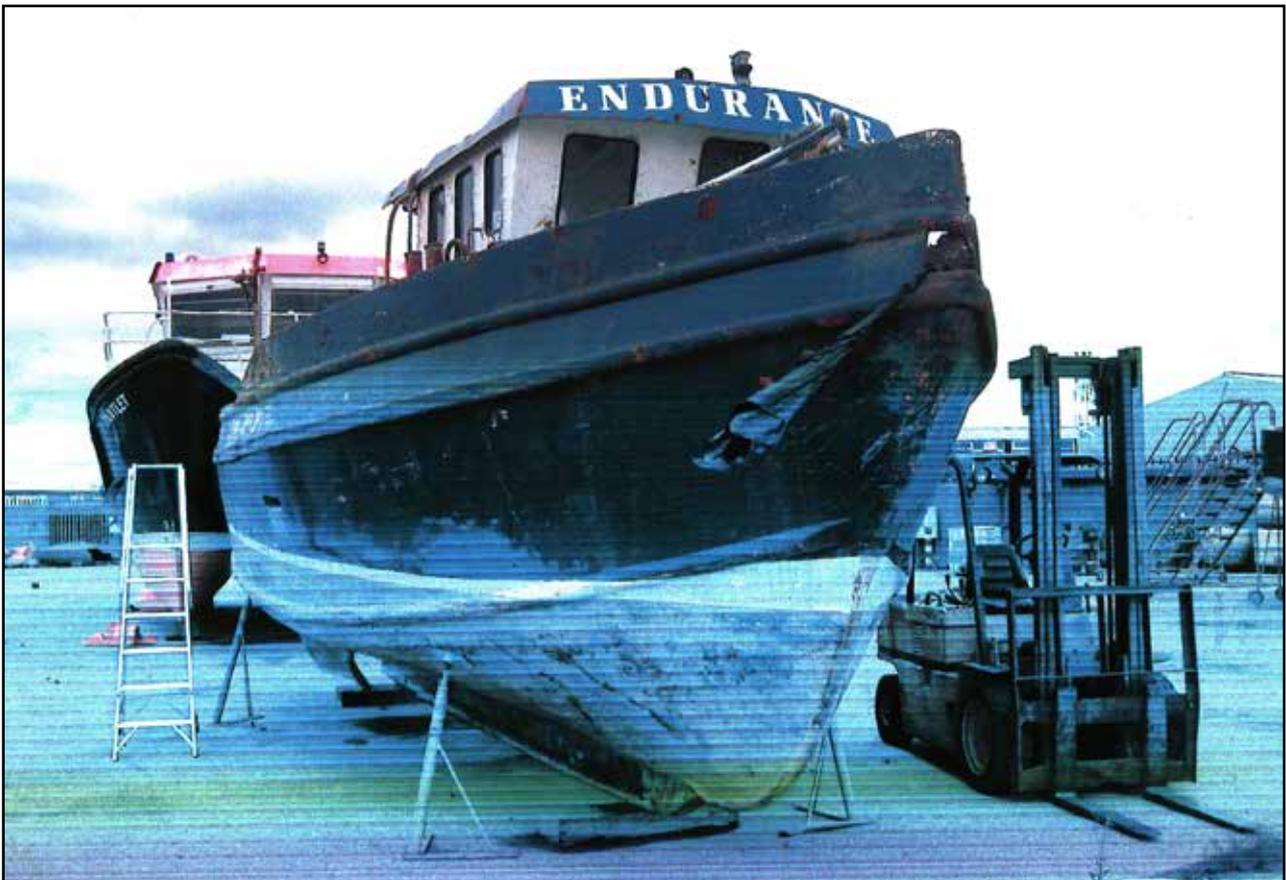
Figure 15: *Endurance* out of the water in 2008 after being salvaged on the River Thames

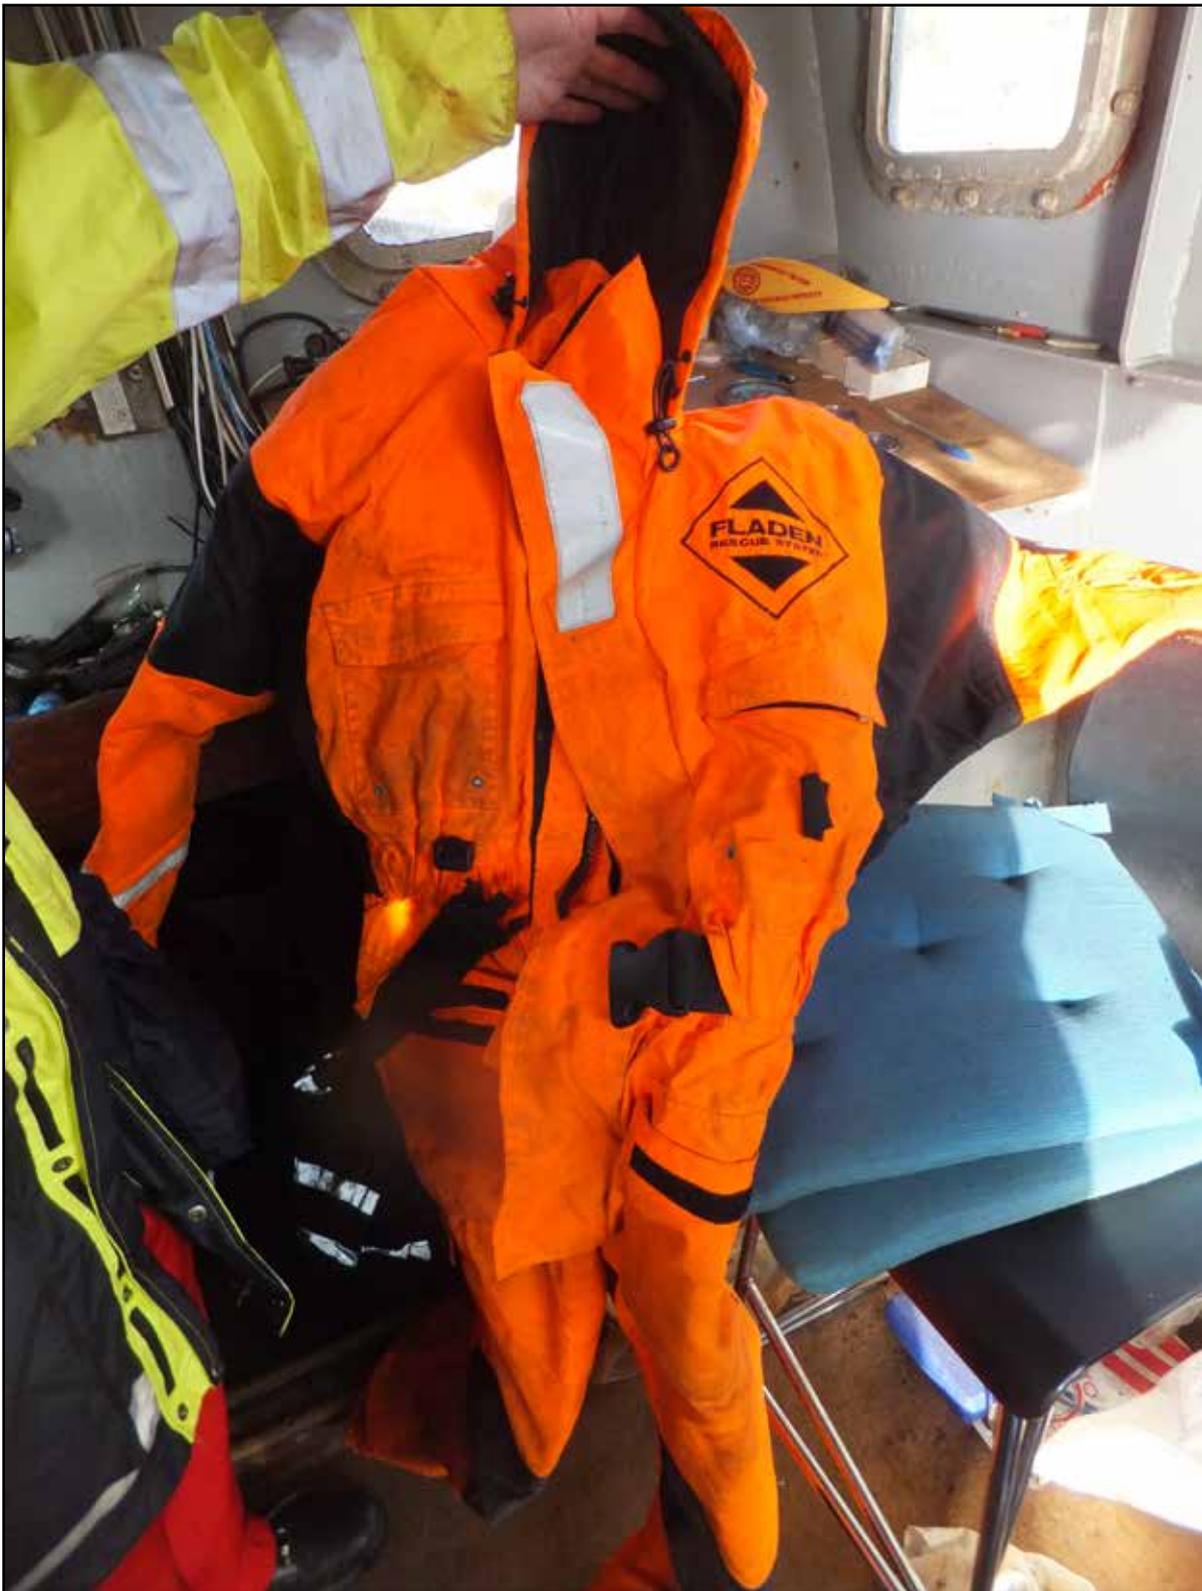
Steven was concerned about the weather conditions forecasted for the tow of *Sirius M* and borrowed an insulated flotation suit (**Figure 23**) from a relative. He also took dry biscuits on board with him because he was worried about becoming sea sick. Steven was less confident steering *Endurance* with *Sirius M* under tow so the skipper took the helm for the majority of the passage.

Figure 23: Flotation suit taken on board *Endurance* by Steven

of his crew across to *Endurance* because it was not safe to do so. Given Steven's concern over the voyage, it is puzzling why he did not don his flotation suit and a lifejacket when faced with such a perilous task.

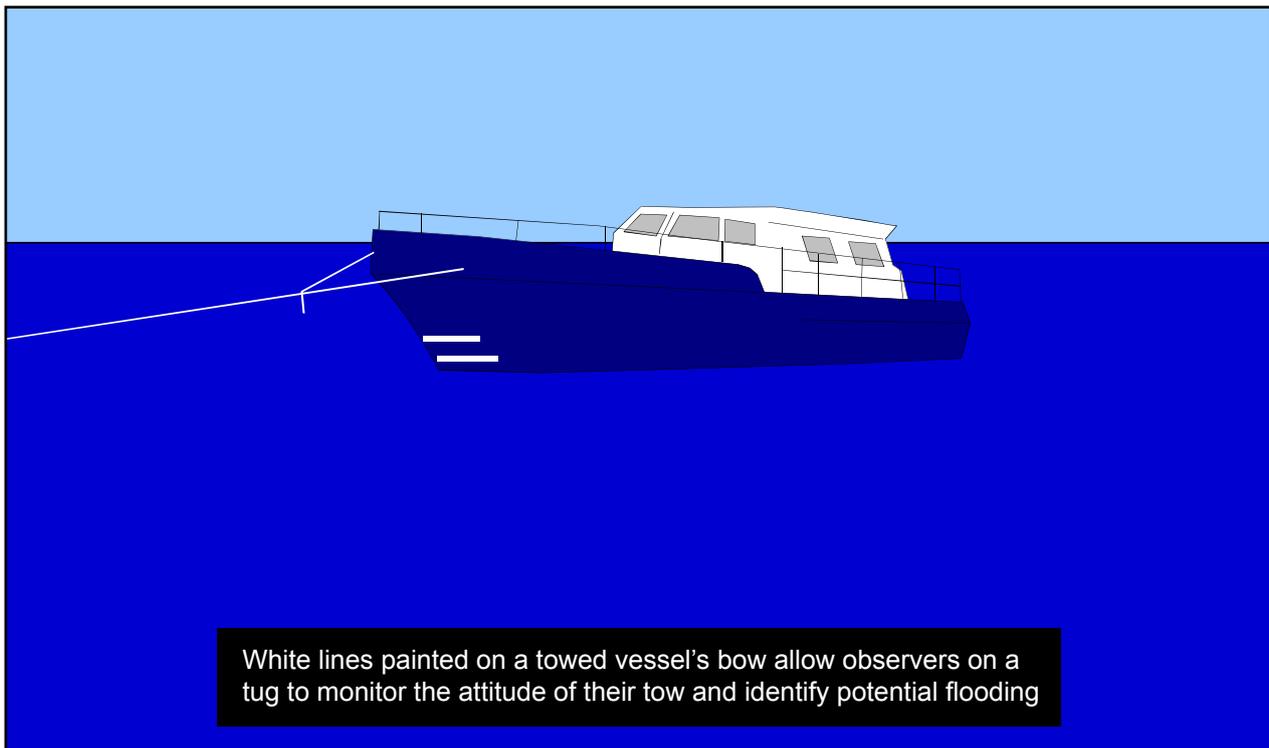
In order to allow the towing master to recognise any changes in the condition of his tow, the SCV Code also requires the towed vessel to be marked at its forward end with one or more white bars (**Figure 27**).

Figure 27: Example of the bow markings recommended in the SCV Code for unmanned towed vessels

- The removal of the lamps in the motor cruiser's sidelights, leaving only the stern light. Although this was probably a misplaced attempt to satisfy the PLA's requirement for an all-round white light, the light configuration fell significantly short of the requirements of the COLREGS.
- The failure to paint marks on the tow's bow to enable the monitoring of its freeboard (**Figure 27**) during the passage.

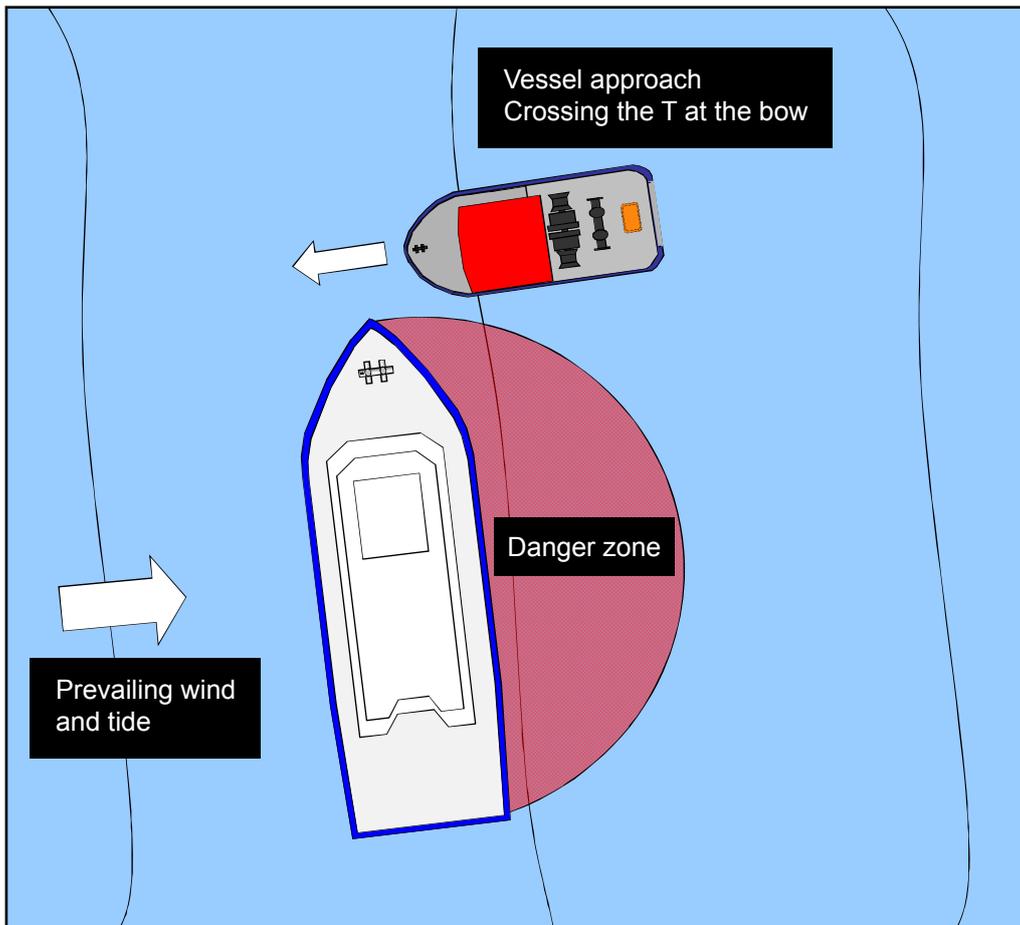
Sirius M was lying beam-on to the wind and waves. In such situations it is usual practice for a rescue vessel to approach a disabled vessel by passing close by its bow or stern (crossing the 'T') to avoid the leeward danger zone (**Figure 29**). In this case, *Endurance* approached *Sirius M* on the drifting vessel's leeward side, aiming amidships (**Figure 9**). Heading into the wind and sea possibly made *Endurance* a more stable platform, and the motor cruiser's superstructure would have provided some shelter. Nonetheless, the risk of *Sirius M* being set towards *Endurance* when the vessels were close was significant and predictable.

In view of the danger caused by the relative movement of the vessels in the rough seas, the darkness, and the difficulty in carrying the towline, it is clear that Steven's transfer across to *Sirius M* should not have been attempted. This is endorsed by the fact that during the SAR the coxswain of the Eastbourne ALB would not transfer one

Figure 29: Crossing the 'T'
