Combined report on the investigation of the contact with a floating target by the wind farm passenger transfer catamaran

Windcat 9

while transiting Donna Nook Air Weapons Range in the south-west approaches to the River Humber on 21 November 2012

with turbine I-6, in Sheringham Shoal Wind Farm on 21 November 2012

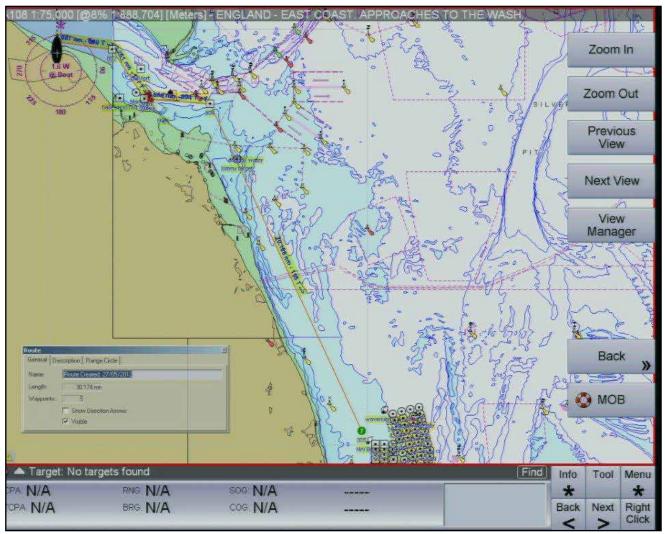
Figure 3: Modified version of chart plotter route to Lynn and Inner Dowsing Wind Farm planned on 27 May 2012

The Simrad GB60 chart plotter was switched on and the five-waypoint, 31.5nm historical route, originally entered on 27 May 2012, from Grimsby Fish Dock to LID Wind Farm (Figure 3)⁴ was selected. No passage plan checks were made to confirm the plotter's waypoints. The radar display was set north-up on a range scale of 1.5nm.

⁴ The image shows a modified version of the stored route – it was not possible to recover the actual route for departure because it was later altered.

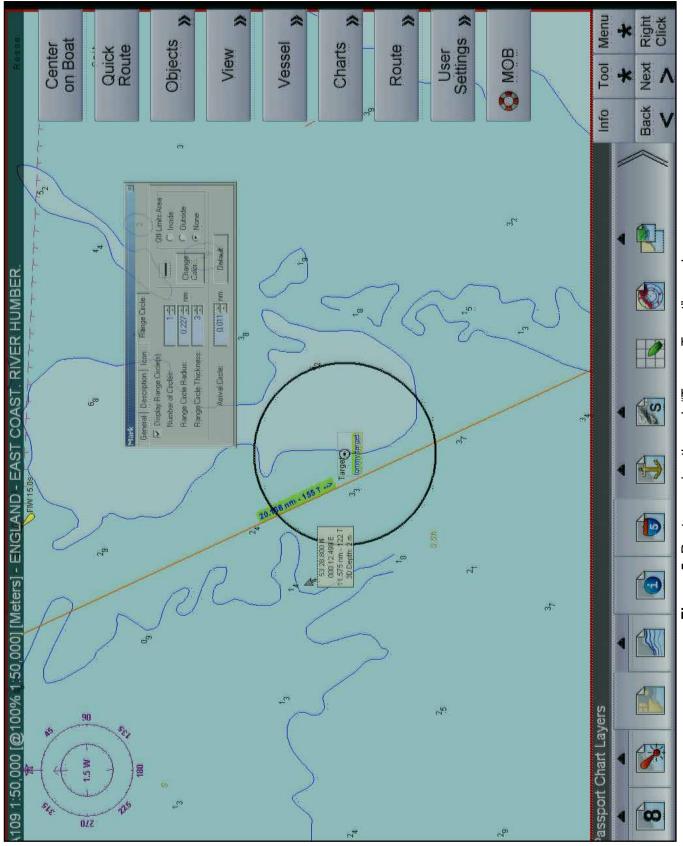
Figure 5: Route passing through "Tommy Target" guard zone

The master continued to follow the chart plotter route towards waypoint 4. He did not notice that the route now passed through Target 3's 0.227nm radius guard zone, identified as "Tommy Target" on the chart plotter display, and within 0.75 cable of Target 3 (Figure 5).

The system could be configured to display guard zones, which could be arranged to provide visual and/or audio alarms. DNAWR Target 3 was identified on the chart plotter's display as "Tommy Target" and by a 0.227nm radius ring **(Figure 5)**.

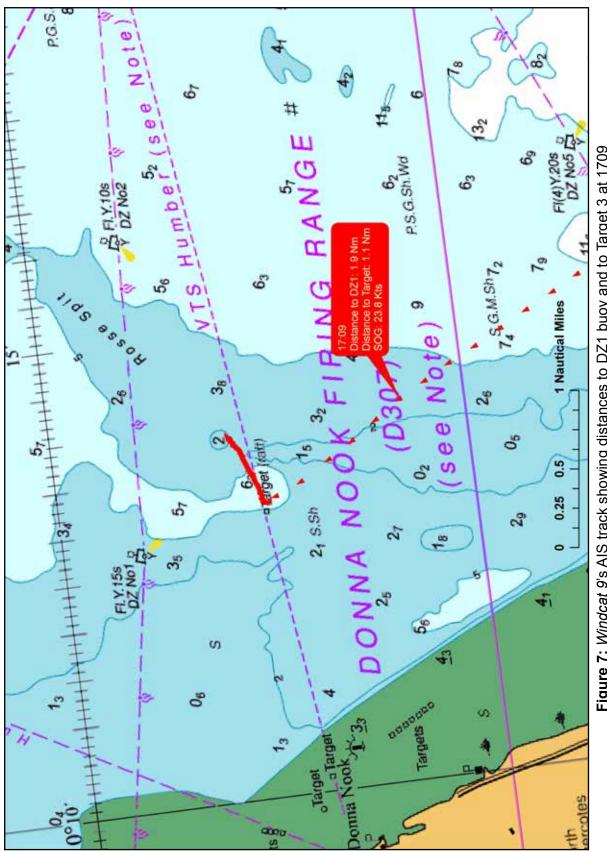
Figure 7: Windcat 9's AIS track showing distances to DZ1 buoy and to Target 3 at 1709

The master occasionally looked out of the wheelhouse window but did not refer to any specific visual references. He noticed on the chart plotter's AIS display that *Fastnet Tern*, another wind farm passenger transfer vessel, was about 0.75nm off *Windcat 9*'s starboard bow and proceeding towards Grimsby at 20 knots (**Figure 6**). The master, believing *Windcat 9* was still on the planned reciprocal outbound route, decided he had enough sea room to cut the corner of the planned track to get ahead of *Fastnet Tern* for the passage up the River Humber towards Grimsby. He duly altered course to port by adjusting the autopilot setting. At 1709, AIS recorded *Windcat 9*'s speed over the ground (SOG) as 23.8 knots with its position 1.1nm from the target and 1.9nm from DZ1 buoy (**Figure 7**). The master had not identified an echo from Target 3 on his radar display at this time.

Windcat 9 continued on its course for a short time until the master glanced at the radar display and noted a radar echo from DZ1 buoy; he had still not identified a radar echo from Target 3. It quickly became apparent to him that *Windcat 9* was

significantly to the west of the planned reciprocal track. The master then looked through the wheelhouse window and, noting that the flashing yellow light of DZ1 buoy was fine on the starboard bow, realised that had *Windcat 9* been on the correct planned reciprocal track, the buoy should have been off the port bow. At 1711:14, *Windcat 9* was 1nm from DZ1 buoy and 445m from Target 3. Unsure of *Windcat 9*'s true position, the master opted to turn the vessel to starboard and head between DZ1 and DZ2 buoys.

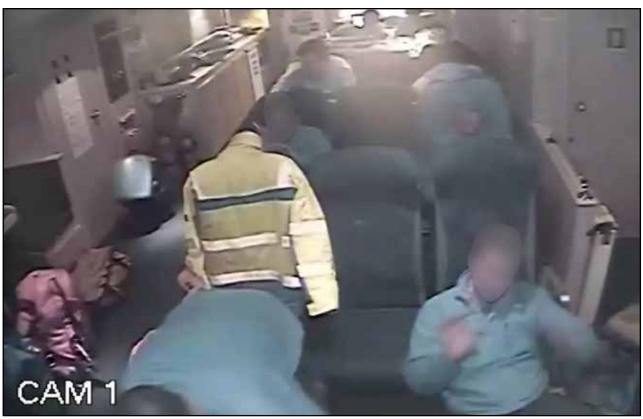
Figure 9: Passenger cabin at the time of the impact

At 1712:15 seconds, *Windcat* 9's port hull made contact with Target 3. The vessel forced the target down into the water as she rode over it. There was very little vessel motion due to the impact although a number of the technicians were jolted from their seats (**Figure 9**).

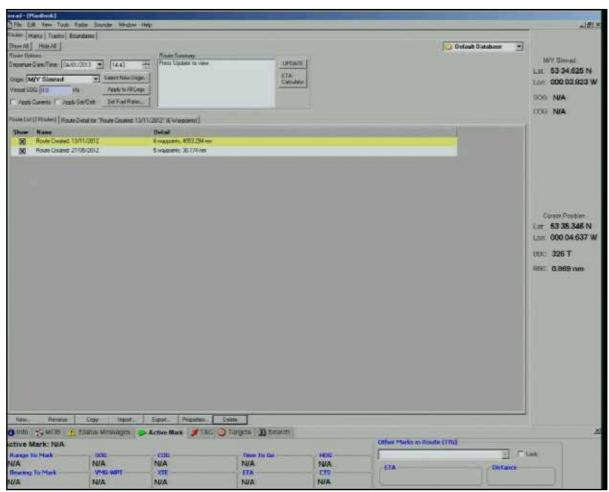
Figure 18: Routes stored on the chart plotter's log file

Planned routes could be stored and recalled as necessary. There were only two routes (Figure 18) stored on the system's log file. The 31.5nm route from Grimsby Fish Dock to LID Wind Farm, comprising five waypoints, was created on 27 May 2012 and was in use at the time of the accident. A 4053.294nm route was created on 13 November 2012 and had six waypoints extending through the mainland of the African continent. It is unknown why this route was planned and stored.

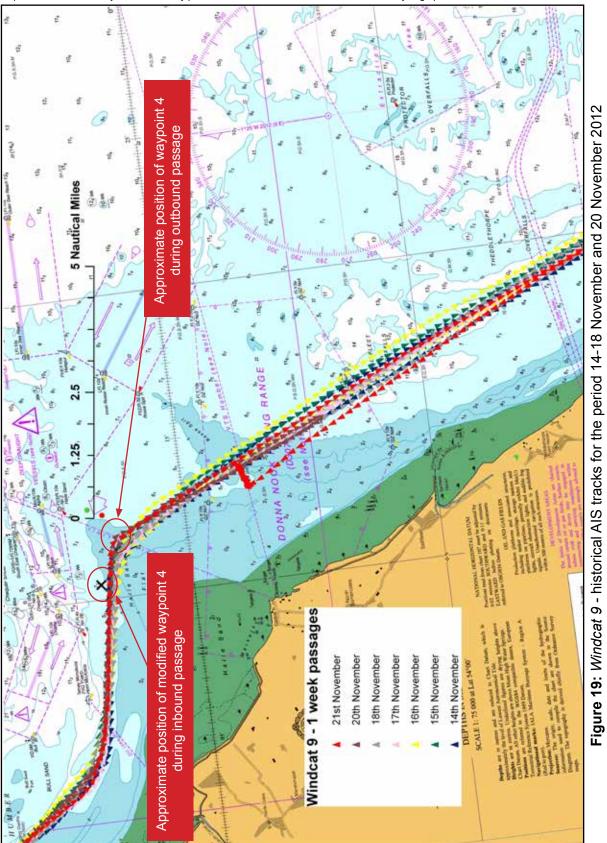
Six historical, outbound and return, AIS tracks for *Windcat 9*, covering the period 14-18 November and 20 November 2012 were plotted on Admiralty chart 107 – Approaches to the River Humber (**Figure 19**). The tracks showed that *Windcat 9* consistently passed between DZ1 and DZ2 buoys and to within about 0.5nm to the east of Target 3. On the basis that the master assumed his vessel was following the normal reciprocal route, he would have expected *Windcat 9* to pass safely to the east of Target 3 as she had on previous occasions.

In considering the cause of the initial route divergence, checks were made of the positions of the five waypoints. It was found that waypoint 4 had been moved to the west (**Figure 19**) and that the master had been following a route towards the modified position of waypoint 4 from 1654 until he made the course alteration at 1709.

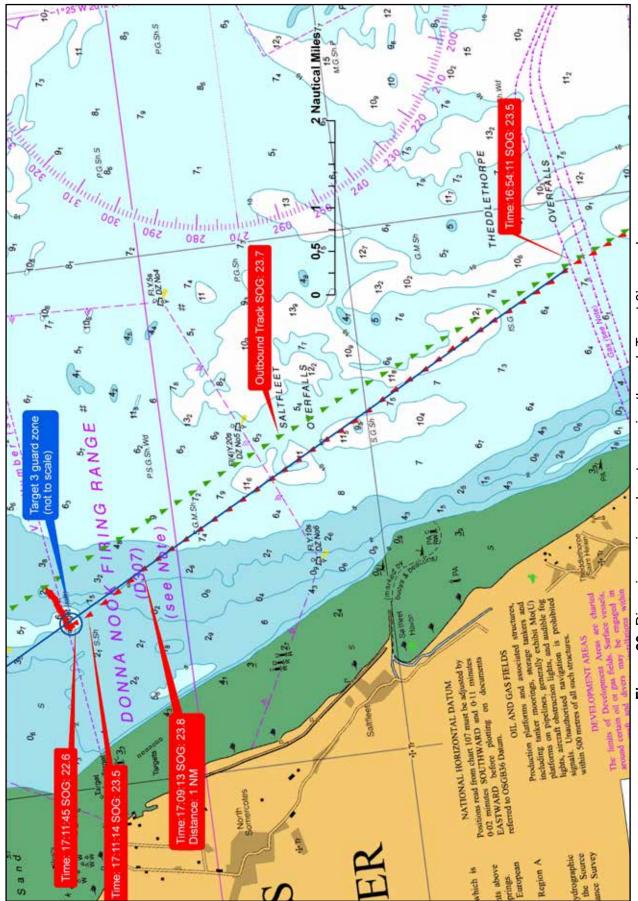
Referring to **Figure 20**, *Windcat 9*'s AIS positions (red arrows) can be seen diverging to the west of the historic outbound AIS track from 1654. This is coincident with the time at which the master was demonstrating the chart plotter's range options to the trainee master using the tracker ball control. The track (in solid blue) shows a steady course over the ground (COG) of 329°, passing through Target 3's 0.227nm radius guard zone, until the master altered to port at 1709 to get ahead of *Fastnet Tern*. The master then noticed a radar echo from, and the flashing light of DZ1 buoy and realised that *Windcat 9* was significantly west of the planned reciprocal track. By 1711.45, he had altered course to starboard in an attempt to pass between DZ1 and DZ2 buoys and regain the safe reciprocal route. However, 30 seconds later *Windcat 9* made contact with Target 3.

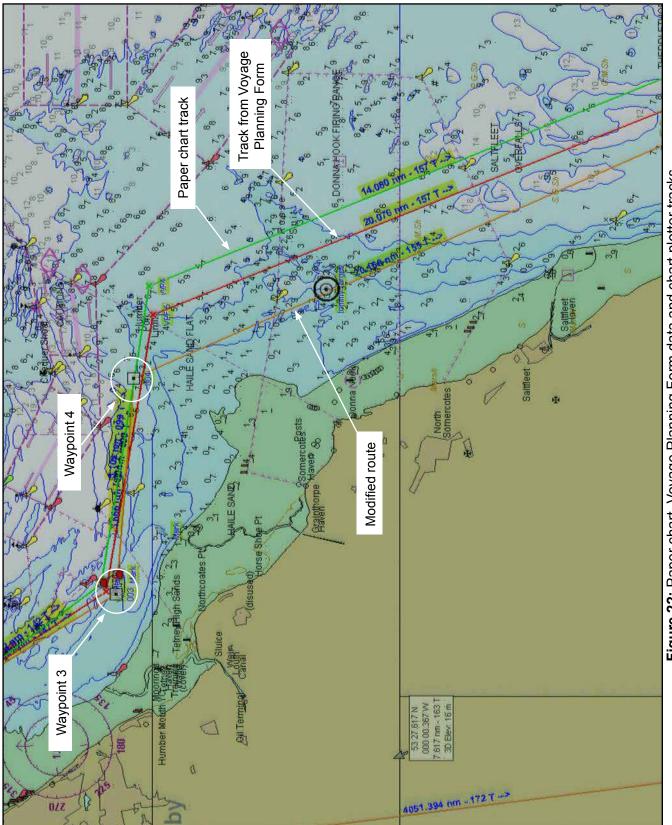
Figure 22: Paper chart, Voyage Planning Form data and chart plotter tracks

Although WWL declared that paper charts were indeed the primary means of navigation, in practice the chart plotter was used for this purpose. It is impractical to expect the master of a catamaran, travelling in excess of 20 knots, to leave the conning position to consult a paper chart, full-sized or otherwise to determine the vessel's position. It can be argued that the deckhand could take the con at this time, but this would compromise his lookout duties.

It is reasonable to use paper charts for passage planning purposes and then use the chart plotter for passage monitoring provided that an ability to navigate safely is not compromised. The SCV Code gives owners an option to declare that the electronic

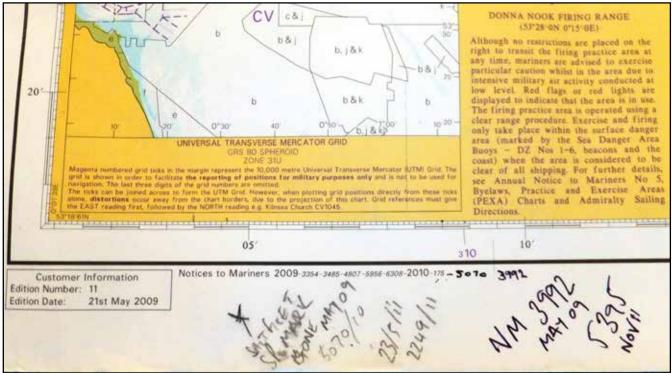
Figure 23: Chart correction annotations on Admiralty chart 107 - Approaches to the River Humber

DNAWR Target 3 was placed in position in November 1974 and, at the time, was fitted with a flashing light, which illuminated during the hours of darkness. However, owing to the raft's usage, the light often became unserviceable. To avoid confusion regarding its operational state, it was decided that Target 3 should remain unlit and navigation charts were duly amended to reflect this.

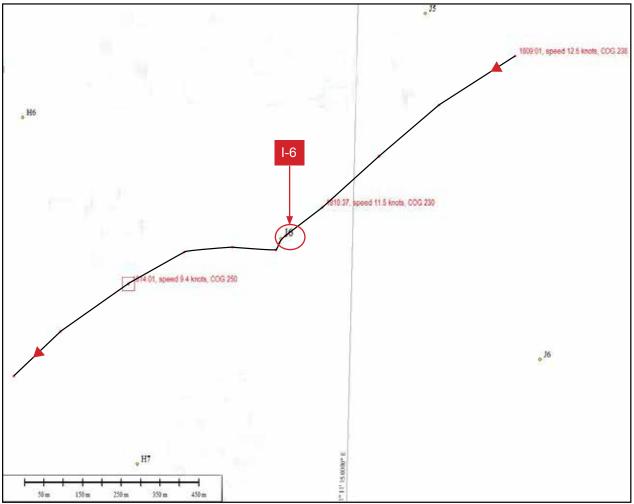
At 1811, the transition piece of turbine I-6 suddenly appeared out of the darkness dead ahead. The night master attempted to apply astern propulsion, but this did not prevent *Island Panther*'s bow fender from making heavy contact (**Figure 31**) with the turbine, resulting in everyone on board being forced out of their seats.

Figure 31: Island Panther AIS track approaching turbine I-6

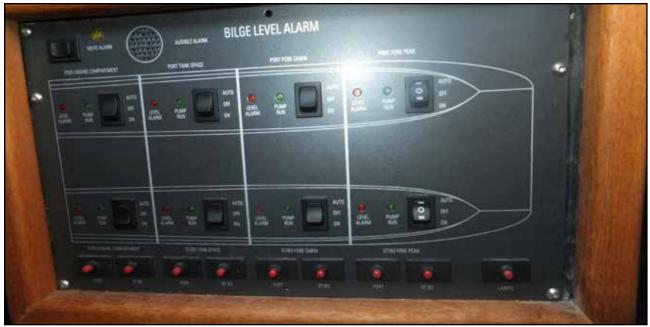
The day master came up to the wheelhouse as the night deckhand went below to tend to a cut on his hand, and asked the night master if he still had power, to which the night master confirmed he had. There were no alarms activated on the bilge alarm panel and no indications of bilge pumps running (Figure 32). Island Panther drifted clear of the tower.

Figure 32: Bilge alarm panel

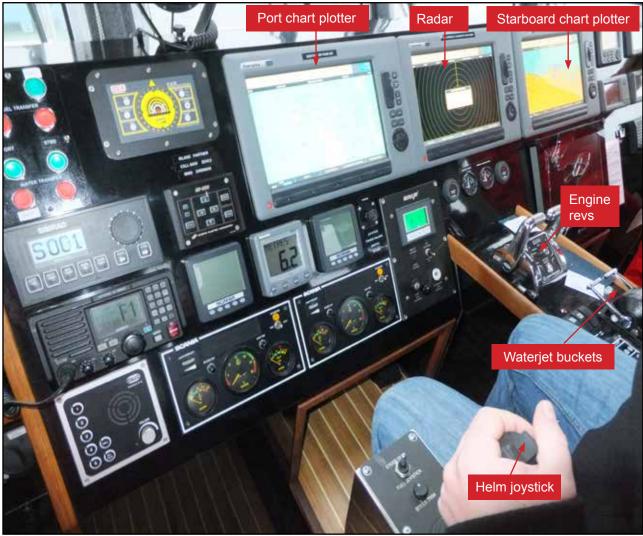
Island Panther was fitted with a modern ergonomically-designed wheelhouse enabling the master to operate most equipment from his port seat (Figure 36). The wheelhouse was fitted with three Raymarine C-Series windscreen multifunction displays. The system took inputs from the echo sounder, radar, satellite compass, AIS, GPS and radar. The screens could then be used to display different outputs as required by the operator. The normal arrangement employed had the port screen assigned as a chart plotter, overlaying positional and AIS information on Navionics charts, the centre screen set as the radar, and the starboard screen used as a chart plotter for the deckhand. The radar was fitted with a mini automatic radar plotting aid to assist in target tracking and collision avoidance.

Figure 36: Island Panther helm position

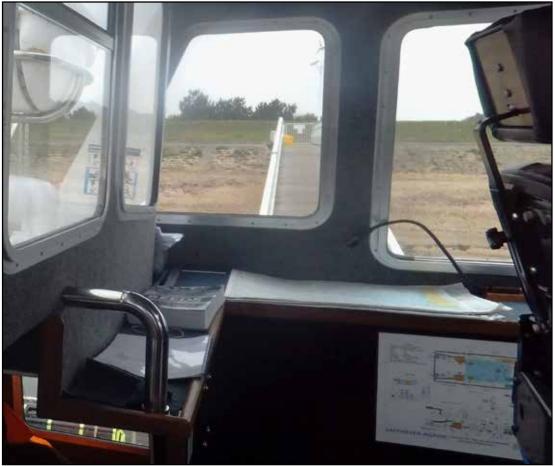
Island Panther did not have a dedicated chart table, although the table in the passenger area could be used to lay out a chart. There was also a shelf at the rear of the wheelhouse on which charts could be stored and readily accessed from the two wheelhouse seats (**Figure 37**).

Figure 37: Chart stowage area

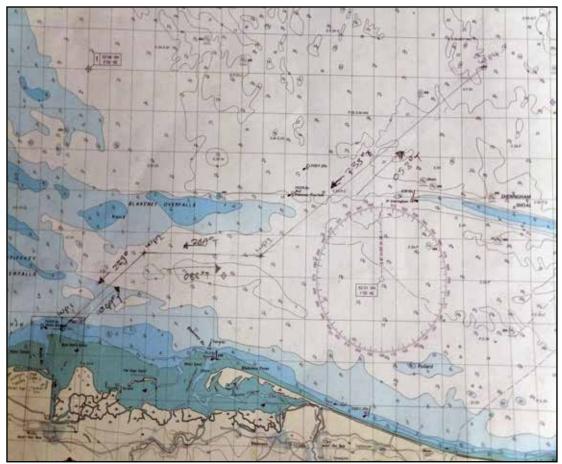
An approved passage plan from Wells-next-the-Sea to the wind farm was provided by Scira and was contained in Sheringham Shoal Captain's Handbook (Annex N). The plan had been transposed onto the paper chart on board *Island Panther* (Figure 38) and input to the chart plotter in the form of four waypoints OB1-OB4 that formed the route. The crew also had manually added all 88 turbines in the wind farm to the chart plotter, highlighting them with a buoy symbol (Figure 39). The turbine positions were taken from the Captain's Handbook.

Figure 38: Chart with passage plan, in use on board Island Panther

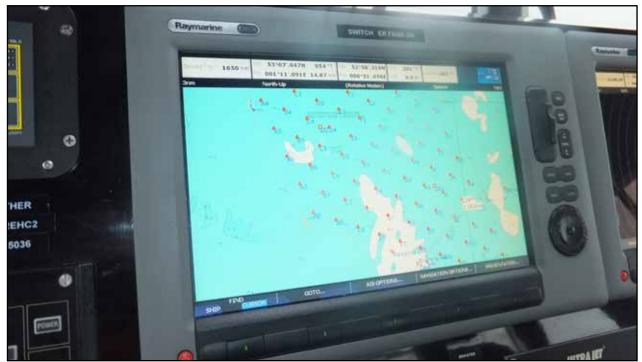
Figure 39: Turbine positions displayed on Island Panther's chart plotter

Island Panther's crew did not plot positions on the paper chart as the chart plotter provided them with an instantaneous GPS position. The chart plotter system had the functionality of many similar systems, including an ability to show the vessel's heading and course over the ground vectors, and cross-track error. At the time of the accident, the night master was not employing these functions.

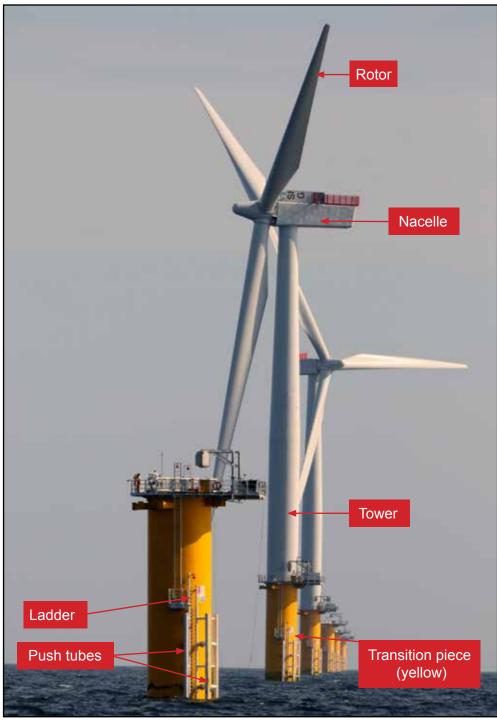
Each turbine consists of several key components (Figure 40). Access to and from the turbine is gained via a ladder with push tubes situated on either side, against which a PTV's bow is positioned. Each turbine has two ladders and associated push tubes situated on the transition piece. The PTV master chooses the best ladder to use depending on the tidal stream and sea conditions. Each ladder has fall-arrest gear to which the turbine technicians attach themselves before climbing the ladder. Masters were encouraged to report defects, such as faulty fall-arrest gear, to enable repairs to be scheduled.

Figure 40: Wind turbine
