Report on the investigation of
the contact and grounding of
the bulk carrier

Amber

at Gravesend Reach, River Thames

on 15 November 2012

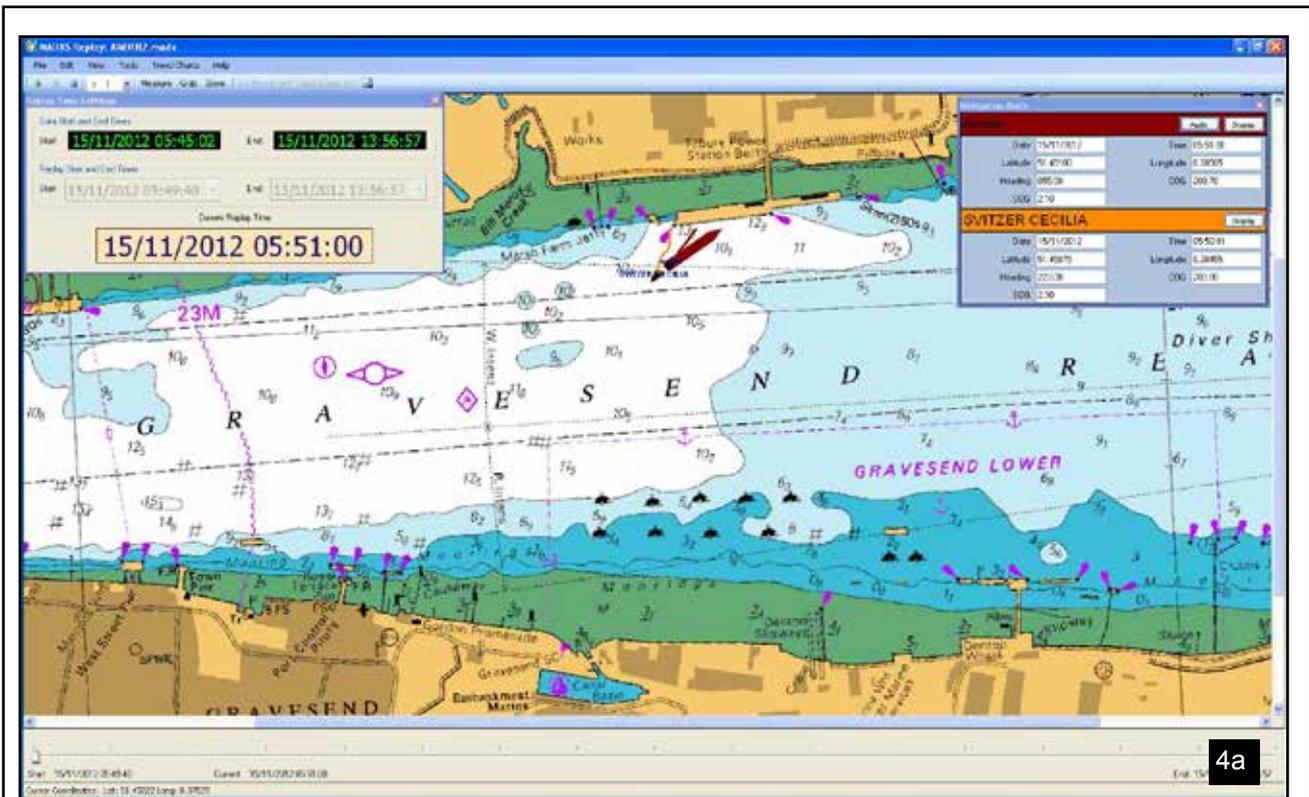
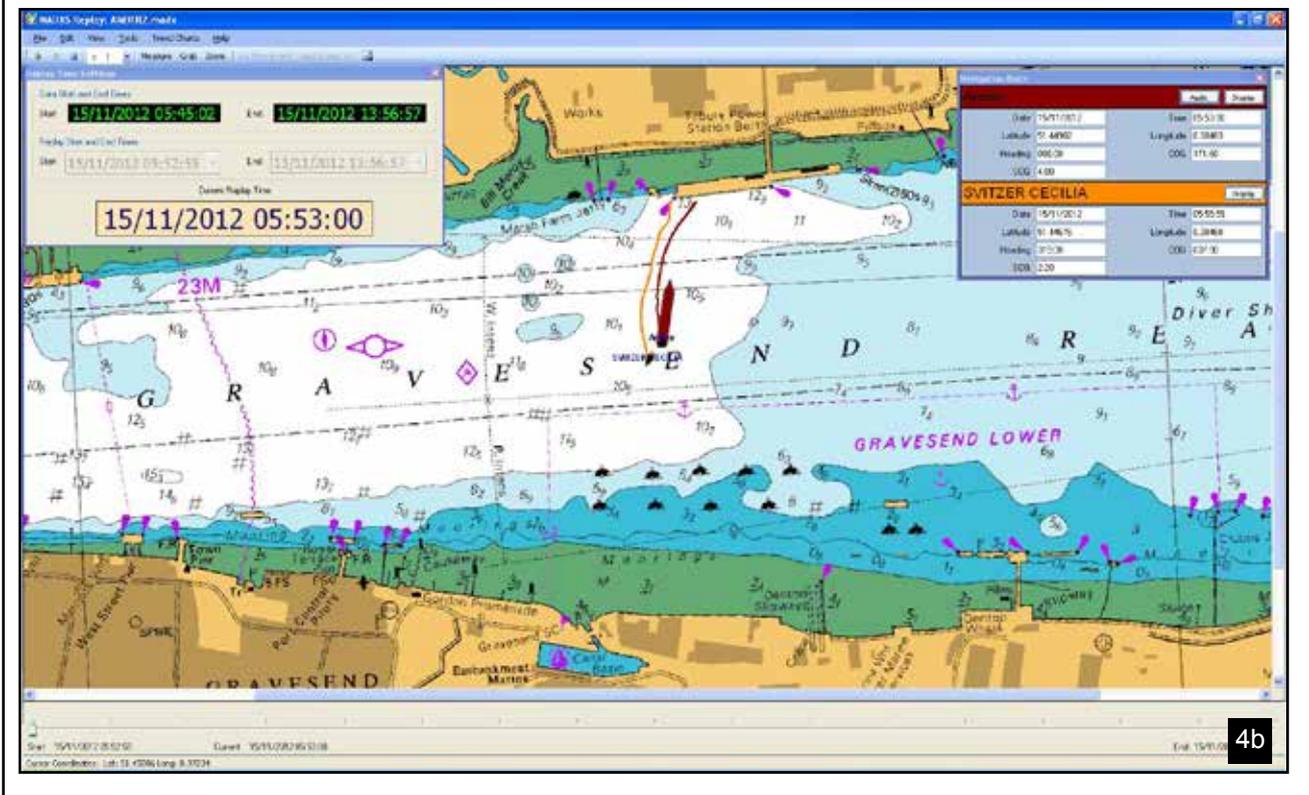
Figures 4a and 4b: Amber's manoeuvre from departure to accident

At 0551 (**Figure 4a**) the master and pilot entered the wheelhouse: the pilot ordered the engine to slow-astern and *Amber's* speed over the ground (SOG) increased to 2.1 knots on a course over the ground (COG) of 210°. As the vessel moved astern and swung to port, the radar screen became cluttered as the trails from the land on both sides of the river moved relative to the vessel.

At 0553, *Amber's* engine was stopped and the pilot ordered 'dead-slow-ahead' and the helm hard-to-starboard: the SOG was 4.0 knots and COG 171° (**Figure 4b**). The pilot requested *Svitzer Cecilia* to pull on the port quarter at 25% power and, at 05:53:40, ordered the tug to increase to 50% power. At that time, *Amber's* SOG was 4.0 knots on a COG of 163° (**Figure 4c**). At 0554 the pilot ordered *Amber's* engine to slow-ahead and a few seconds later to half-ahead.

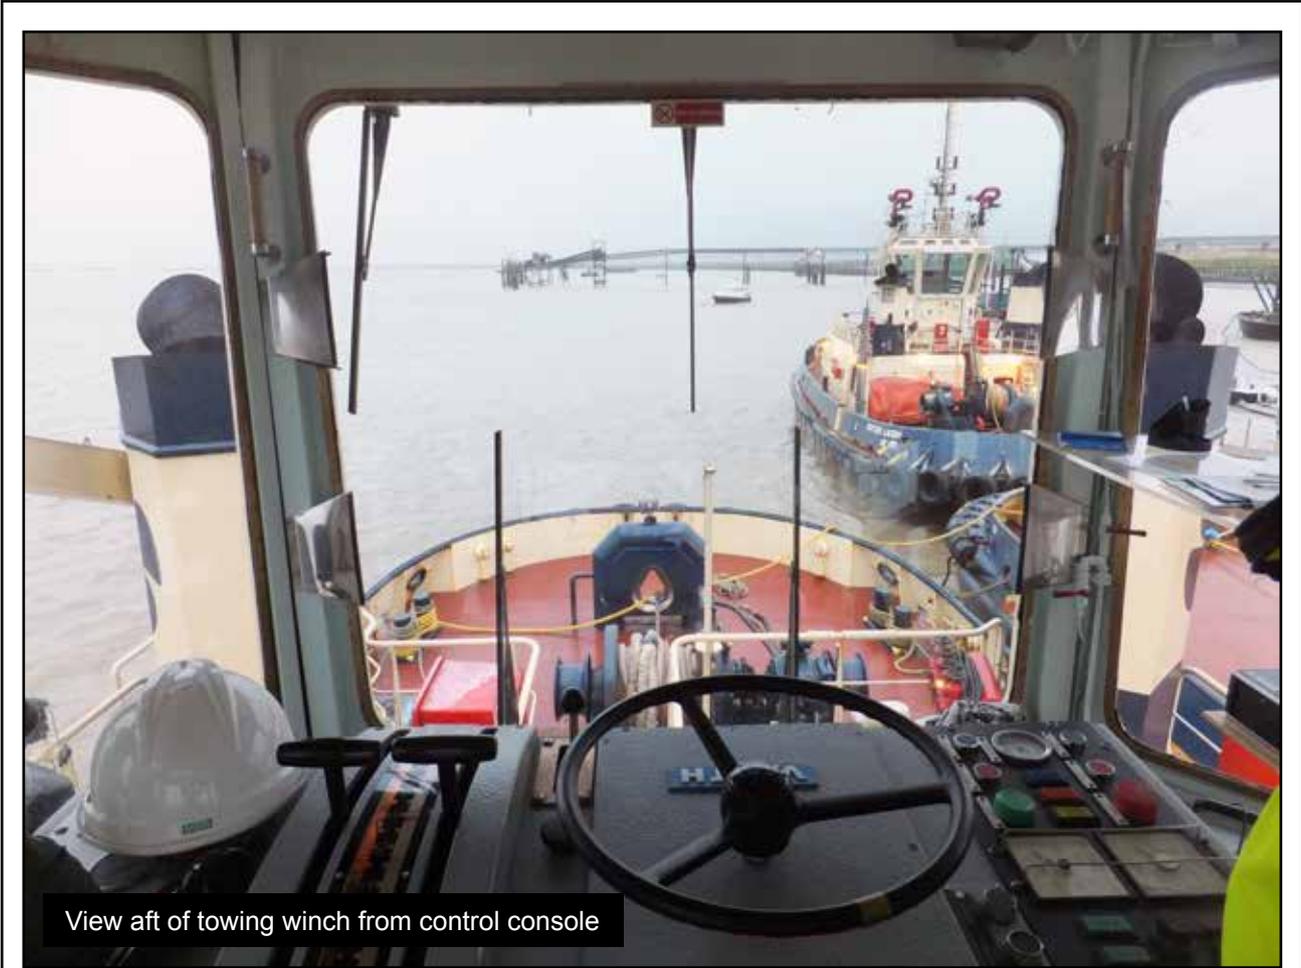
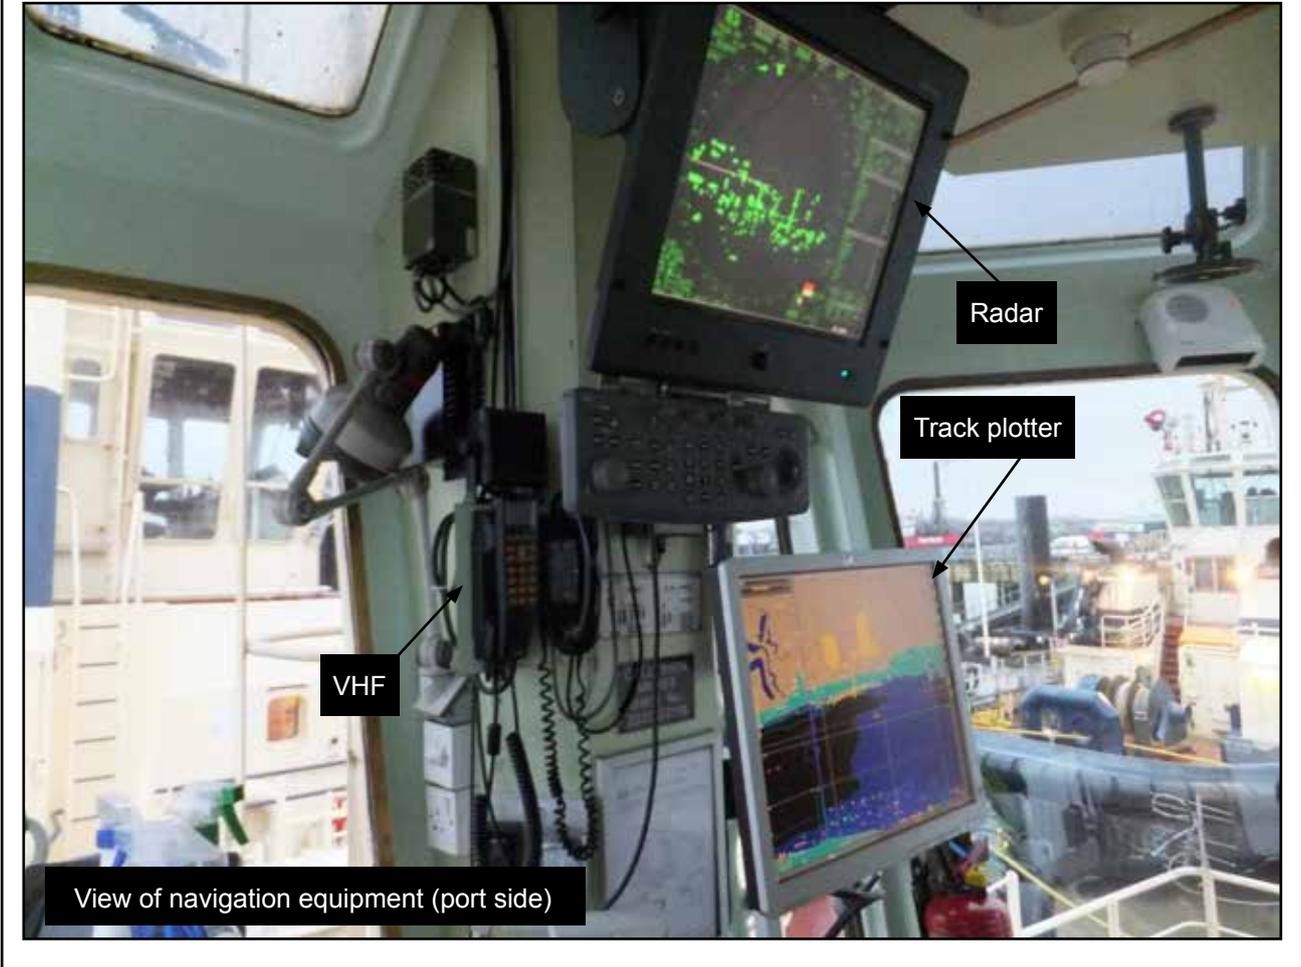
Figure 7: Svitzer Cecilia - bridge layout

Svitzer Cecilia's bridge was equipped with VHF radios, a JRC radar and a Transas chart plotter capable of displaying vessels with Automatic Identification Systems (AIS). The radar display and chart plotter were located on a pillar between two windows on the port side of the wheelhouse (**Figure 7**). When towing, the master sat at the control console and looked aft towards the vessel under tow, with the radar and chart plotter on his right hand side.
