Report on the investigation of
the foundering of the small passenger ferry

Vixen

in Ardlui Marina, Loch Lomond

on 19 September 2012

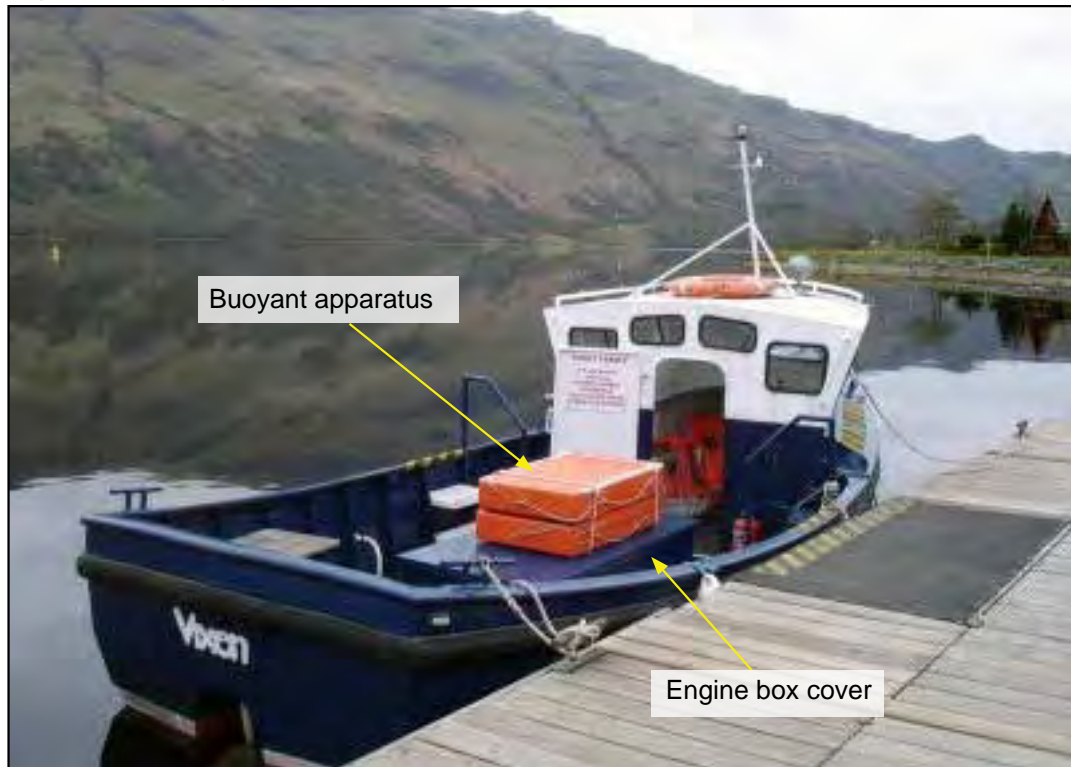
Figure 3: *Vixen* alongside in Ardlui before the accident

all sat on the seats which were situated at the stern of the boat. The female passenger sat forward on the starboard side facing the wheelhouse (**Figure 5**). The passengers placed their rucksacks either on the deck in front of them, or on top of the engine box (**Figure 3**). The skipper manoeuvred *Vixen* astern away from Ardluish jetty, turned it to port and increased to a speed of around 6 knots, and steered a heading back to Ardlui marina.

Two buoyant apparatus, each one approved for six persons, were located on top of *Vixen's* engine box and were tied down with quickly releasable bungee cords (**Figure 3**).

A lifebuoy was located on top of *Vixen's* wheelhouse (**Figure 3**).

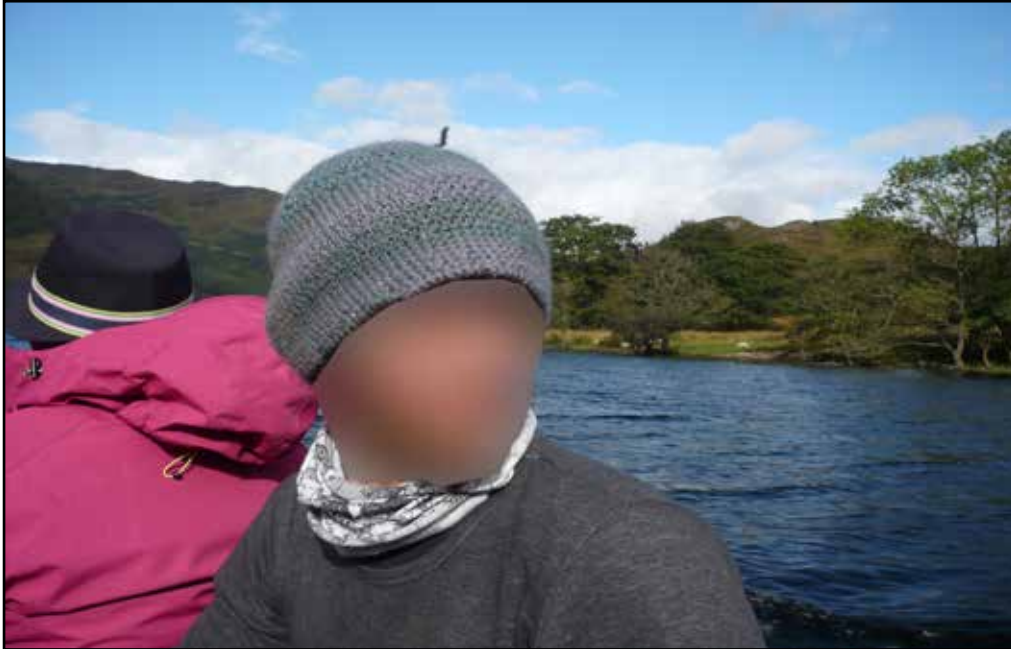
Figure 5: Passengers sitting on *Vixen*'s starboard side immediately prior to the accident

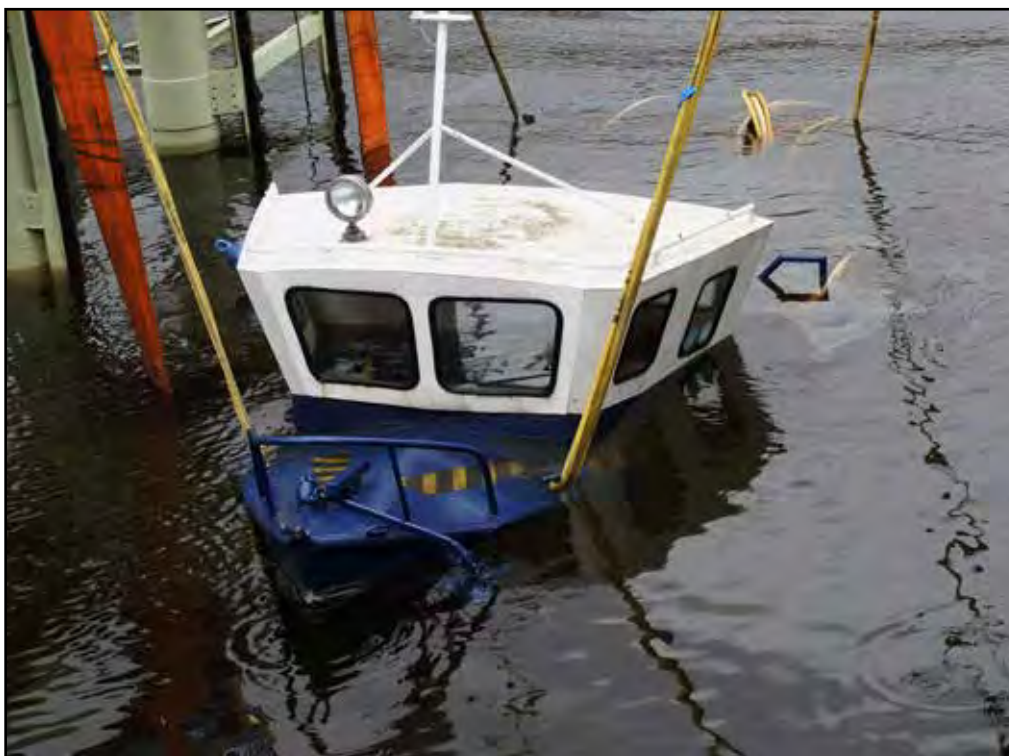
Vixen sank in a depth of between 6m and 7m. When the vessel was located by divers the boat was found to be upright with the stern embedded in soft mud. *Vixen* was lifted using airbags on 2 October 2012, transferred to the boat lift in Ardlui Marina and lifted out of the water (**Figure 7**).

Figure 7: *Vixen's* salvage

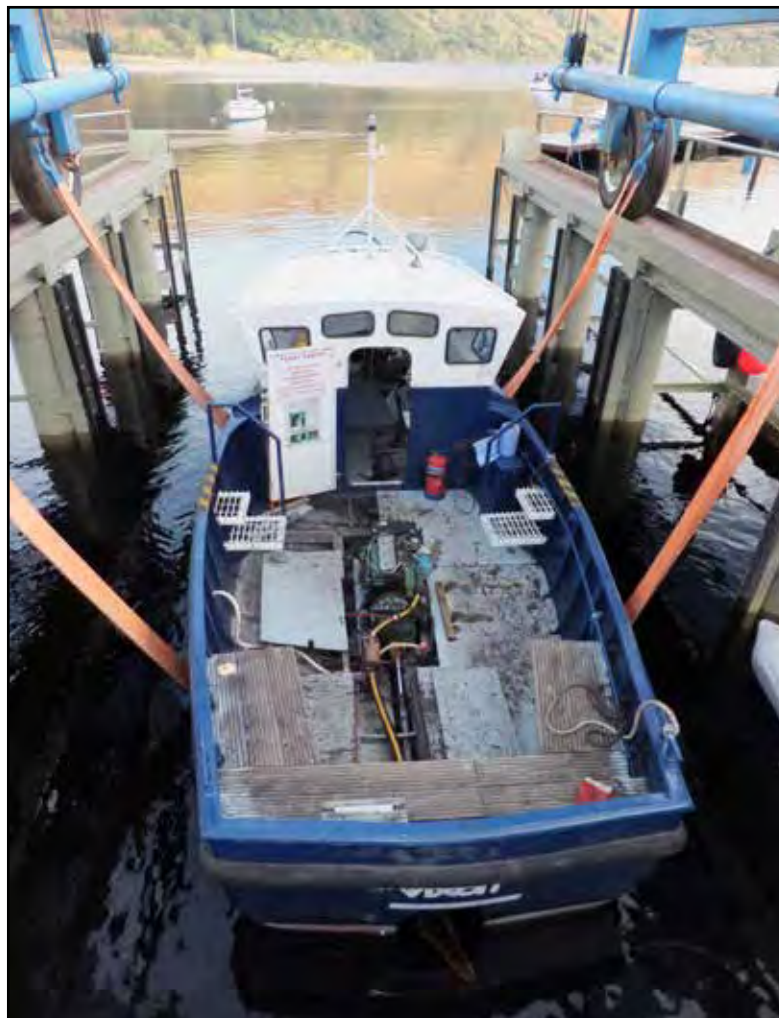
The passengers were provided with fixed bench seating at the stern of the boat (**Figure 8**). This could comfortably seat a maximum of around 6 passengers. Additional passengers could also sit on the edge of the engine box cover (**Figure 3**).

Figure 8: *Vixen*'s passenger seating arrangement

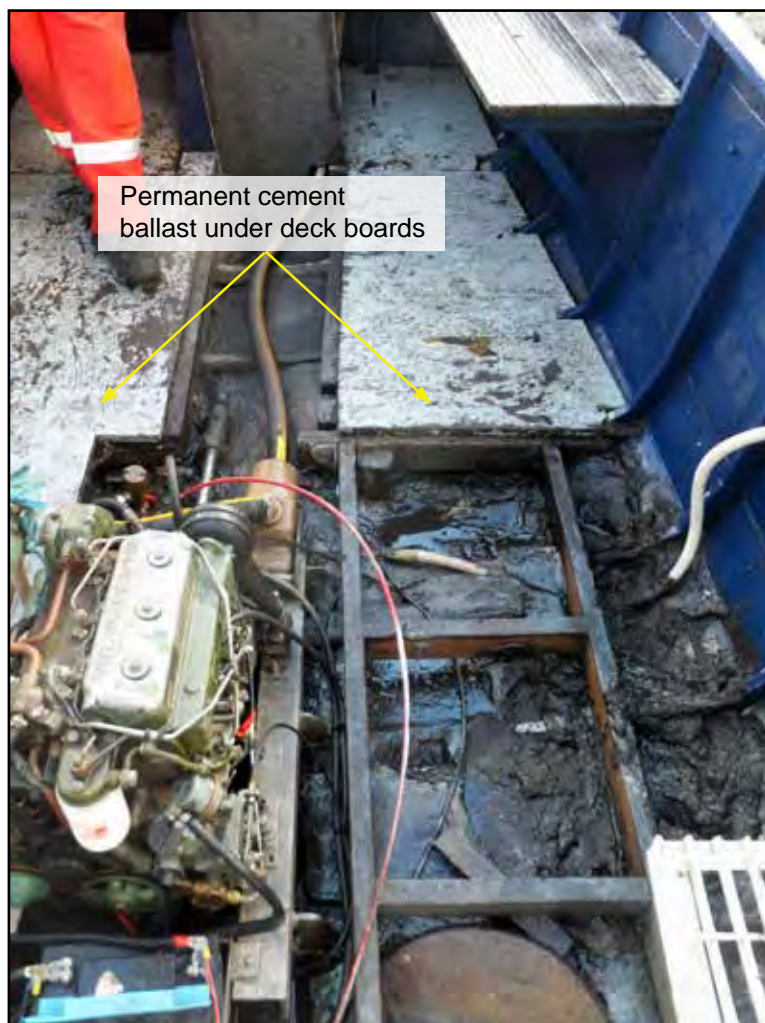
Vixen had been fitted with permanent cement ballast at the stern on both port and starboard sides (**Figure 12a**). Steel weights were placed in the mid section, mostly on the port side (**Figure 12b**). It was not known when the ballast was fitted.

Figure 12a: Permanent cement ballast at stern

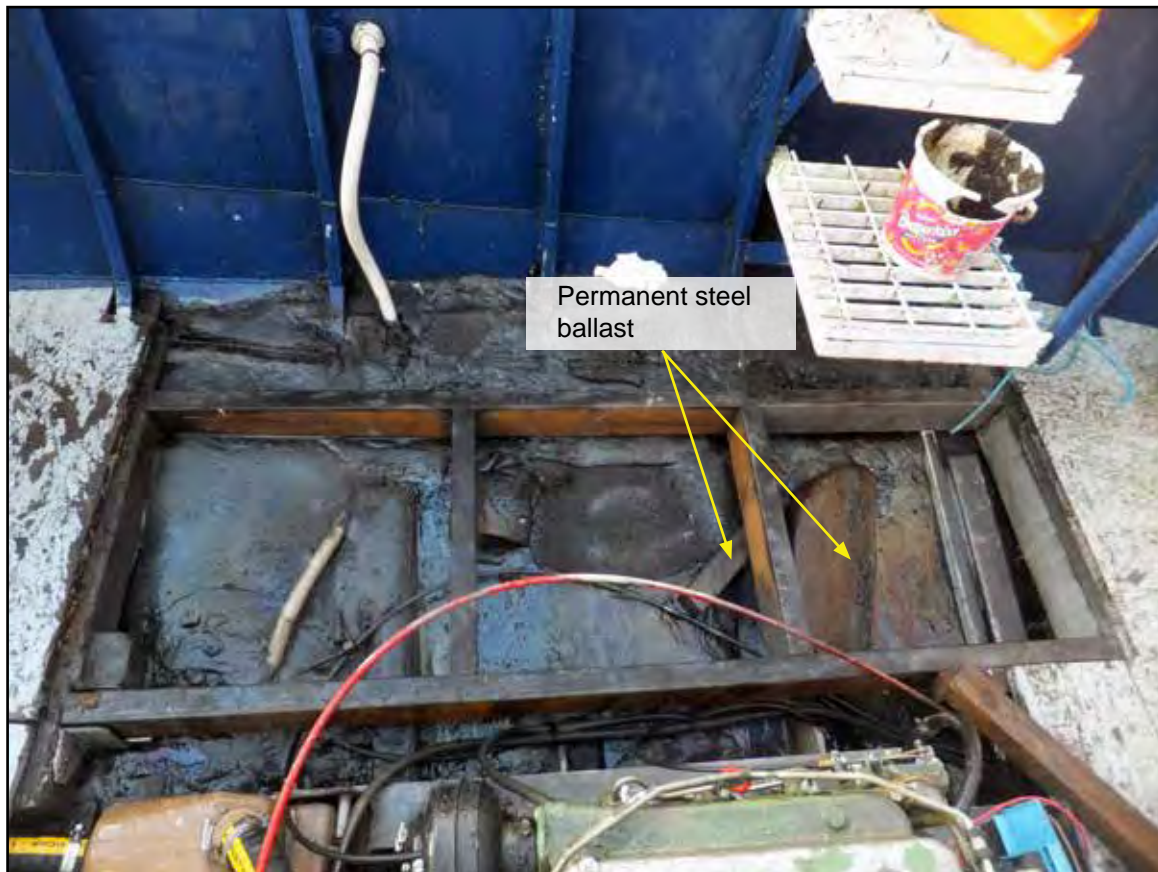
Figure 12b: Permanent metal ballast in mid section

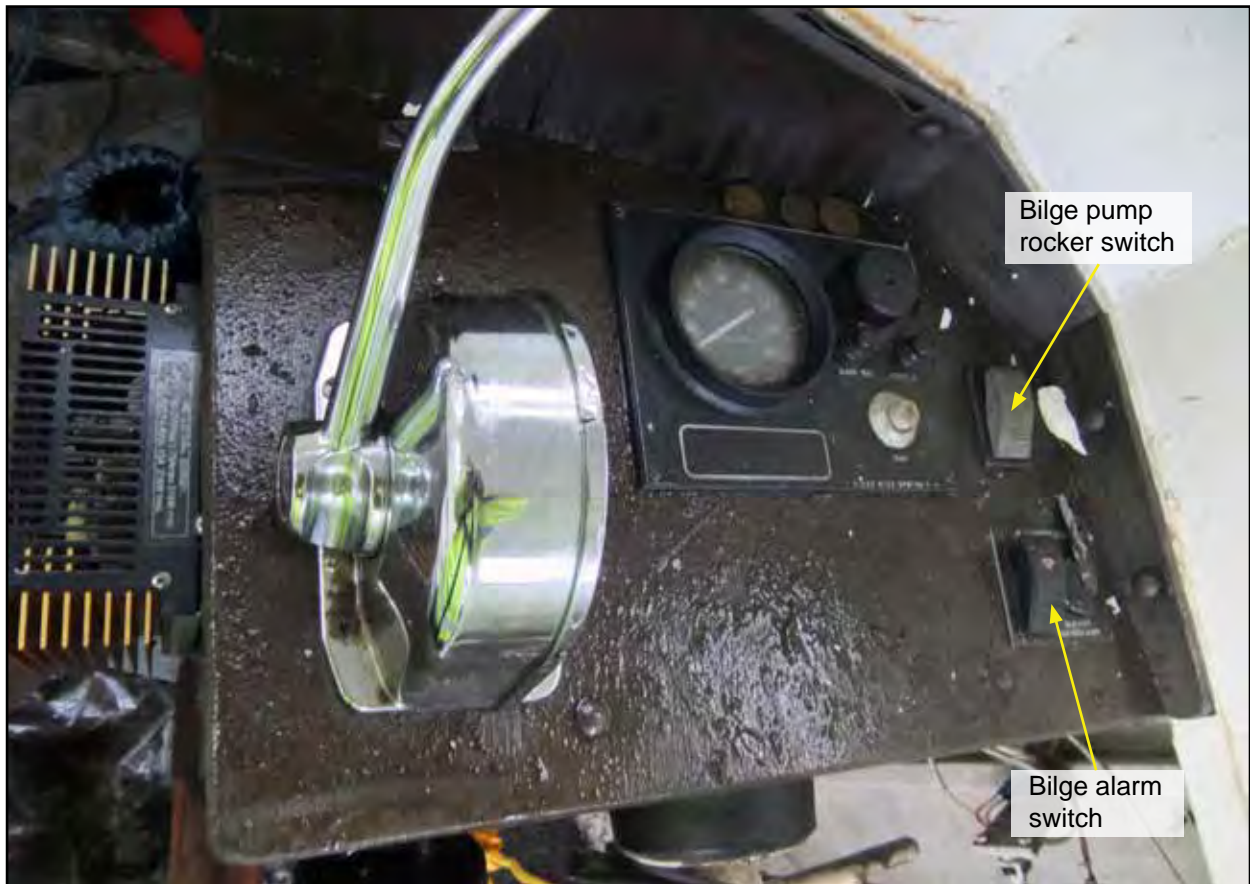
The bilge pump could also be activated manually, regardless of the position of the float switch, by a rocker switch located in the wheelhouse (**Figure 14**).

Figure 14: Bilge pump rocker switch

A new bilge alarm system was fitted to *Vixen* in March 2010. The alarm was activated by a sensor fitted in the bilge (**Figure 17**). The bilge alarm was powered from the main battery and was activated by a switch in the wheelhouse (**Figure 14**). The alarm system was also protected by an in-line fuse.

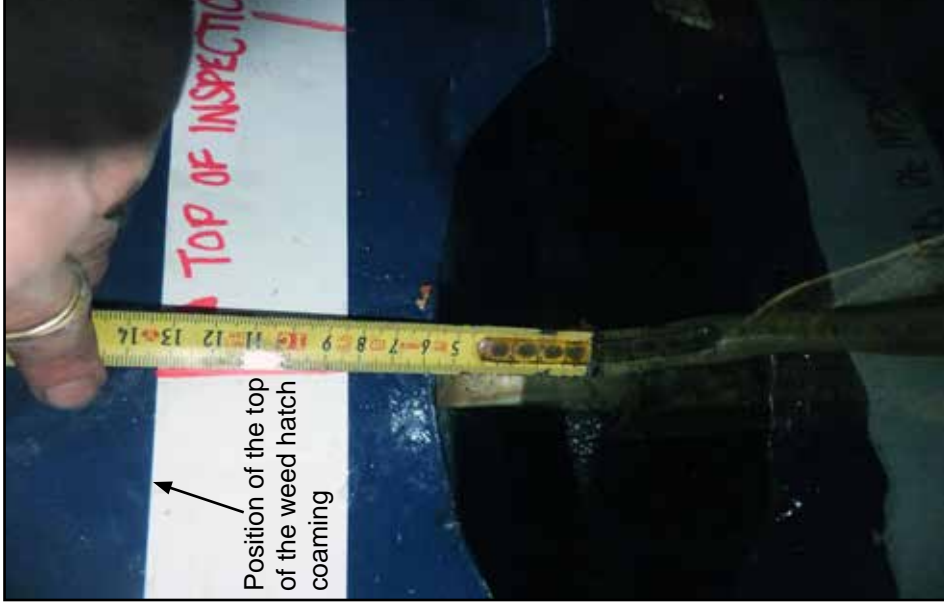
| Condition | Passenger and crew loads | Rucksacks | Bilge conditions | Effective freeboard (waterline to top of weed hatch coaming) |
|---|---|---|--|--|
| Loaded 2 | 6 passengers 1 crew | 6 | Bilge full to bilge pump suction level | 130mm (Figure 19b) |

Figure 19b: Loading condition 2

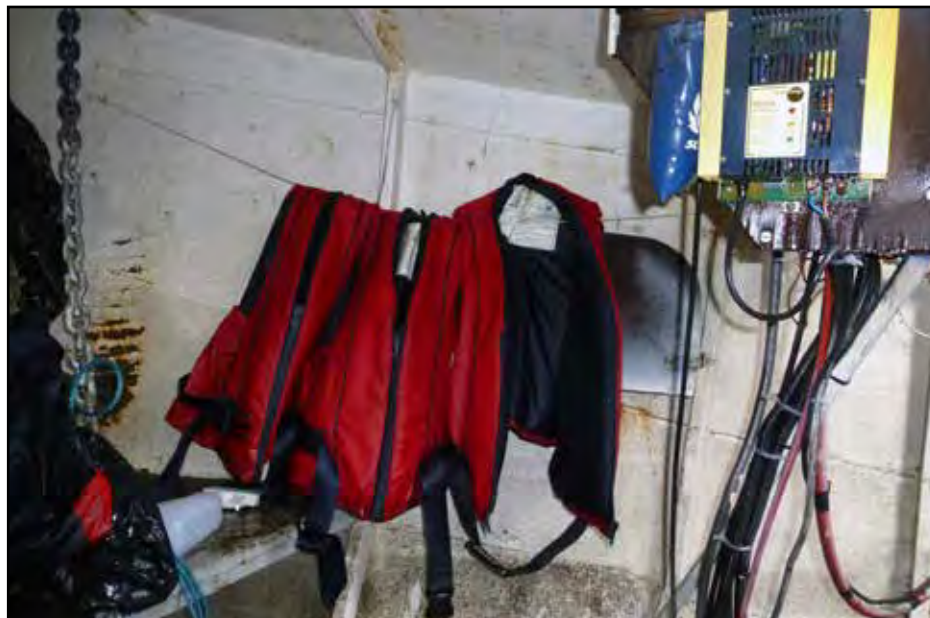
Five 100 N² lifejackets (**Figure 20a**) were located inside the port side of *Vixen's* wheelhouse, inside plastic bags. Six other buoyancy aids of various sizes (**Figure 20b**) were found on board *Vixen* after the accident. Of these, two 100 N buoyancy lifejackets were found on the port side of the wheelhouse; three 45 N buoyancy aids were found tied to a horizontal line secured on the starboard side of the wheelhouse (**Figure 20c**) and one child's 45 N buoyancy aid was found at the forward end of the wheelhouse.

Figure 20c: Buoyancy aids secured inside the wheelhouse
