Report on the investigation of
the capsized and foundering of the fishing vessel

Sarah Jayne (BM 249)

6nm east of Berry Head, Brixham

11 September 2012

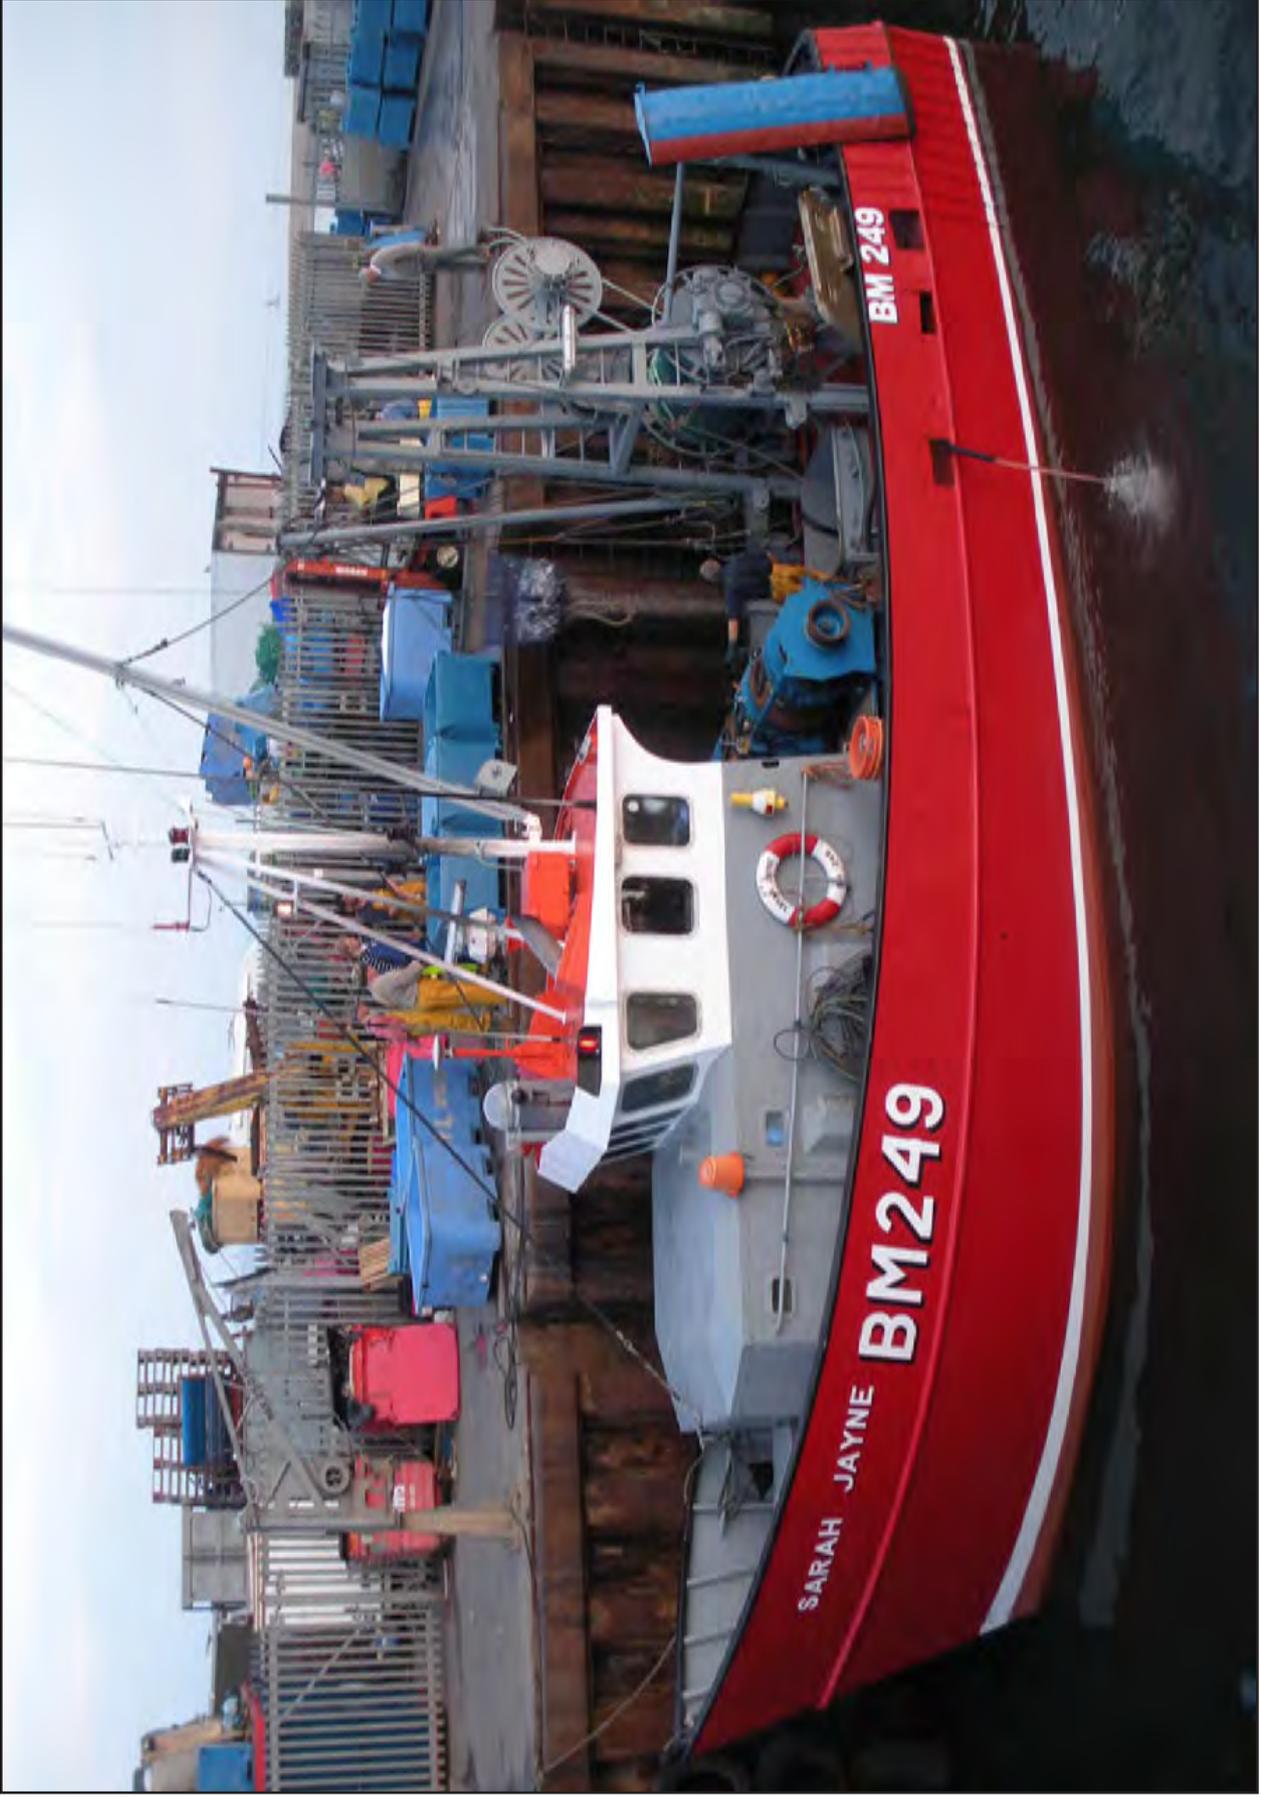
Figure 1: Sarah Jayne, rigged for stern trawling

Sarah Jayne (**Figure 1**) was based in Exmouth. She was used primarily for scallop dredging but also carried out stern trawling, particularly for sprats between August and January. The start and length of the sprat season depended on fish stocks. At the time of the accident, sprat stocks were abundant and local fishing vessels were landing large catches.

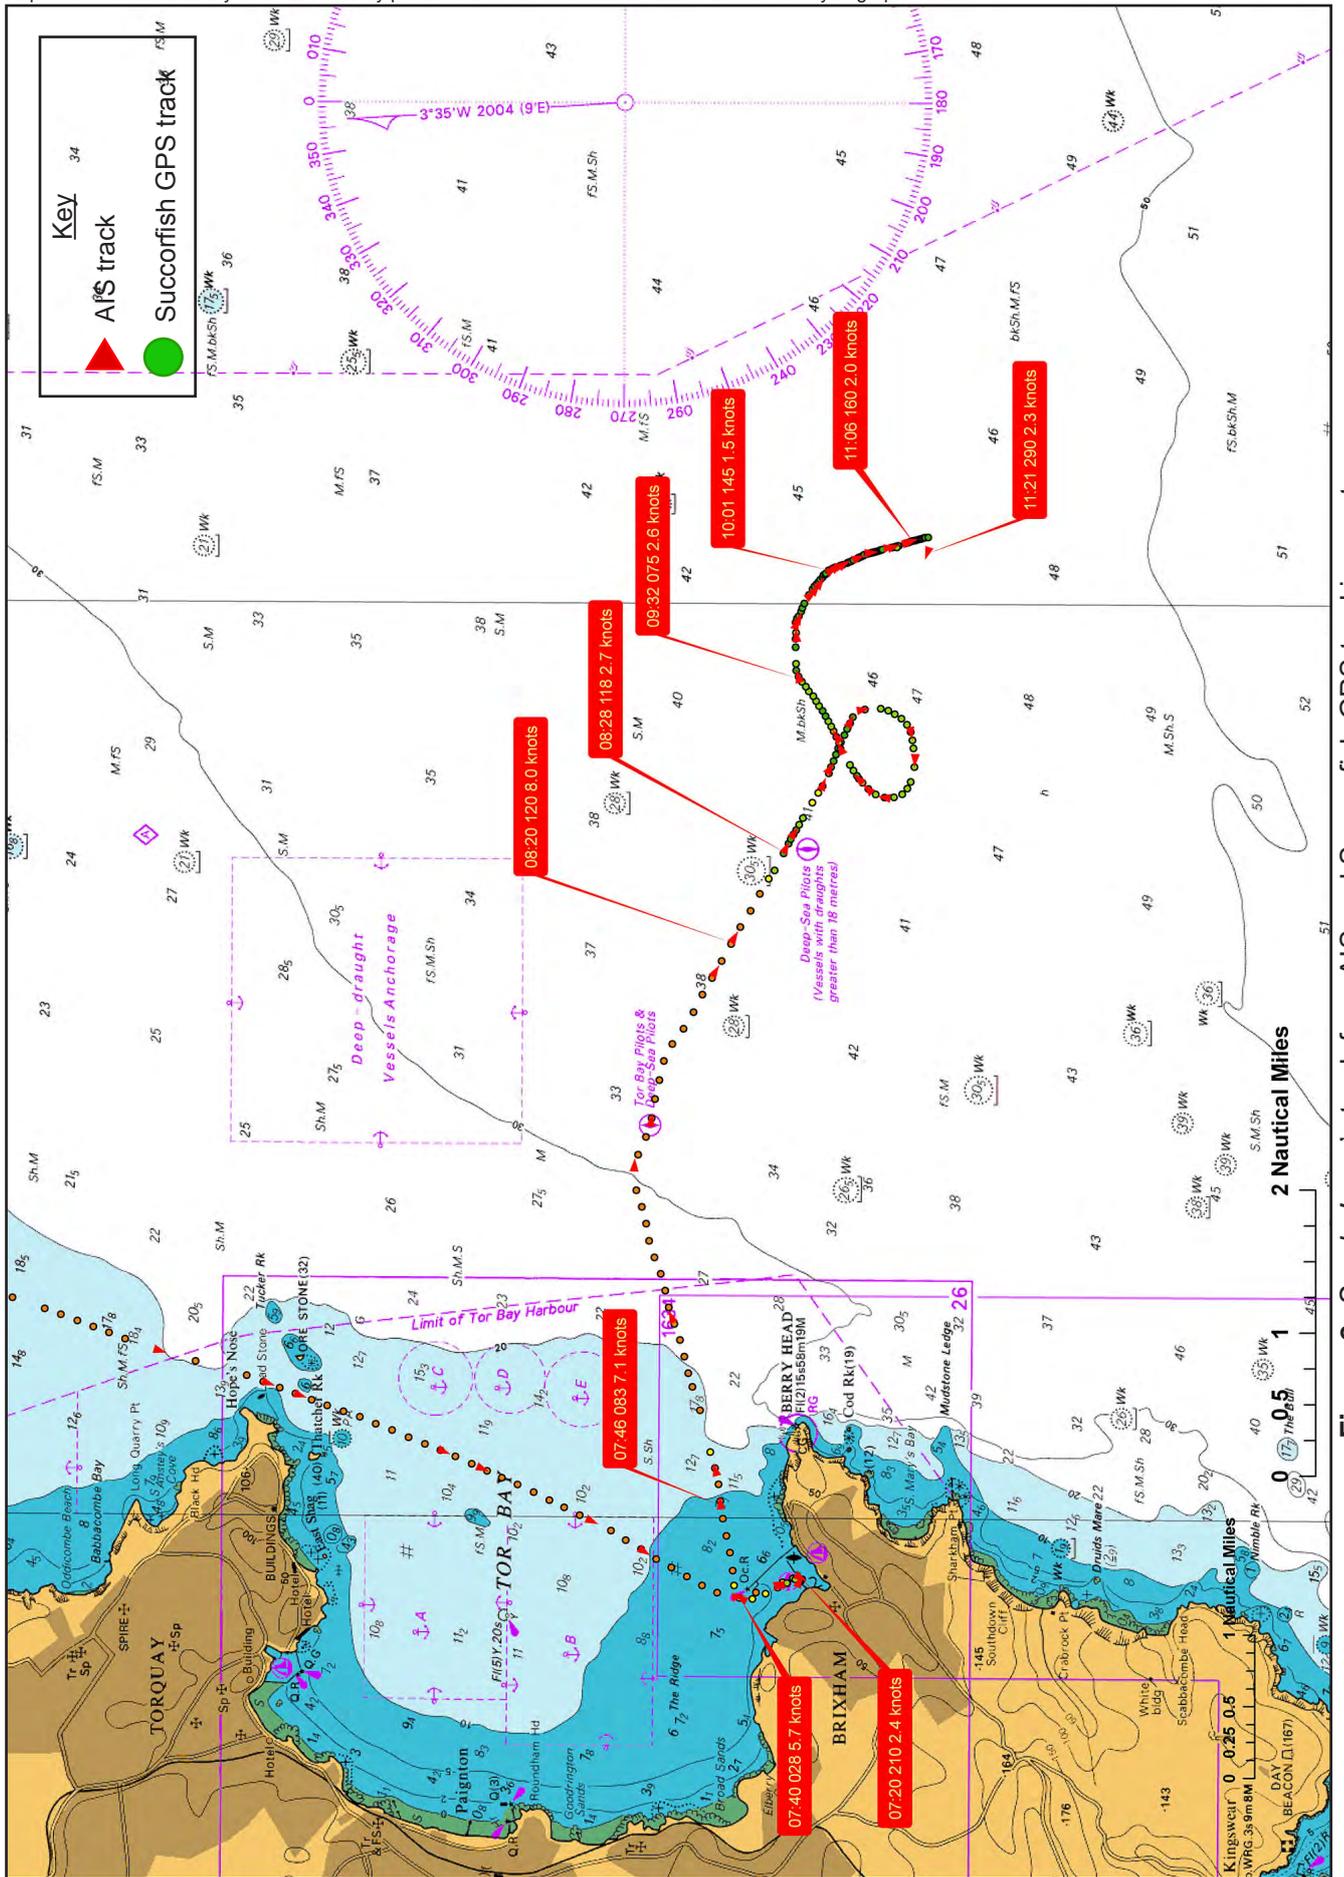
Figure 2: Sarah Jayne's track from AIS and Succorfish GPS tracking system

Fishing vessels *Constant Friend* and *Girl Rona*, with which *Sarah Jayne* often fished, were already heading towards the fishing grounds in Torbay. At about 0740, *Sarah Jayne* departed Brixham and a course was set for the fishing grounds. During the passage to the fishing grounds the mate rested, but he was called to assist with shooting the gear, which occurred around 0830-0845. The skipper started his tow in a south-easterly direction with 90 fathoms of wire deployed. Later, another 20 fathoms of trawl wire length was veered as the shoal of fish the vessel was tracking had swum deeper. At about 1000, the skipper decided to haul the net. **Figure 2** shows *Sarah Jayne*'s track from AIS and the Succorfish GPS tracking system.

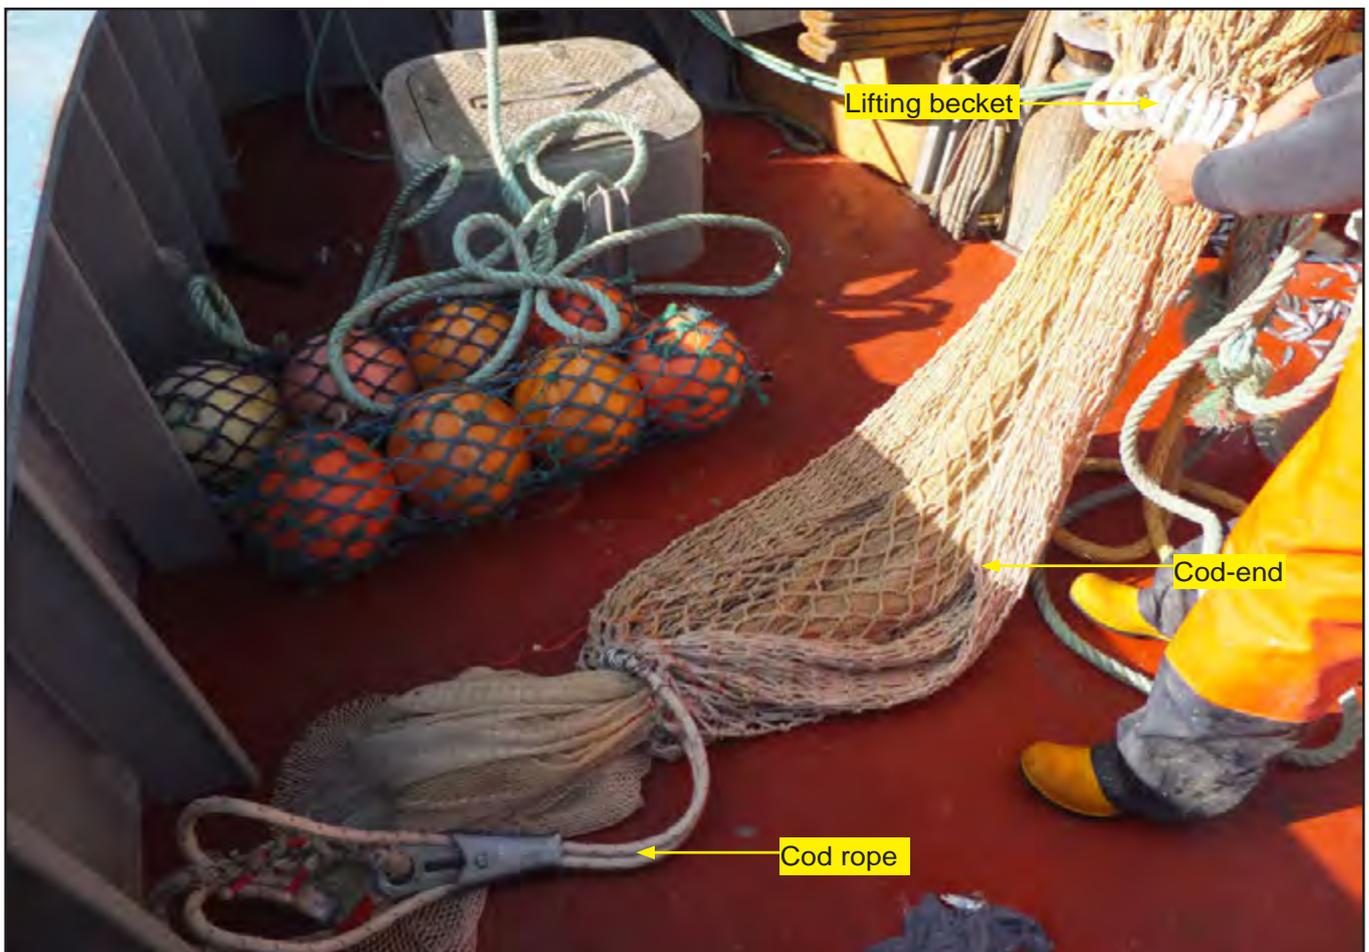
Figure 4: Cod-end

¹ Besides providing a lifting point, the lifting becket also tightened around the cod-end, so that only the fish between the becket and the opening in the end of the cod-end were released onto deck.

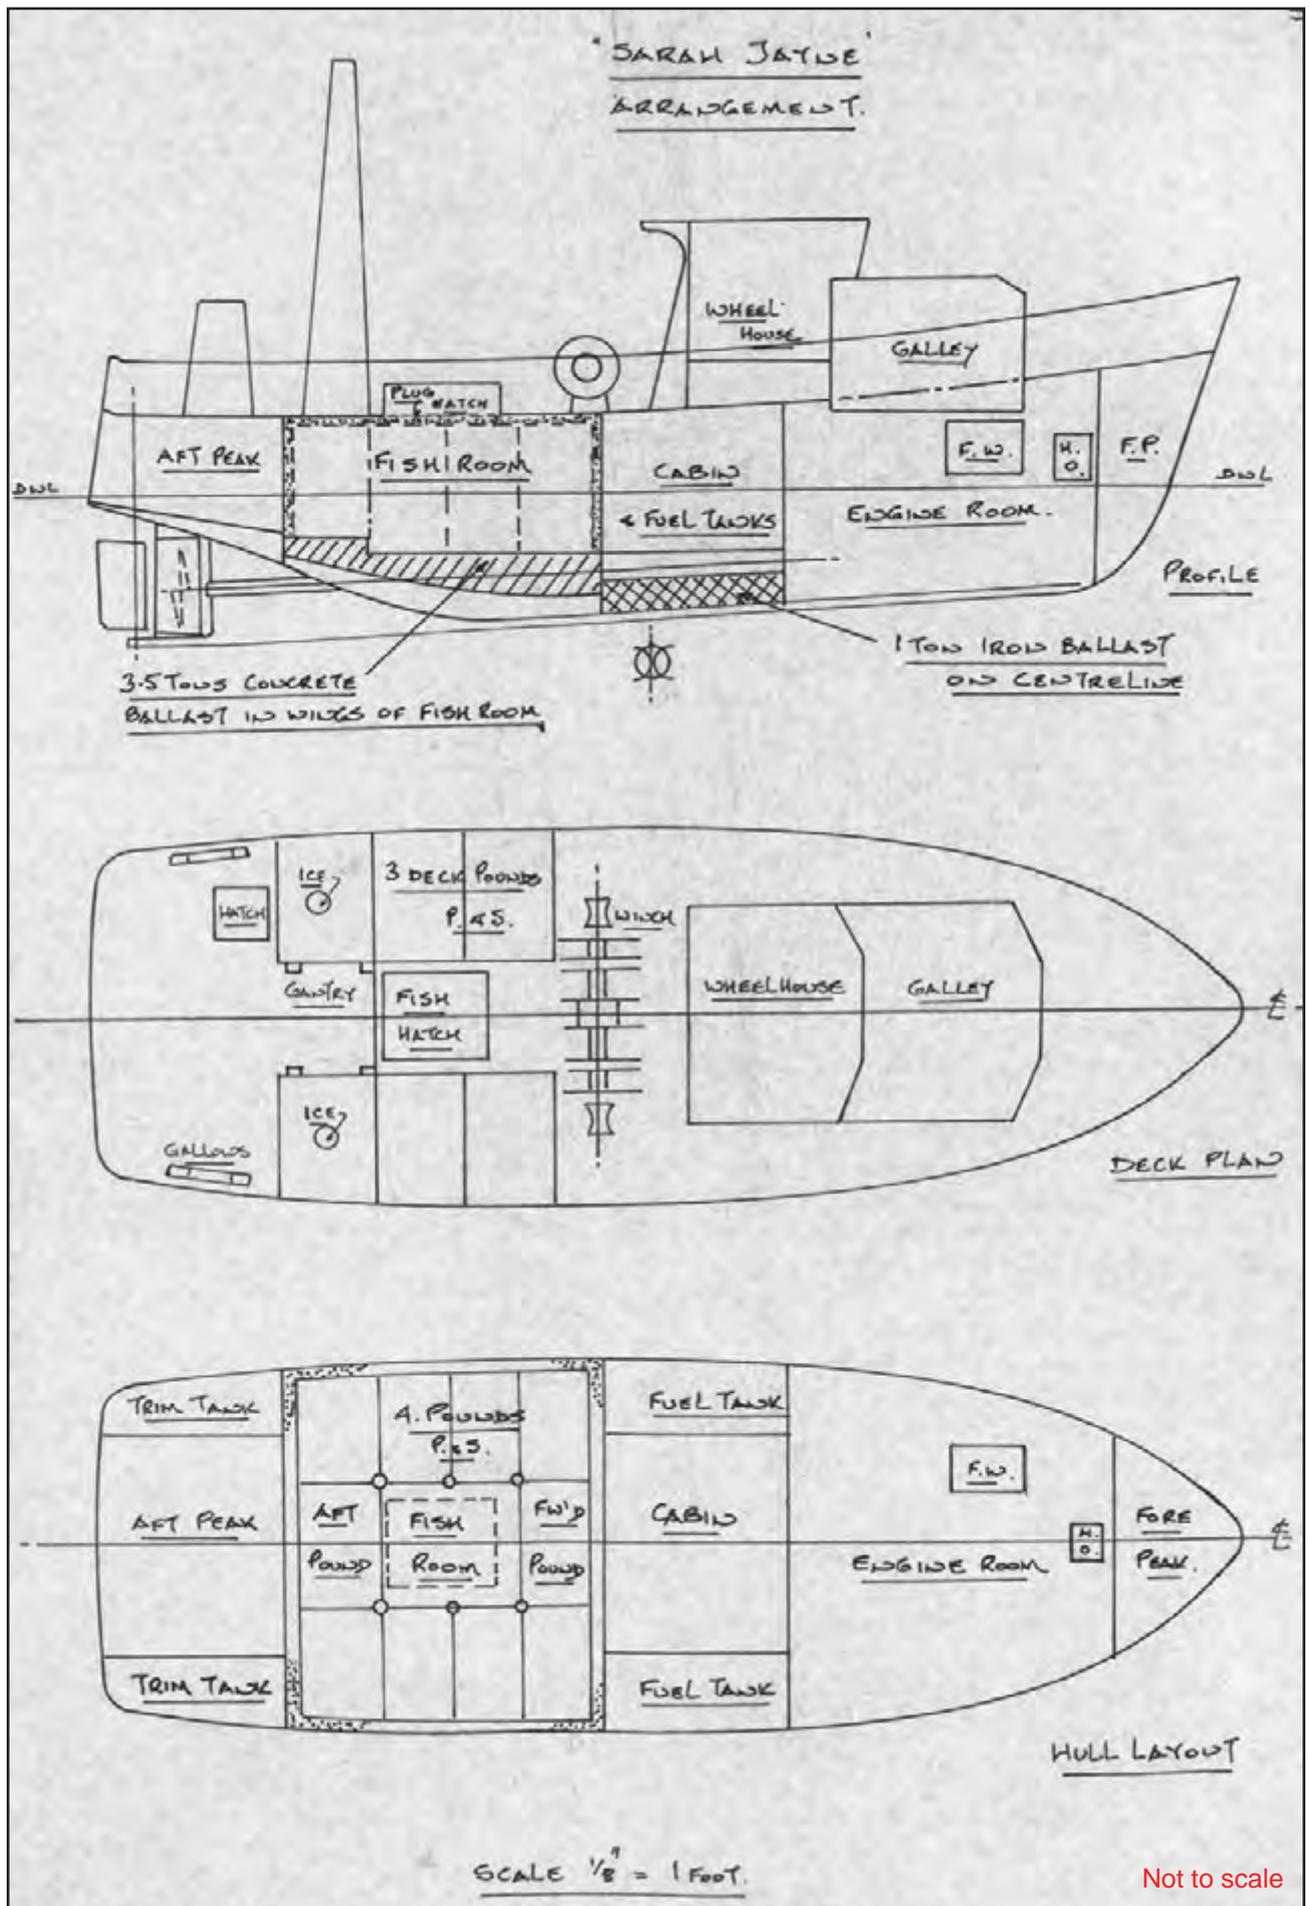
Figure 5: Sarah Jayne general arrangement

Sarah Jayne was built in 1979 by W. Visick & Sons Ltd, Truro. She was a multi-purpose fishing vessel, capable of being used for scallop dredging as well as beam and stern trawling (**Figure 5**). However, the owner had never used the vessel for beam trawling and had not sought a licence to do so.

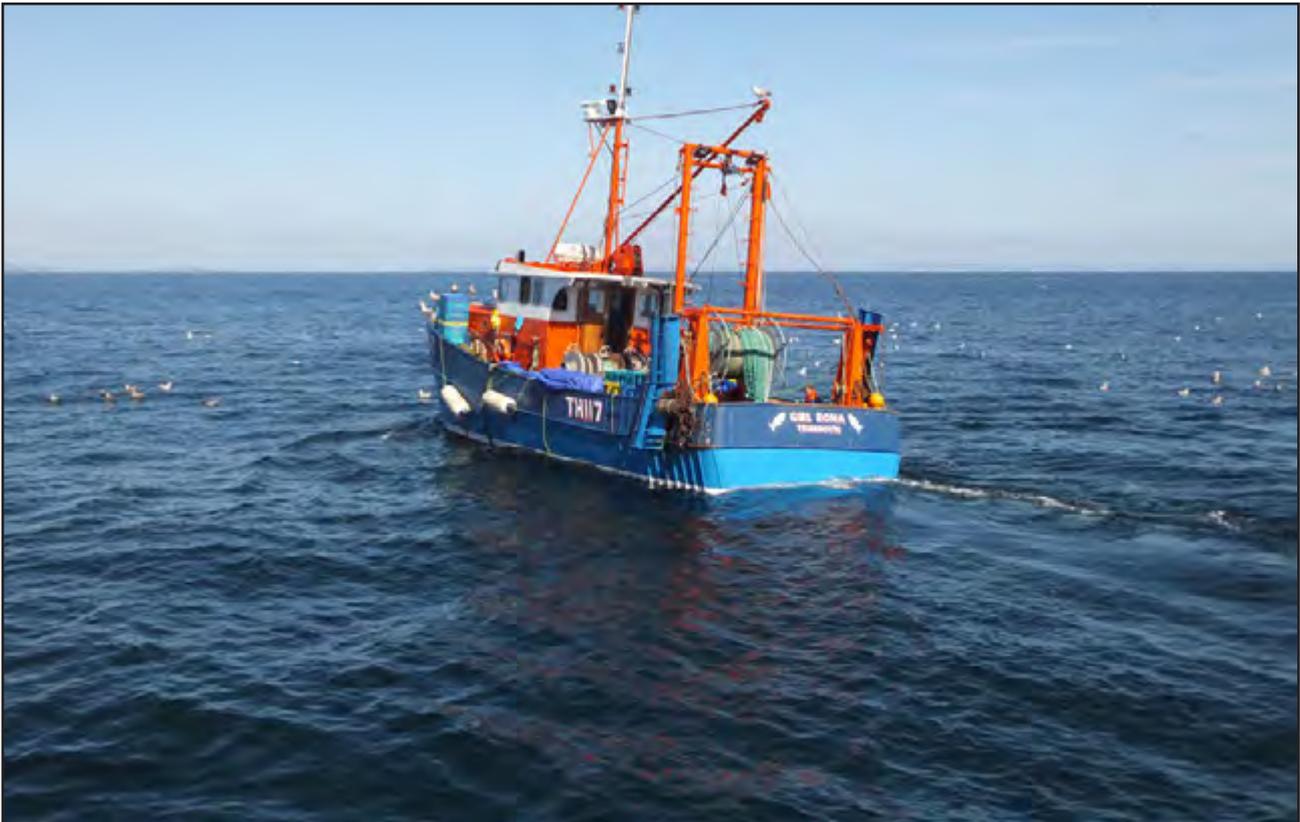
Figure 6: FV *Girl Rona*

Sarah Jayne was built as the second in a series of three similar sister vessels all developed by the same designer. The first, *Gerry Ann C* (TH 257), was constructed in 1975 and the third, *Girl Rona* (TH 117) (**Figure 6**), was completed in 1980. All three vessels operated in the Torbay and Lyme Bay area.
