Report on the investigations of the flooding and foundering
of the fishing vessel

Audacious

the flooding and foundering of the fishing vessel

Chloe T

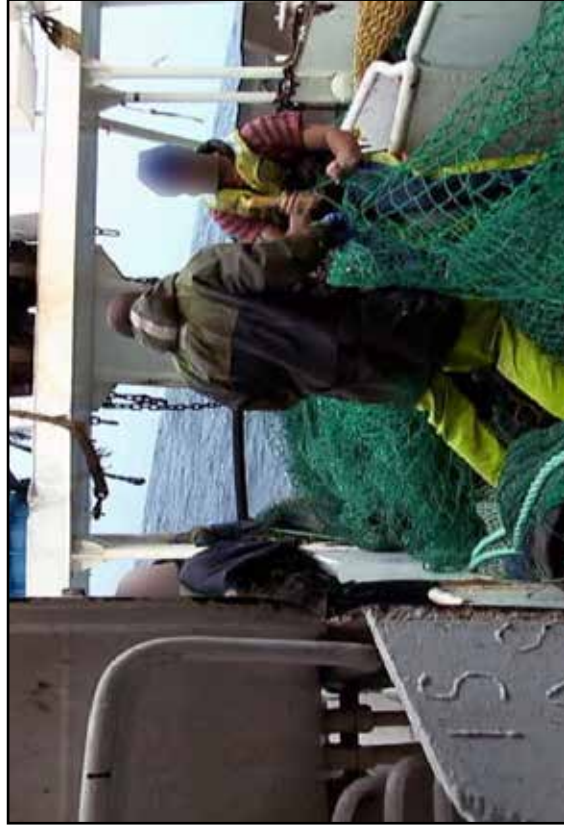
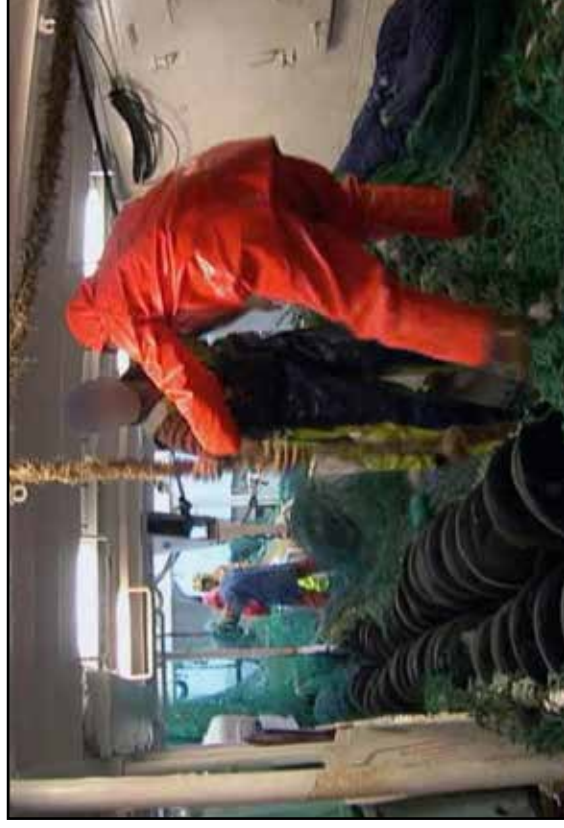
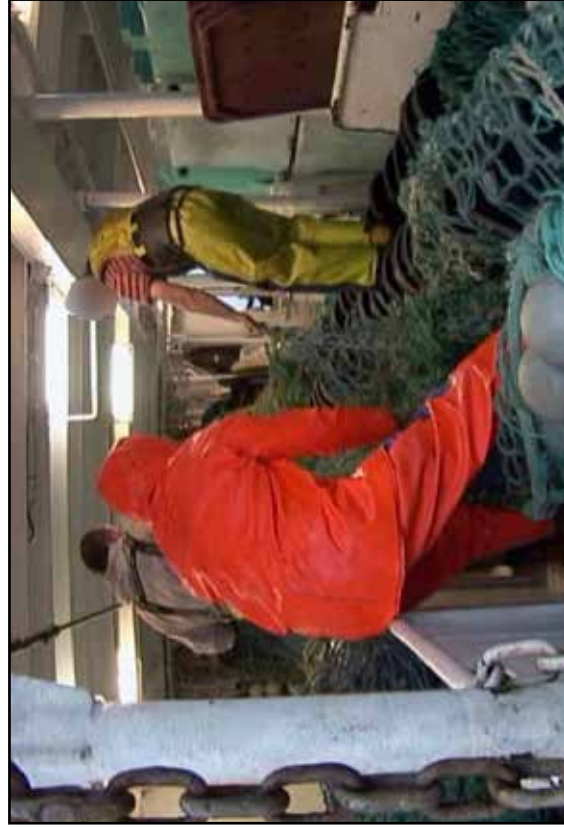
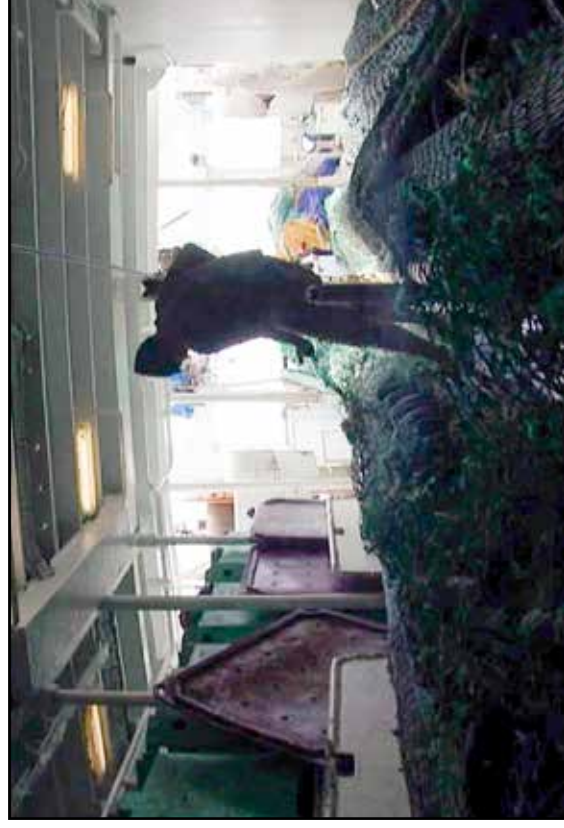
At about 1300, after cleaning and stowing the catch of fish, the damaged net was spread out over the upper and main decks and the crew began to make repairs (**Figure 1**). The skipper was the sole bridge watchkeeper; at the same time he oversaw the four crewmen who were mending the net. The engineer washed down and cleaned the fish processing deck throughout this period.

Figure 1: Torn net spread over the upper and main decks (taken on an earlier fishing trip)

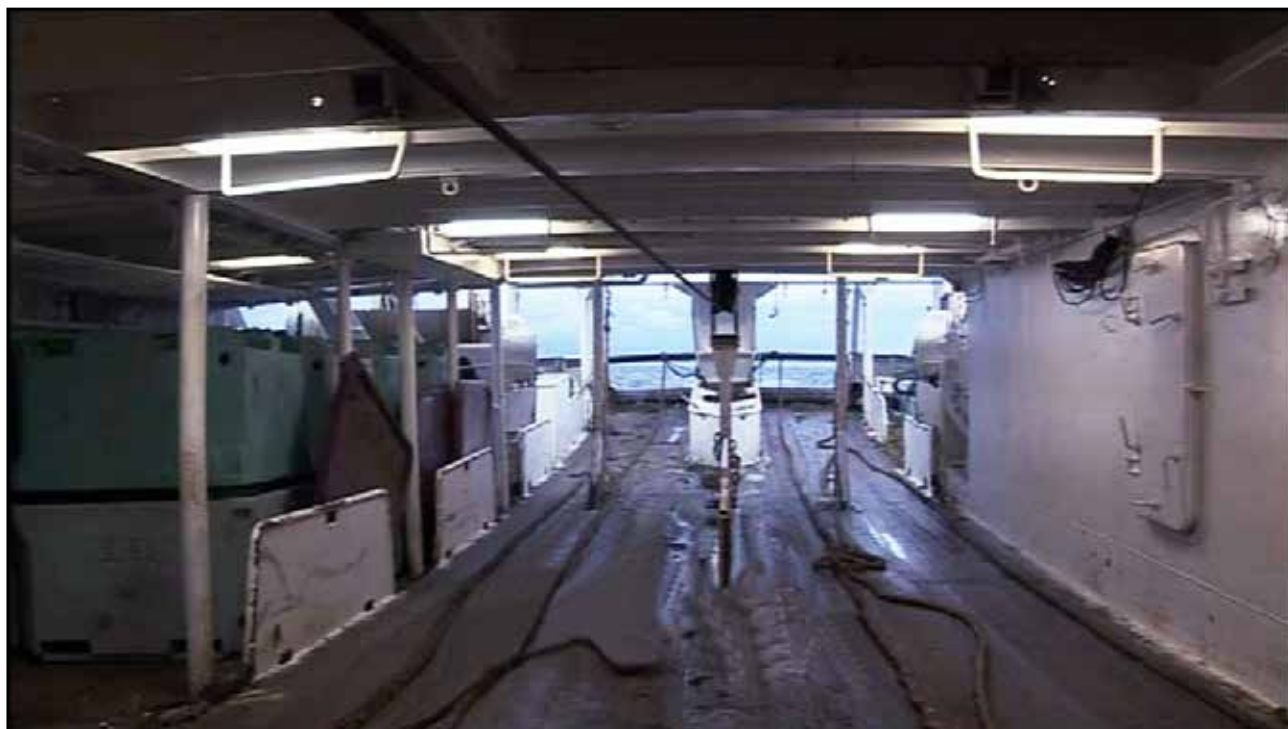
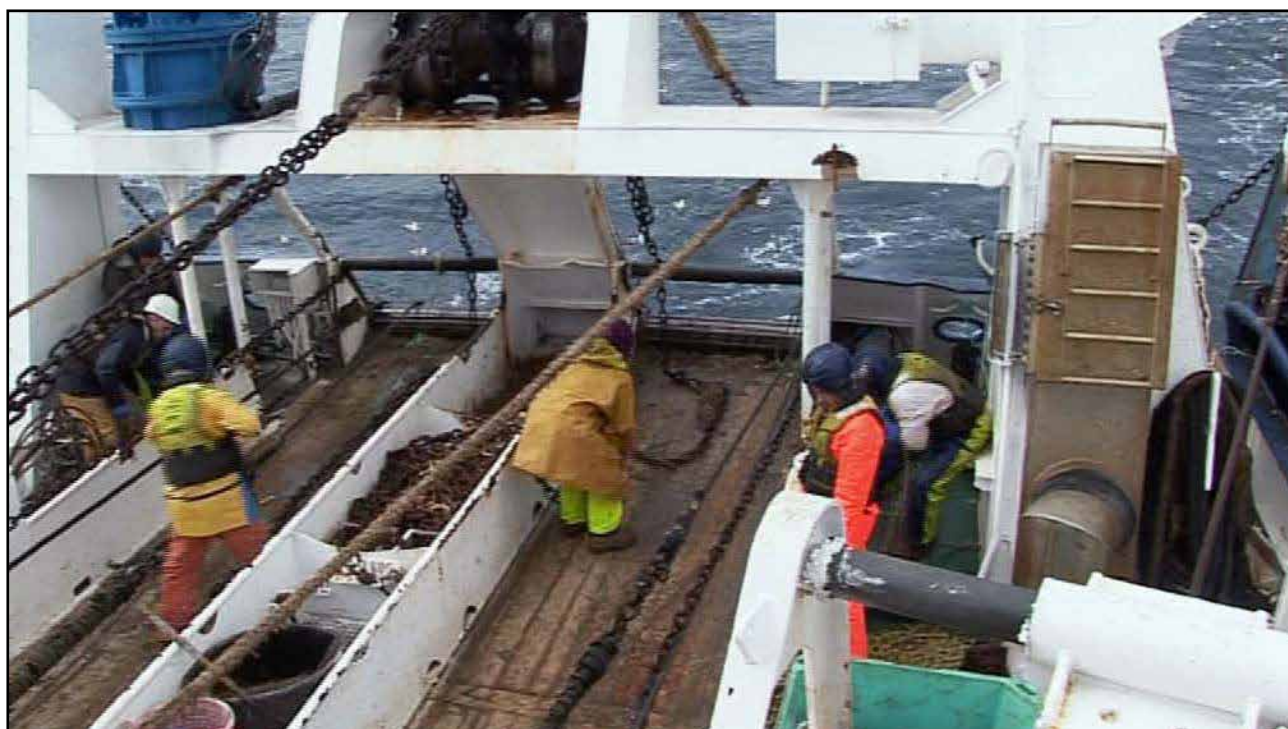
The vessel was a steel twin rig trawler with a deep bilge, bulbous forefoot and transom stern, incorporating a full length working area at upper deck level (**Figure 7**). Two gear hatches were fitted in the transom which gave access to a full length twin trawl track, the two trawl line winches (port and starboard) and the sweep line winch, forward.

Figure 7: Upper deck showing full length working area (taken on an earlier fishing trip)

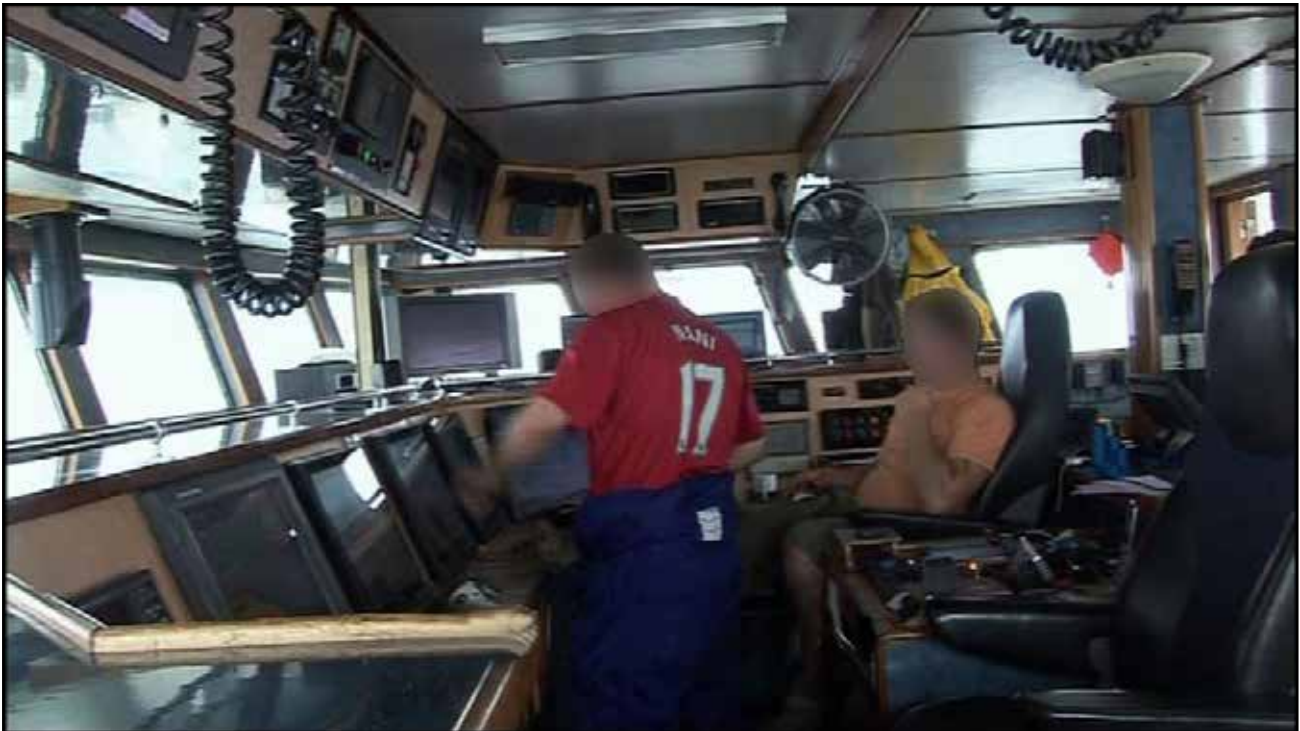
The wheelhouse was fitted with a full width console forward which incorporated the electronic fishing and navigational aids (**Figure 8**). The winch controls and auto-trawl system were located at the aft end of the wheelhouse, overlooking the stern area.

Figure 8: Wheelhouse – view at forward console

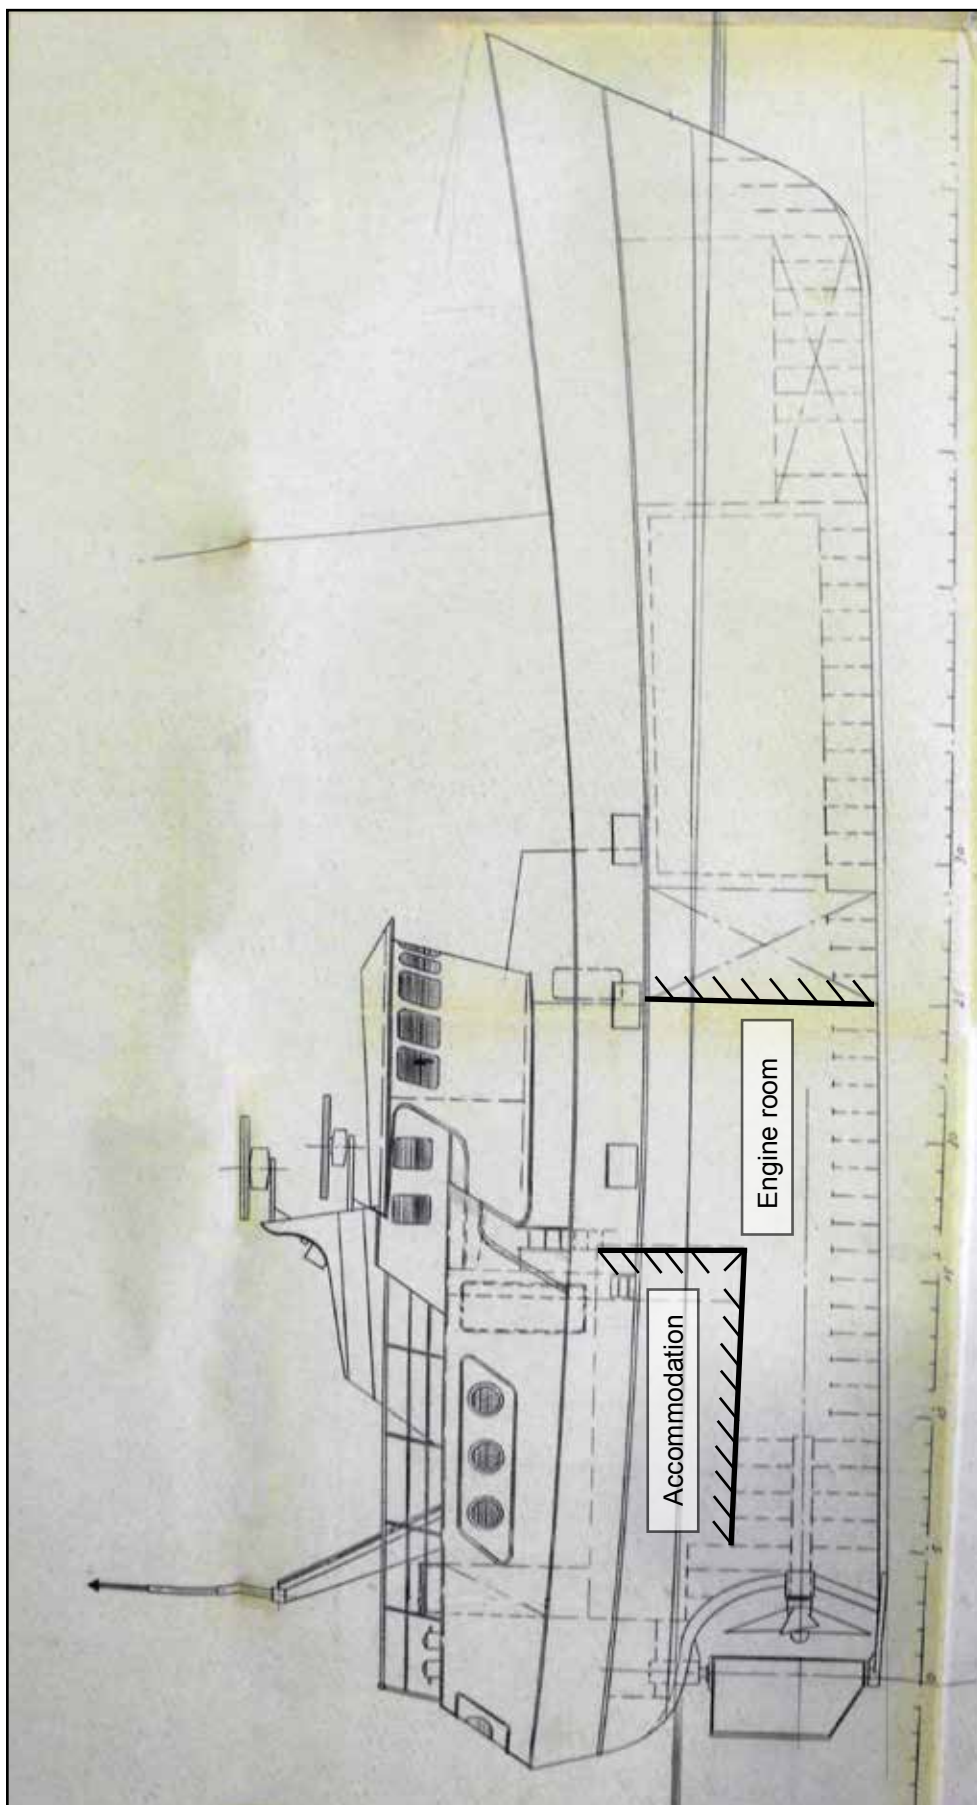
Figure 11: Chloe T — general arrangement
