Report on the investigation of the collision between

Alexander Tvardovskiy

UKD Bluefin and ***Wilson Hawk***

1 August 2012

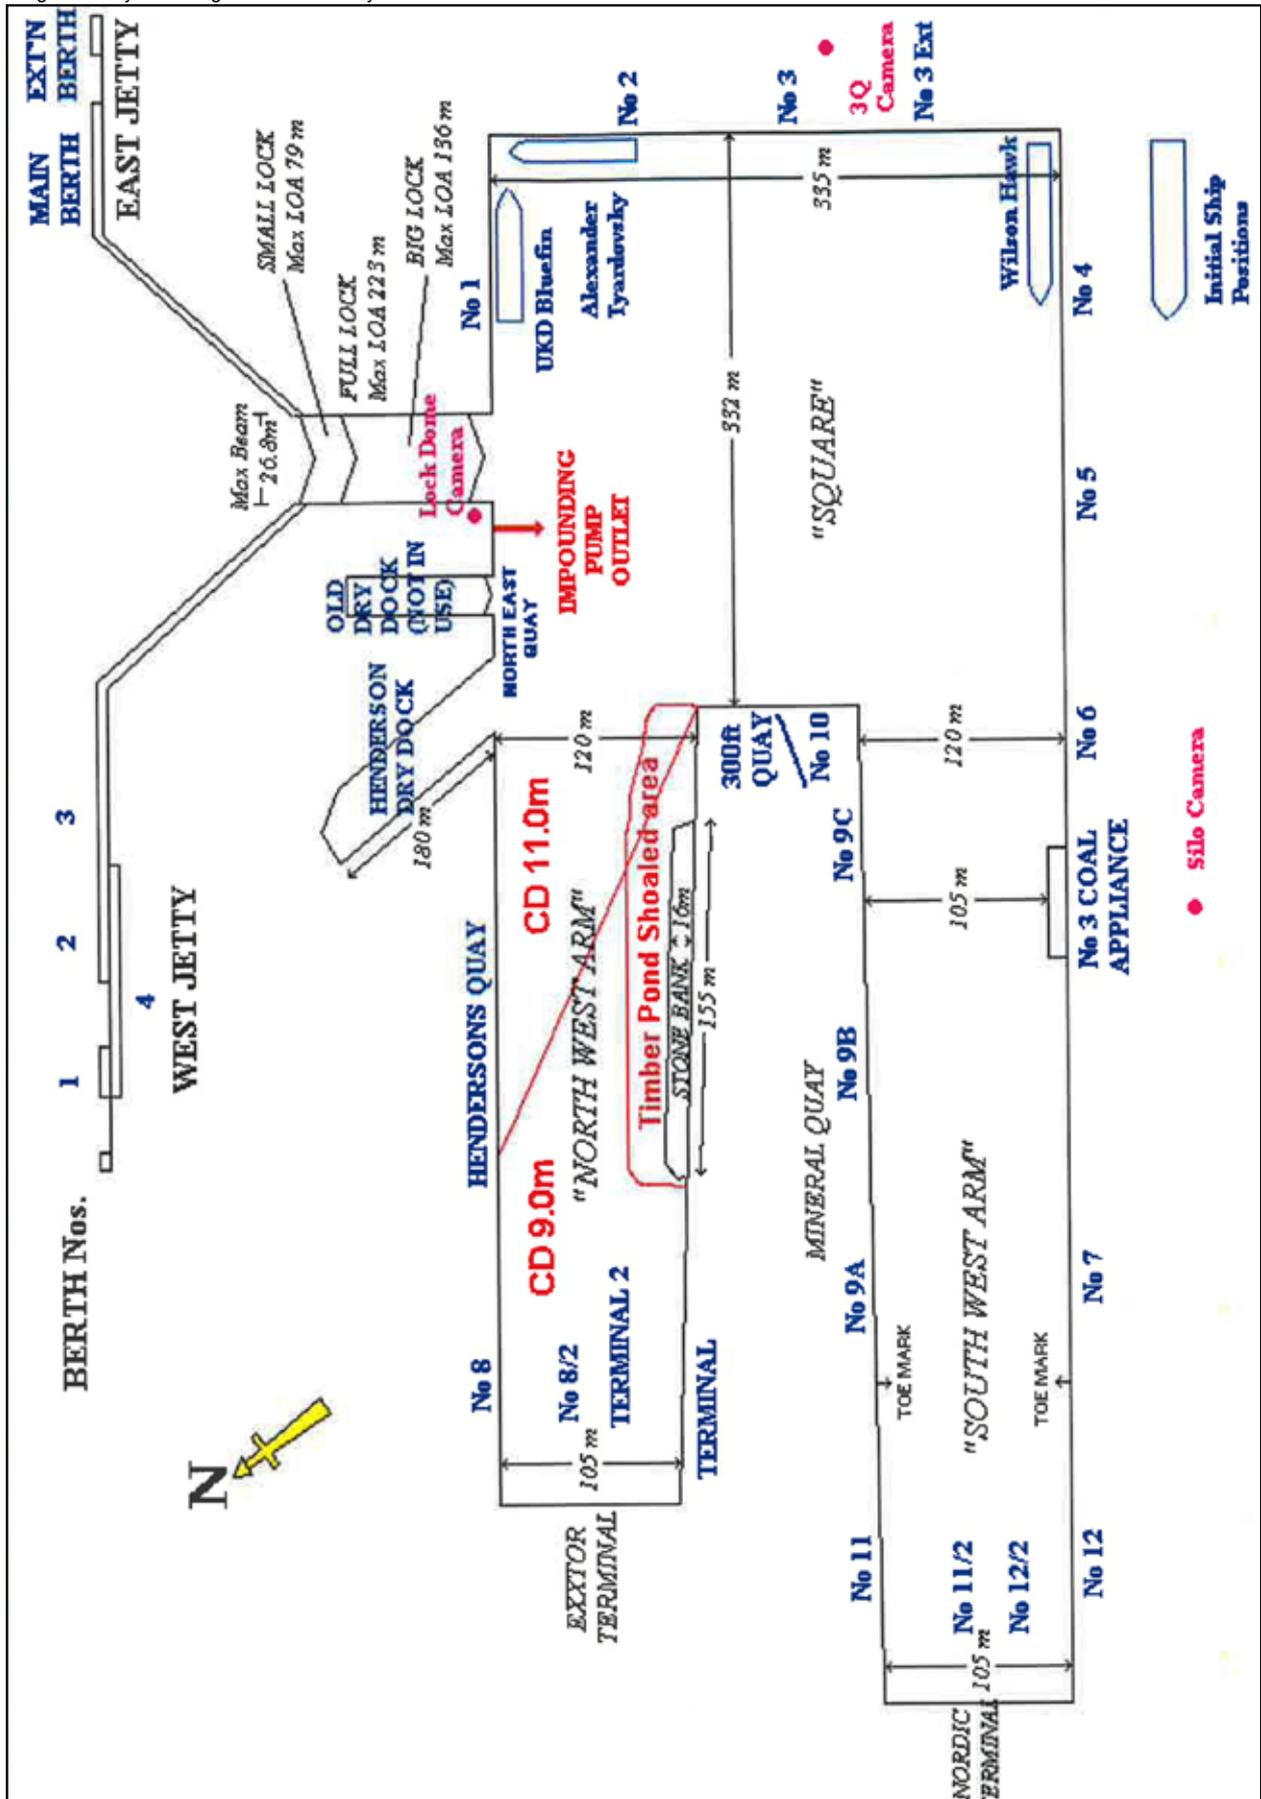
Figure 1: Immingham port layout

On 1 August 2012, the multi-purpose dry cargo vessel *Alexander Tvardovskiy* was scheduled to sail from berth 2 in Immingham, UK (**Figures 1 and 2**) for passage to Sunderland, UK. The vessel was in ballast.

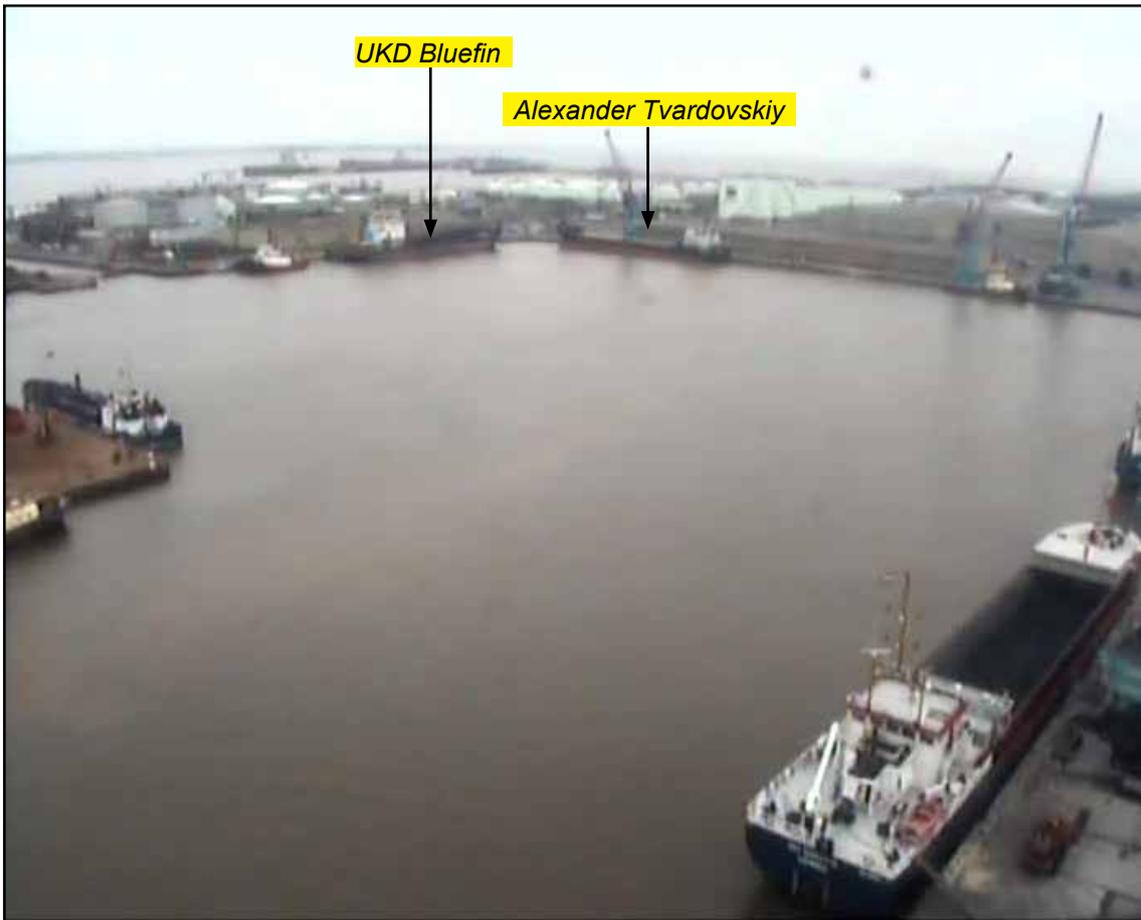
Figure 2: Port CCTV: *Alexander Tvardovskiy* alongside berth 2 in Immingham

At 1320, the pilot arrived on board and was met by the chief officer on the bridge. The chief officer confirmed to the pilot that the vessel was ready for departure and that there were no significant defects. He did not provide the pilot with a copy of the pilot card. At the time, the dredger *UKD Bluefin* was secured alongside berth 1 and the general cargo vessel *Wilson Hawk* was discharging her cargo at berth 4 (**Figures 1 and 2**).

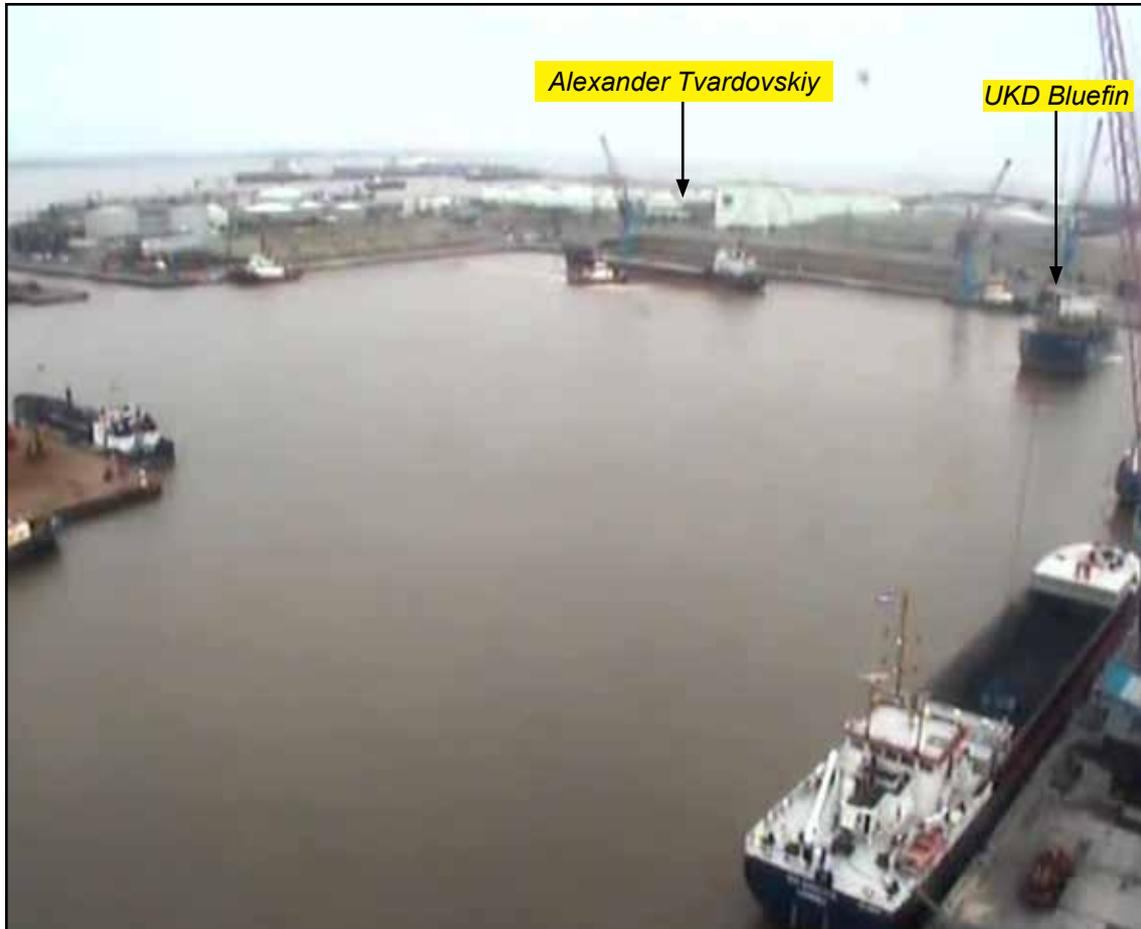
Figure 3: Port CCTV 1334 hrs: *Alexander Tvardovskiy* leaving her berth

When *Alexander Tvardovskiy* was about 40m off the berth (**Figure 3**), the master moved the bridge telegraph lever (**Figure 4**) to the 'dead slow astern' position, and the vessel started to move astern. The propeller shaft tachometer on the bridge control panel was not monitored.

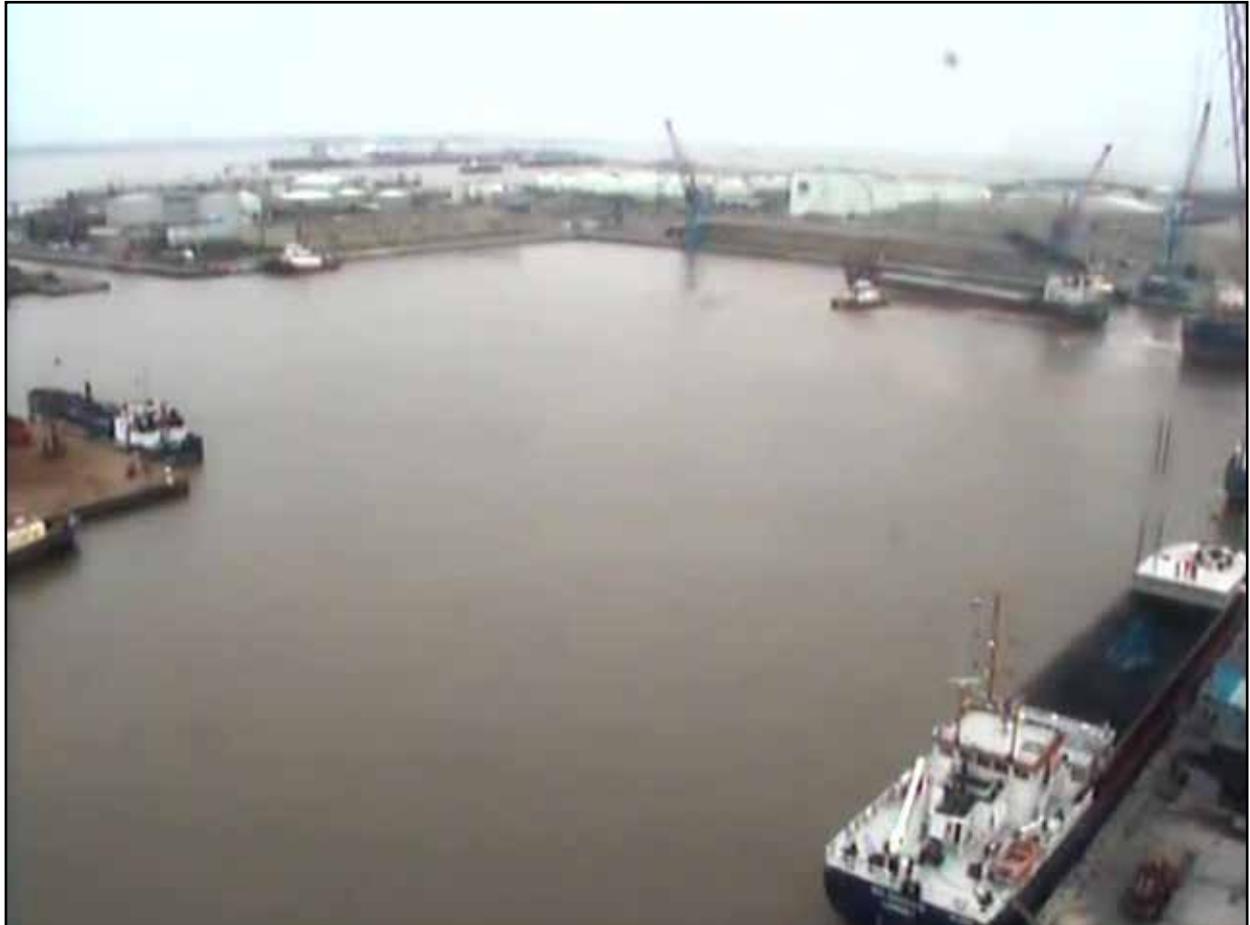
Figure 5: Port CCTV 1336 hrs: *Alexander Tvardovskiy* funnel smoke

At about 1335, the master moved the telegraph lever to the 'stop' position. However, the vessel did not slow as the master had expected, so he set the lever to 'slow ahead'. This action had no effect and *Alexander Tvardovskiy* continued to move astern at a speed of about 1 knot. As the vessel closed to within 50m of *UKD Bluefin*, which was stopped in the water parallel to and near *Wilson Hawk*, the pilot told the master that *Alexander Tvardovskiy* needed to be stopped. In response, the master moved the telegraph lever to 'full ahead'. The order of 'full ahead' was also passed verbally by the chief officer to the engine room over a fixed intercom system. The engine speed soon increased and a large cloud of black smoke emitted from *Alexander Tvardovskiy*'s funnel (**Figure 5**); the vessel's speed astern increased to about 2 knots.

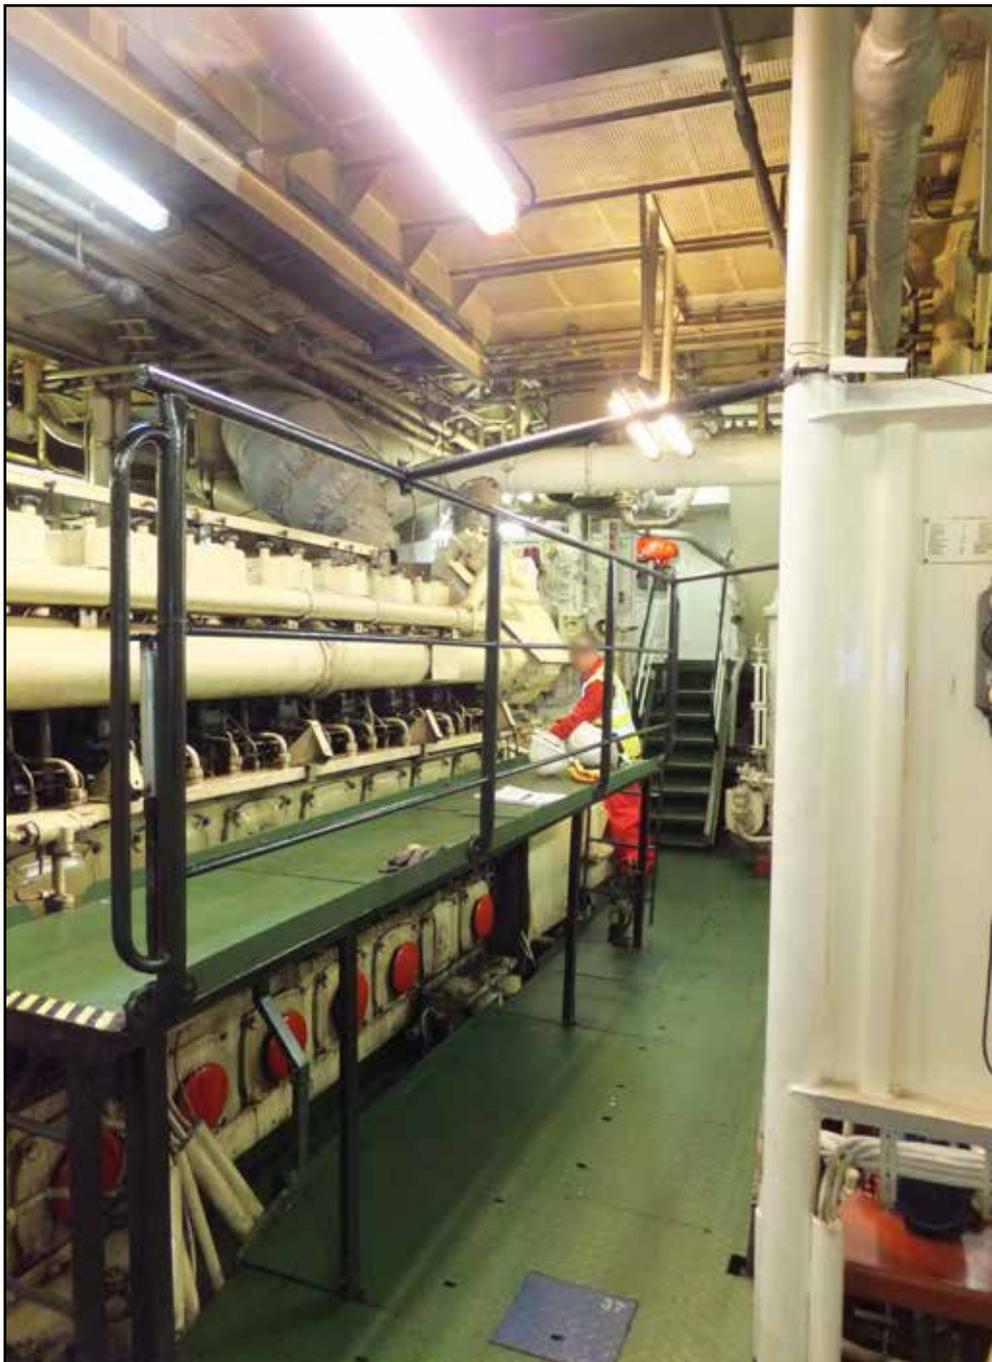
Figure 14: Main engine and gearbox as seen from the telegraph position

Alexander Tvardovskiy was powered by an 8 cylinder medium speed 4-stroke diesel engine, type VDS 29/24 AL, manufactured by SKL Motor GmbH (**Figure 14**), which had an output of 1890kW at a nominal speed of 900rpm and a rated (operational maximum) speed of 1000rpm. The engine's speed was regulated by a Heinzmann electronic governor. The engine's idle and minimum speed was 300rpm and the clutch engagement speed when coupling to the gearbox was 450rpm.

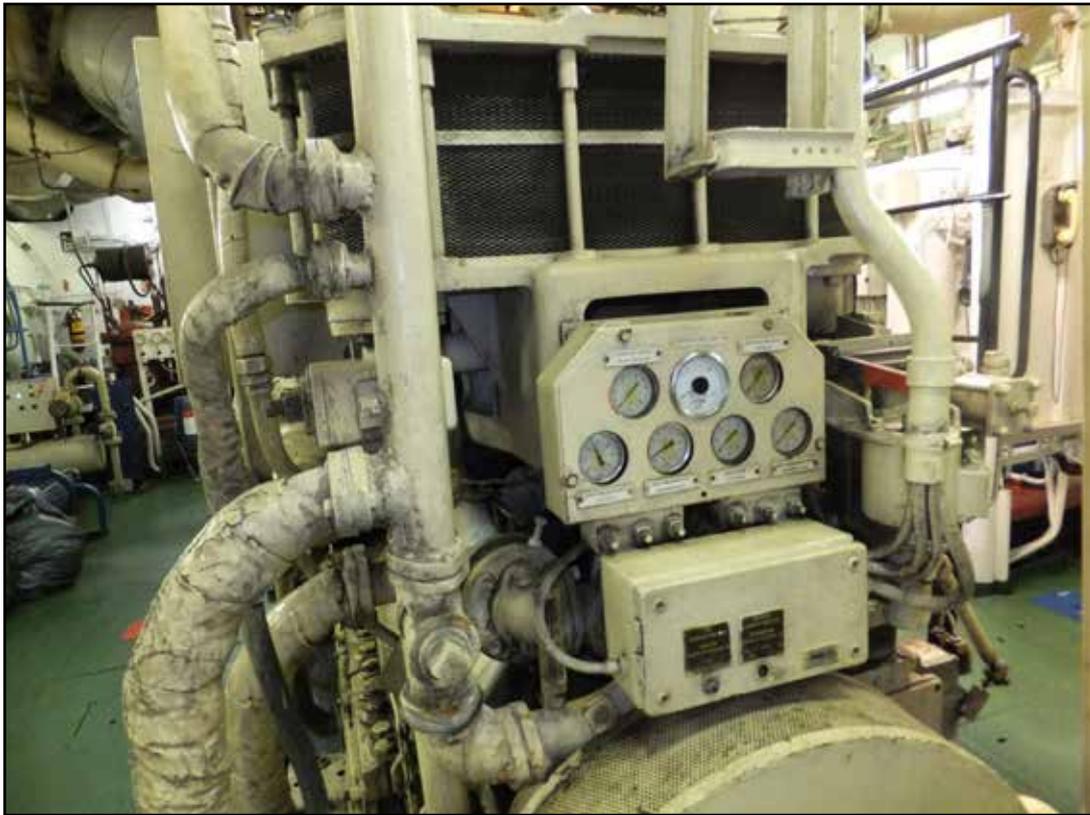
Figure 15: Main engine control panel

The engine could be stopped either electrically through a remote 'emergency stop' button on the bridge (**Figure 4**), or manually by the operation of a fuel rack lever on the engine. The engine's operating parameters were monitored on a control panel sited at its front (**Figure 15**).

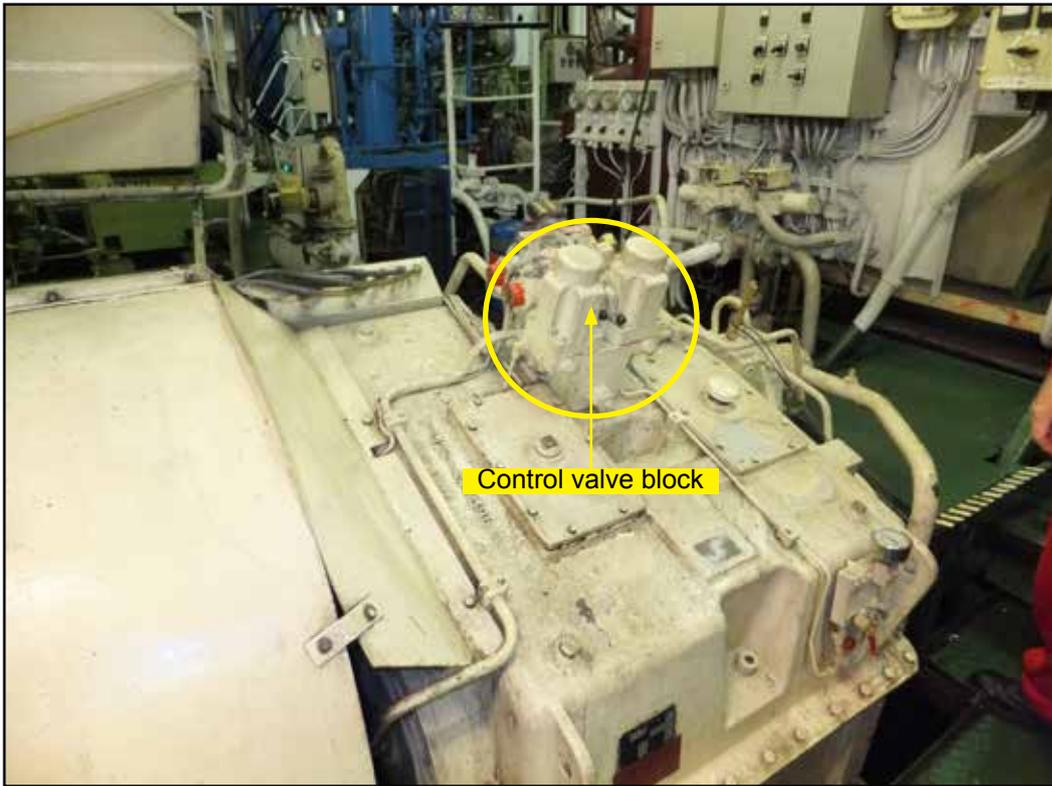
Figure 16: Main engine gearbox

The gearbox (**Figure 16**) was a Reintjes type WAF 1961 reverse reduction gearbox designed for use with a fixed pitch propeller. The gearbox was close-coupled to the main engine and incorporated hydraulically-operated disc clutches. The clutch was engaged and disengaged, and the direction of the gearbox (ahead or astern) was controlled via solenoid valves mounted on a control valve block on top of the gearbox.

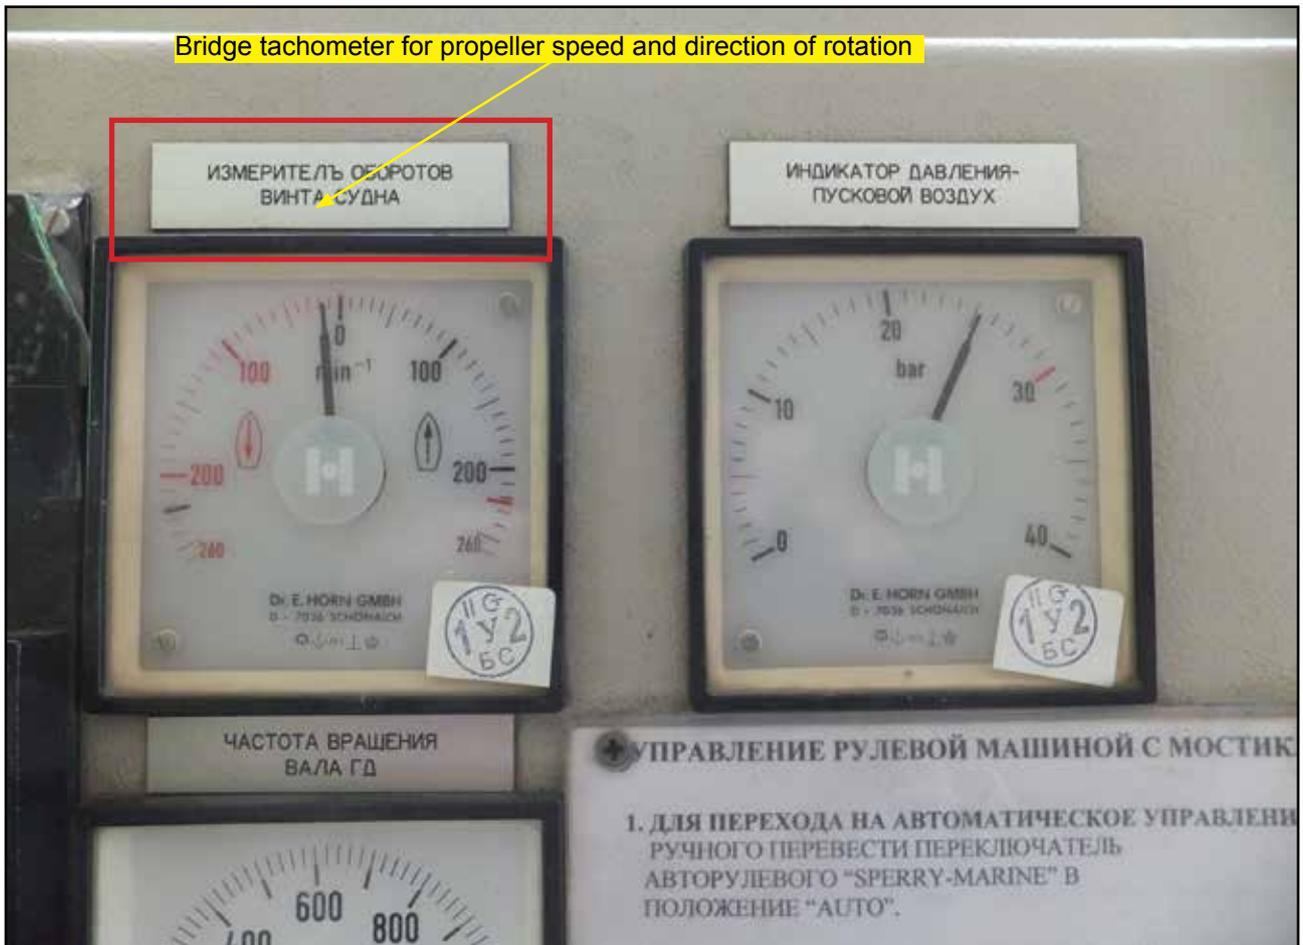
Figure 17: Bridge tachometer for propeller speed and direction of rotation

A propeller tachometer was sited on the central console on the bridge that indicated the speed and direction of rotation of the propeller shaft (**Figures 4 and 17**).

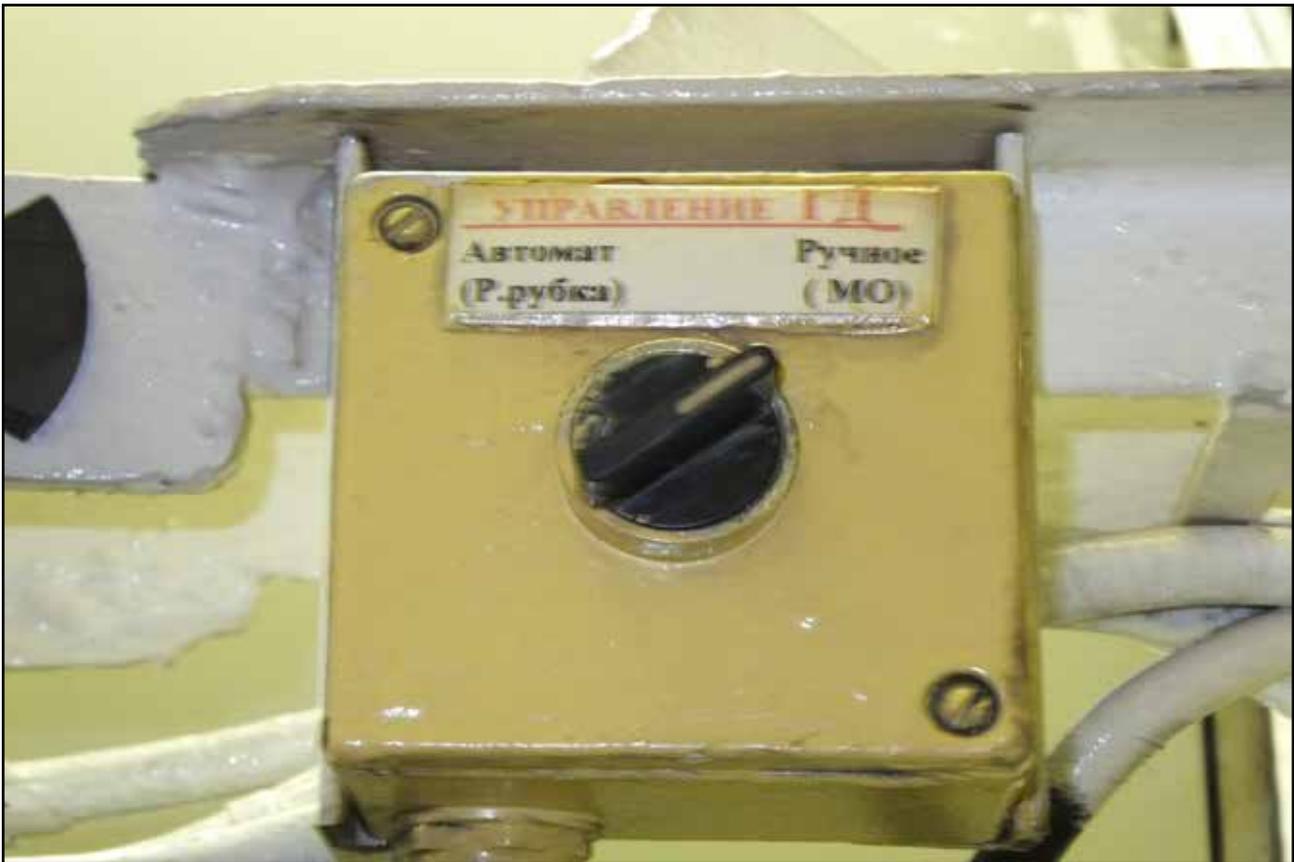
Figure 18: Changeover switch: automatic or manual control

The main engine speed governor and the gearbox solenoids could be controlled either automatically from the bridge or manually in the engine room. A two-position switch to enable the changeover between automatic and manual propulsion control was situated adjacent to the engine room telegraph (**Figure 18**).

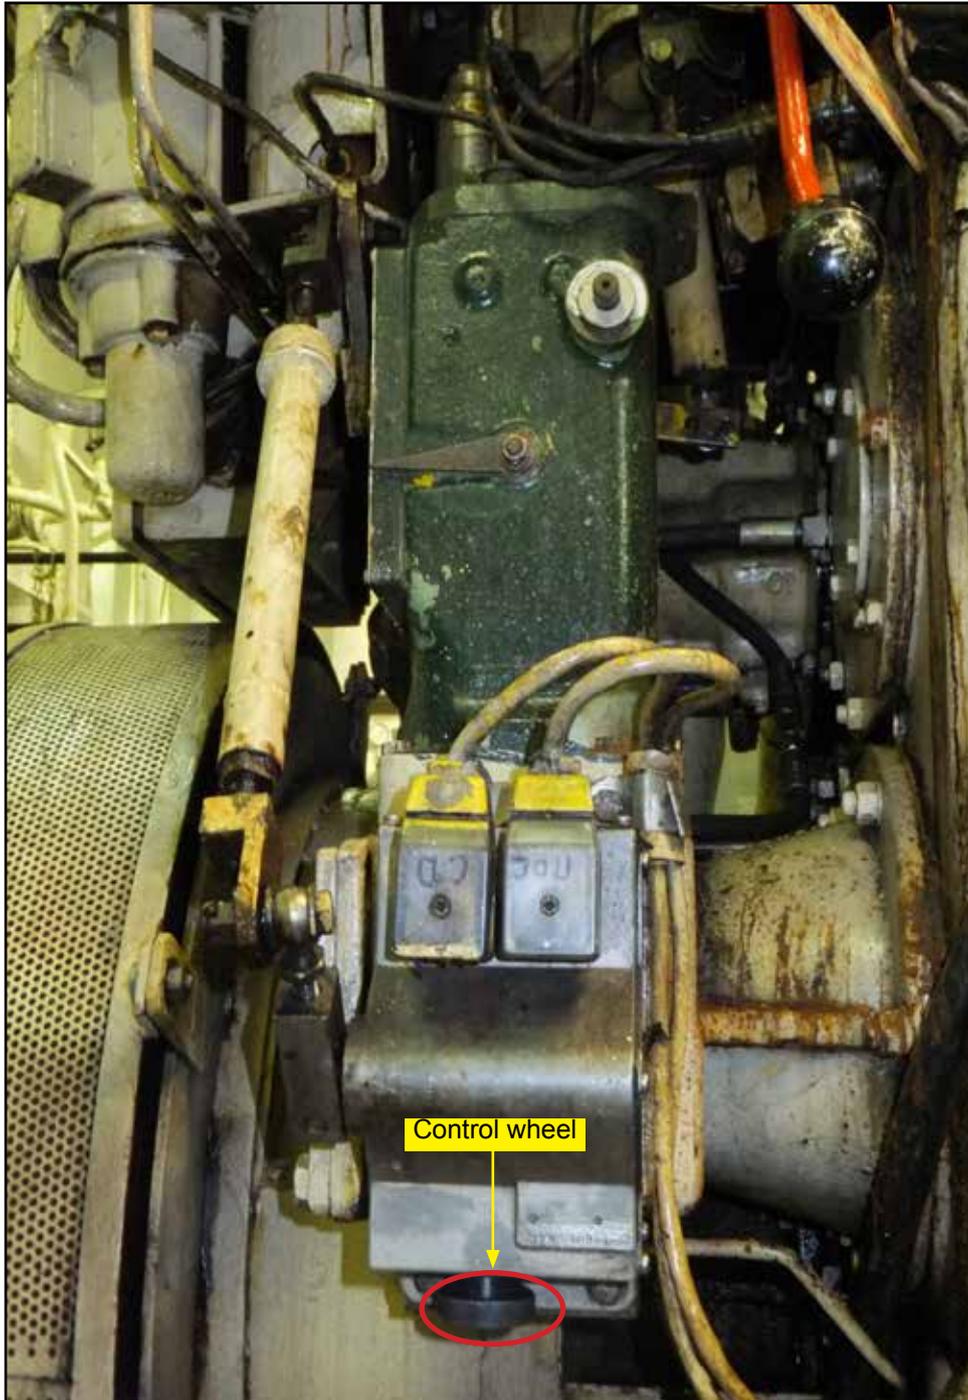
Figure 19: Main engine governor

and gearbox were disabled and the demanded propulsion setting was displayed on a repeater in the port forward corner of the engine room. Engine room personnel then made the necessary changes. The speed governor was adjusted using a wheel at its base (**Figure 19**) while the gearbox solenoids were activated using dedicated metal pins to push the actuating shafts (**Figure 20**).

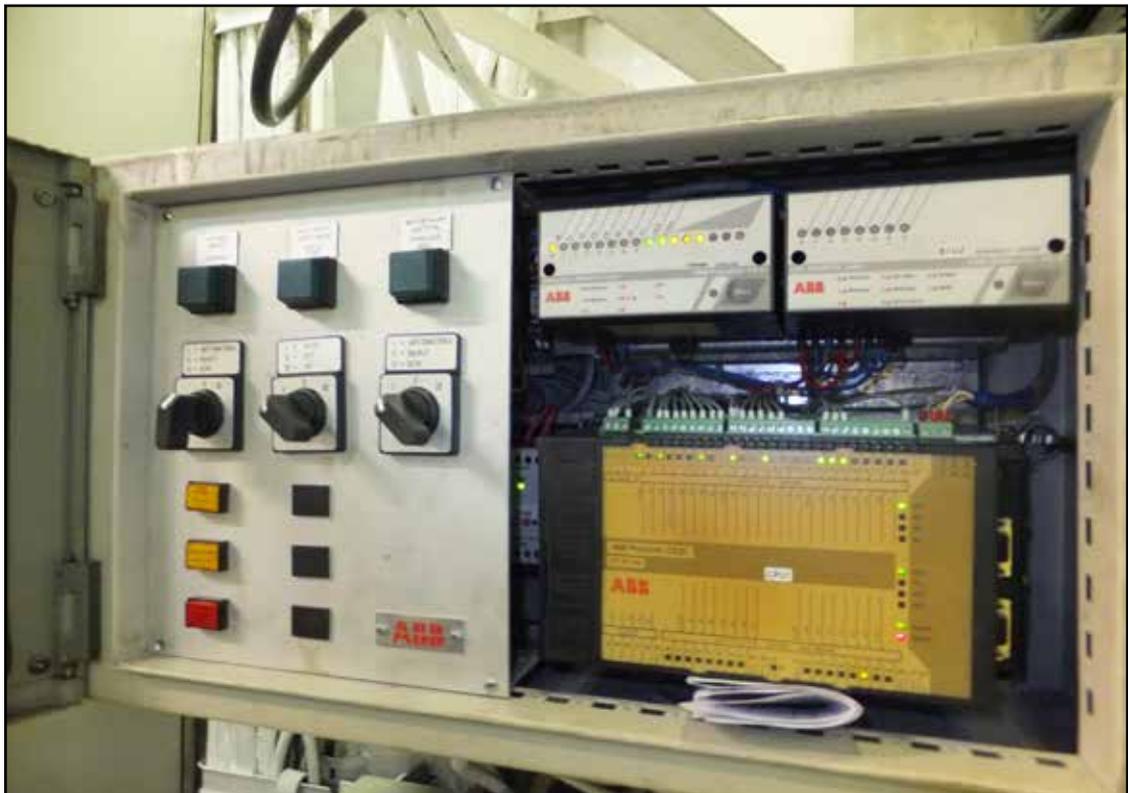
Figure 21: ABB bridge control panel

The telegraph was linked to a programmable electronic remote control system, ABB type RC94-RRG (**Figure 21**), designed for use with reversing reduction gear systems and fixed pitch propellers. The remote control system was type approved by Lloyd's Register (LR), GL and Bureau Veritas (BV), and included:

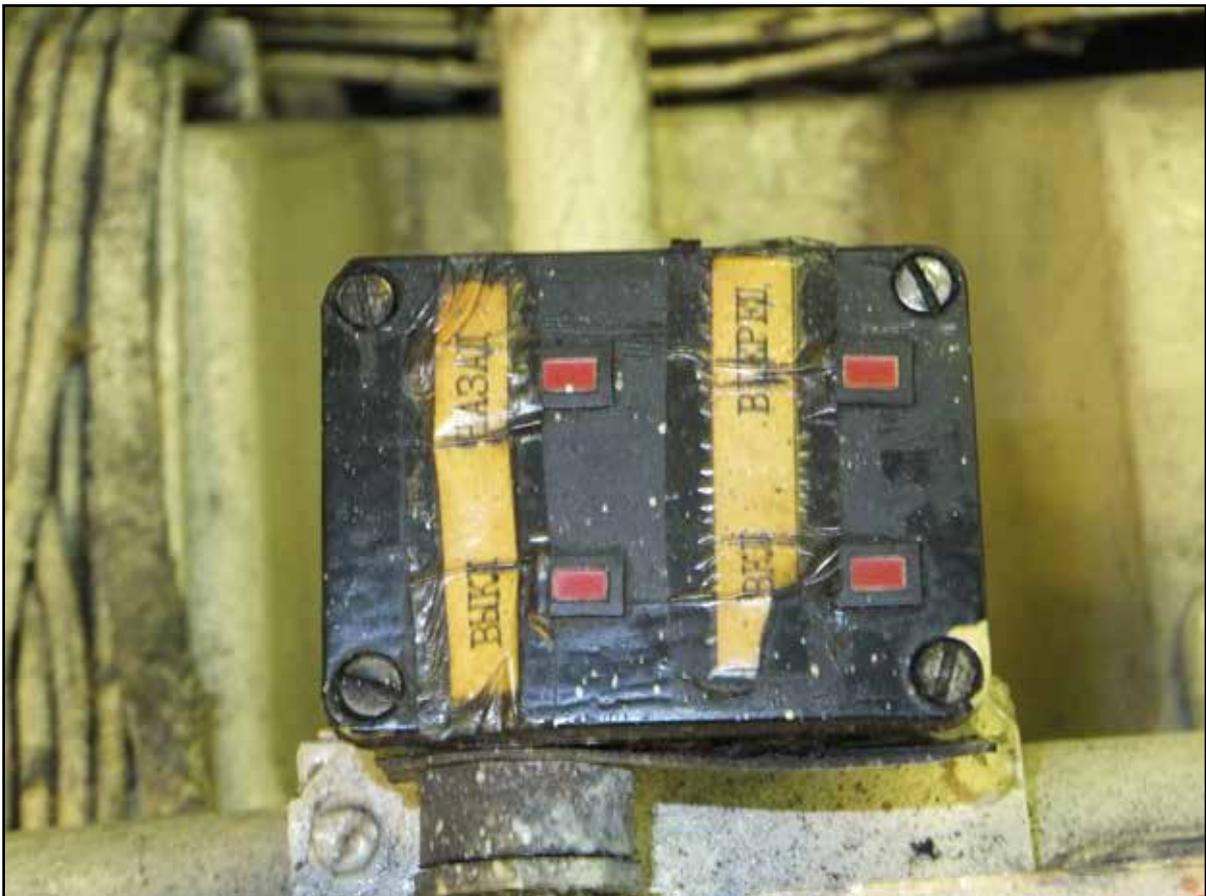
Figure 22: Solenoid valves indicator lamps

During operation in automatic control, four red lamps adjacent to the control valve box on the gearbox (**Figures 20 and 22**) indicated which solenoids were energised, for example 'clutch in' and 'astern'. These lamps did not illuminate when operating in manual control.

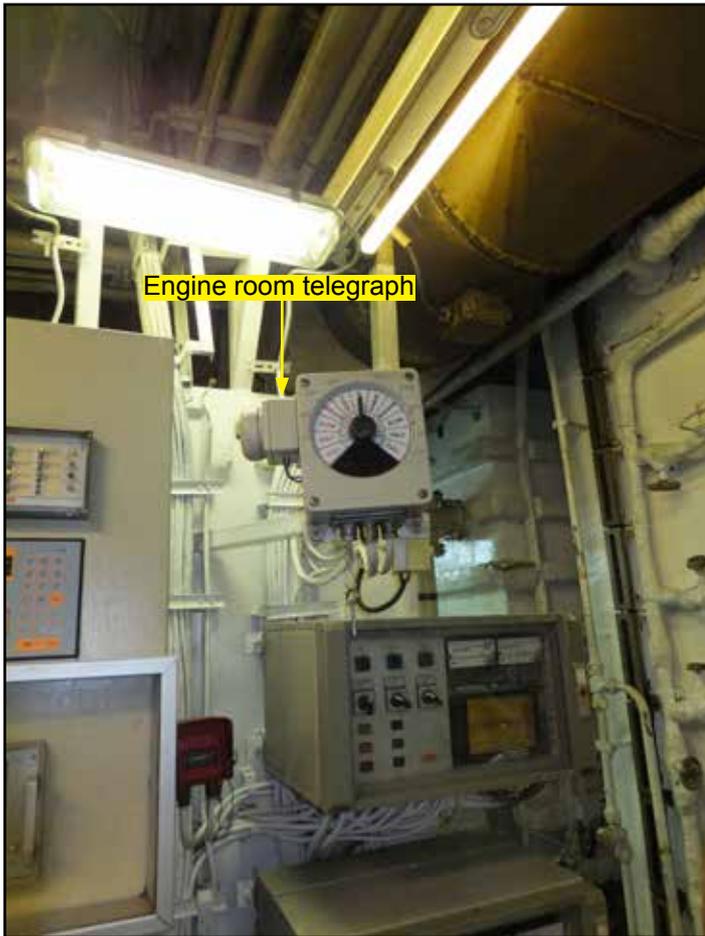
Figure 24: Engine room telegraph

On 1 August 2012, the manual control of the propulsion system was undertaken by the chief engineer, the second engineer and the electrician (**Figure 23**). The electrician operated the engine room telegraph repeater indicator pointer (**Figure 24**) to confirm receipt of bridge orders, the chief engineer operated the solenoid control valves on top of the gearbox for the clutch and ahead or astern gears (**Figure 20**), and the second engineer operated the control wheel on the main engine governor to control the engine speed (**Figures 19 and 25**).

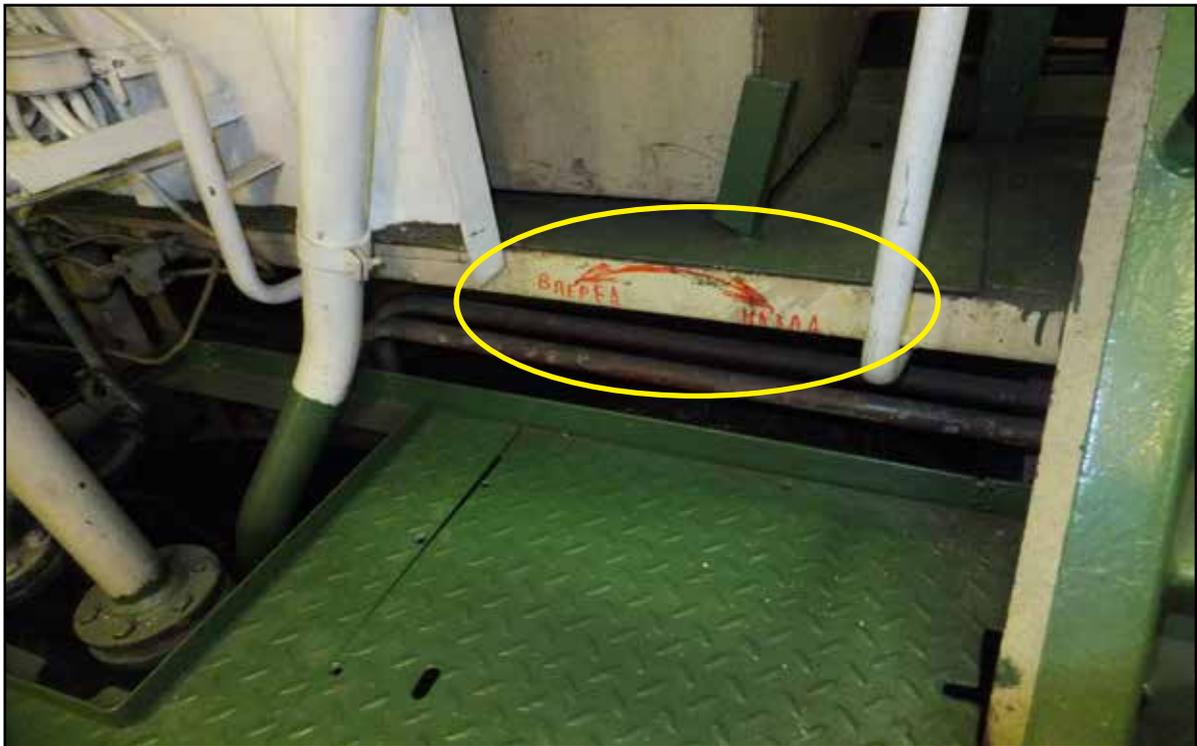
Figure 26: Signage showing the direction of shaft rotation in the engine room

The second engineer monitored the engine speed by observing a tachometer on the engine control panel. The chief engineer was able to check the direction of shaft rotation by comparing the shaft movement against a double-headed arrow which had been roughly painted onto a deck plate step above the propeller shaft (**Figure 26**). This required the chief engineer to use a torch in order to see the shaft below the engine room deck plates, during which time he had to turn away from the electrician.

Once the 'astern' rather than the 'ahead' solenoid was operated, the error could have been quickly identified and rectified had the chief engineer checked that the propeller shaft was rotating in the desired direction. However, as the indicator lamps on the solenoid valve block did not work when in manual control, this was only possible by referencing the shaft's movement against the double-headed arrow marked above the deck plates (**Figure 26**).
